**DESIGNATED SUBSTANCE SURVEY
143-153 ARLINGTON AVENUE, OTTAWA, ONTARIO**

Centretown Citizens Ottawa Corporation
PO Box 2787, Station D
Ottawa, Ontario
K1P 5W8

September 2013

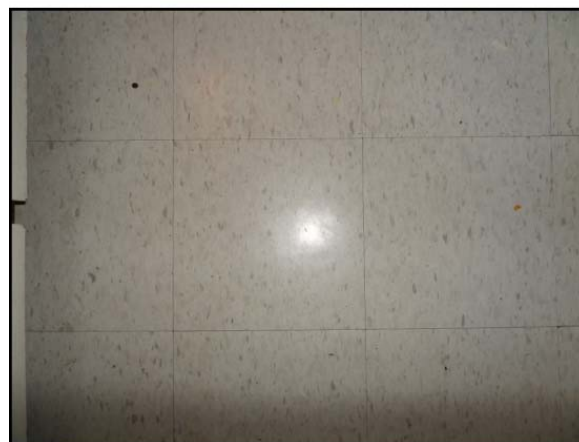
According to the analytical results, the following flooring building materials are **NON DETECT** for asbestos (Photograph 2):

- 12” x 12” vinyl floor tiles (light beige with blue streaks), Kitchen, 1-145 Arlington Avenue;
- 12” x 12” vinyl floor tiles (light beige with brown specks), Kitchen, 2-145 Arlington Avenue.

Photograph 2 - Flooring **NON-DETECT** for asbestos.
TOP: 12”x12” vinyl floor tiles (light beige with blue streaks) from the Kitchen at 1-145 Arlington Avenue.
BOTTOM: 12’x12” vinyl floor tiles (light beige with brown specks) from the Kitchen at 2-145 Arlington Avenue.
