FINAL
Baseline Property
Condition Assessment

151 Metcalfe Street, Ottawa,
Ontario

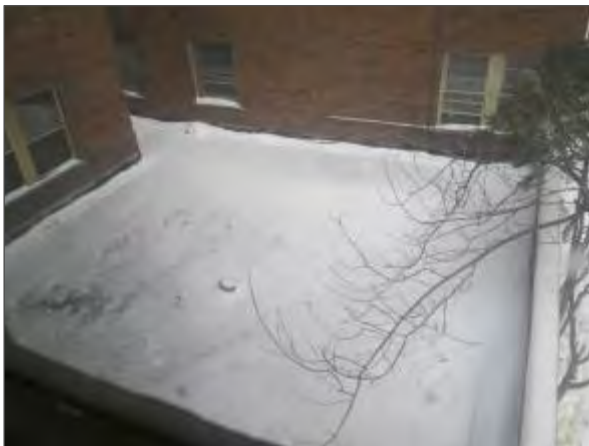
View of the snow covered roof system atop the UPG roof on the south portion of the building.

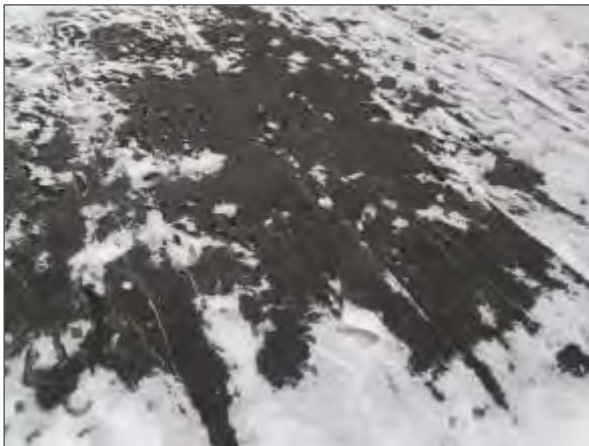
View of cracking and deterioration noted in the mop-on membrane on the north UPG roof.

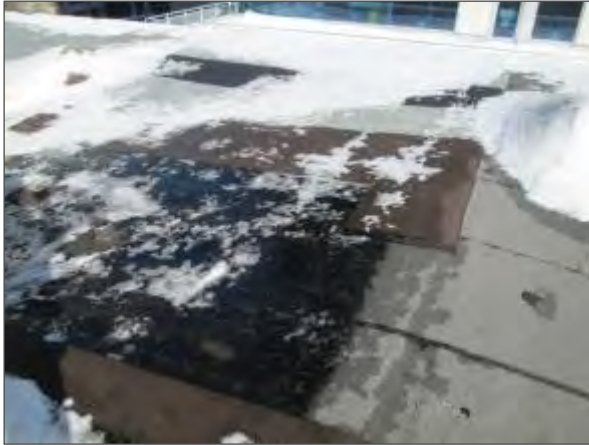
View of several patch repairs noted on the main roof of the building atop the fourth floor.

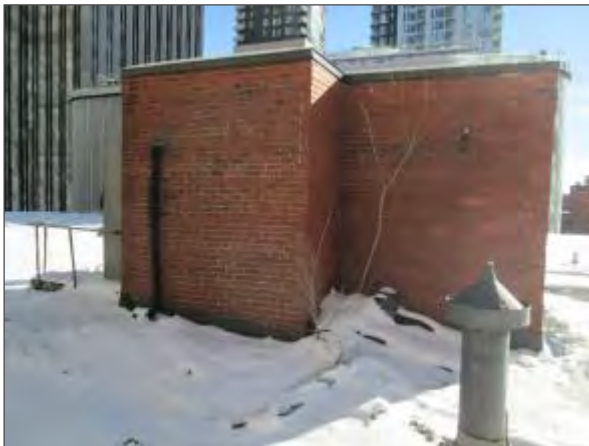
View of vegetative growth noted near the exterior wall of the stairwell penthouse on the main roof.

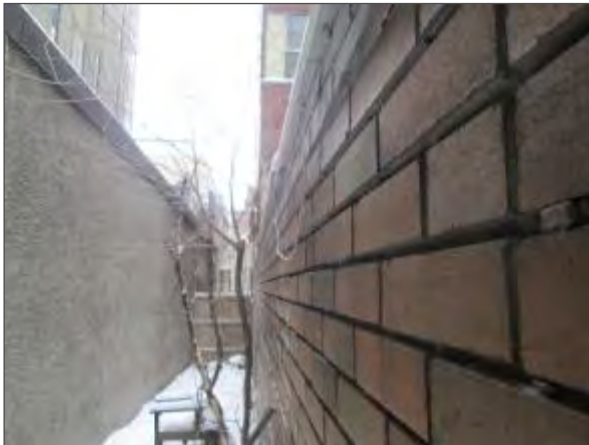
View of an area of brick masonry on the north elevation of the building (wall which flanks the UPG) which has a slight bulge.

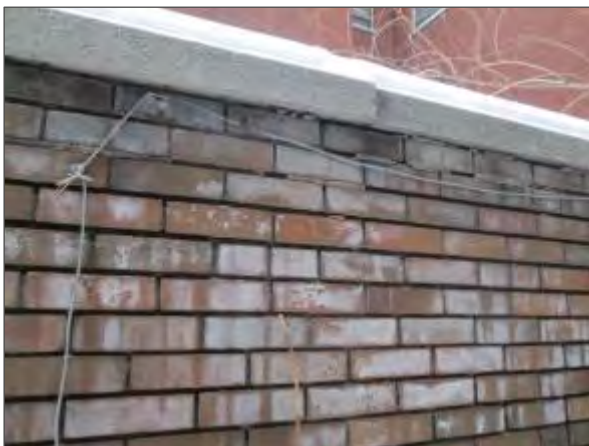
View of deteriorated mortar joints, efflorescence and a displaced concrete coping stone noted on the portion of the exterior wall which is slightly bulged.

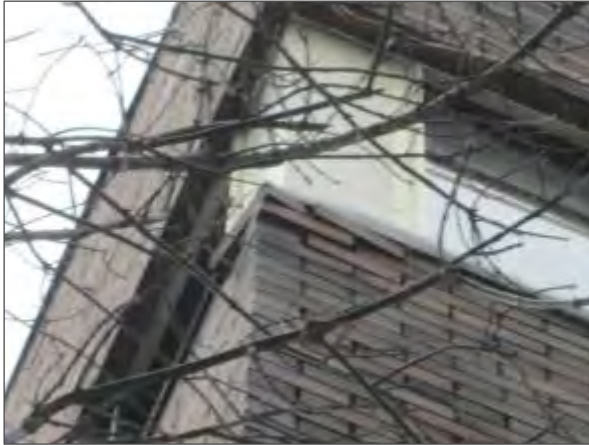
View of loose brick masonry units noted on the south elevation of the building.

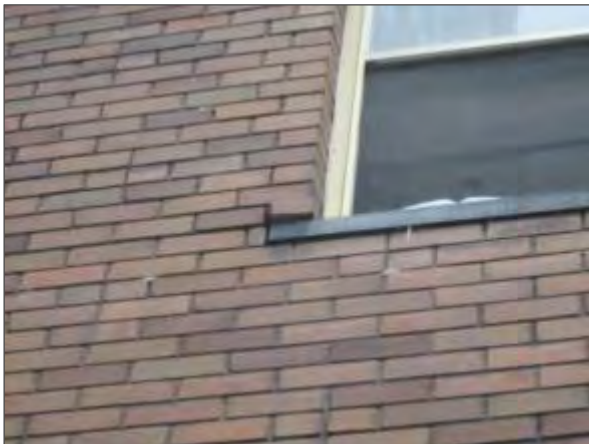
View of a loose brick masonry unit noted on the west elevation of the building.

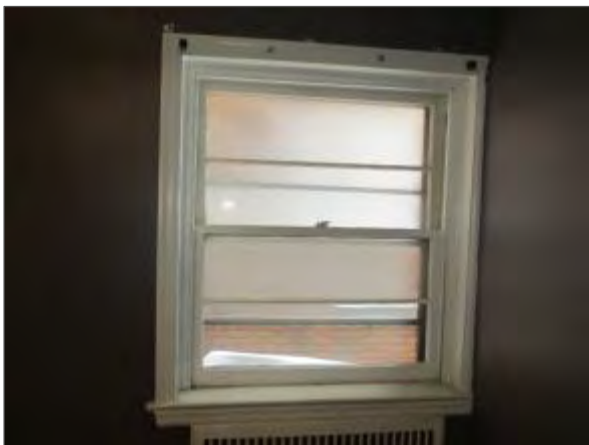
View of a typical older wood framed window serving the majority of the building.

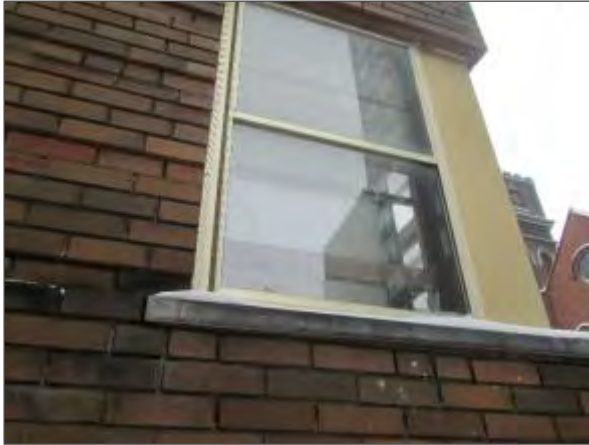
View of a cracked glazing unit noted on a storm window on the north elevation.

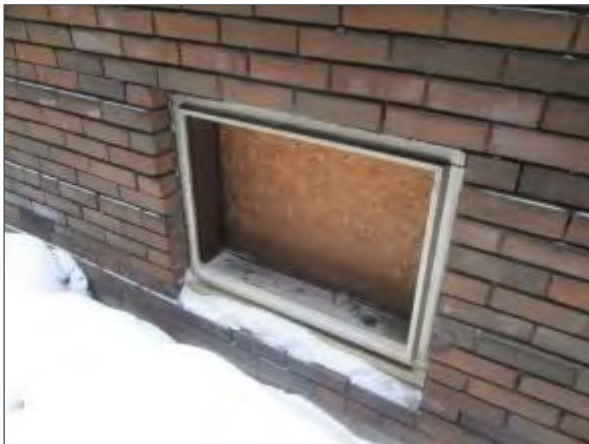
View of a missing window unit which has been covered with plywood on the north elevation of the building.

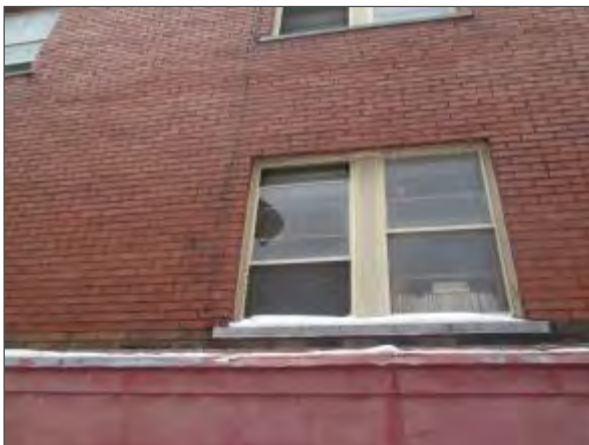
View of a cracked glazing unit noted on a storm window on the east elevation of the building.

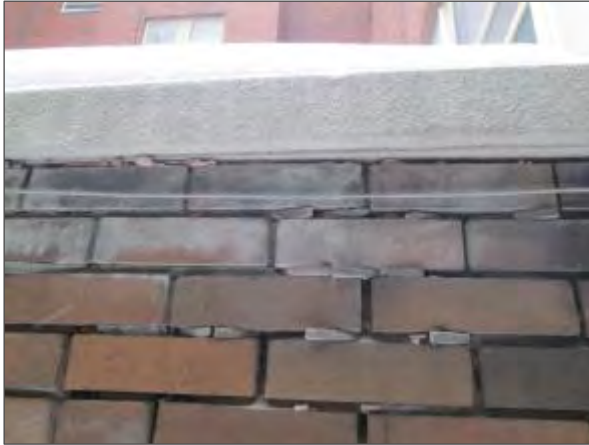
View of deteriorated mortar joints noted in the brick masonry on the south elevation and a crack in the concrete coping stone.

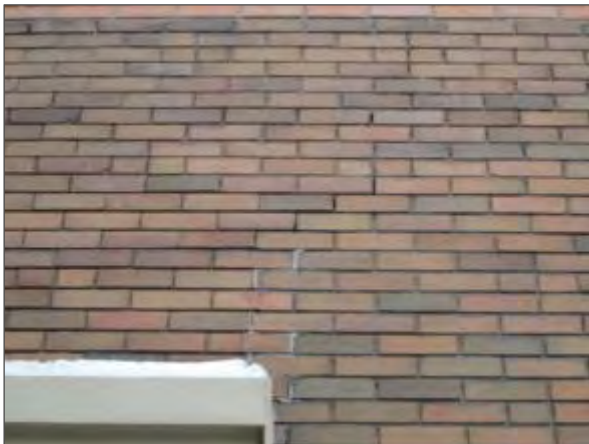
View of cracked masonry units and deteriorated mortar joints noted in the brick masonry on the west elevation of the building.

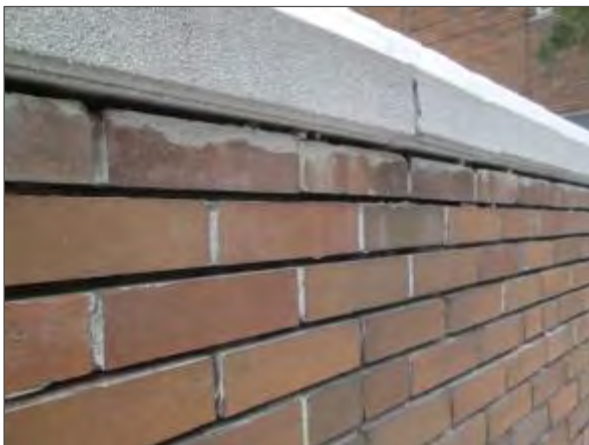
View of deteriorated mortar joints noted within the brick masonry on the south elevation of the building.

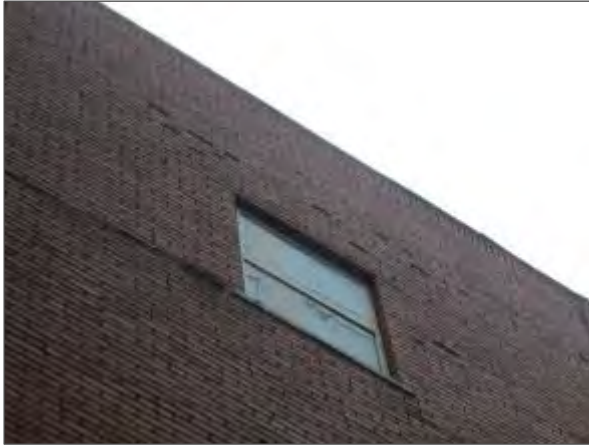
View of spalled brick masonry units noted at the top of the east elevation of the building.

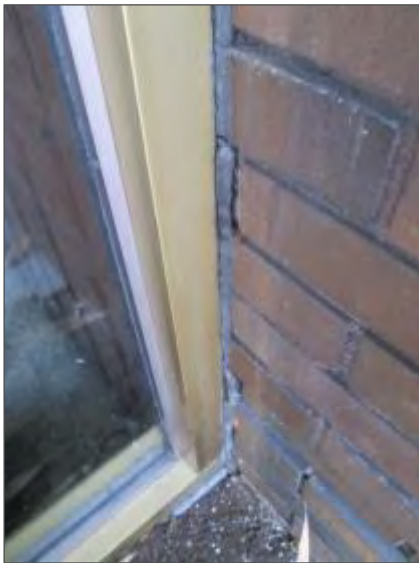
View of a cracked and deteriorated perimeter window sealant serving the fixed main entrance windows on the west elevation of the building.

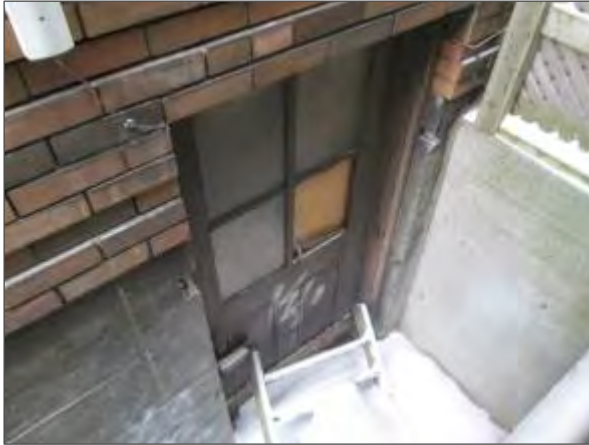
View of the old and damaged secondary access door to the boiler room which is reportedly no longer used.

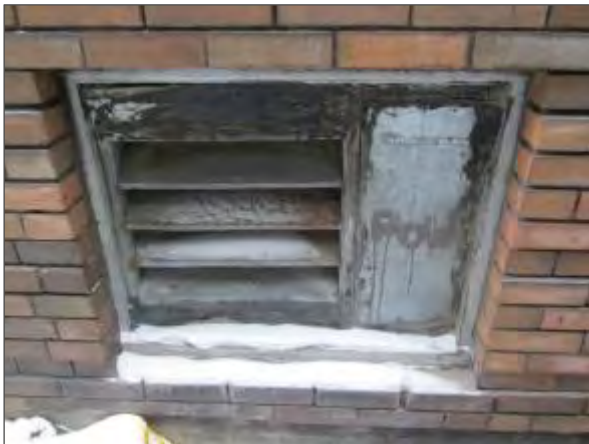
View of faded paint finishes and deteriorated sealants on the boiler room ventilation louver.

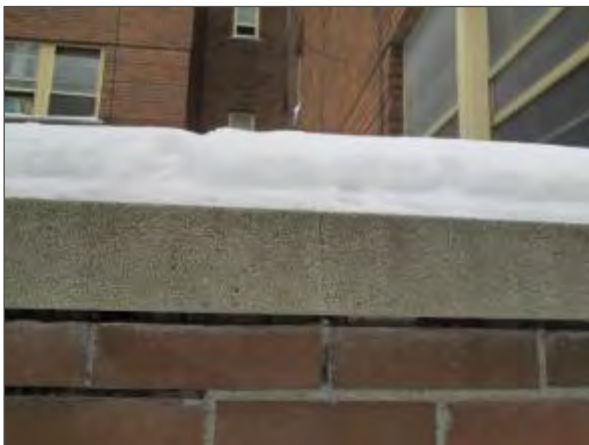
View of a small crack noted in a concrete coping stone on the south elevation of the building.

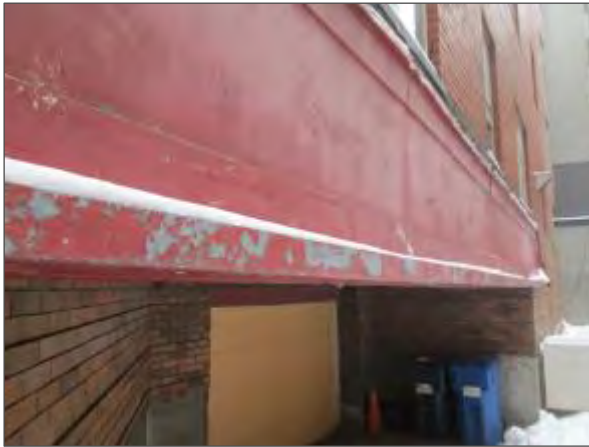
View of deteriorated paint finishes noted on the metal cladding above the overhead door serving the UPG on the east elevation of the building.

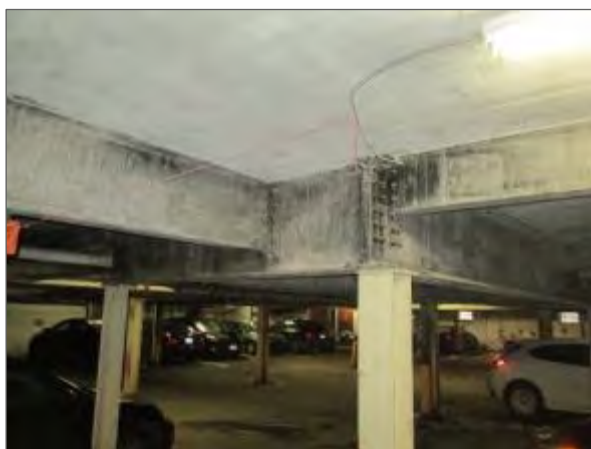
View of the steel beams and columns located in the UPG of the building which support the central portion of the building.

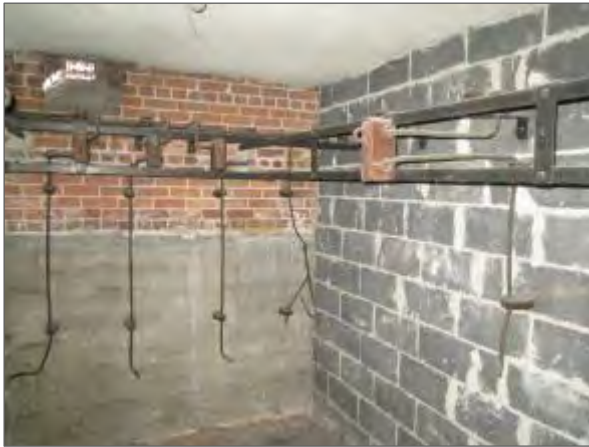
View of a combination cast-in-place concrete and solid brick masonry foundation wall as well as a typical cinder block masonry demising wall.

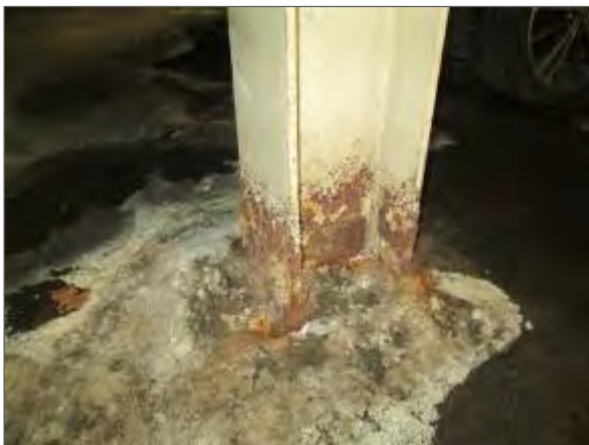
View of severe corrosion noted at the base of a column within the UPG.

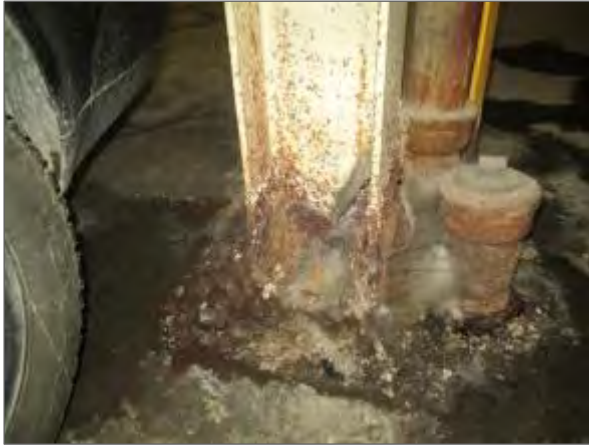
View of severe corrosion noted at the base of a column within the UPG.

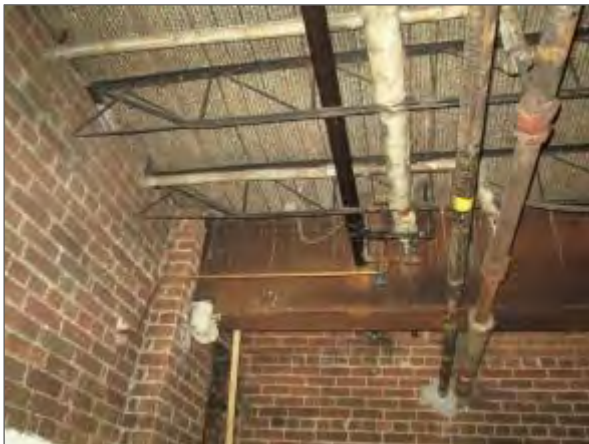
View of corrosion on a steel beam in the basement of the building.

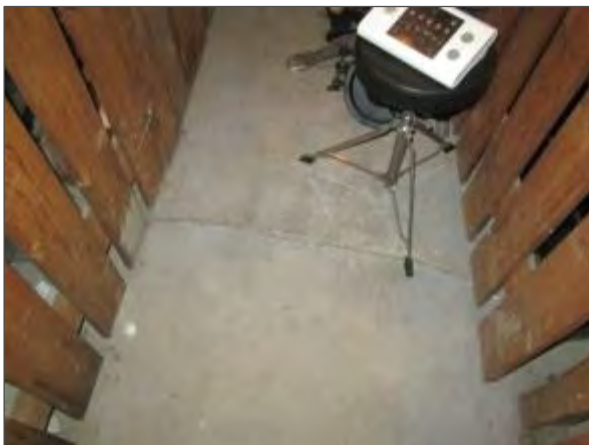
View of cracking noted in the concrete floor slab in a basement locker room.

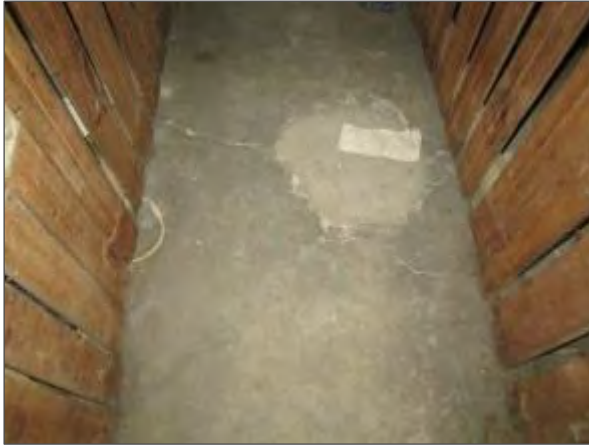
View of cracking noted in the concrete floor slab in a basement locker room.

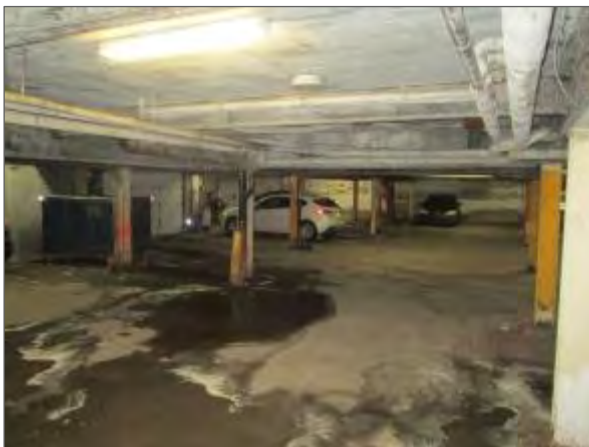
General view of the UPG serving the Site Building.

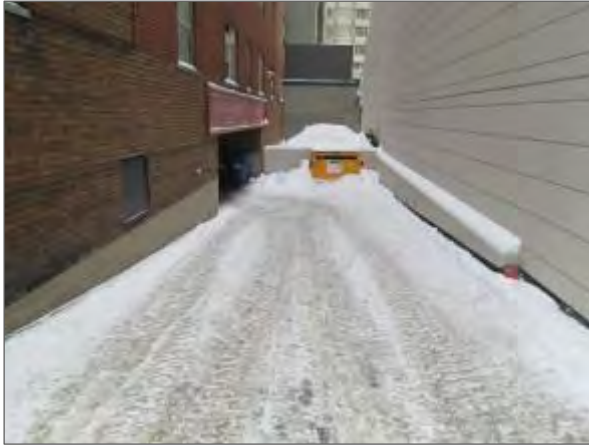
View of the UPG access ramp located on the east portion of the Site.

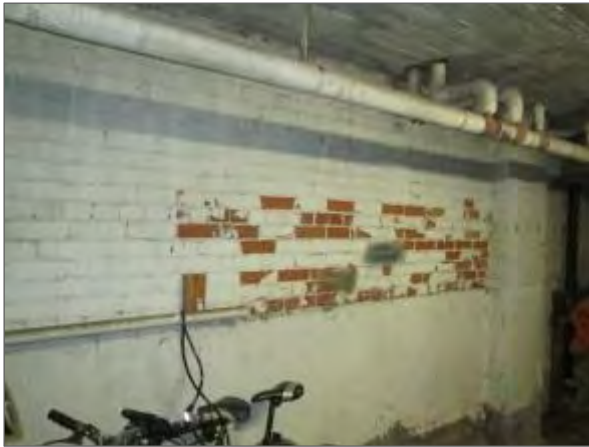
View of spalling brick masonry noted on the south foundation wall of the UPG.

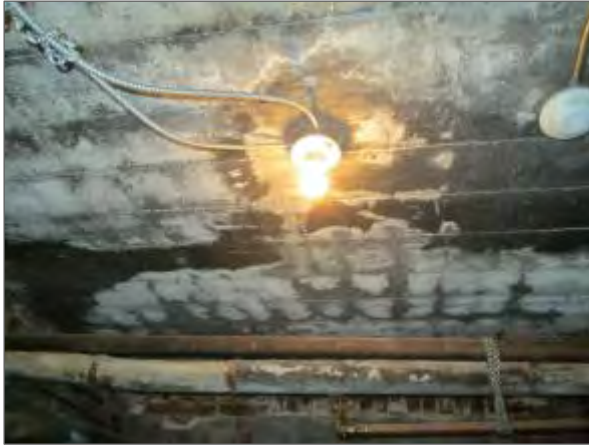
View of efflorescence noted on the soffit of the UPG roof deck within a service room in the northwest portion of the UPG.

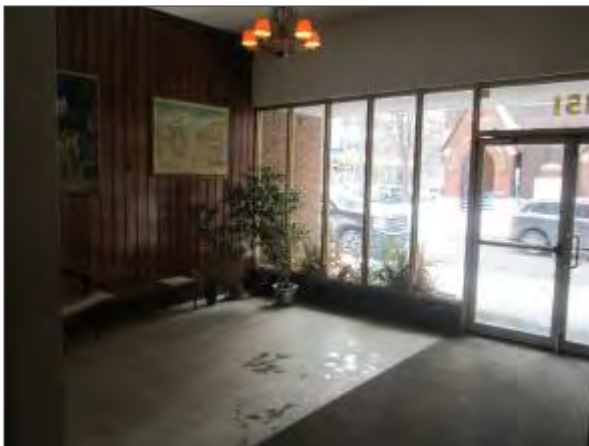
General view of the interior finishes in the main entrance lobby area.

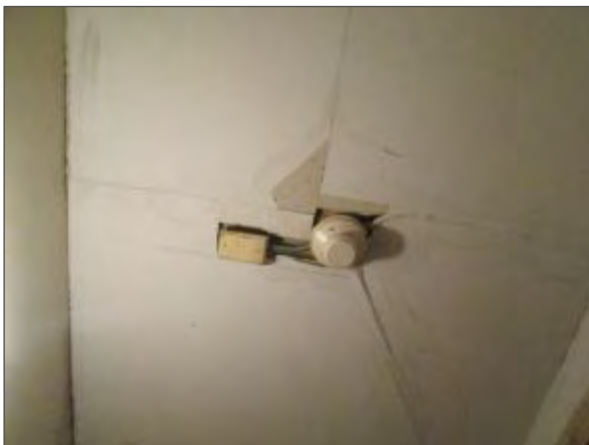
View of damaged gypsum ceiling finishes noted near the roof access door.

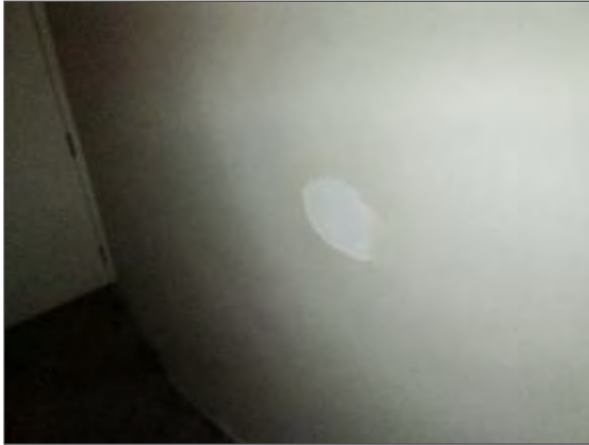
View of popping plaster finishes noted within a stairwell.

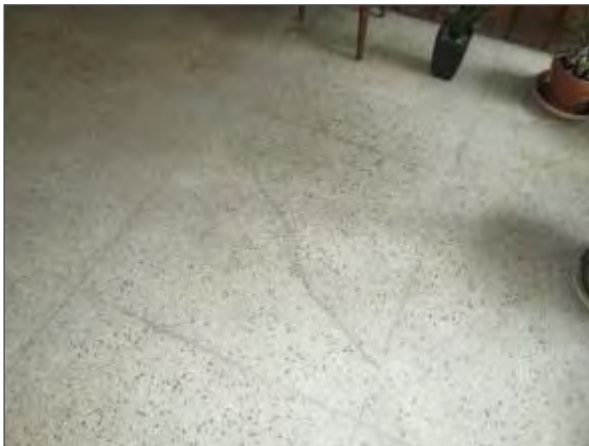
View of cracked terrazzo flooring noted in the main entrance lobby.

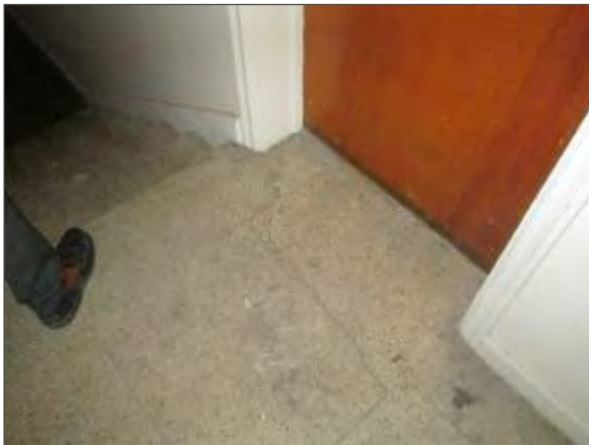
View of cracking terrazzo flooring noted within a corridor.

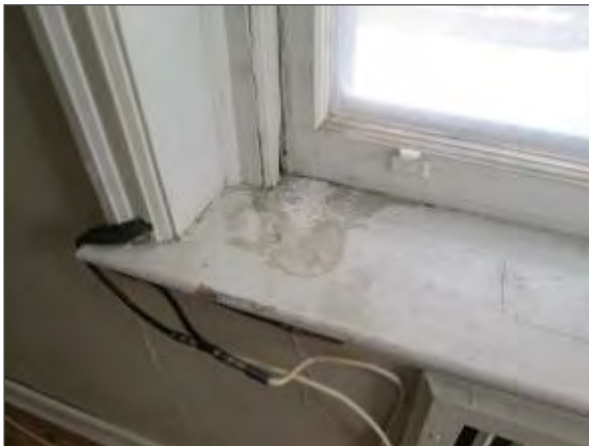
View of a damaged wood window sill noted in suite 204.

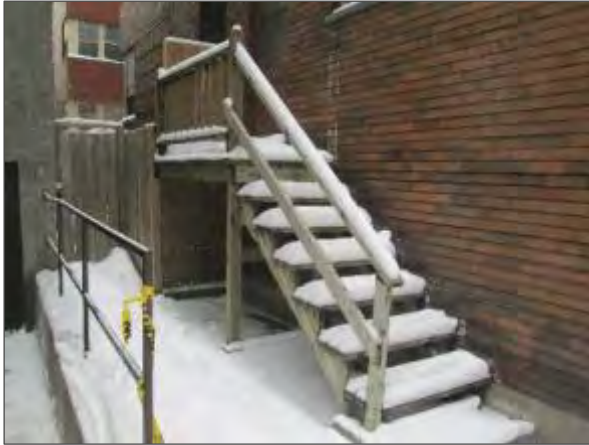
View of the wood framed staircase located on the north elevation of the building.

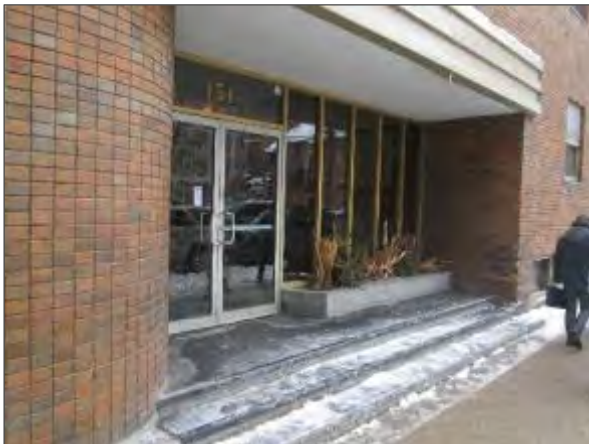
View of the terrazzo staircase serving the main entrance of the building on the west elevation.

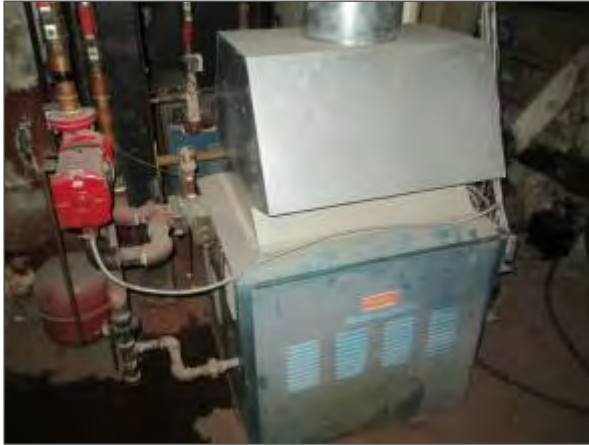
View of the first heating boiler serving the Site Building.

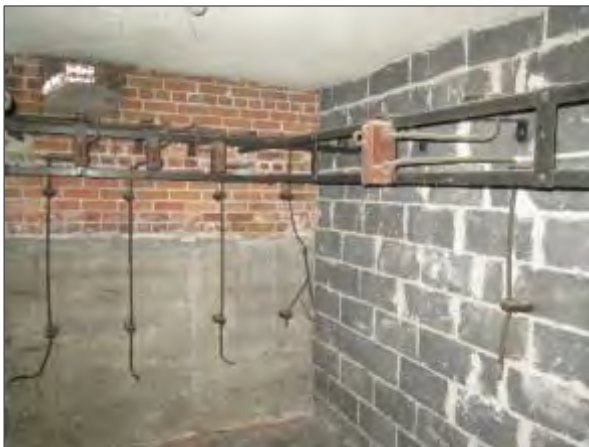
View of the abandoned knob and tube wiring system noted in the former main electrical room.

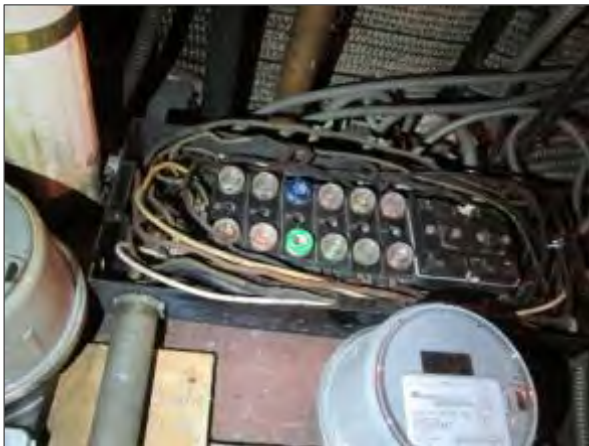
View of a glass plug fuse electrical panel noted in the main electrical room.

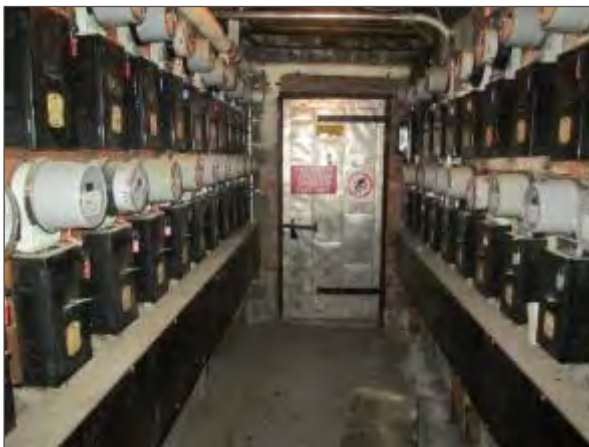
General view of the main electrical room in the basement of the building.
