FINAL Baseline Property Condition Assessment

151 Metcalfe Street, Ottawa,
Ontario

January 26, 2016

Pinchin File: 111978

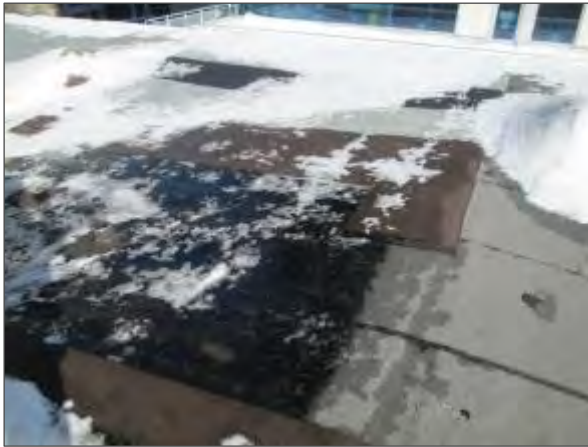
View of several patch repairs noted on the main roof of the building atop the fourth floor.

Based on the observed condition of the visible areas and the numerous patch repairs noted, it is Pinchin's opinion that the roof systems have achieved or exceeded their PUL. Pinchin has carried allowances for the replacement of the roof systems within the early portion of the term of the analysis. Assuming the roof systems are replaced in the early portion of the term and regular annual maintenance is performed, no other major expenditures should be required within the term of the analysis.

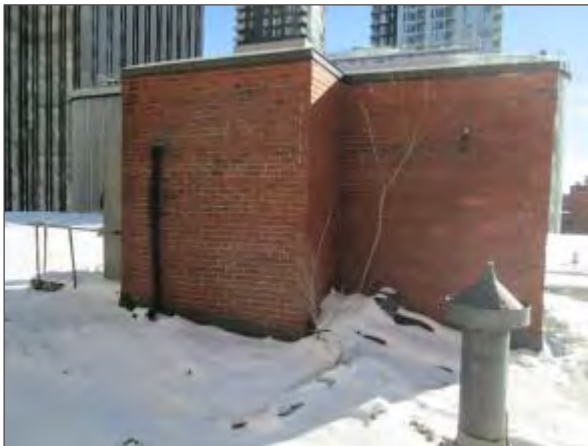
View of vegetative growth noted near the exterior wall of the stairwell penthouse on the main roof.

<ul style="list-style-type: none"> Vegetative growth was observed on the main roof system. 	<ul style="list-style-type: none"> This deficiency will be addressed as part of the anticipated roof replacement in the early portion of the term.

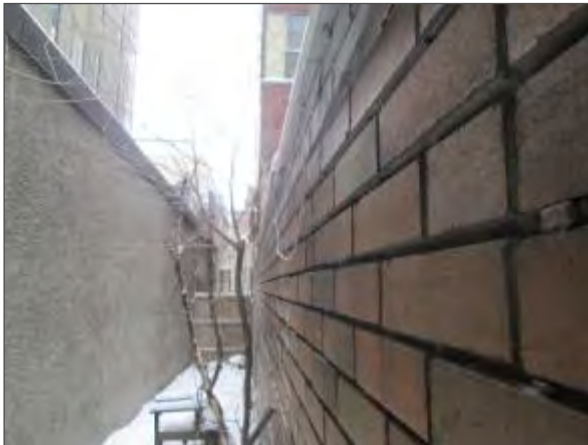
View of an area of brick masonry on the north elevation of the building (wall which flanks the UPG) which has a slight bulge.

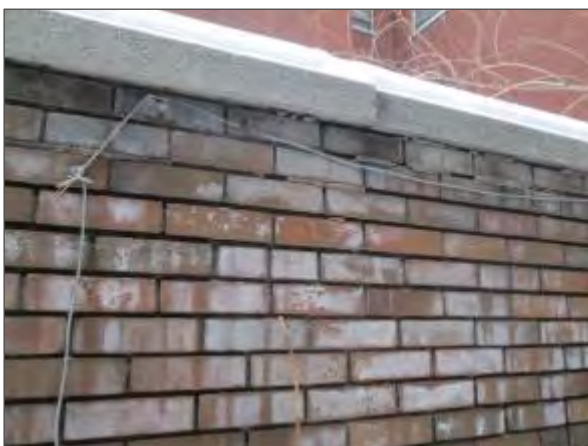
View of deteriorated mortar joints, efflorescence and a displaced concrete coping stone noted on the portion of the exterior wall which is slightly bulged.

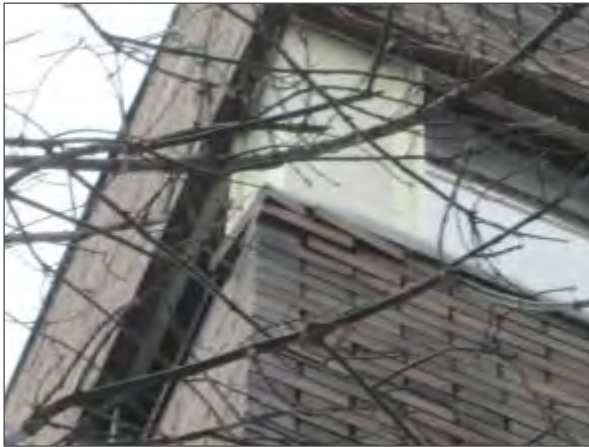
View of loose brick masonry units noted on the south elevation of the building.

An immediate cost of \$3,500.00 has been identified for the repair to the loose brick masonry units on the south and west elevations which have the potential to fall to grade and cause personal injury or vehicle damage. Repair requirements (under replacement reserves) over the term of the analysis (i.e., 10 years) of \$935,900.00 have been identified. As noted during the Site visit, deficiencies relating to the roof systems, wall systems, structural elements, underground parking garage, elevator systems, interior finishes, Site features and mechanical/electrical systems were noted. Of particular note, recommendations, repairs and replacements for the following items are included throughout the term of the analysis:

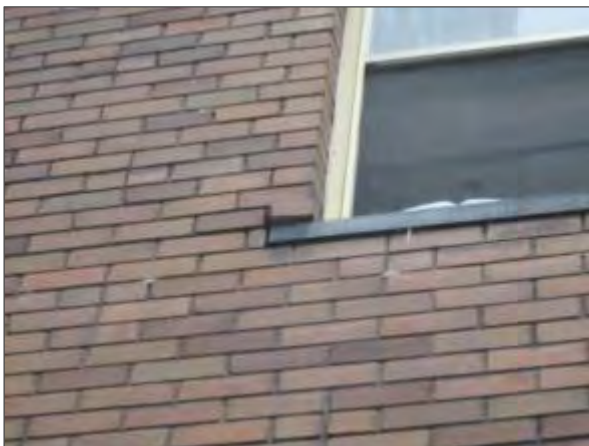
View of a loose brick masonry unit noted on the west elevation of the building.

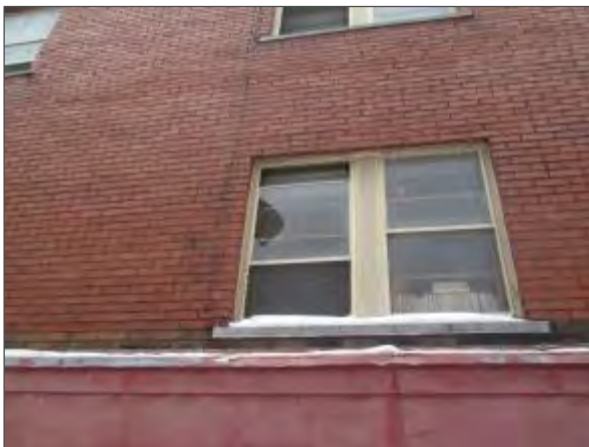
View of a cracked glazing unit noted on a storm window on the east elevation of the building.

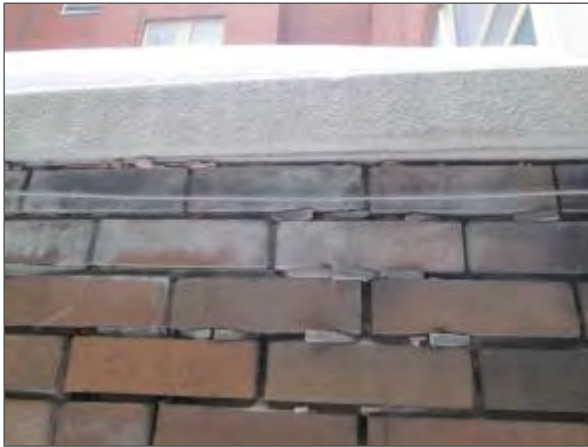
View of deteriorated mortar joints noted in the brick masonry on the south elevation and a crack in the concrete coping stone.

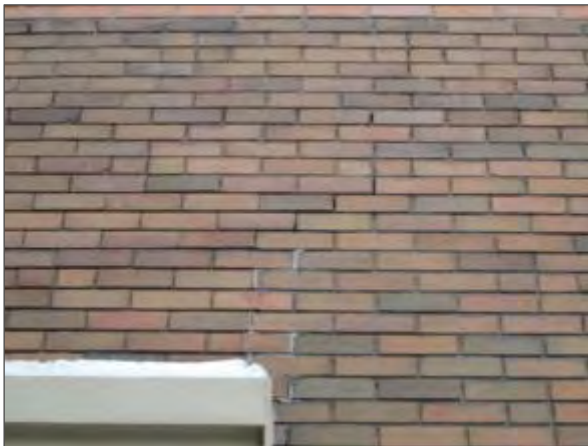
View of cracked masonry units and deteriorated mortar joints noted in the brick masonry on the west elevation of the building.

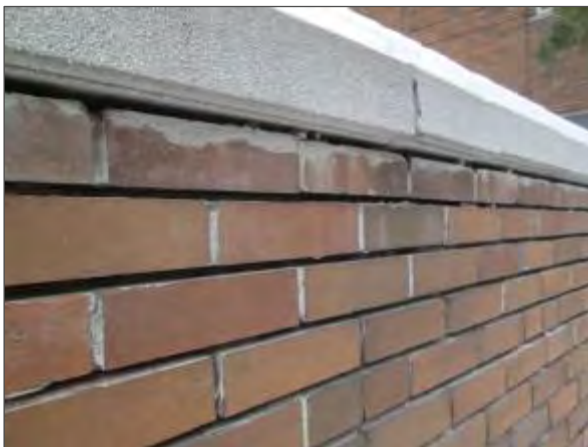
View of deteriorated mortar joints noted within the brick masonry on the south elevation of the building.

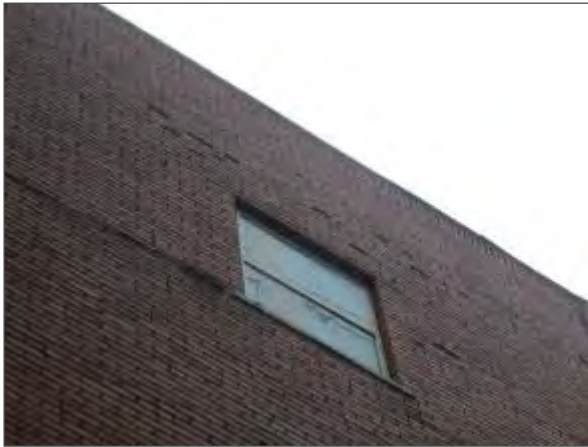
View of spalled brick masonry units noted at the top of the east elevation of the building.

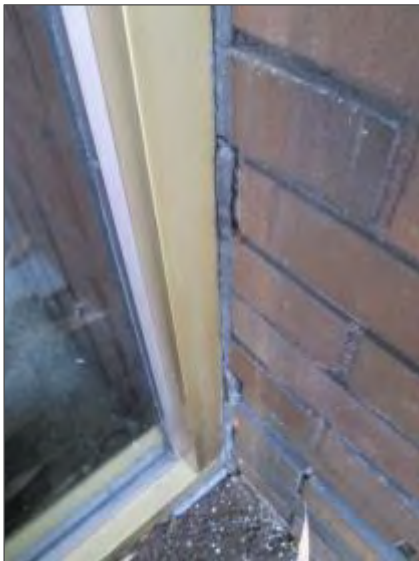
View of a cracked and deteriorated perimeter window sealant serving the fixed main entrance windows on the west elevation of the building.

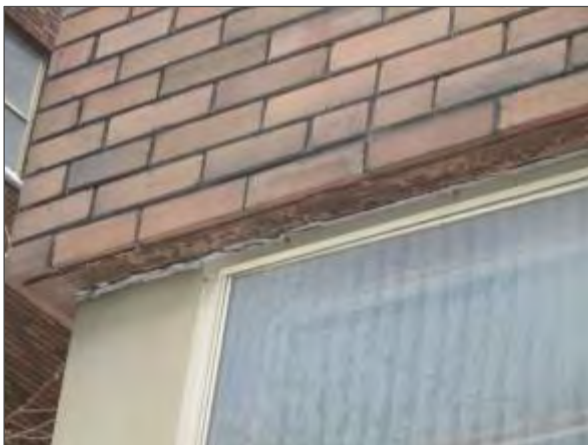
View of corrosion on a window lintel and a deteriorated perimeter window sealant observed on the south elevation of the building.

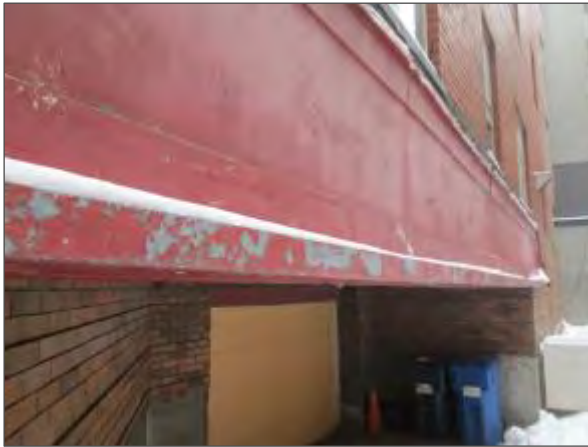
View of deteriorated paint finishes noted on the metal cladding above the overhead door serving the UPG on the east elevation of the building.

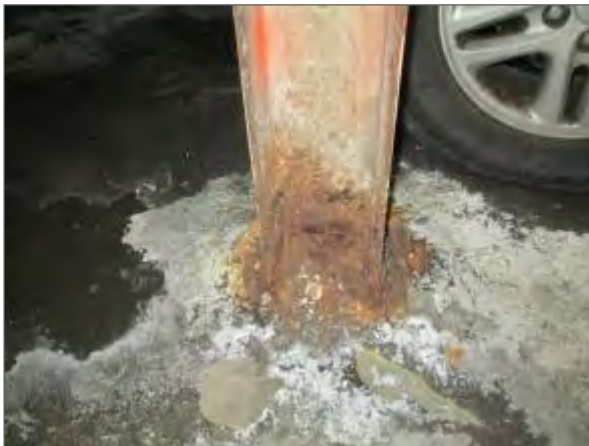
View of severe corrosion noted at the base of a column within the UPG.

Note: Almost every column within the UPG was affected by moderate to severe corrosion.

- A structural investigation of the corroded steel elements within the UPG and basement of the building to determine the appropriate method of repair and anticipated costs involved;

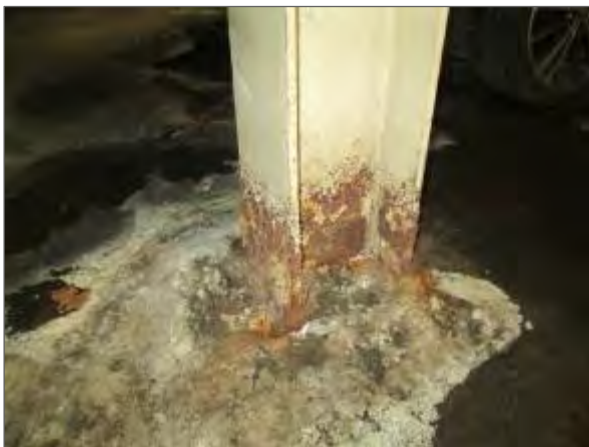
View of severe corrosion noted at the base of a column within the UPG.

Note: Almost every column within the UPG was affected by moderate to severe corrosion.

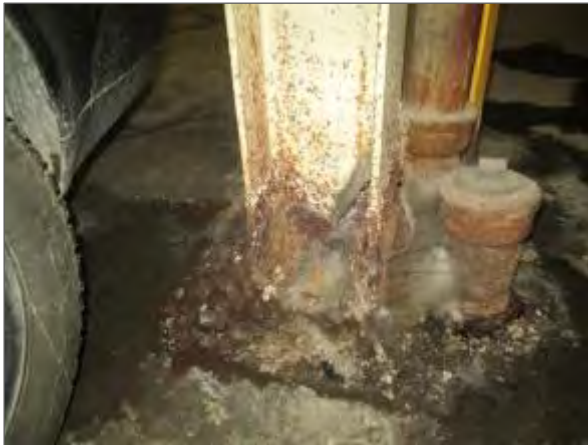
View of severe corrosion noted at the base of a column within the UPG.

Note: Almost every column within the UPG was affected by moderate to severe corrosion.

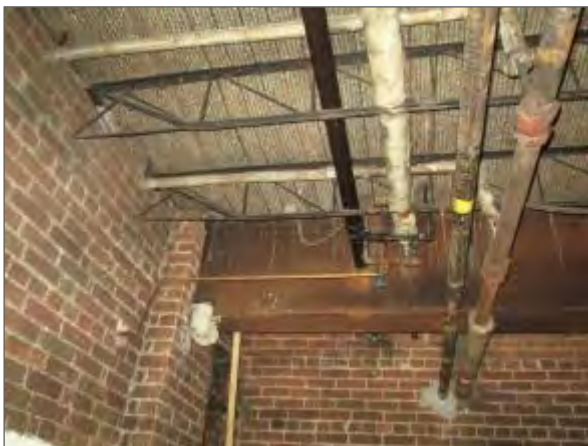
View of corrosion on a steel beam in the basement of the building.

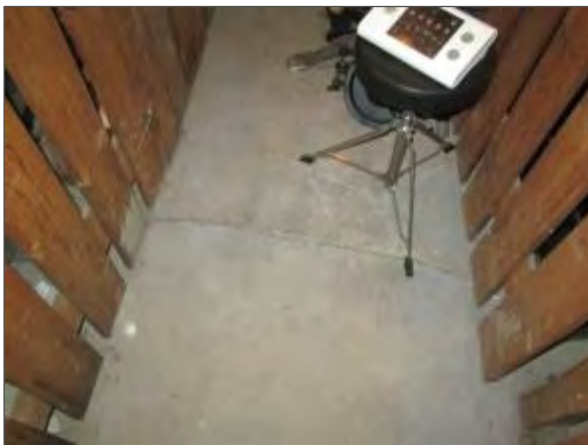
View of cracking noted in the concrete floor slab in a basement locker room.

View of cracking noted in the concrete floor slab
in a basement locker room.

<ul style="list-style-type: none"> Cracking was noted in the concrete floor slab in the basement of the building within the locker rooms. 	<ul style="list-style-type: none"> Rout and seal the cracking in the concrete floor slabs within the locker rooms.

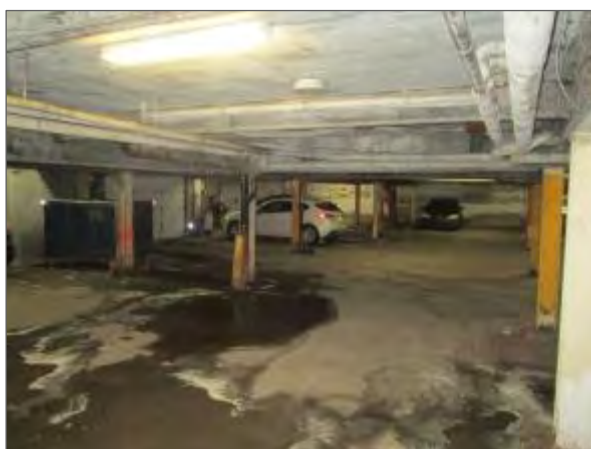
General view of the UPG serving the Site Building.

Note: The asphalt pavements were noted to be cracked, heaved and deteriorated.

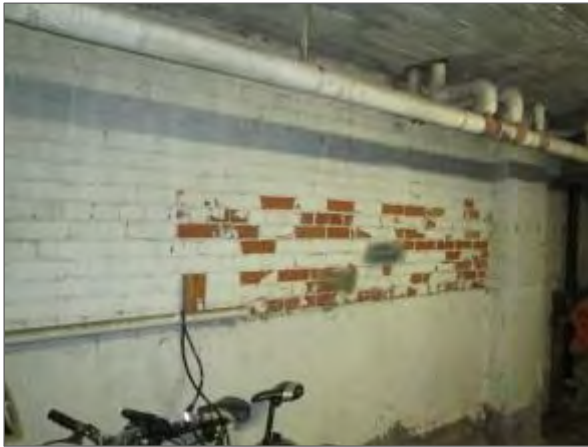
View of spalling brick masonry noted on the south foundation wall of the UPG.

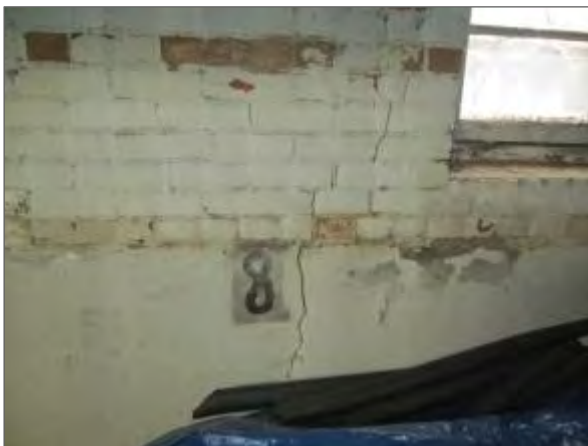
View of cracking noted in the cast-in-place concrete and brick masonry foundation walls on the south portion of the UPG.

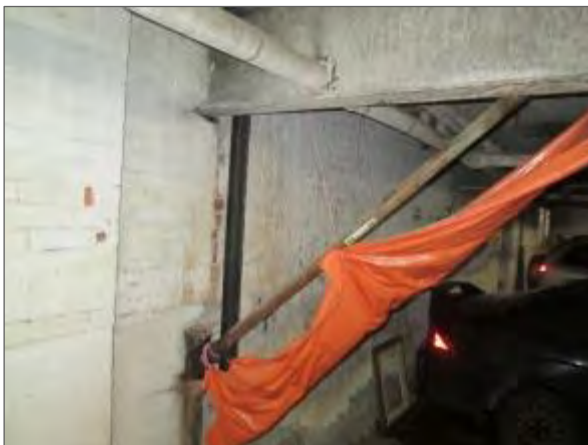
View of an orange tarp which is being used to divert leaking water from the UPG roof deck to the perimeter of the UPG.

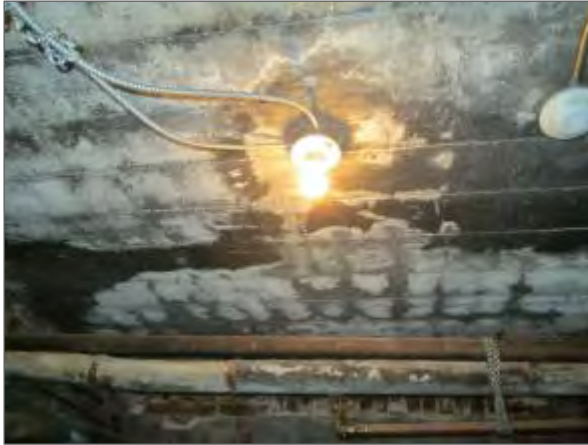
View of efflorescence noted on the soffit of the UPG roof deck within a service room in the northwest portion of the UPG.

<ul style="list-style-type: none"> Efflorescence was noted on the soffit of the UPG roof deck in the north portion of the UPG. 	<ul style="list-style-type: none"> Once the membrane atop the exposed section of the UPG roof deck is replaced, clean the areas of efflorescence.
<ul style="list-style-type: none"> The asphalt pavements within the UPG were noted to be deteriorated. 	<ul style="list-style-type: none"> Replace and repair the asphalt pavements within the UPG.

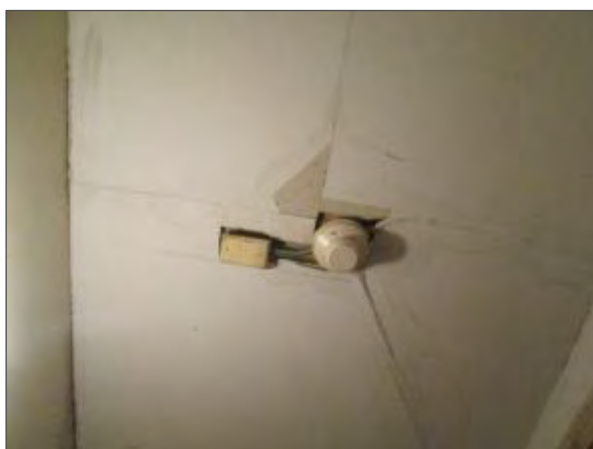
View of damaged gypsum ceiling finishes noted near the roof access door.

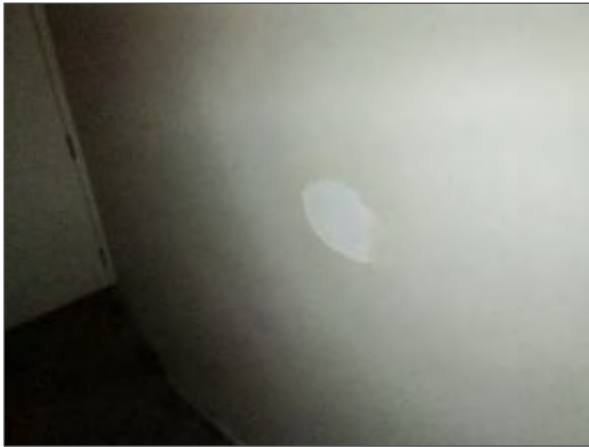
View of popping plaster finishes noted within a stairwell.

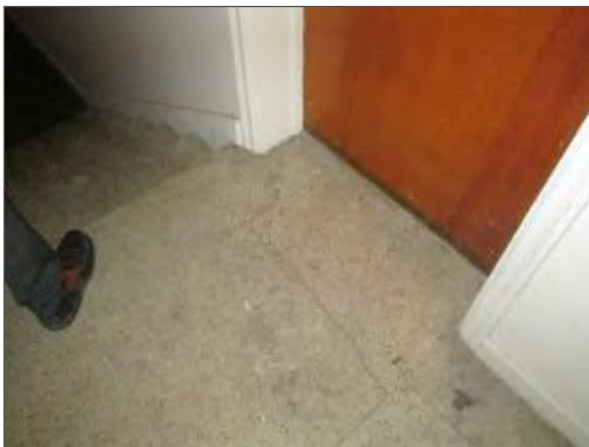
View of cracking terrazzo flooring noted within a corridor.

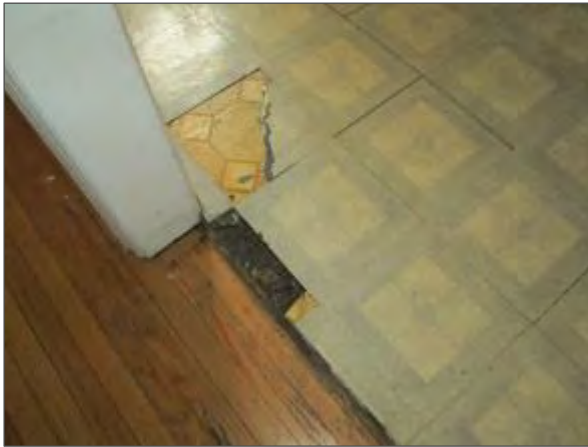
View of damaged vinyl floor tiles noted within the kitchen of suite 204.

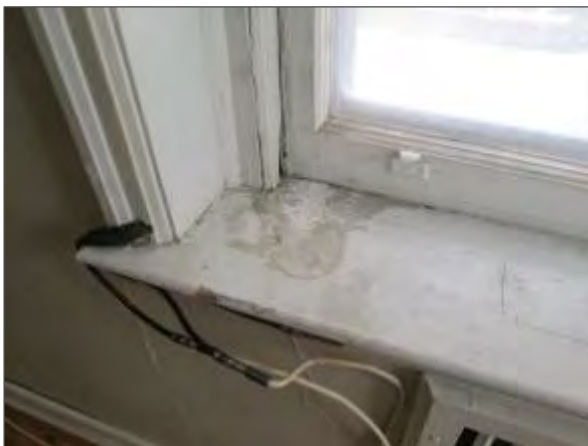
View of a damaged wood window sill noted in suite 204.

Findings	Remarks/Recommendations
Major Deficiencies/Deterioration <ul style="list-style-type: none"> None observed/reported. 	<ul style="list-style-type: none"> None required.
Minor Deficiencies/Deterioration <ul style="list-style-type: none"> Damaged plaster and gypsum wall and ceiling finishes were noted in various areas of the building. 	<ul style="list-style-type: none"> Repair the areas of damaged plaster and gypsum wall and ceiling finishes in the Site Building.
<ul style="list-style-type: none"> Several areas of cracked terrazzo flooring were noted throughout the building. 	<ul style="list-style-type: none"> Repair the cracking in the terrazzo flooring.
<ul style="list-style-type: none"> Damaged vinyl floor tiles were noted within select units. 	<ul style="list-style-type: none"> Replace the damaged vinyl floor tiles.
<ul style="list-style-type: none"> Damaged wood window sills were noted in the majority of the suites. 	<ul style="list-style-type: none"> Repair the damaged wood window sills in the suites.

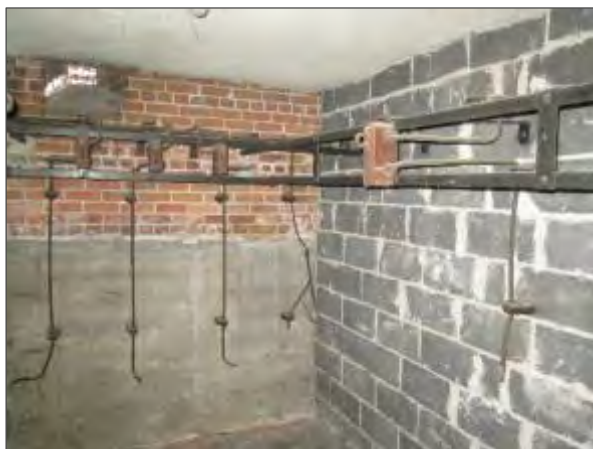
View of the abandoned knob and tube wiring system noted in the former main electrical room.

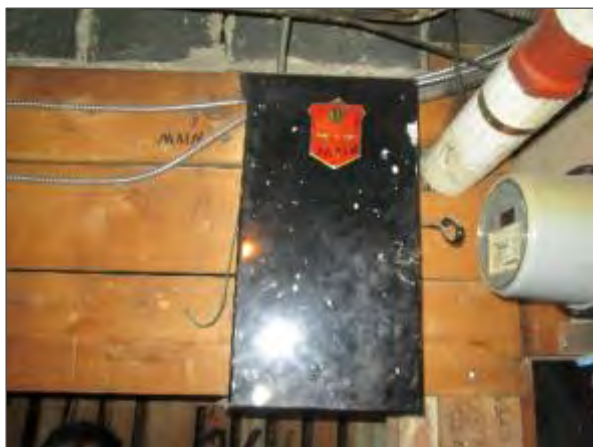
View of the original main disconnect switch serving the Site Building.

- Replacement of the likely original main electrical disconnect switch serving the building;
- Inspection and repairs to the emergency exit lights throughout the building;

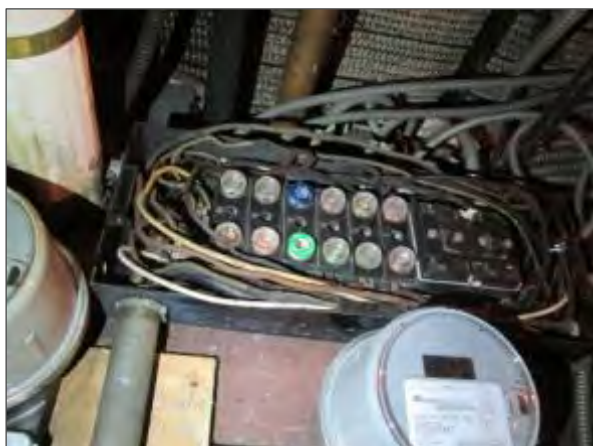
View of a glass plug fuse electrical panel noted in the main electrical room.

- Replacement of the main and annunciator fire alarm panels; and
- Replacement of the glass fuse plug style electrical panels within the suites and the electrical room.

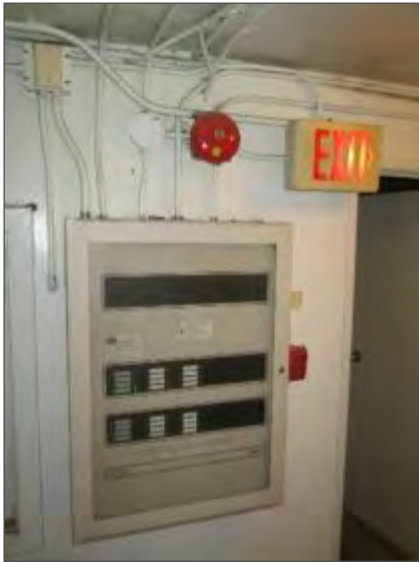
View of the main fire alarm panel and the typical pull stations, gong-style alarm bell and emergency exit sign within the building.

<ul style="list-style-type: none"> The main and annunciator fire alarm panels have exceeded their PUL. 	<ul style="list-style-type: none"> Pinchin has included allowances to replace the main and annunciator fire alarm panels within the early portion of the term. The allowances carried do not include the replacement of the wiring and associated devices (i.e., pull stations and heat detectors) throughout the building.
<ul style="list-style-type: none"> The electrical panels were reported to consist of glass plug fuse style panels throughout the building. 	<ul style="list-style-type: none"> Pinchin recommends that these panels be replaced as part of unit turnover.

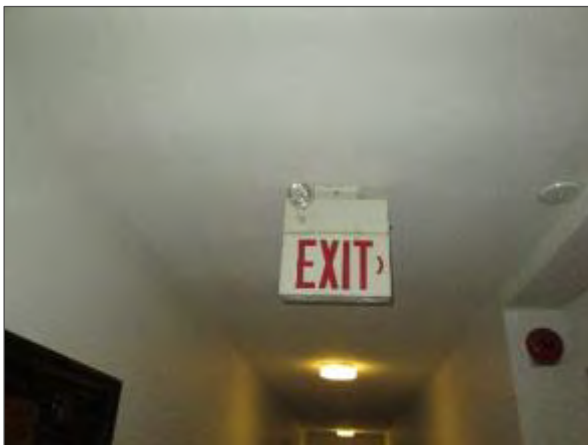
View of an emergency exit sign which was not properly illuminated at the time of the Site visit.
