FINAL
Baseline Property
Condition Assessment

151 Metcalfe Street, Ottawa,
Ontario

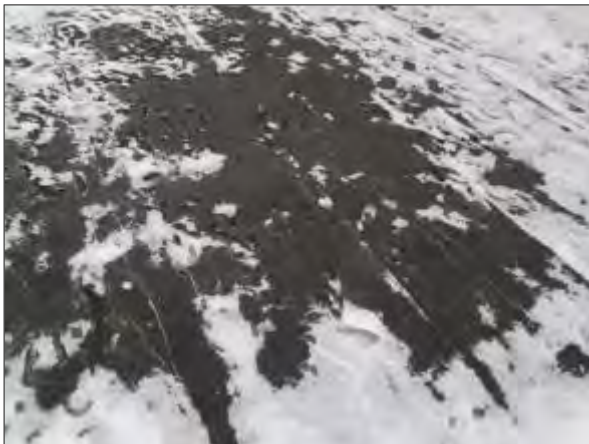
View of cracking and deterioration noted in the mop-on membrane on the north UPG roof.

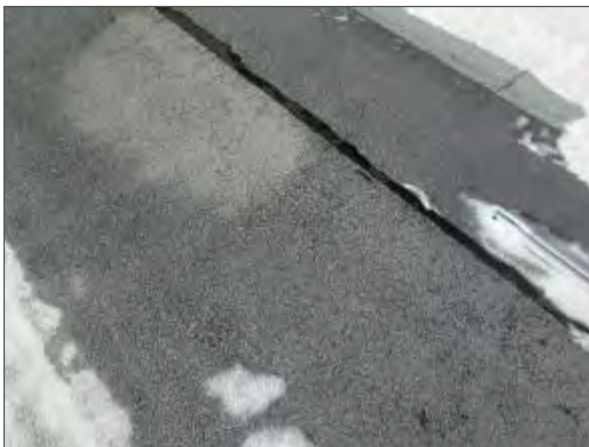
View of crazing and deterioration noted in a section of modified bitumen membrane atop the fourth floor roof.

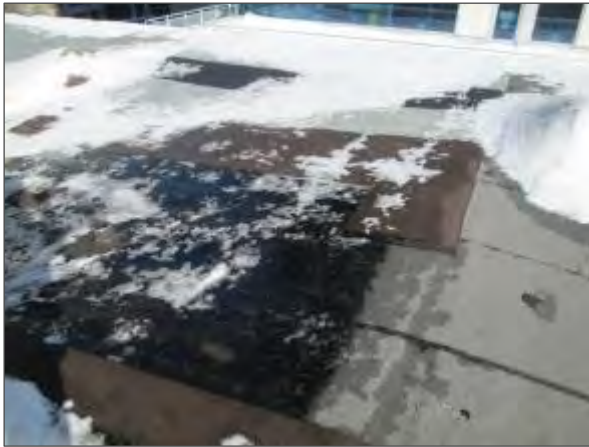
View of several patch repairs noted on the main roof of the building atop the fourth floor.

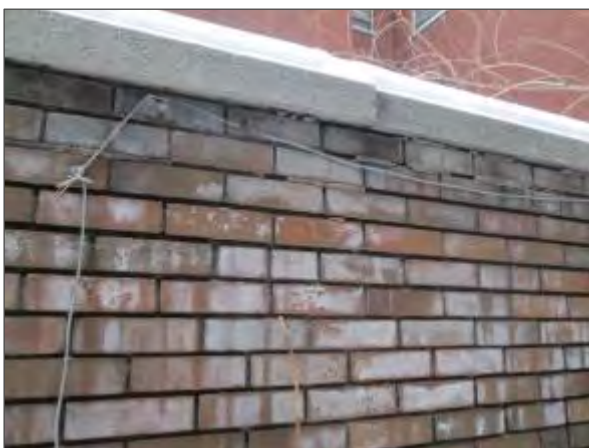
View of deteriorated mortar joints, efflorescence and a displaced concrete coping stone noted on the portion of the exterior wall which is slightly bulged.

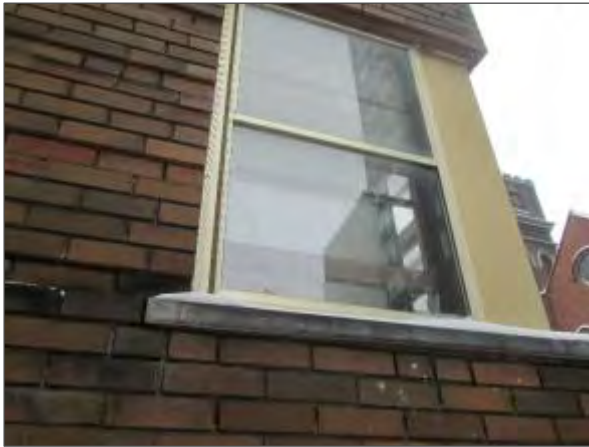
View of a cracked glazing unit noted on a storm window on the north elevation.

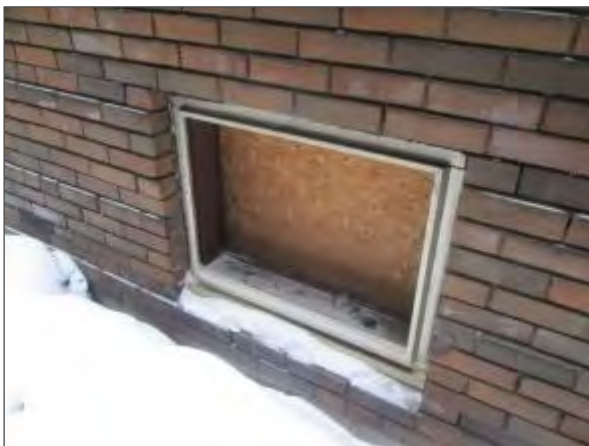
View of a missing window unit which has been covered with plywood on the north elevation of the building.

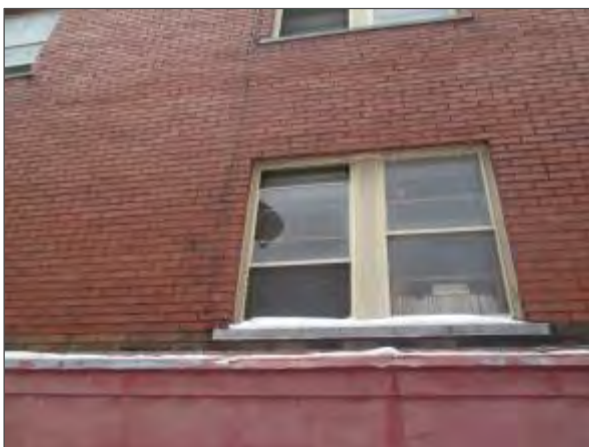
View of a cracked glazing unit noted on a storm window on the east elevation of the building.

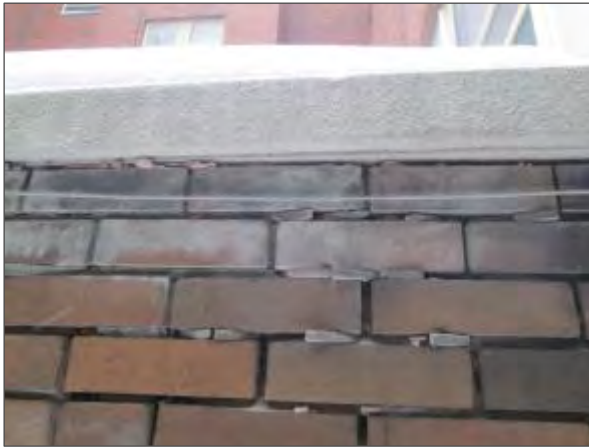
View of deteriorated mortar joints noted in the brick masonry on the south elevation and a crack in the concrete coping stone.

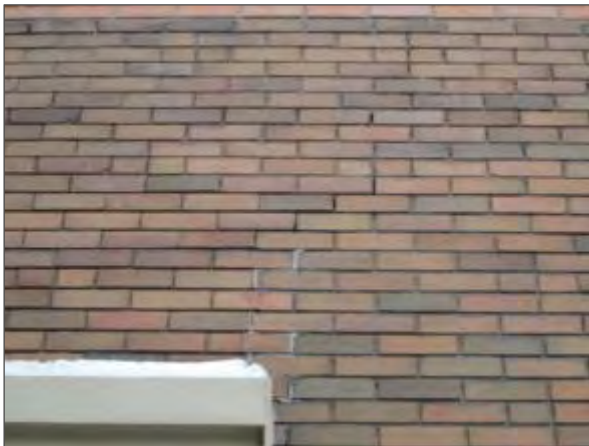
View of cracked masonry units and deteriorated mortar joints noted in the brick masonry on the west elevation of the building.

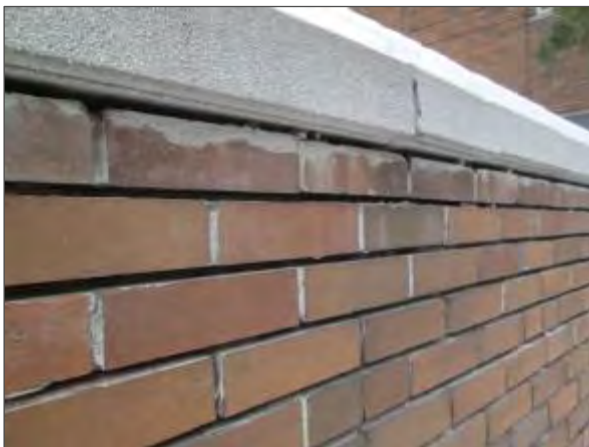
View of deteriorated mortar joints noted within the brick masonry on the south elevation of the building.

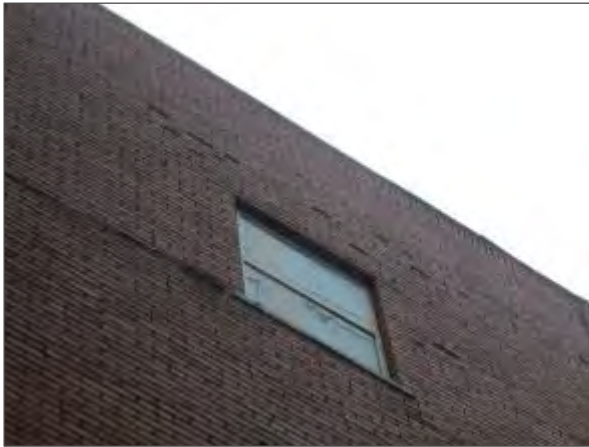
View of spalled brick masonry units noted at the top of the east elevation of the building.

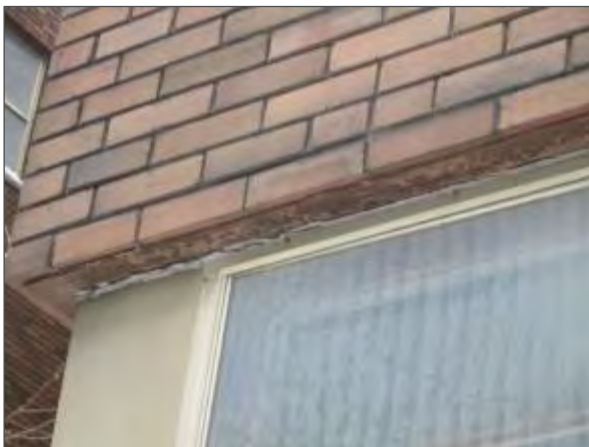
View of corrosion on a window lintel and a deteriorated perimeter window sealant observed on the south elevation of the building.

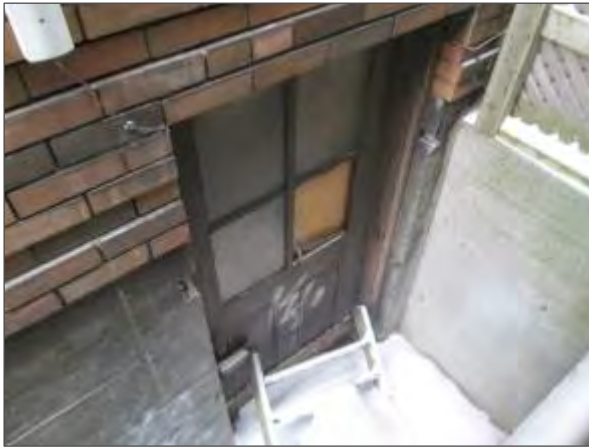
View of the old and damaged secondary access door to the boiler room which is reportedly no longer used.

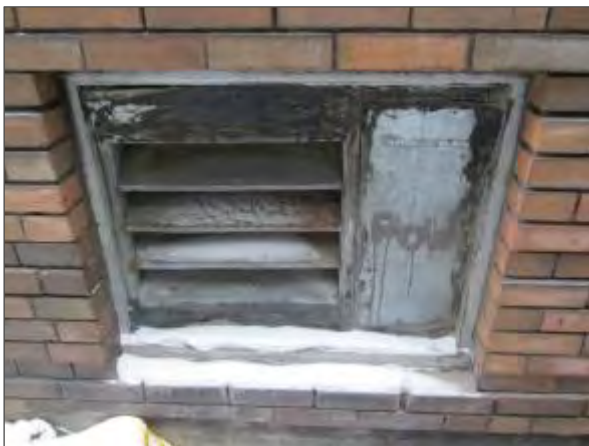
View of faded paint finishes and deteriorated sealants on the boiler room ventilation louver.

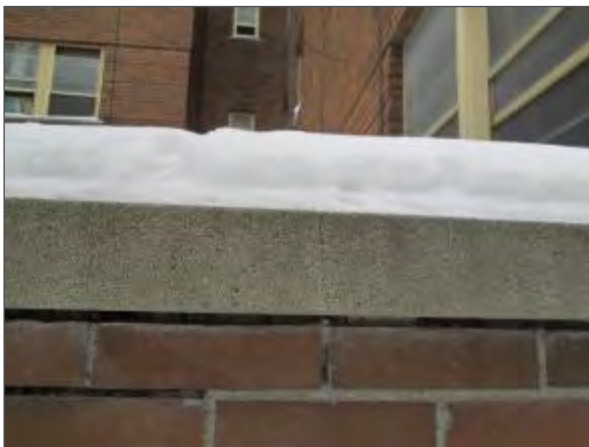
View of a small crack noted in a concrete coping stone on the south elevation of the building.

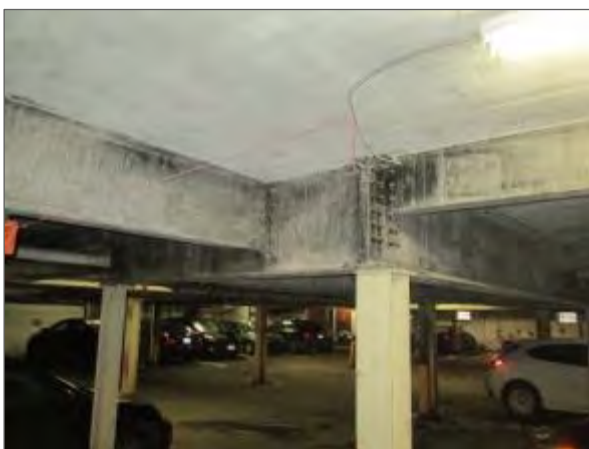
View of the steel beams and columns located in the UPG of the building which support the central portion of the building.

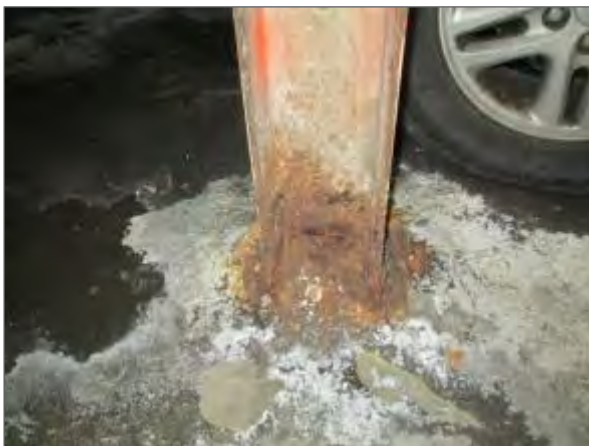
View of severe corrosion noted at the base of a column within the UPG.

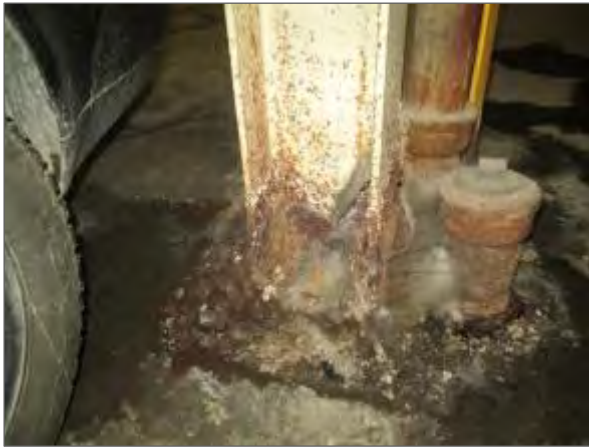
View of severe corrosion noted at the base of a column within the UPG.

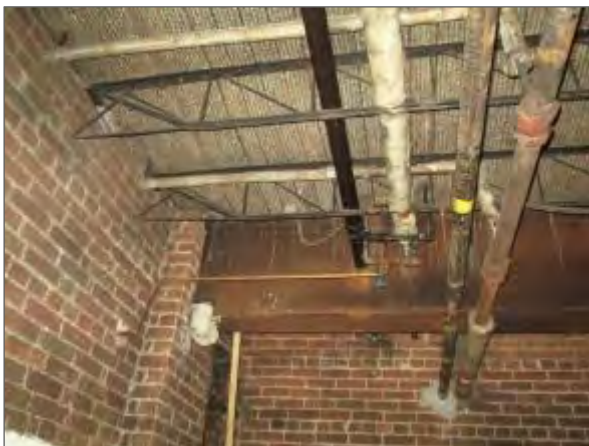
View of corrosion on a steel beam in the basement of the building.

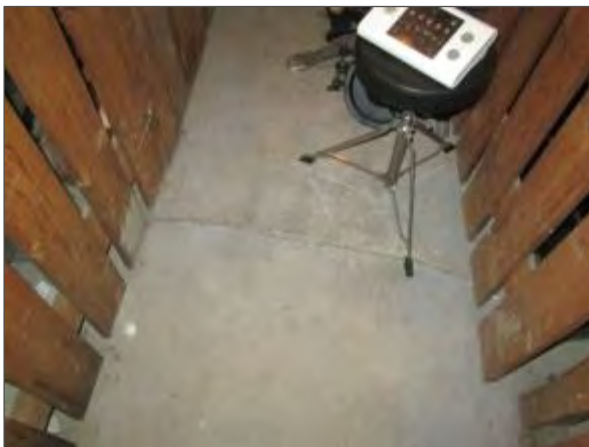
View of cracking noted in the concrete floor slab in a basement locker room.

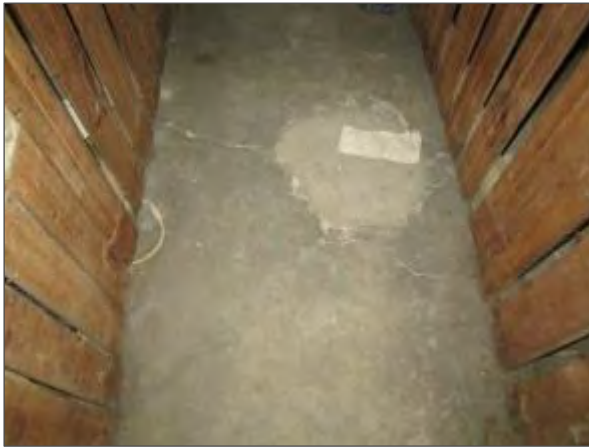
View of cracking noted in the concrete floor slab in a basement locker room.

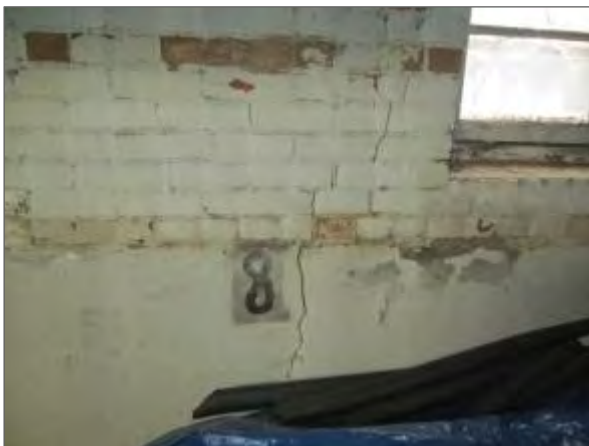
View of cracking noted in the cast-in-place concrete and brick masonry foundation walls on the south portion of the UPG.

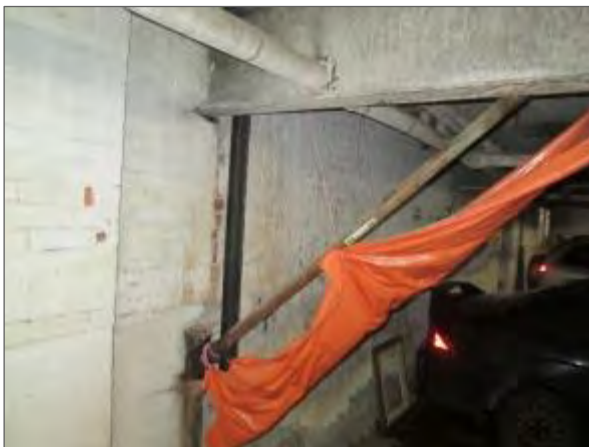
View of an orange tarp which is being used to divert leaking water from the UPG roof deck to the perimeter of the UPG.

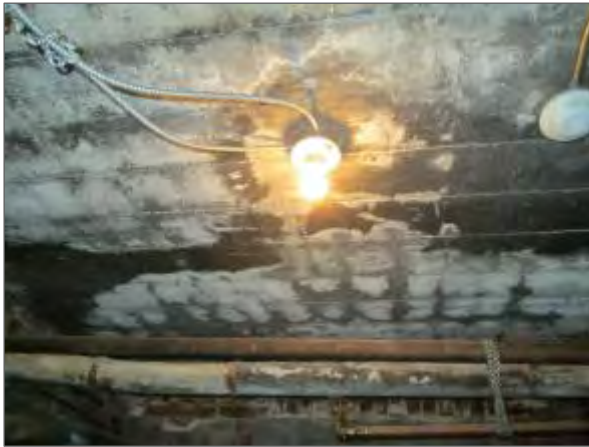
View of efflorescence noted on the soffit of the UPG roof deck within a service room in the northwest portion of the UPG.

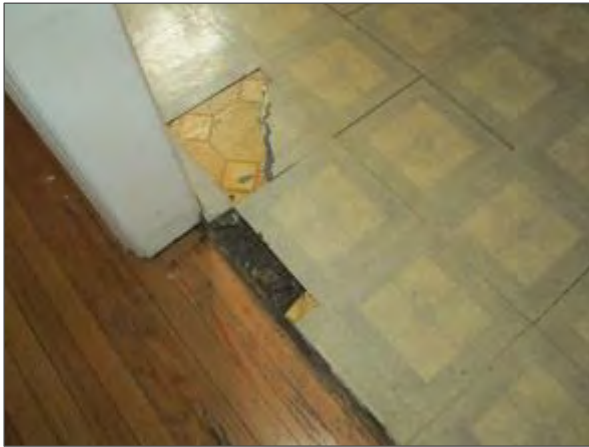
View of damaged vinyl floor tiles noted within the kitchen of suite 204.

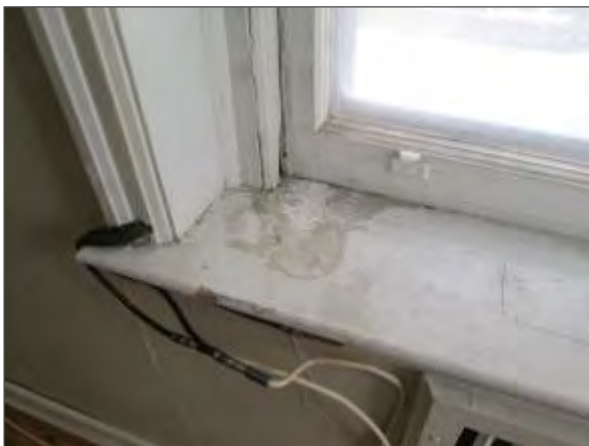
View of a damaged wood window sill noted in suite 204.

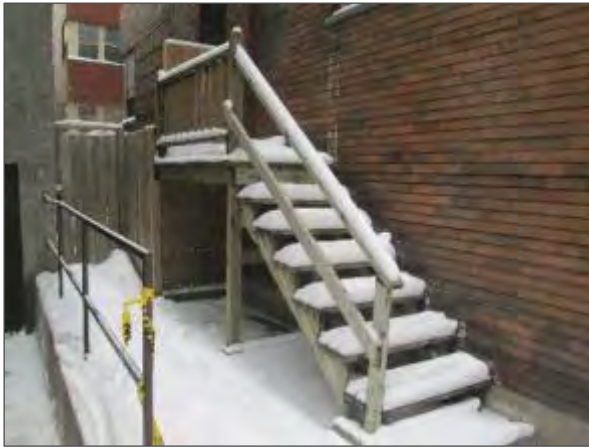
View of the wood framed staircase located on the north elevation of the building.

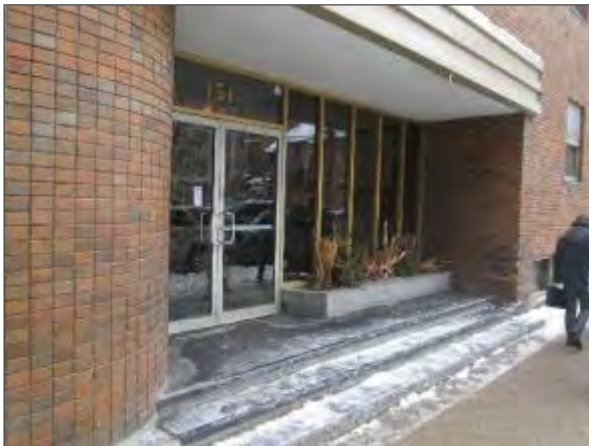
View of the terrazzo staircase serving the main entrance of the building on the west elevation.

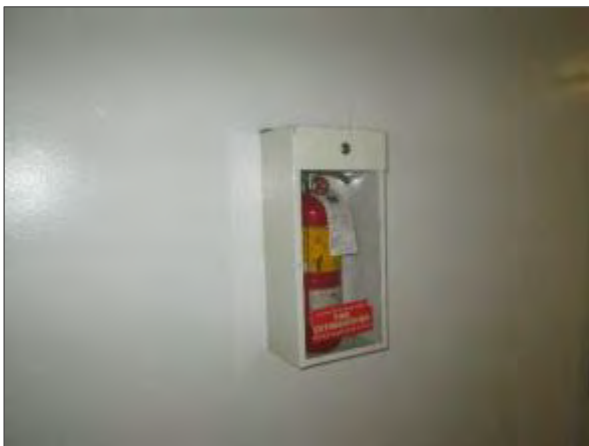
View of the typical cabinet mounted chemical fire extinguishers serving the Site Building.

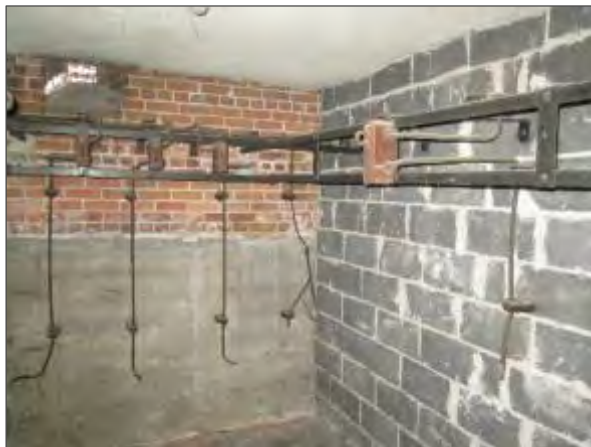
View of the abandoned knob and tube wiring system noted in the former main electrical room.

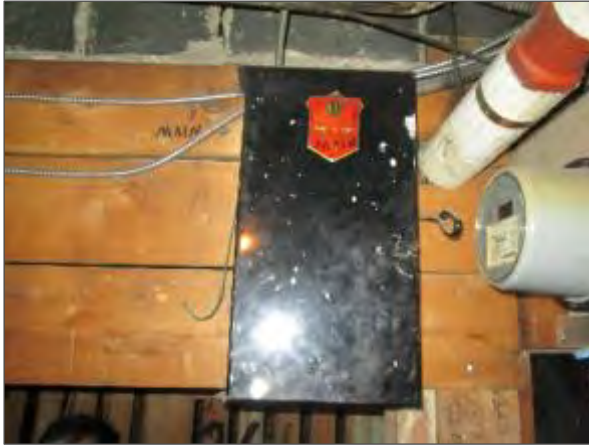
View of the original main disconnect switch serving the Site Building.
