DRAFT **Baseline Property** **Condition Assessment**

240 Montreal Road, Ottawa,
Ontario

March 8, 2018

Pinchin File: 218394

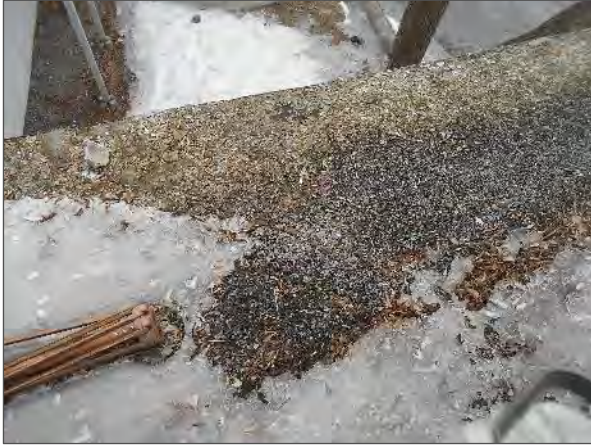
Findings	Remarks/Recommendations
Major Deficiencies/Findings	
<ul style="list-style-type: none"> The BUR system is estimated to be over 20 years old. 	<ul style="list-style-type: none"> Replacement the BUR system is anticipated within the early portion of the term of analysis.
<ul style="list-style-type: none"> Wood rot was noted on the perimeter fascia of the roof systems. 	<ul style="list-style-type: none"> Replace the wood fascia during the roof replacement.
Minor Deficiencies/Findings	
<ul style="list-style-type: none"> None observed/reported. 	<ul style="list-style-type: none"> None required.

View of the BUR system atop the single storey portion of the Site Building.

It has been Pinchin's experience that the Projected Useful Life (PUL) of BUR system typically ranges between 20 to 25 years, depending on the quality of building materials used, the quality of workmanship during installation and the level to which the roof system has been maintained. The roof systems atop the Site Building are estimated to be over 20 years old. Pinchin anticipates the replacement of the roof system within the early portion of the term of analysis.

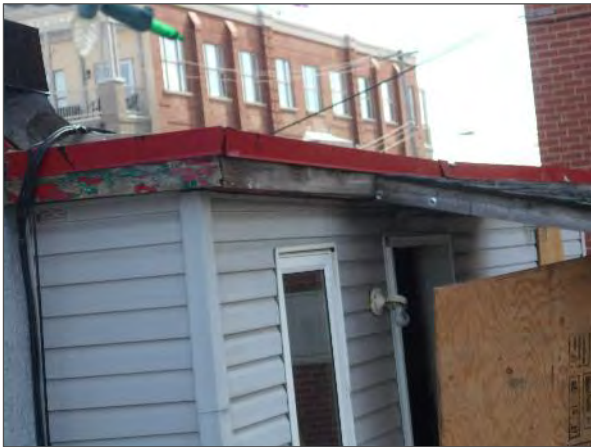
View of fascia wood rot on the two storey portion of the Site Building.

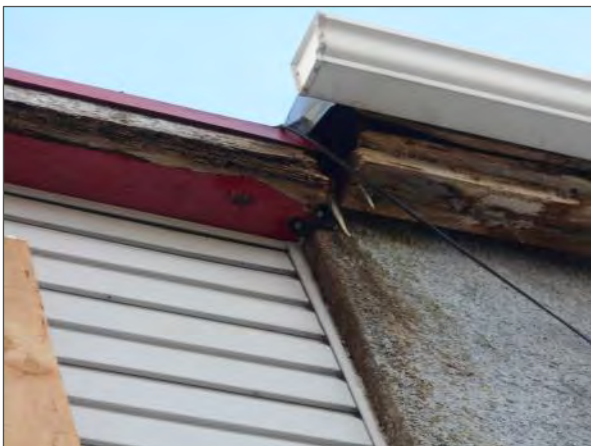
View deteriorated wood fascia on the east elevation of the Site Building.

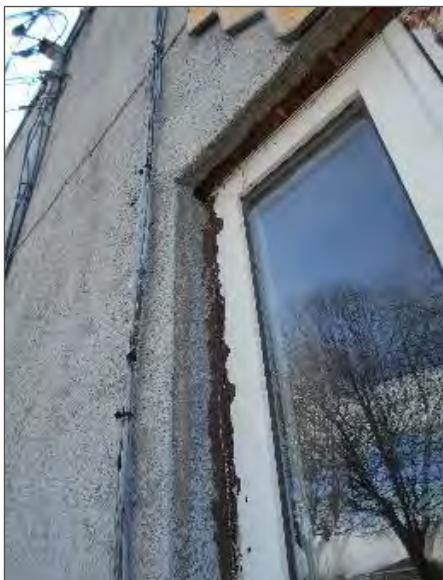
View of cracked stucco on the north elevation wall.

The wall, window and door systems of the Site Building were generally noted to be in poor condition at the time of the Site visit with the above noted deficiencies. Pinchin has carried allowances for replacement of the stucco, repairs to the brick masonry and replacement of the doors and windows.

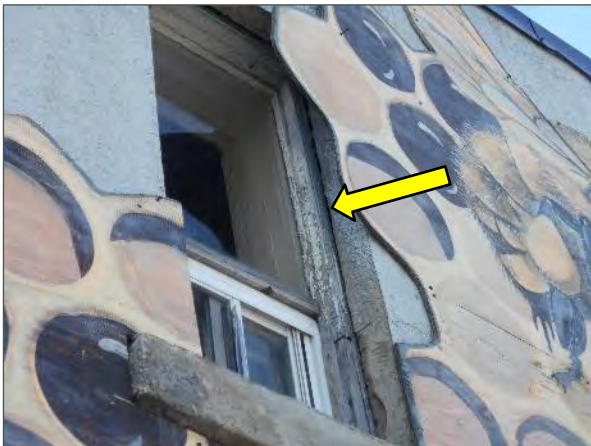
View of deteriorated window frame and sealant at perimeter of the window frame.

Due to the visual failure of sealants around windows and cracking of the stucco cladding the presence of mould within the wall assembly is possible. The presence of the mould cannot be determined since intrusive testing to determine the presence of mould within wall system was not part of the scope of work.

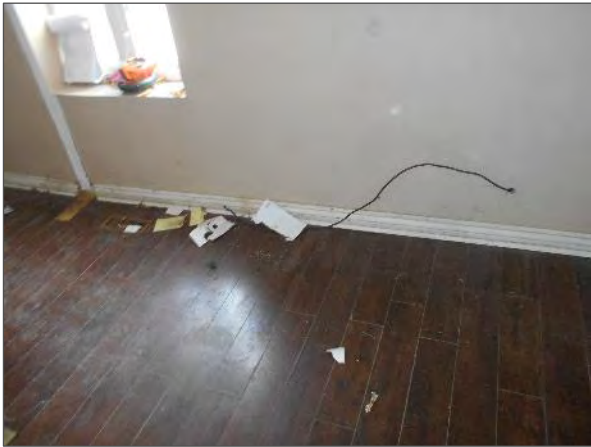
View of vertically misaligned floor.

Note: First floor apartment.

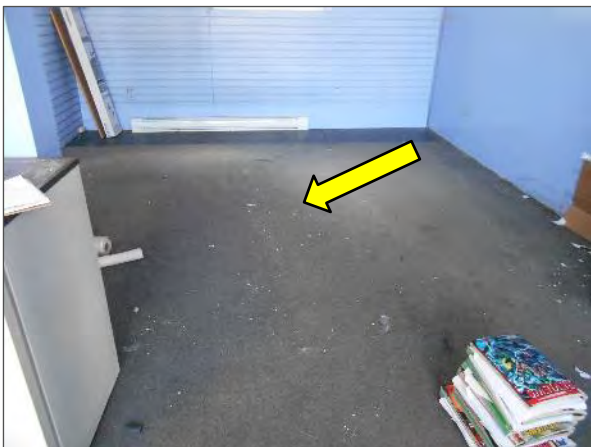
Table 3.4 – Structural Elements	
Findings	Remarks/Recommendations
Major Deficiencies/Findings	
<ul style="list-style-type: none"> Slab heaving was noted within the commercial unit on the northwest elevation of the Site Building. 	<ul style="list-style-type: none"> Pinchin has carried an allowance for structural/geotechnical review to determine the cause of the heaving and providing repair methods.
<ul style="list-style-type: none"> Vertical misalignment was noted in floors of first and second floor apartment units. 	<ul style="list-style-type: none"> Repair the floors under the supervision of a structural engineer.
Minor Deficiencies/Findings	
<ul style="list-style-type: none"> Water infiltration noted within the basement area. 	<ul style="list-style-type: none"> Refer to section 3.6 for mould investigation.

View of slab heaving in commercial unit on the northwest elevation of the Site Building.

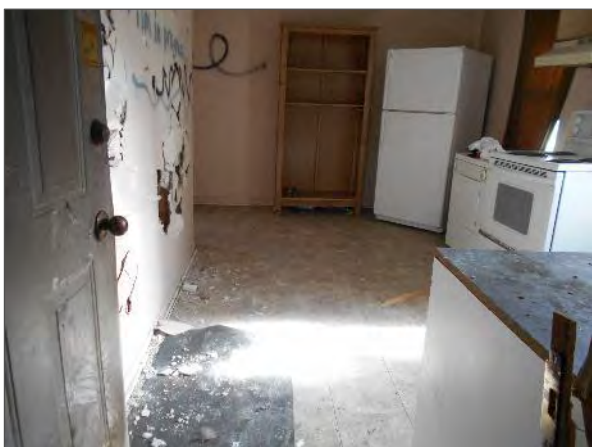
View of damaged drywall in the second floor apartment unit.

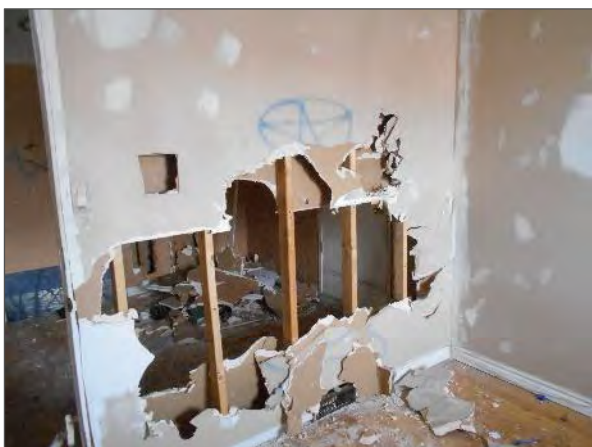
View of damaged drywall in the second floor apartment unit.

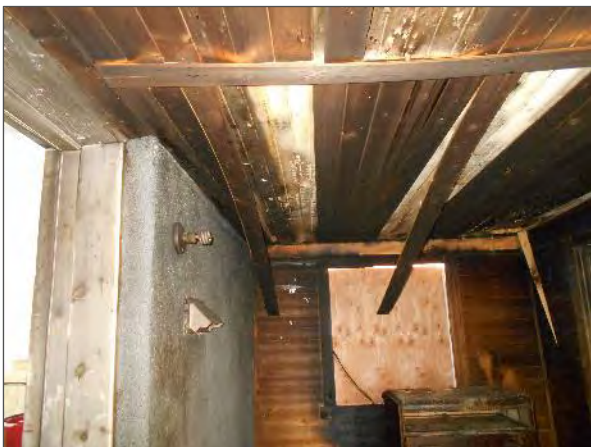
Table 3.6 – Interior Finishes	
Findings	Remarks/Recommendations
Major Deficiencies/Findings	
<ul style="list-style-type: none"> Extensive damage noted to interior walls of the apartment units from vandalism. 	<ul style="list-style-type: none"> Replace and paint the damaged drywall boards.
<ul style="list-style-type: none"> Water damaged and suspected mould growth was noted within the basement area 	<ul style="list-style-type: none"> Pinchin has carried allowances for mould investigation and remediation.
Minor Deficiencies/Findings	
<ul style="list-style-type: none"> Charred ceiling and wall wood panels noted within second floor apartment unit. 	<ul style="list-style-type: none"> Replace the fire damaged finishes.

View of charred finishes in second floor apartment unit.
