STRUCTURAL REPORT

<i>Client:</i>	McCormick Park Developments	<i>Date:</i>	Oct.23/2018
<i>Area:</i>	Existing House	<i>Revision:</i>

- Overall condition of building after fire damage.

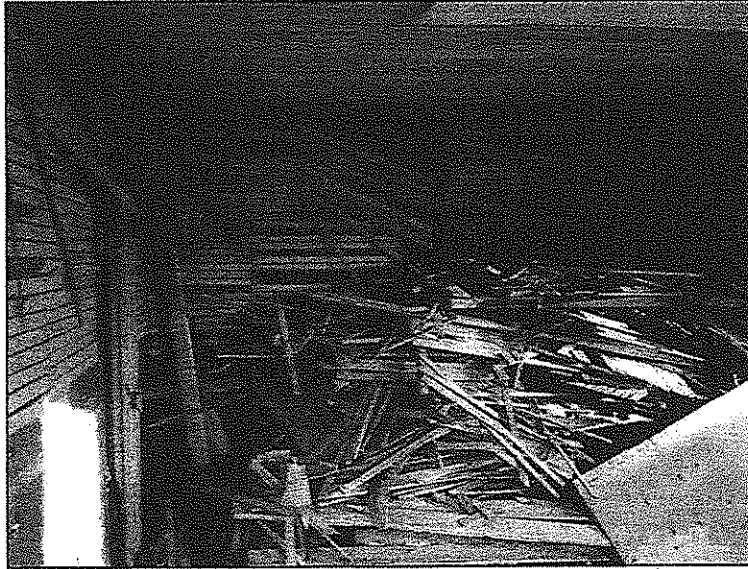
- Much of the interior finishes have been removed at the first and second floors which allowed for inspection of the structural framing. The demolished materials have been piled on the floor and are adding significant dead loads to the structure in some areas (see Fig.1);

Figure 1 - Demolition materials piled near rear elevation at 2nd floor.

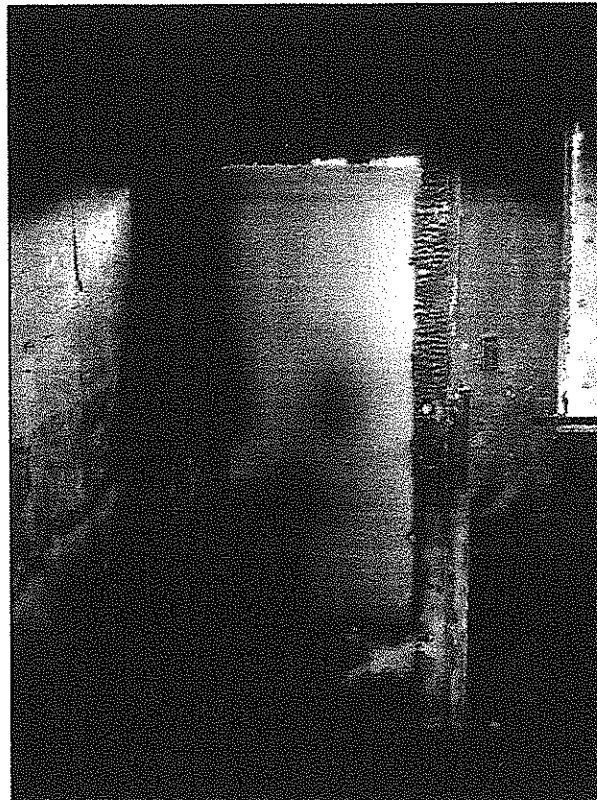
- Almost all of the windows have been broken and the client indicated that vandalism of the house has been an issue since it's been unoccupied;
- The fire appears to have started at the back of the building as this area has suffered the most damage (see Figs. 2 & 3);

Figure 2 - Charred door at rear elevation.

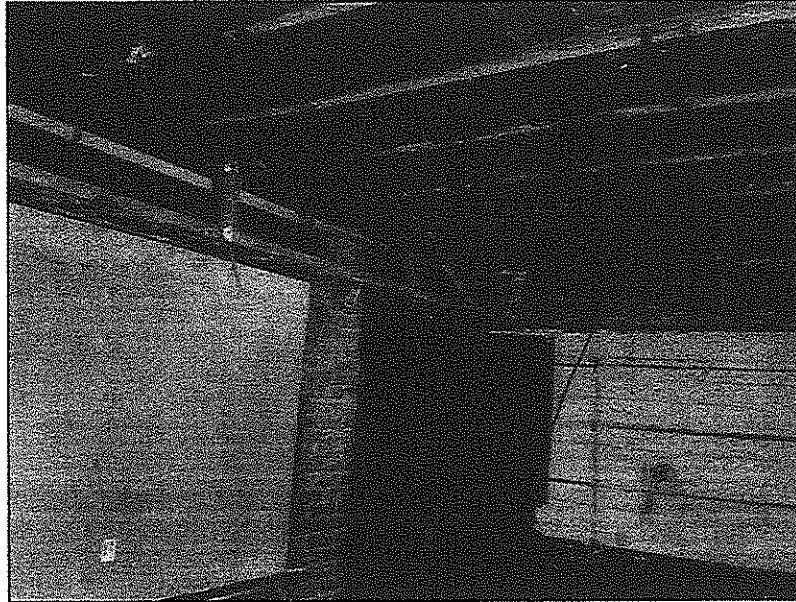
- The floor joists supporting the second floor were in good condition near the front of the house, though they were damaged by smoke. Near the back of the house the joists were found with damages and cross section reduced due to fire;

Figure 3 - View of burnt framing at rear elevation and damaged joists inside.

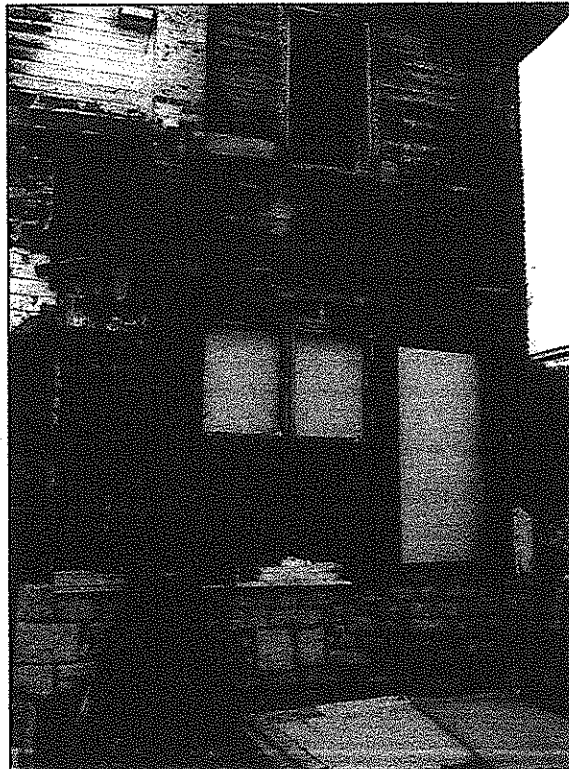
- The studs, in partition and bearing walls, also signs of damage by fire;
- The wall framing at the rear elevation was badly charred and was in critical condition at the previous location of the rear door which is near the West elevation (see Fig.4). The wall has lost at least 80% of its load bearing capacity from the West elevation to the chimney as a result of the fire;

Figure 4 - View of damaged rear elevation.

- It is in our opinion that the existing 3-storey detached residential structure is not safe to occupy;
- The frost penetration below the stone foundation walls has already affected the structure and is likely to further compromise the foundation should it be left in its current state;
- In addition to the conditions found on site the partial collapse of a building of similar size and age at 1119 Wellington St. W located less than 200m away earlier this summer should be noted;
- Therefore, we would recommend that the structure be demolished prior to further deterioration and/or failure.

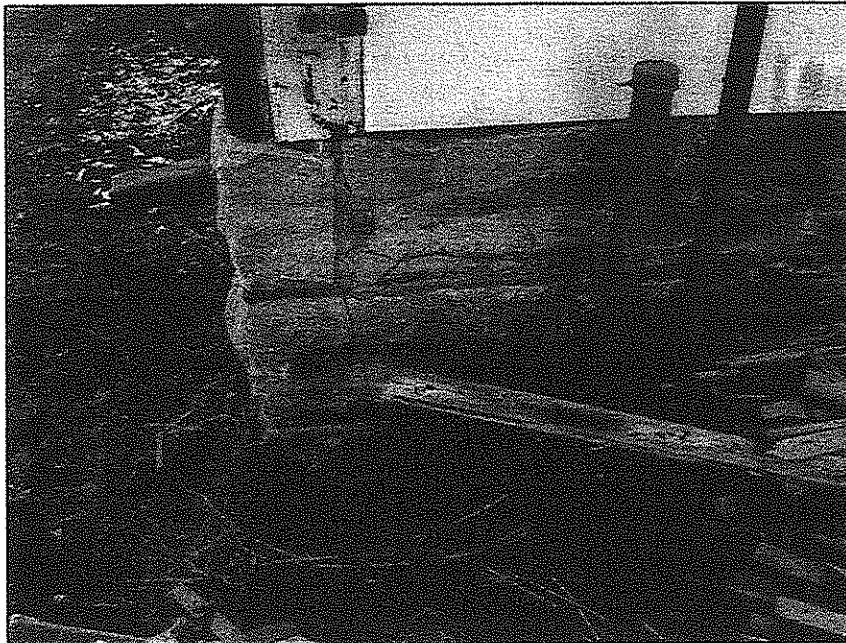
- The staircase from 1st to 2nd floor did not show any signs of damage.
- The stone foundation wall was exposed from the outside. A large vertical crack was visible through the stone on the North-East corner of the building (see Fig.5). Minor cracking in the parging between stones visible on all other areas of the foundation wall;

- The rear elevation was found to be bowing outwards;
- Since the basement has been unheated the depth of the frost line is penetrating below the level of the existing stone foundation walls and is creating further damages to the structure.

Figure 5 - Cracked stone foundation wall at rear elevation.
