Building Condition Report

**12, 14, 16 and 18 Hawthorne Avenue
Ottawa, Ontario**

Issued August 1, 2023

CJEL Reference No. 23-1216

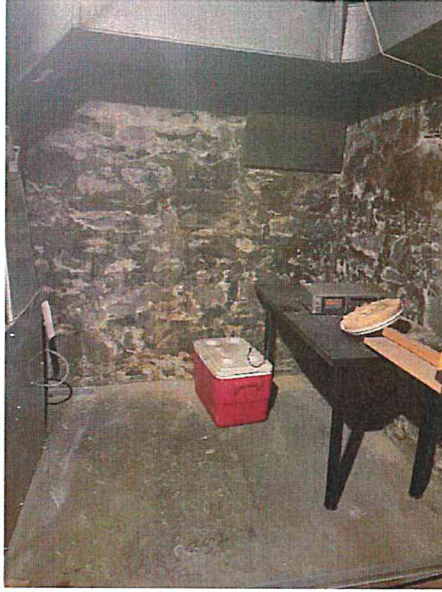
The stone foundation walls were found to be exhibiting moderate to extensive deterioration of the mortar joints. It is recommended that all walls be repointed.

Typical Foundation Deterioration

Estimated Foundation Structural Repair Cost: \$75,000 plus HST

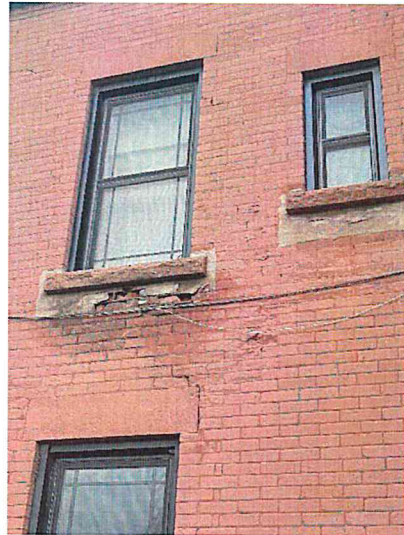
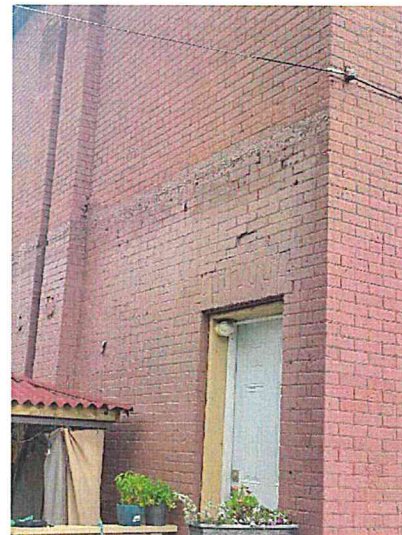
The buildings are clad primarily with a masonry brick veneer. Numerous areas of deterioration were noted on all four structures. It is recommended that an allowance of \$110,000 be carried for masonry repairs.

Estimated Masonry Cladding Repair Cost: \$110,000 plus HST

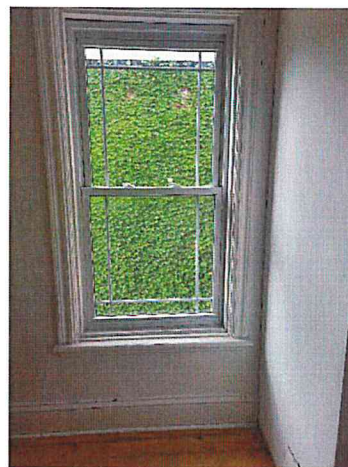
The typical window configuration consists of double hung PVC framed units. The age of the windows is not known but they are generally in good condition.
