Subject: 269-281 Bell Street South – Building Reviews | Condition Report

As requested, BPA Inc. has completed a structural condition review of the seven buildings with the civic addresses of 269, 271, 273, 275, 277, 279, and 281 Bell Street South, Ottawa, Ontario.

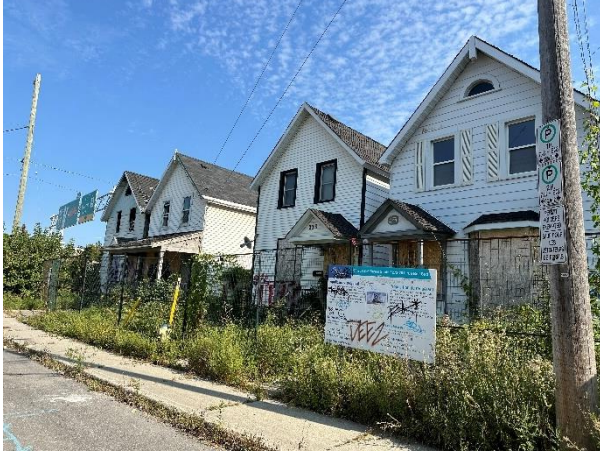
Based on our observations of the condition of the buildings at 269 and 271 Bell Street South, it is our opinion that both of these buildings are not structurally salvageable.

Photo 1: 269, 271, 273 and 275 Bell St S.

Between the fire and water damage and the conditions of the foundations of buildings 269 and 271 Bell Street South, it is our opinion that both of these buildings are not structurally salvageable and should be demolished.

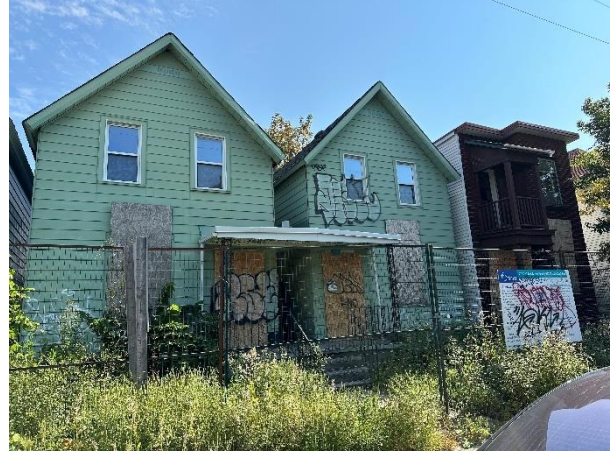
Photo 2: 277, 279 and 281 Bell St S

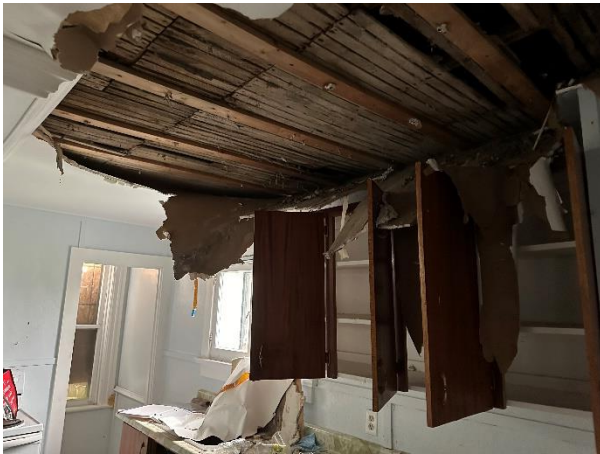
Photo 3: Failed Interior Ceiling

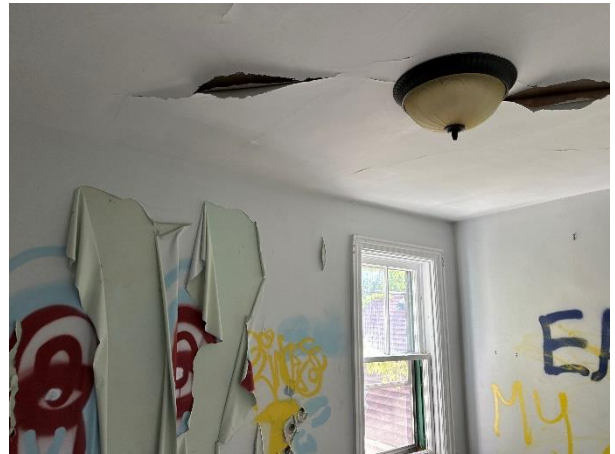
Photo 4: Interior paint peeling and ceiling damage

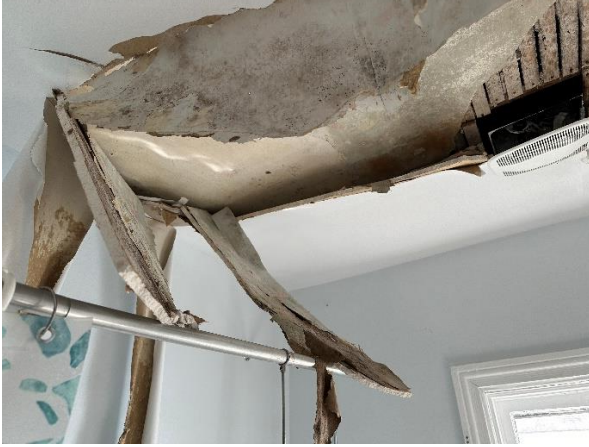
Phot 5: Interior Failed Ceiling

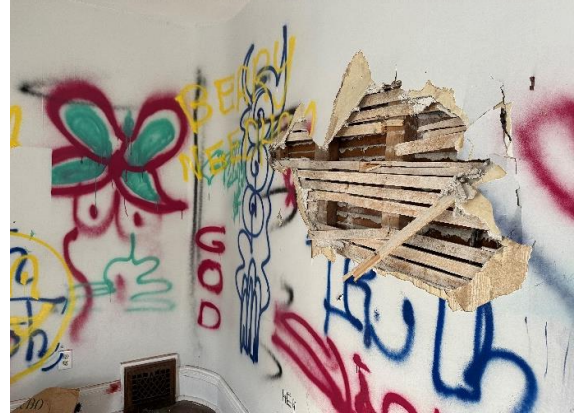
Photo 6: Interior wall damage

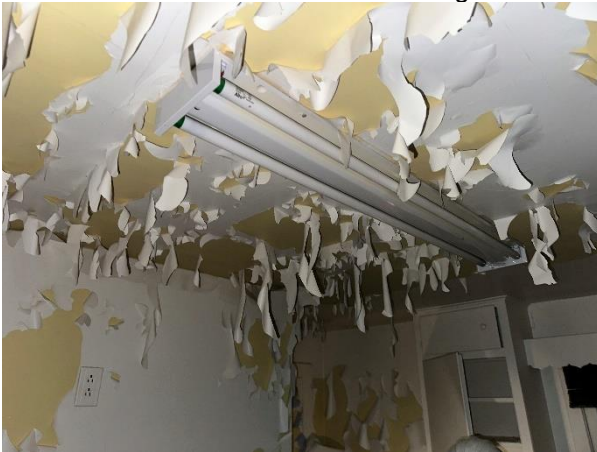
Photo 7: Interior finishes deterioration

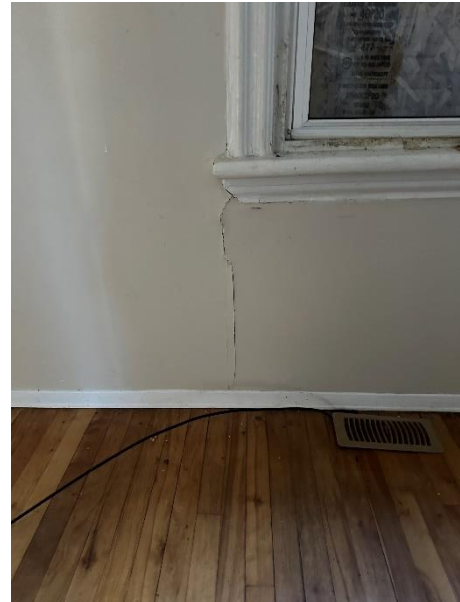
- Cracking in finished walls.
  - Several locations of cracking were observed throughout the finished ceilings and walls. These were located across mid spans of ceiling and at windows, door frames and vertically within walls at locations where floor deflections were noted.

Photo 8: Interior cracking in finishes at window

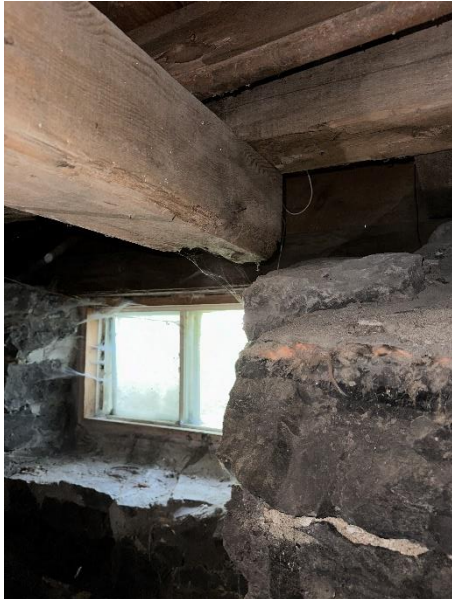
- Localized damage observed along the wood beams (missing cross sectional area, checking, etc.)
- Unsupported wood floor framing.
  - A primary wood beam was observed to have shifted away from the foundation wall and floating above the wall.

Photo 9: Primary ground floor beam shifted and unsupported

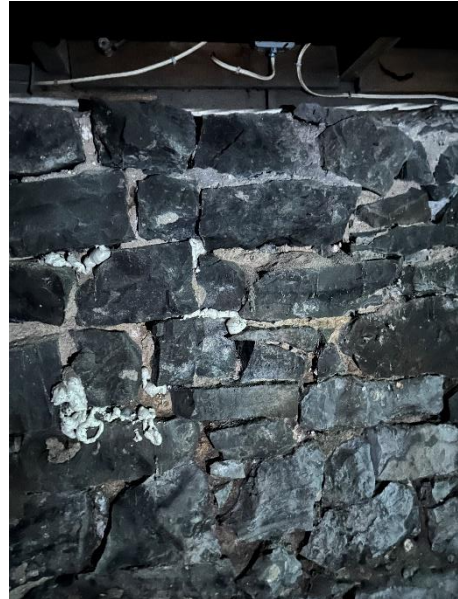
Photo 10: Deteriorated and Missing mortar in rubble stone wall

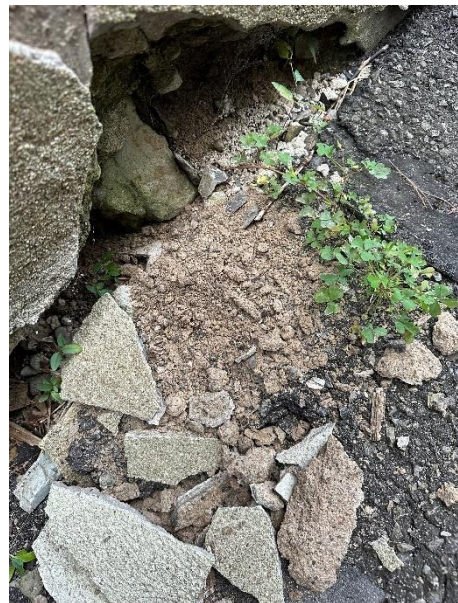
- Significant deterioration of the concrete foundation walls.
  - The deterioration of the concrete foundation walls was observed above grade on the exterior of the walls and below grade on the interior of the walls.

Photo 12: Concrete foundation deterioration at grade (exterior)

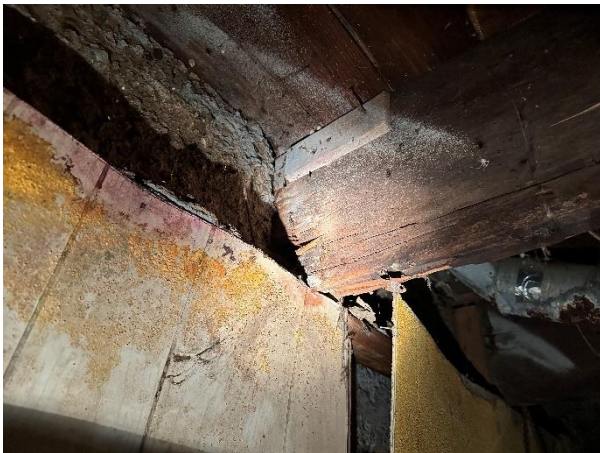
- The deterioration of the foundation walls has resulted in the loss of bearing at localized beam and joist locations.
  - Wood floor framing was observed to be inadequately supported and missing posts.

Photo 15: Unsupported wood floor beam

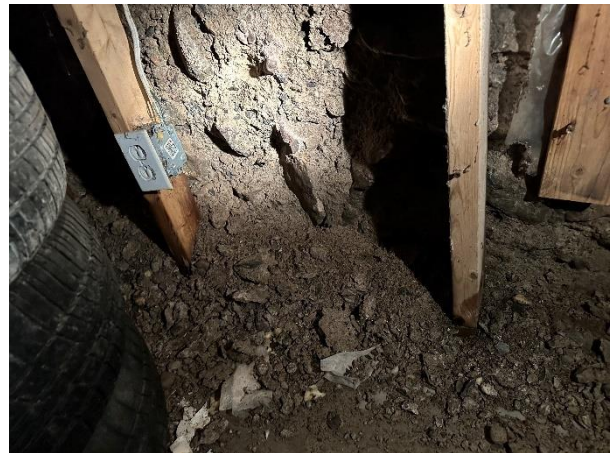
- The concrete was observed to be deteriorating to a sandy material that was able to be easily removed from the walls by hand. Piles of the sandy material and the stone aggregate from the wall was observed on floors around the interior of the foundation walls indicating that the wall deterioration is occurring without physical disturbance.

Photo 16: Concrete foundation deterioration (interior)

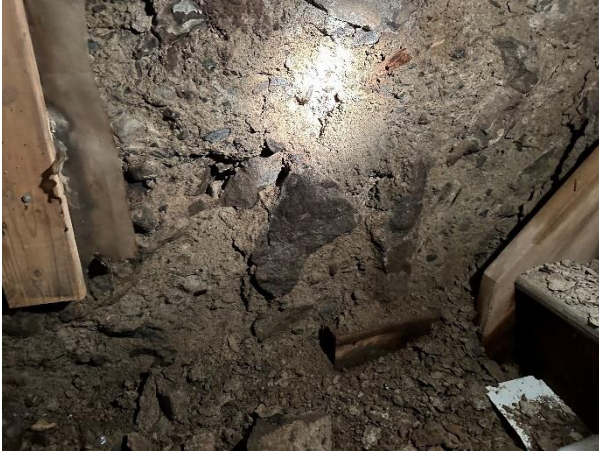
Photo 17: Concrete foundation deterioration (interior)

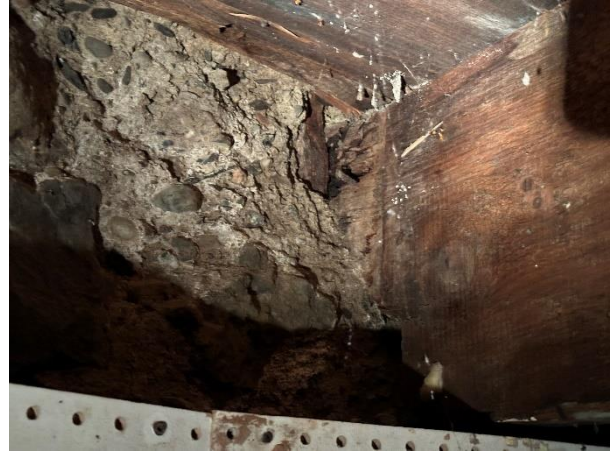
- Ground floor framing was observed to contain localized dry rot at the ends of joists and beams at the locations where they are pocketed into the foundation walls or bearing on the walls.

Photo 18: Wood beam Dry rot

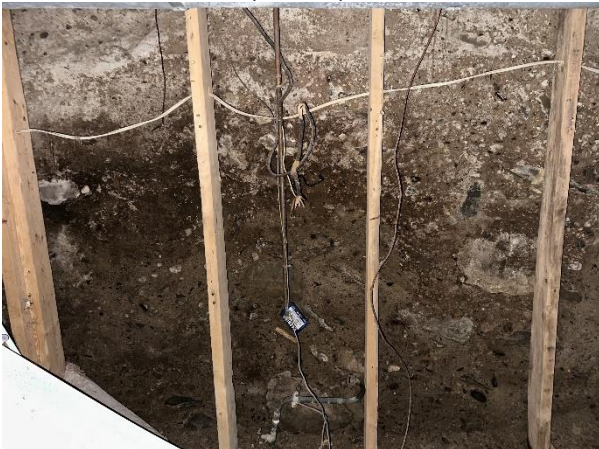
- Water ingress and efflorescence staining was observed throughout the foundation walls. The basement floors and walls were observed to be damp and wet.

Photo 19: Foundation wall Water ingress and deterioration (interior)

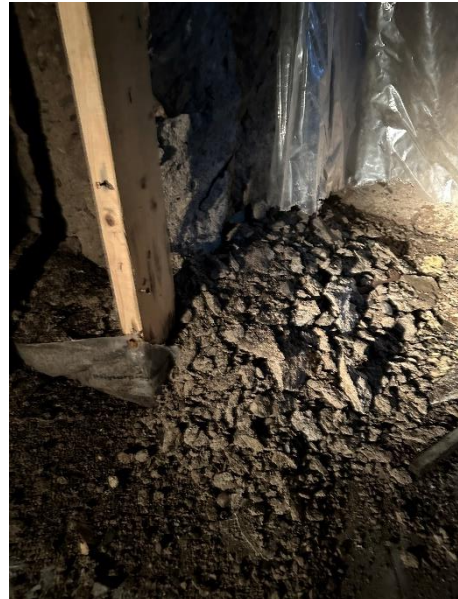
Photo 20: Foundation wall debris at base of wall (interior)

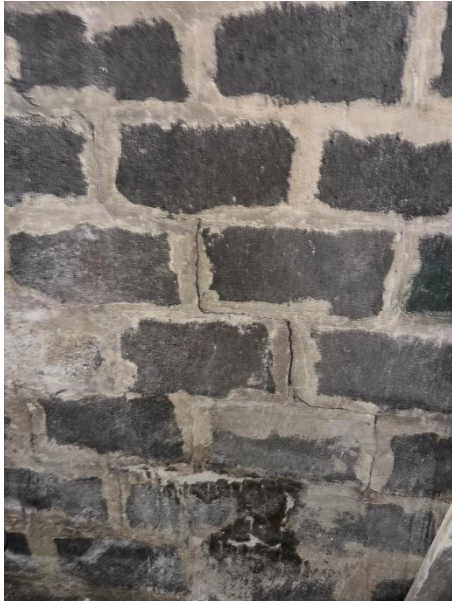
Photo 21: Step cracking in interior foundation wall
