October 3rd, 2024 (Rev. 1)

Subject: 269-281 Bell Street South – Building Reviews | Condition Report

Appendix A: Photos

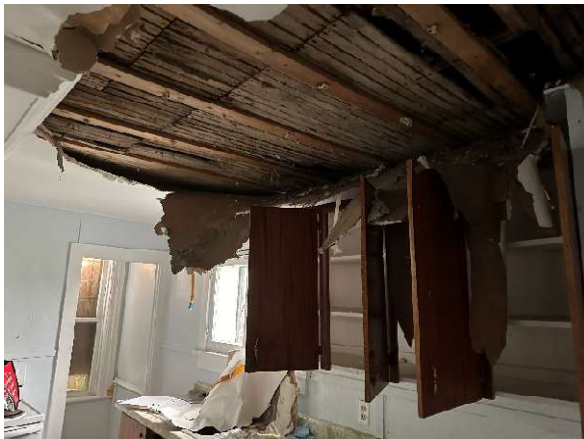
Photo 3: 281 Bell St - Failed Interior Ceiling

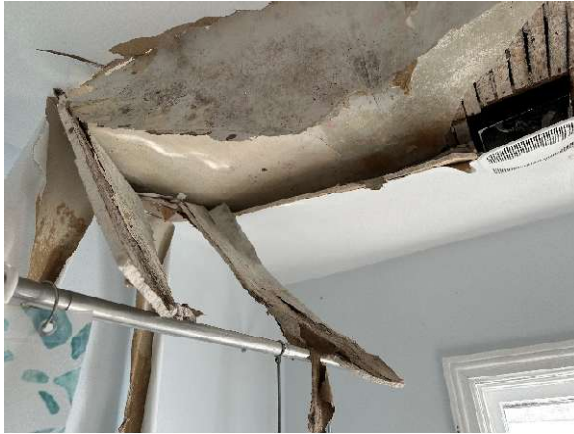
Phot 5: 281 Bell St - Interior Failed Ceiling

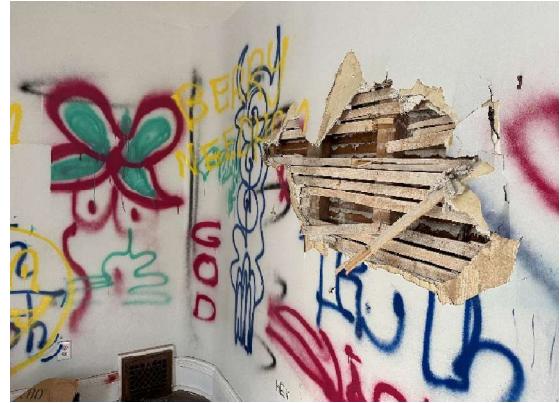
Photo 6: 281 Bell St - Interior wall damage

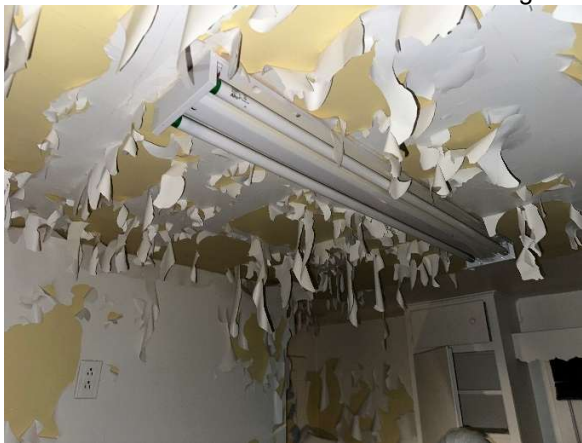
Photo 7: 277 Bell St - Interior finishes deterioration

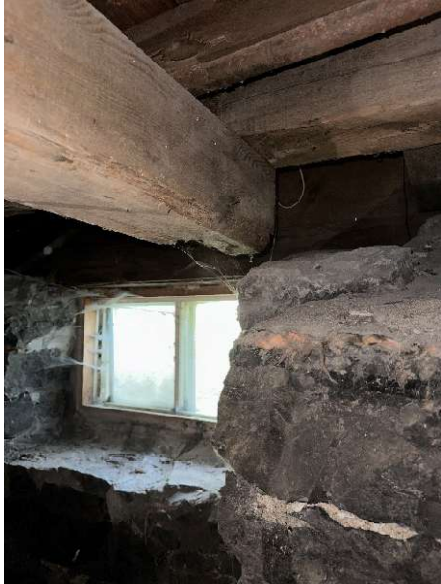
- Localized damage observed along the wood beams (missing cross sectional area, checking, etc.)
- Unsupported wood floor framing.
 - A primary wood beam was observed to have shifted away from the foundation wall and floating above the wall.

Photo 9: 281 Bell St - Primary ground floor beam shifted and unsupported

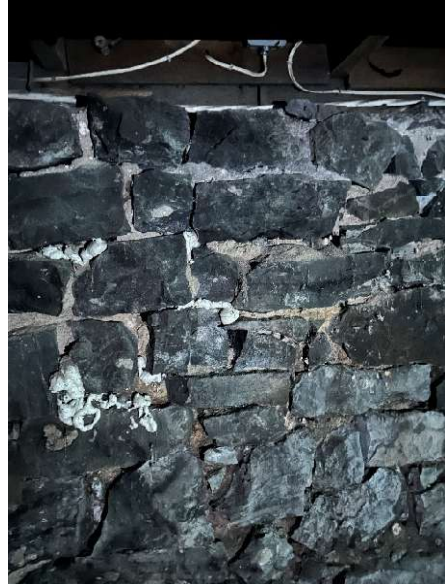
Photo 10: 281 Bell St - Deteriorated and Missing mortar in rubble stone wall

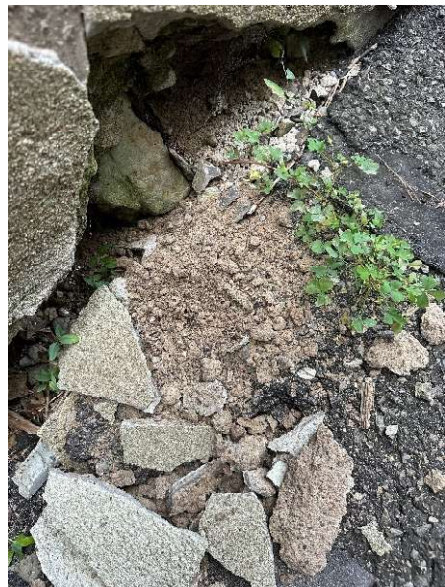
- Significant deterioration of the concrete foundation walls.
 - The deterioration of the concrete foundation walls was observed above grade on the exterior of the walls and below grade on the interior of the walls.

Photo 12: 273 Bell St - Concrete foundation deterioration at grade (exterior)

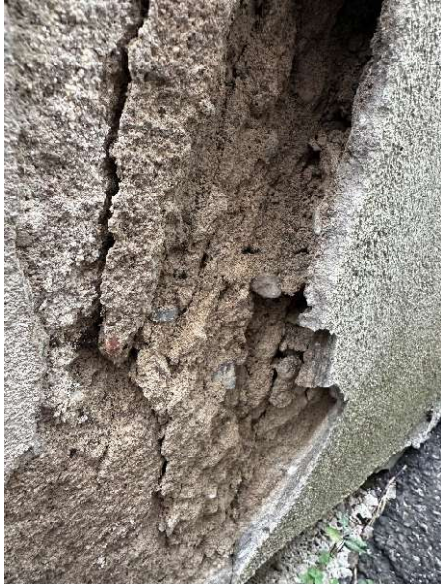
Photo 13: 275 Bell St - Concrete foundation deterioration (exterior)

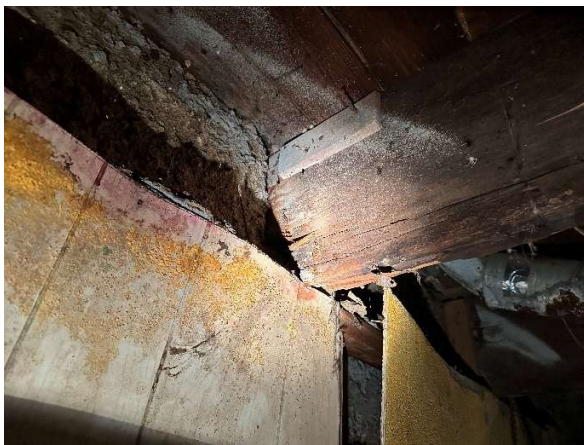
Photo 15: 273 Bell St - Unsupported wood floor beam

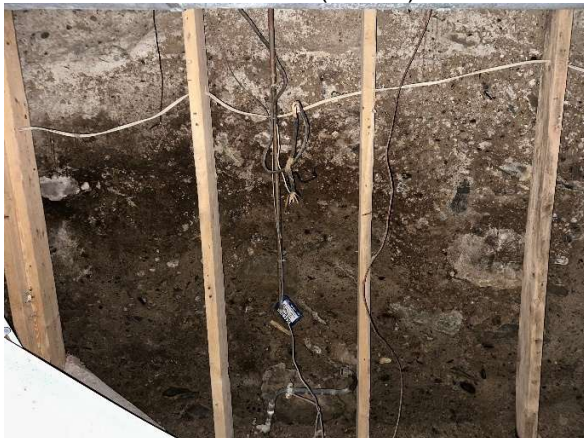
- Water ingress and efflorescence staining was observed throughout the foundation walls. The basement floors and walls were observed to be damp and wet.

Photo 19: 275 Bell St - Foundation wall Water ingress and deterioration (interior)
