DESIGNATED SUBSTANCES AND HAZARDOUS BUILDING MATERIALS SURVEY

Subject Property | 95 Melrose Avenue, Ottawa, ON

Allstate Insurance
Michael Chamanlall
December 23, 2024
SD042628
IGENV-50314
Matthew Magnus
A – Photo Log
Laboratory Results
Sampling Plan
Occurrences Plan

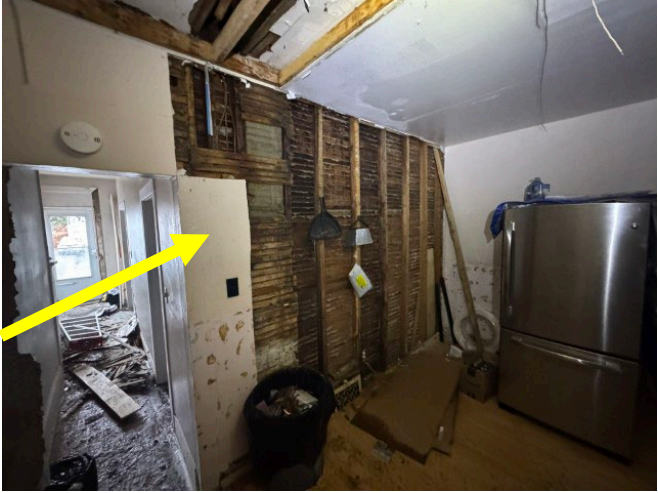
<p>Photo 1: Main Floor Plaster Walls / Ceilings</p>

<p>Plaster walls and ceilings throughout the original portion of the home are asbestos-containing. White-paint is lead-containing.</p>	<p>Photo 2: Thermal System Insulation</p>

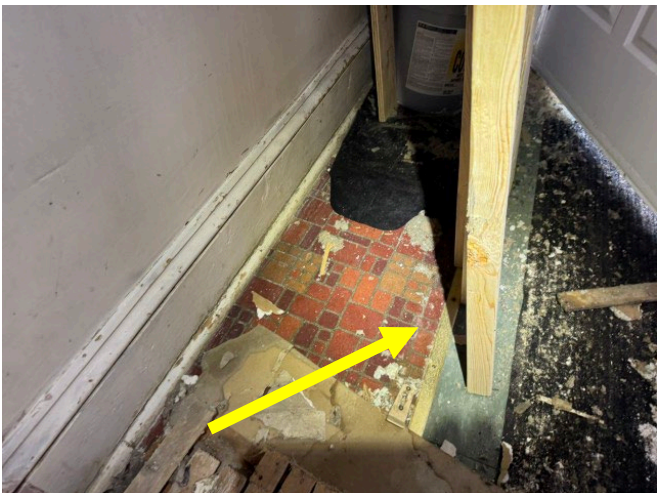
<p>Mastic associated with flooring in the main floor entranceway is asbestos-containing.</p>	<p>Photo 4: Exterior Plaster</p>

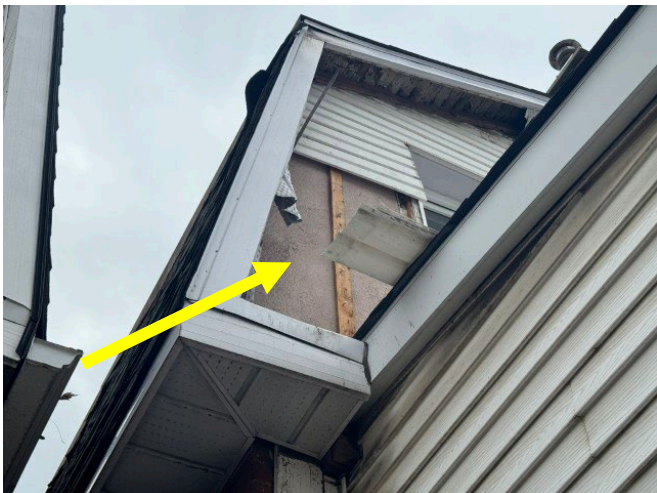
<p>Exterior plaster (pink) is asbestos-containing.</p>

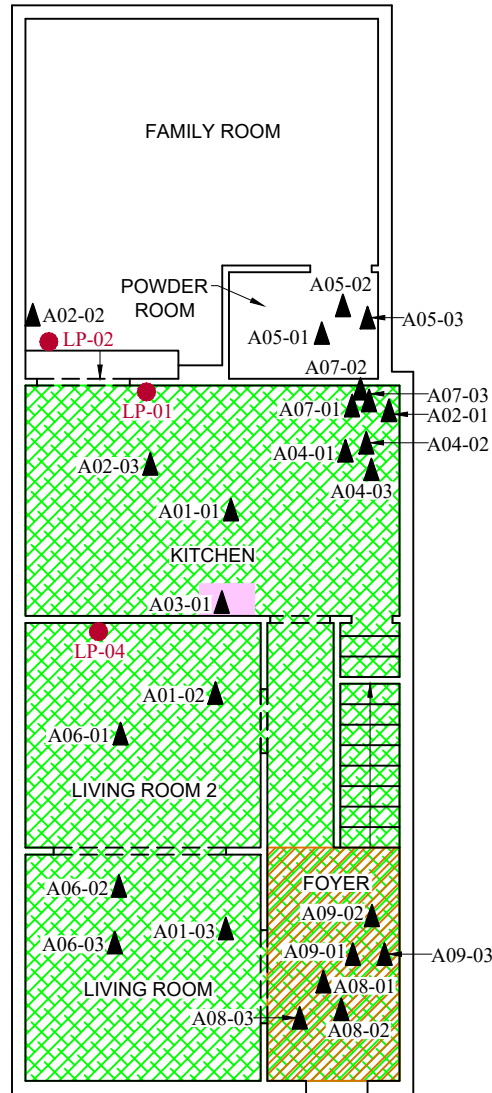
MAIN FLOOR

NOTES: 1. WHITE-PAINT CONTAINS LEAD.

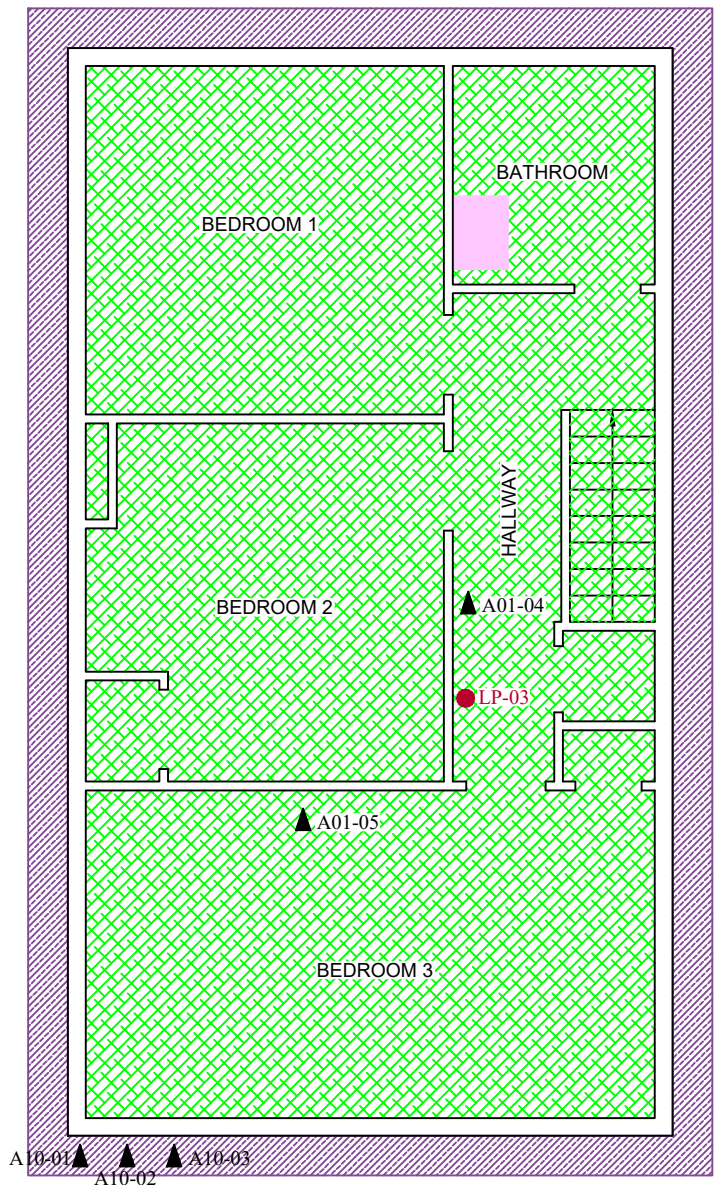
SECOND FLOOR

NOTES: 1. WHITE-PAINT CONTAINS LEAD.
