May 11<sup>th</sup>, 2018

**CM3 File No. TLW-1928**

**Pre Demolition Designated Substance Survey  
24 Hawthorne Avenue  
Ottawa, Ontario**

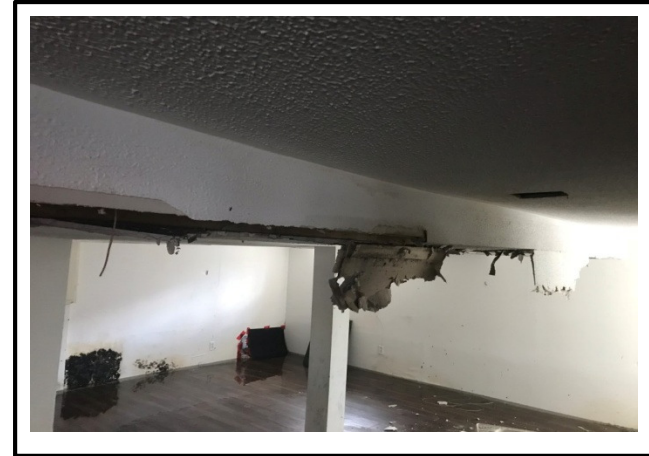
There is a significant amount of visible mould located in the basement. During the assessment it was noted that the basement had flooded and there was approximately eight inches of water throughout the basement.

Photograph 2: Mould impacted drywall located in the  
basement.

- Due to the extensive visible mould contamination throughout the basement. Persons entering the premises should wear a half-face piece air purifying respirator fitted with replaceable filters (N95 minimum), suitable eye protection and disposable coveralls and dust impermeable gloves as well as disposable boot covers prior to entering the residence.
- During demolition activities dust suppression measures must be taken to reduce the release spores and other mould derived particulate matter.

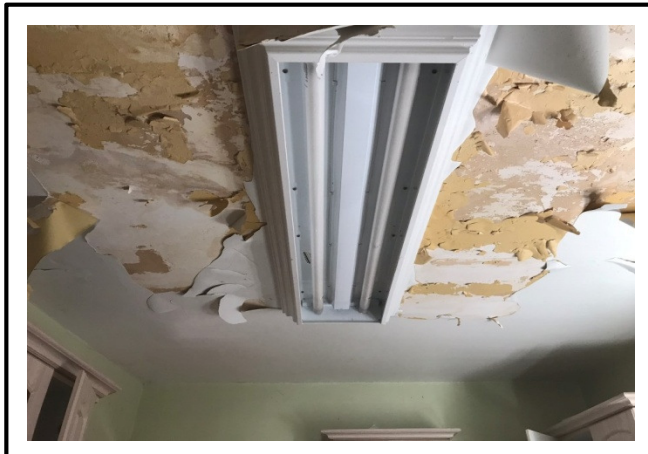
Mercury containing fluorescent light tubes are present throughout the residence. In addition, mercury may also be used as a preservative in paint applications.

Photograph 3: Mercury containing fluorescent light tubes  
located throughout residence.

- Best management practices dictate that the fluorescent light tubes be carefully removed, containerized and picked up and disposed of by a licensed hazardous materials contractor in accordance with Ontario Regulation 347/09 (as amended) prior to demolition.
