BUILDING CONDITIONS REPORT

293 LISGAR STREET

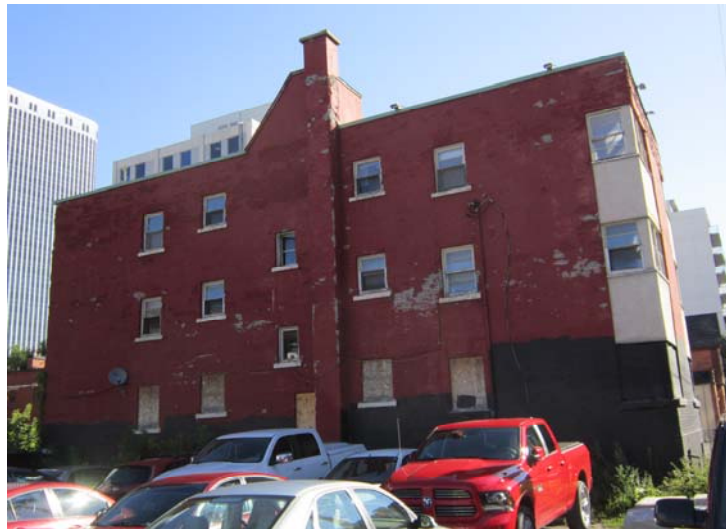
Currently, the building is unoccupied and all lower floor windows and doors have been boarded up. The building appears to be built of load bearing masonry walls and cast in place concrete foundations. It has a flat roof over the main portion of the building with an inclined roof over the walk out stairwell. See Photo 1 for hoarding over lower floor openings and walk out roof projection.

Photo 1 - West Elevation of Building

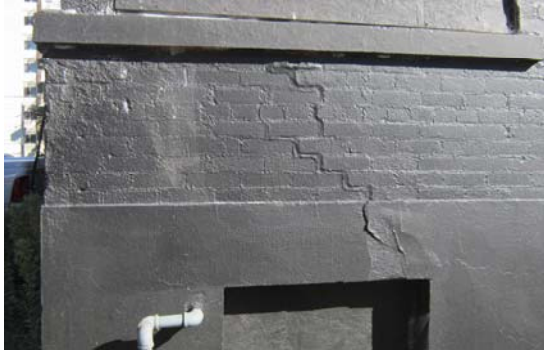
Masonry is cracked in numerous locations indicating possible foundation settlement in localised areas (see Photo 2) and appears to be spalling or delaminating in numerous areas (see Photos 3, 4, & 5)

Photo 2 - South West Corner

This building would require extensive renovations to make it safe. The main structural item is the poor condition of the masonry throughout the building. Spalling masonry units (i.e. bricks) would have to be replaced in large areas. Interior wood framing members would need to be exposed to be inspected, and then replaced as necessary. Masonry gaps would need to be filled in all areas. This work would be required at a minimum if the building is to be reoccupied. A further, more extensive review would be required if the building is to be used in the future.

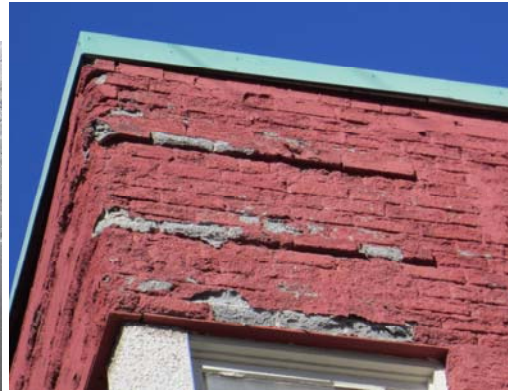
Photo 3 - South East Corner

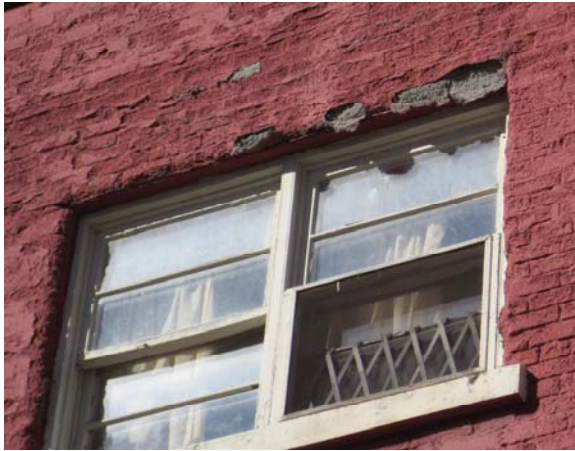
Photo 4 - Brick Spalling Above Window

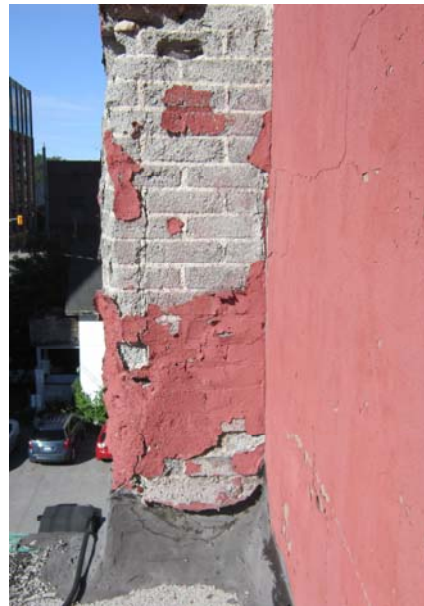
Photo 5 - Brick Spalling Above Roof

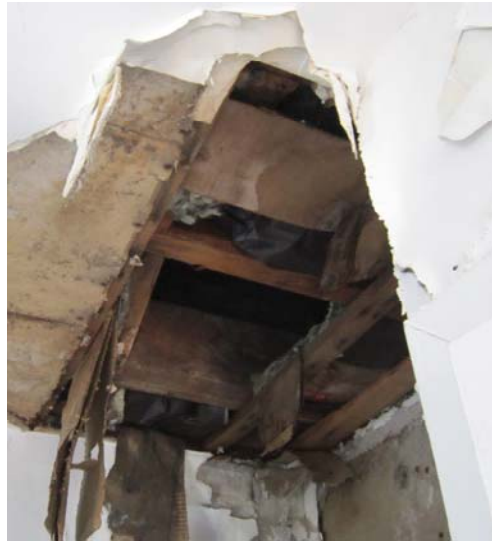
The interior of the building was in serious disrepair. Ceilings had collapsed in multiple units (see Photo 6), exposing wood joists with possible water damage. Masonry in stairwell was cracked in numerous locations (see Photos 7 & 8) with brick and concrete

Photo 6 - Collapsed Ceiling and Water Damage

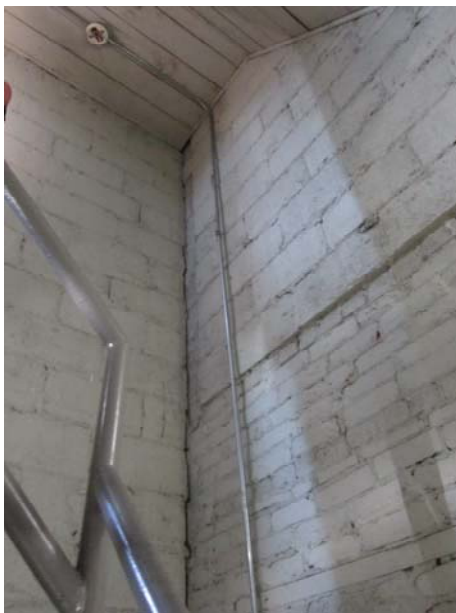
block being used at various junctions. This indicates that walls are not properly tied together and are continuing to shift.

Photo 7 - Stairwell Interior at Roof

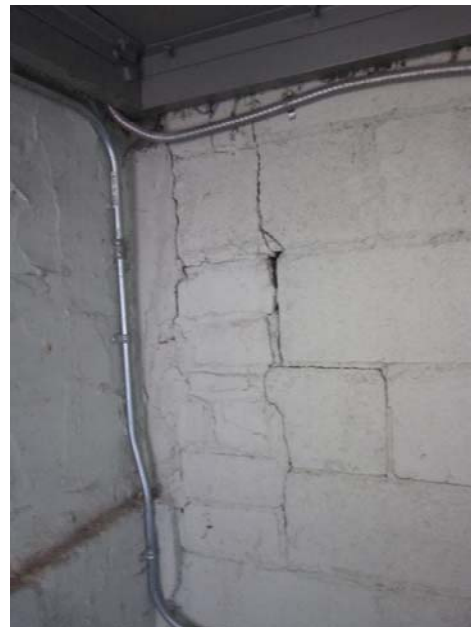
Photo 8 - Underside of Stair Landing
