A Cultural Heritage Impact Statement

100 Argyle Avenue, Ottawa

SUBMITTED TO: Colonnade BridgePort
PREPARED BY: Commonwealth Historic Resource Management
Revised 1 January 2019

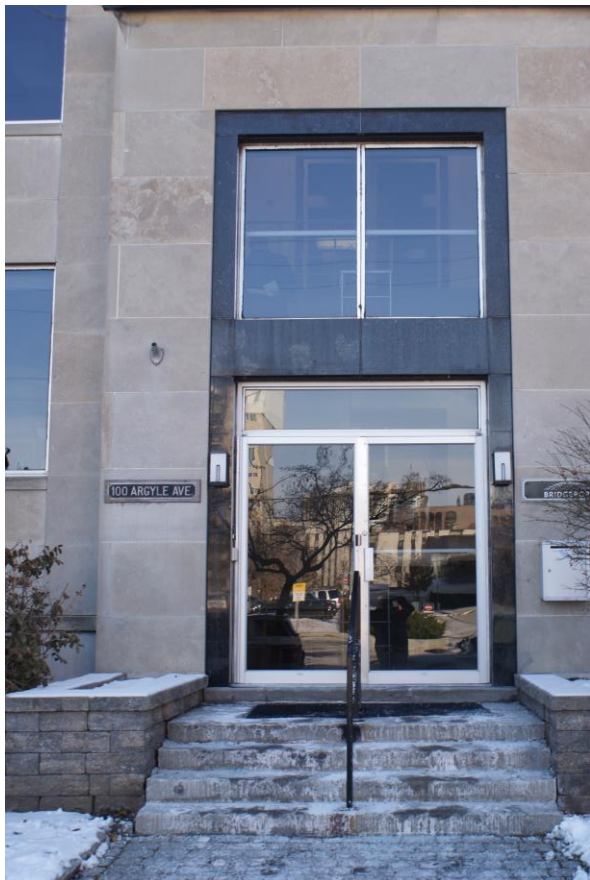
Figure 12: View of the main entrance to 100 Argyle. The entrance steps, doors, and upper transom are modern replacement units. The original entrance design is evident in the 1959 elevation drawings for the addition. Note the polished black granite entrance surround, street address plate and two sidelights all of which are original architectural features. The plan is to remove the stairs and drop the floor level to the same grade as the sidewalk to provide accessible access. Source: CHRML

- The 1959 drawings of the addition to 100 Argyle provide sufficient information for the replacement of the door and transom. Consideration should be given to reconstructing this feature.
- The planting of street trees along the northern boundary of the museum property would help to integrate the heritage character of Argyle Avenue with the Centretown HCD, and more specifically the areas surrounding the Museum of Nature.

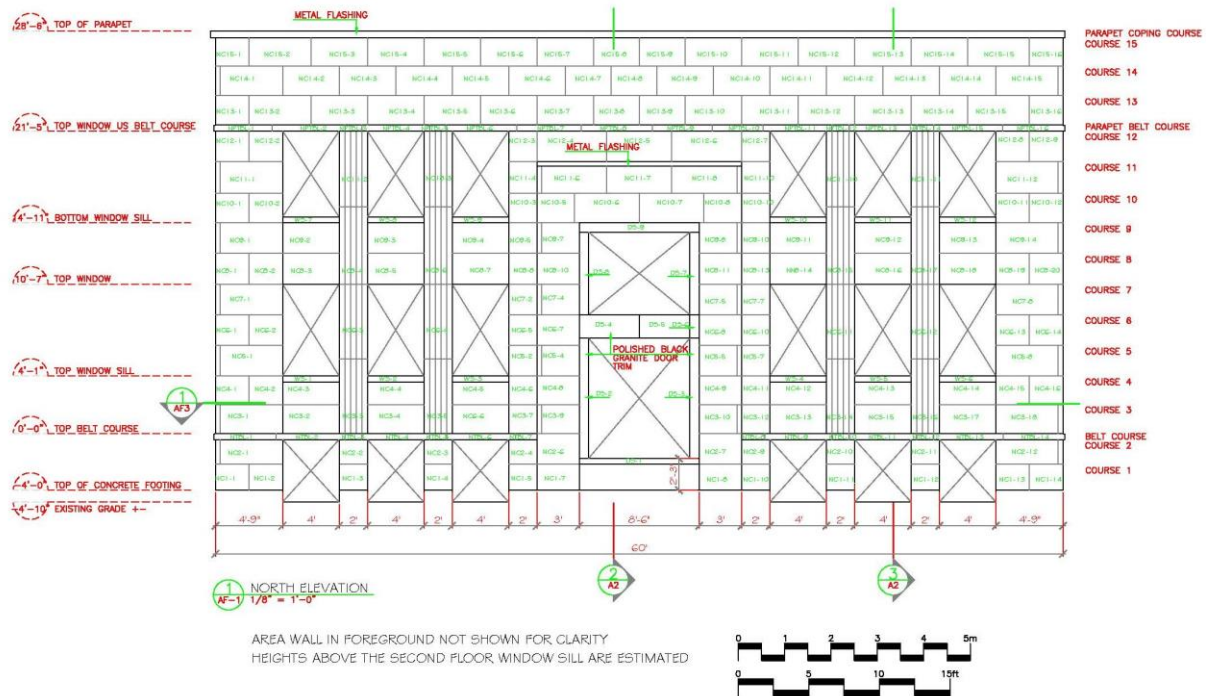
Figure 27: As-found drawing of the front façade with individual limestone units catalogued and their condition noted. Source CHRML

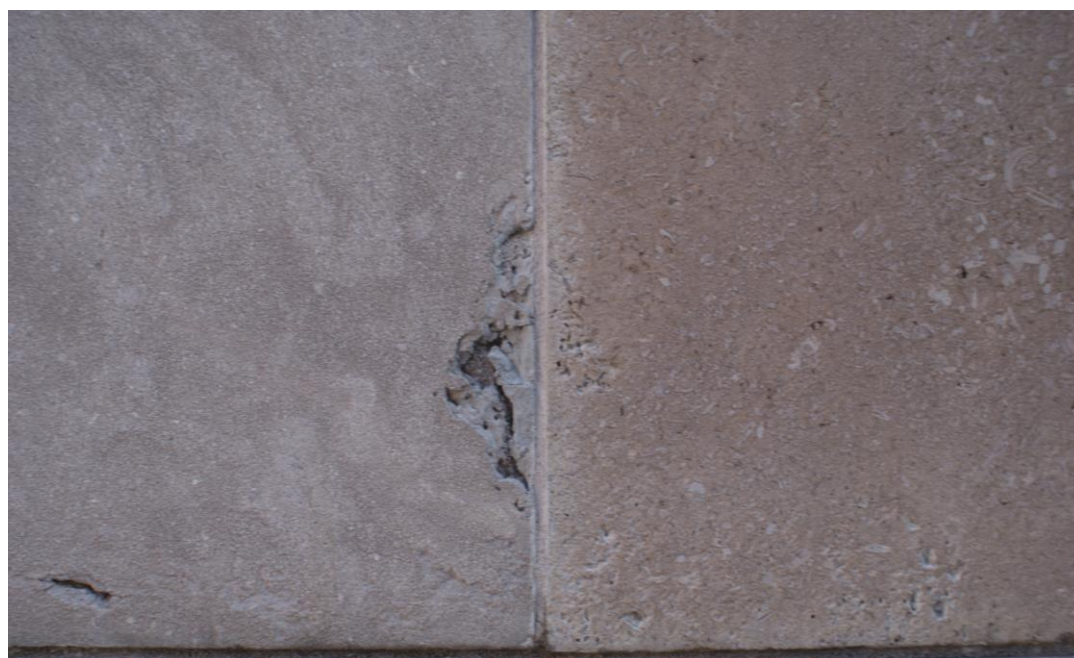
Figure 2: Detail view of ashlar limestone blocks. Note the voids or vugs in the unit to the left. Note the shell fragments in the block to the left. Source: CHRML.

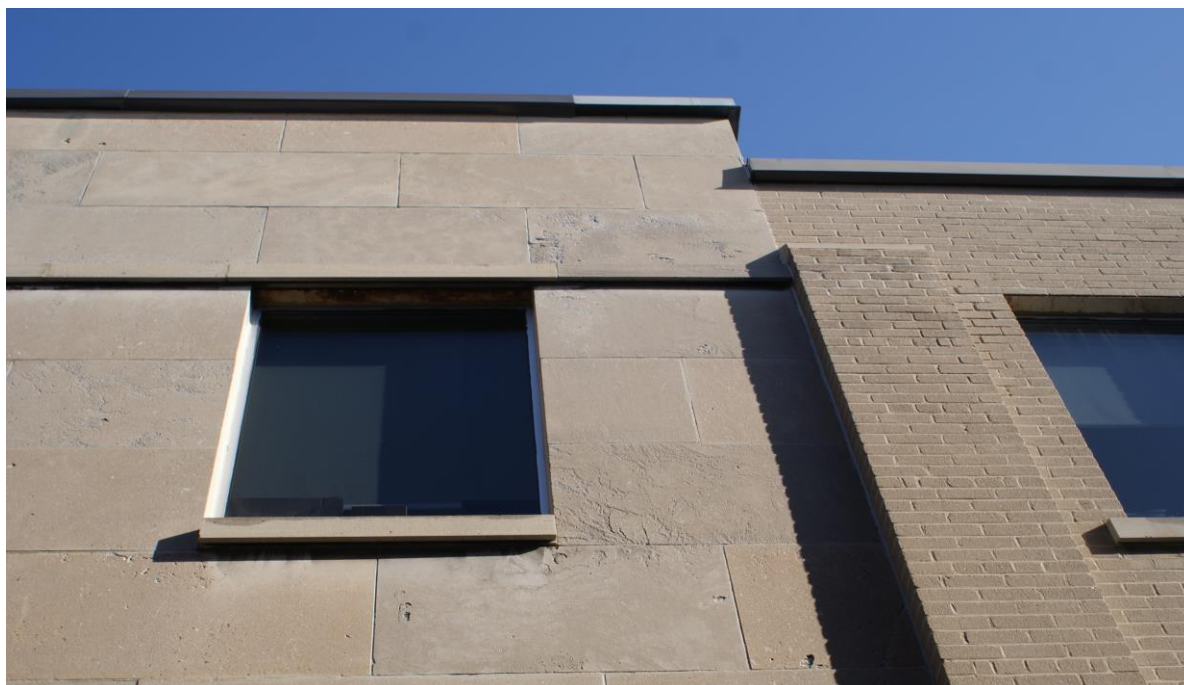
Figure 3: Detail view of a portion of the west façade. A delaminating stone is located to the bottom right of the window, as well as the face stone to the right of the window above the belt course. There are also a number of vugs or inclusions evident in the face stones. Source: CHRML.

Conservation Approach; Selective retooling of the surface to remove loose and scaling material. Complete replacement of stone face units with more severe surface delamination.

Conservation Approach – Selective retooling and removal of loose or disaggregated stone. Application of a repair mortar such as Jahn M70 Limestone custom coloured to match the stone.

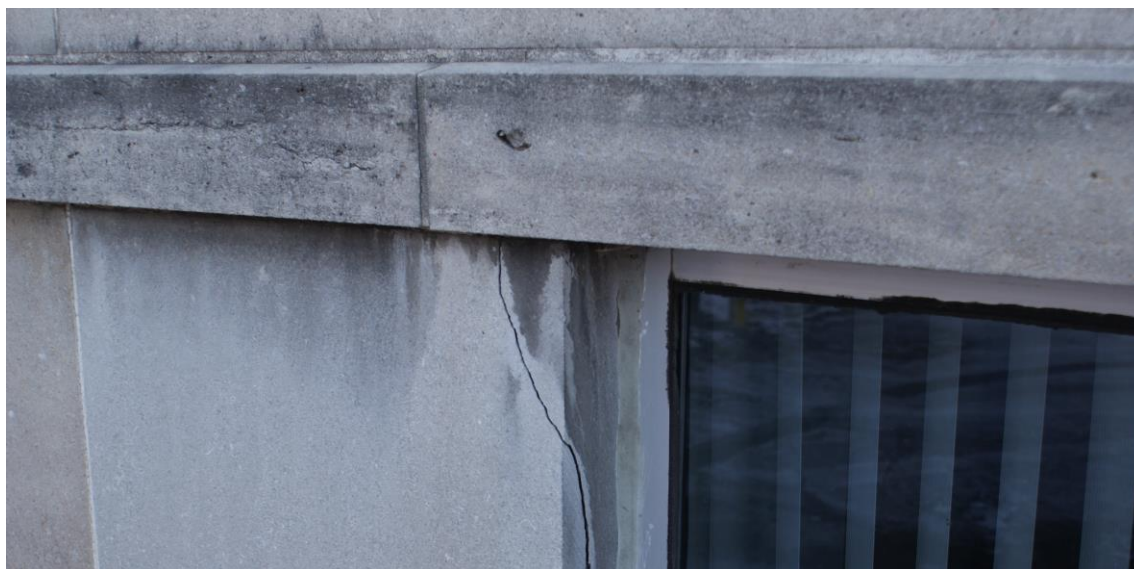
Fracturing – Delamination of a stone at a bedding plane that has different material characteristics. This is more common with the stones in the belt courses, and windowsills.

Figure 4: View of a stone in the belt course (left) that is in the process of fracturing at a bedding plane that has different material characteristics. Source: CHRML.

Conservation Approach – The options in regards to the stone windowsills are to replace defective units. This would entail a minimum of effort in that the slip sills are not tied into the adjacent walls. The course of action in regards to defective stones in the belt courses is to replace the units by cutting out the mortar joints and removing the stone. If the fracturing is more cosmetic and has no impact, on the weathering or water infiltration the stone can be left.

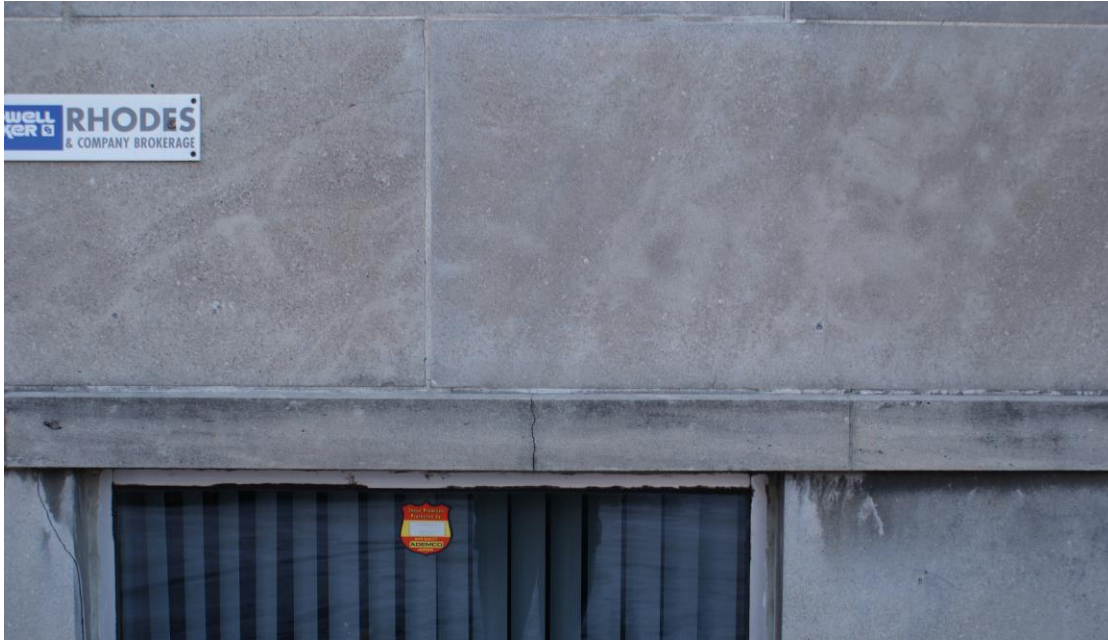
Cracking – A very limited number of stones in the belt course, one face stone, and a doorsill have cracked.

Figure 5: Detail of east elevation at the basement level. The stone belt course is cracked at the approximate mid-point of the window, and the face stone at the lower left below the window has sheared at an external corner. Source: CHRML.

Conservation Approach – Varies from complete replacement, to inserting stainless steel pins and applying a repair mortar such as Jahn M70 Limestone, custom coloured to match the stone. Alternately, if left in-situ, leave the stone in place and do nothing depending upon its visibility.

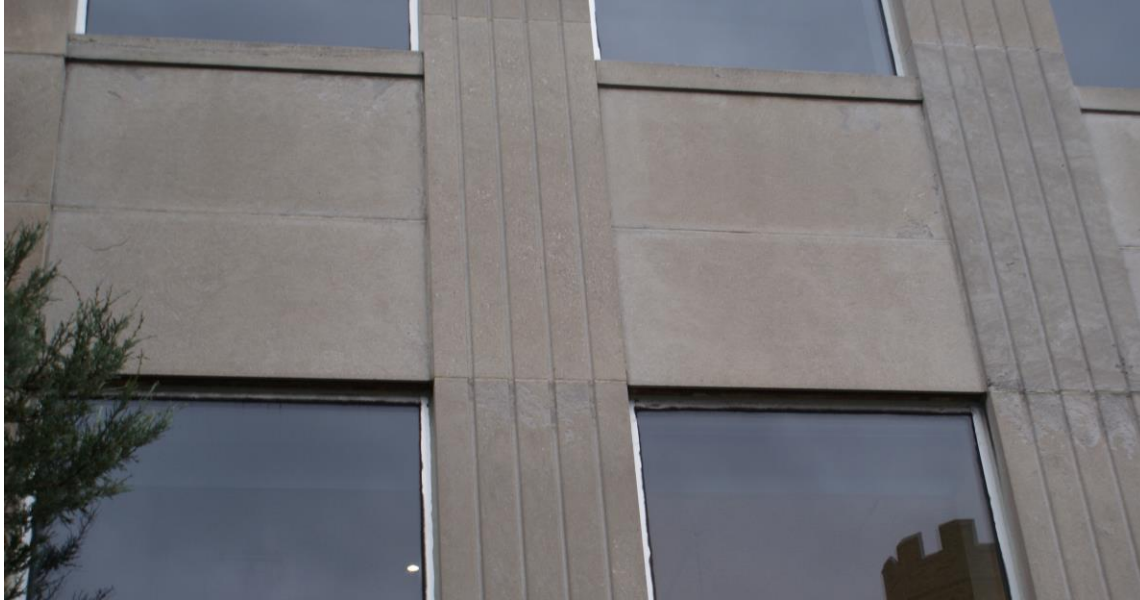
Figure 9: View of reeded stones where they meet at the top of the first floor windows. Note the chipping and scaling of the stones where they meet which may be due to compression failure. Source: CHRML.

Conservation Approach – Remove chips and retool the area. Review structural loading conditions that caused the deflection.

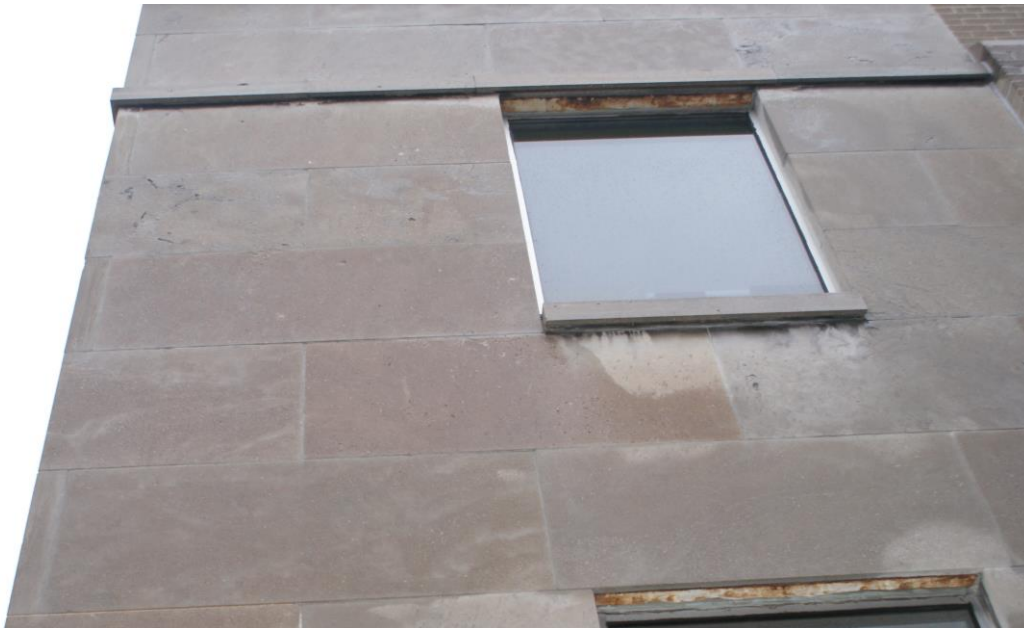
Figure 10: Note the rusting steel angle below the parapet belt course and the first floor window. There are indications on the north façade that the shelf angle below the parapet belt course is continuous. If this is the case, there is a high probability that the steel angle is secured to steel buried behind the wall (See Figure 13). Note the delaminating stone to the left of the second floor window and the discoloured stone below the window sill, which is an indication that the stone is being saturated by water from defective caulking. Source: CHRML.

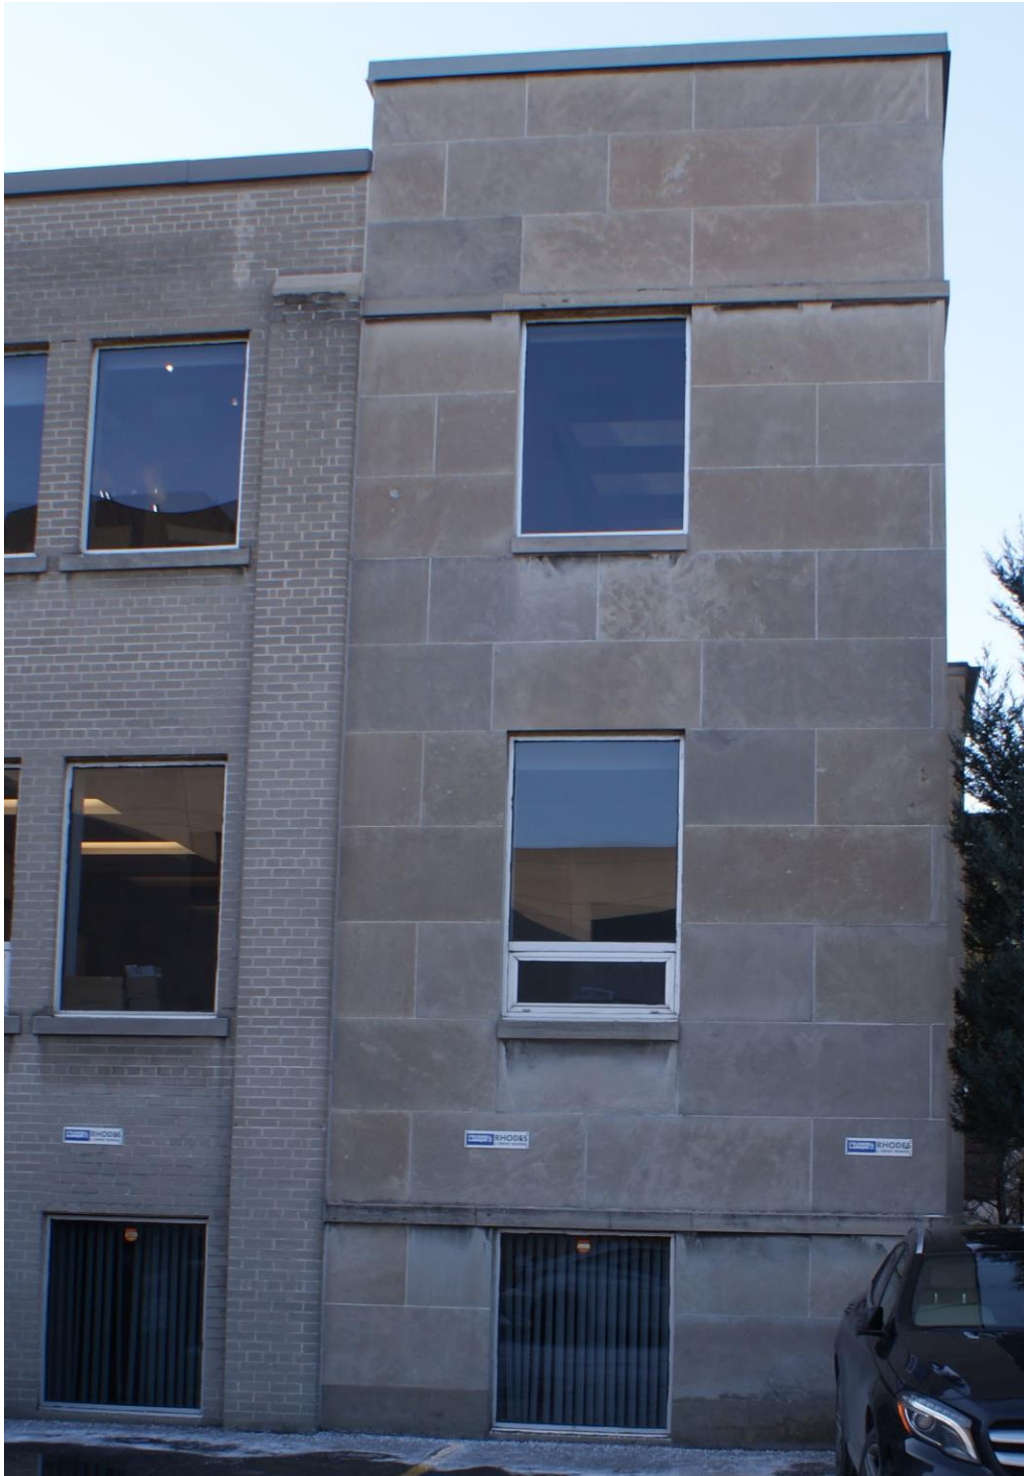
Figure 11: View of the east façade of the building. Note the lintel stone above the first floor window that overlaps onto the adjacent stones indicating a traditional load-bearing application. Note the projecting brick pilaster and its termination at the top. A steel column is likely buried behind the pilaster. The beam may support additional horizontal steel beams that would support the parapet, which the continuous shelf angle evident below the parapet belt course would be attached. Source: CHRML.
