**Phase I - Environmental Site Assessment**

1987 Robertson Road  
Ottawa, Ontario

Hadwen Properties Limited

Report: PE4378-1

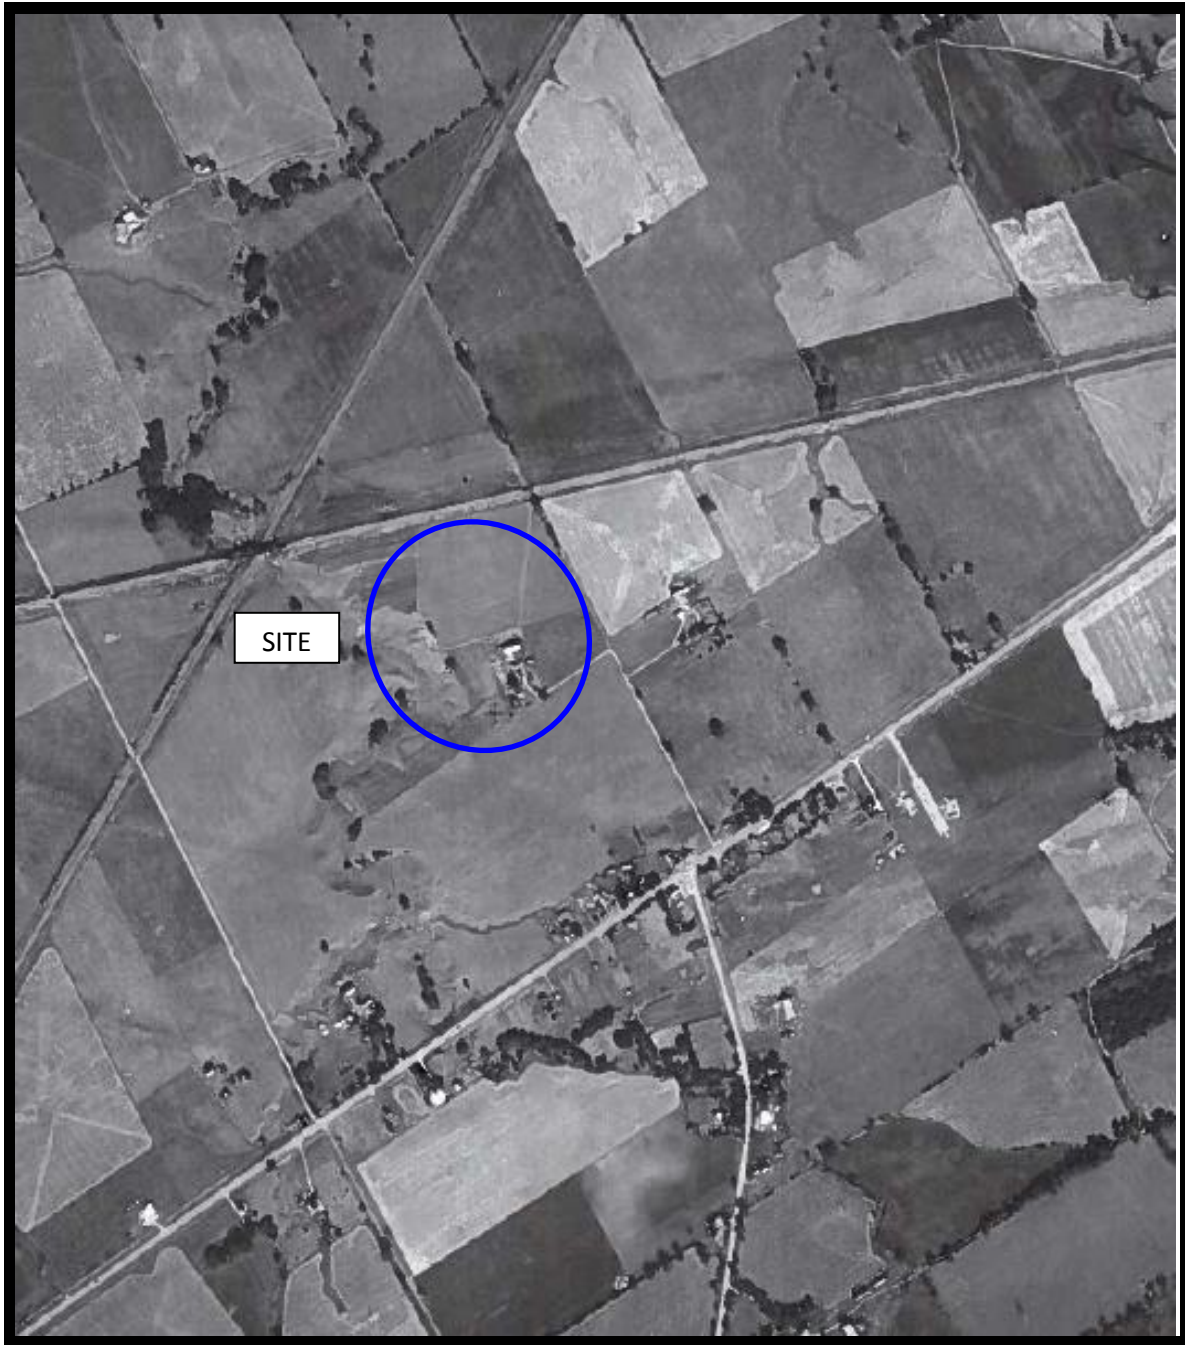
AERIAL PHOTOGRAPH  
1951

| 1951 | The subject site is occupied by a farmstead and associated outbuildings at this time. Another farmstead can be seen to the east of the subject site while the remainder of the neighbouring properties are vacant and appear to be primarily used for agricultural purposes. A railway line can be seen to the north in this photo. Robertson Road is present to the south at this time. |

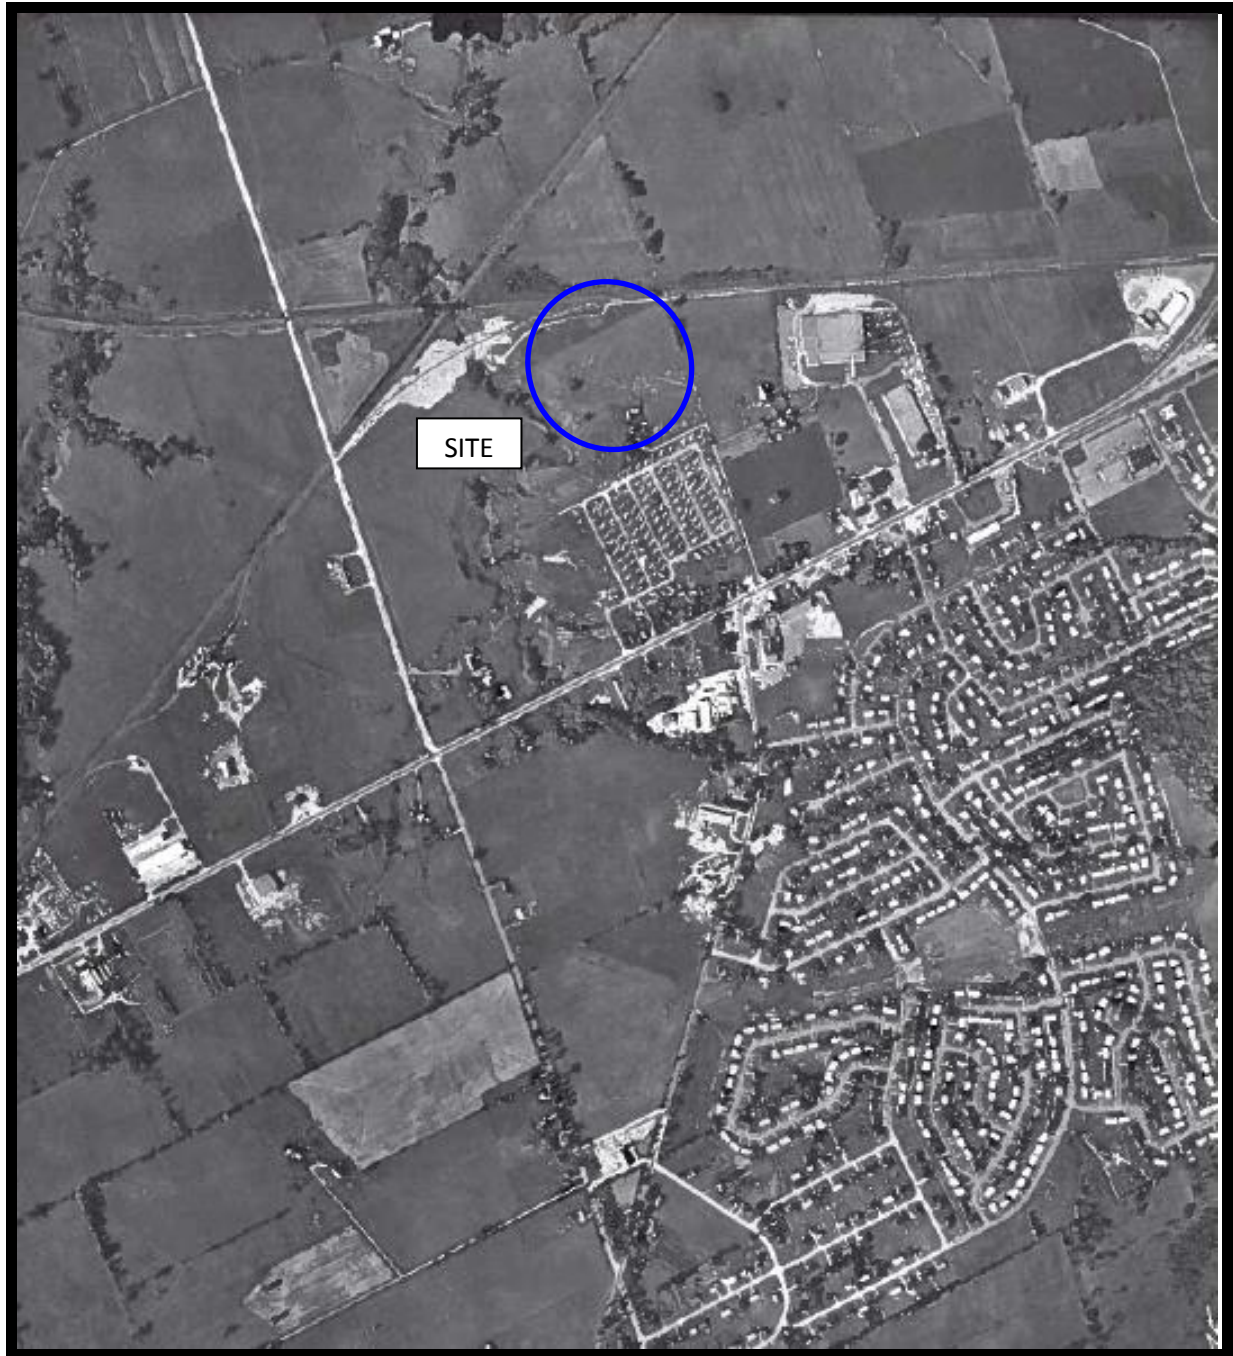
AERIAL PHOTOGRAPH  
1963

| 1963 | The subject and neighbouring properties to the north and west are unchanged from the previous photo. The neighbouring property to the south is now occupied by a trailer park, while increased commercial development can be seen further to the east at this time. |

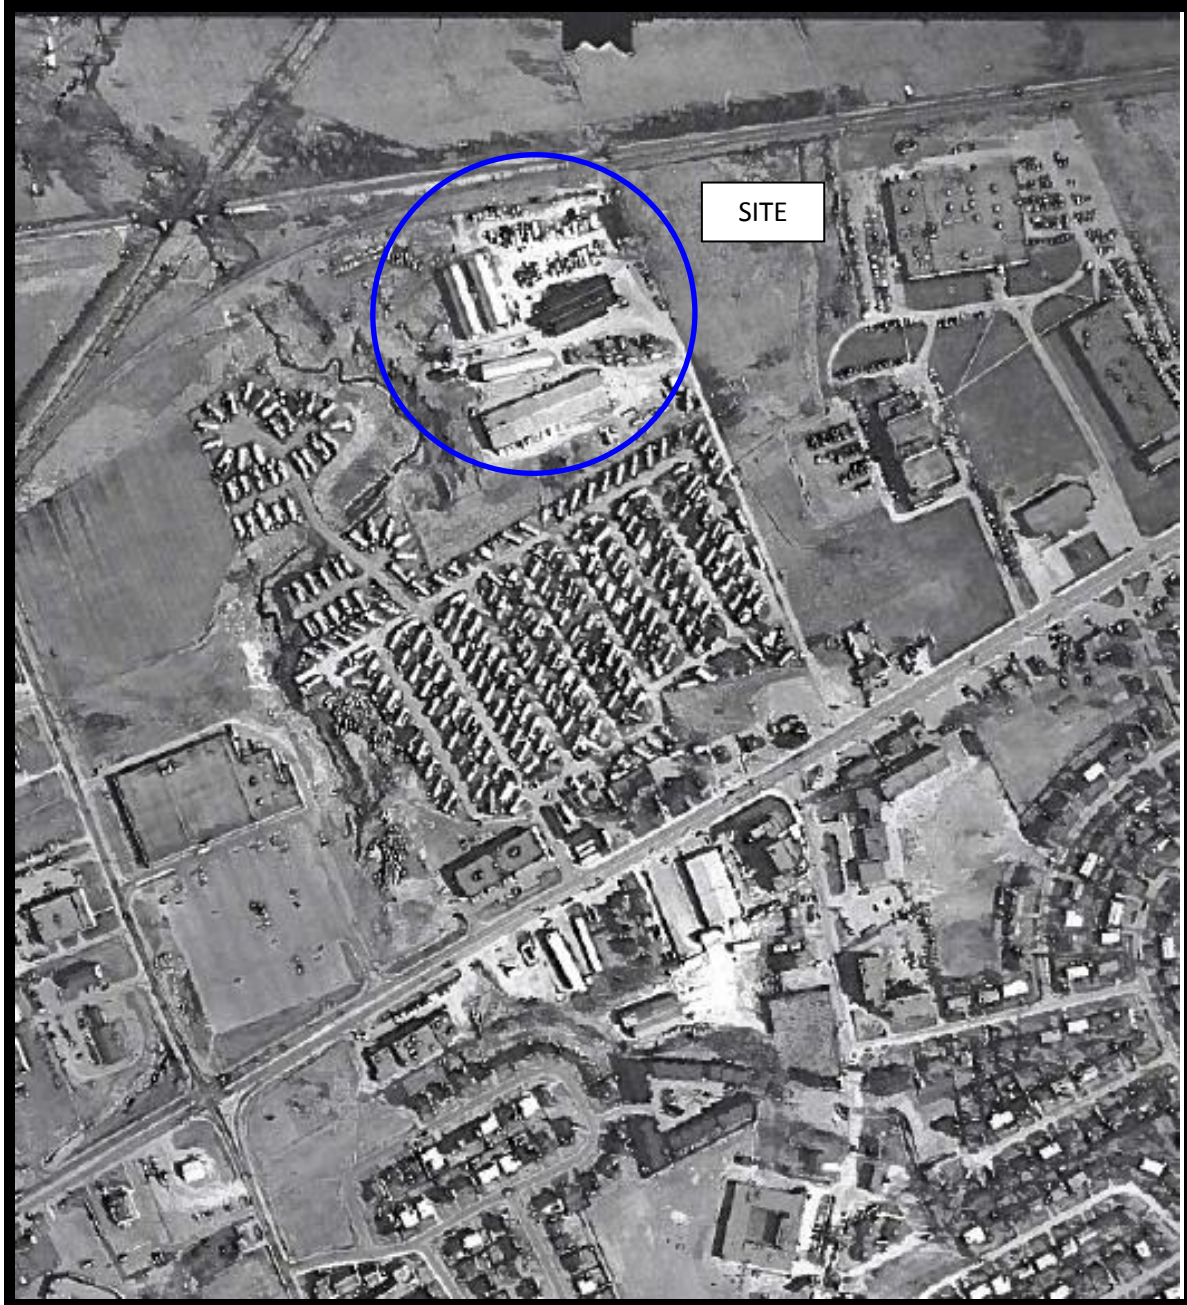
AERIAL PHOTOGRAPH  
1975

| 1975 | The subject site has been re-developed with the farmstead and associated outbuildings having been removed in this photo. The site is utilized as a lumber yard at this time with approximately six large shed type structures visible in this photo. The trailer park on the neighbouring property to the south has expanded at this time and now occupies the neighbouring property to the west. The remaining neighbouring properties are unchanged from the previous photo. |

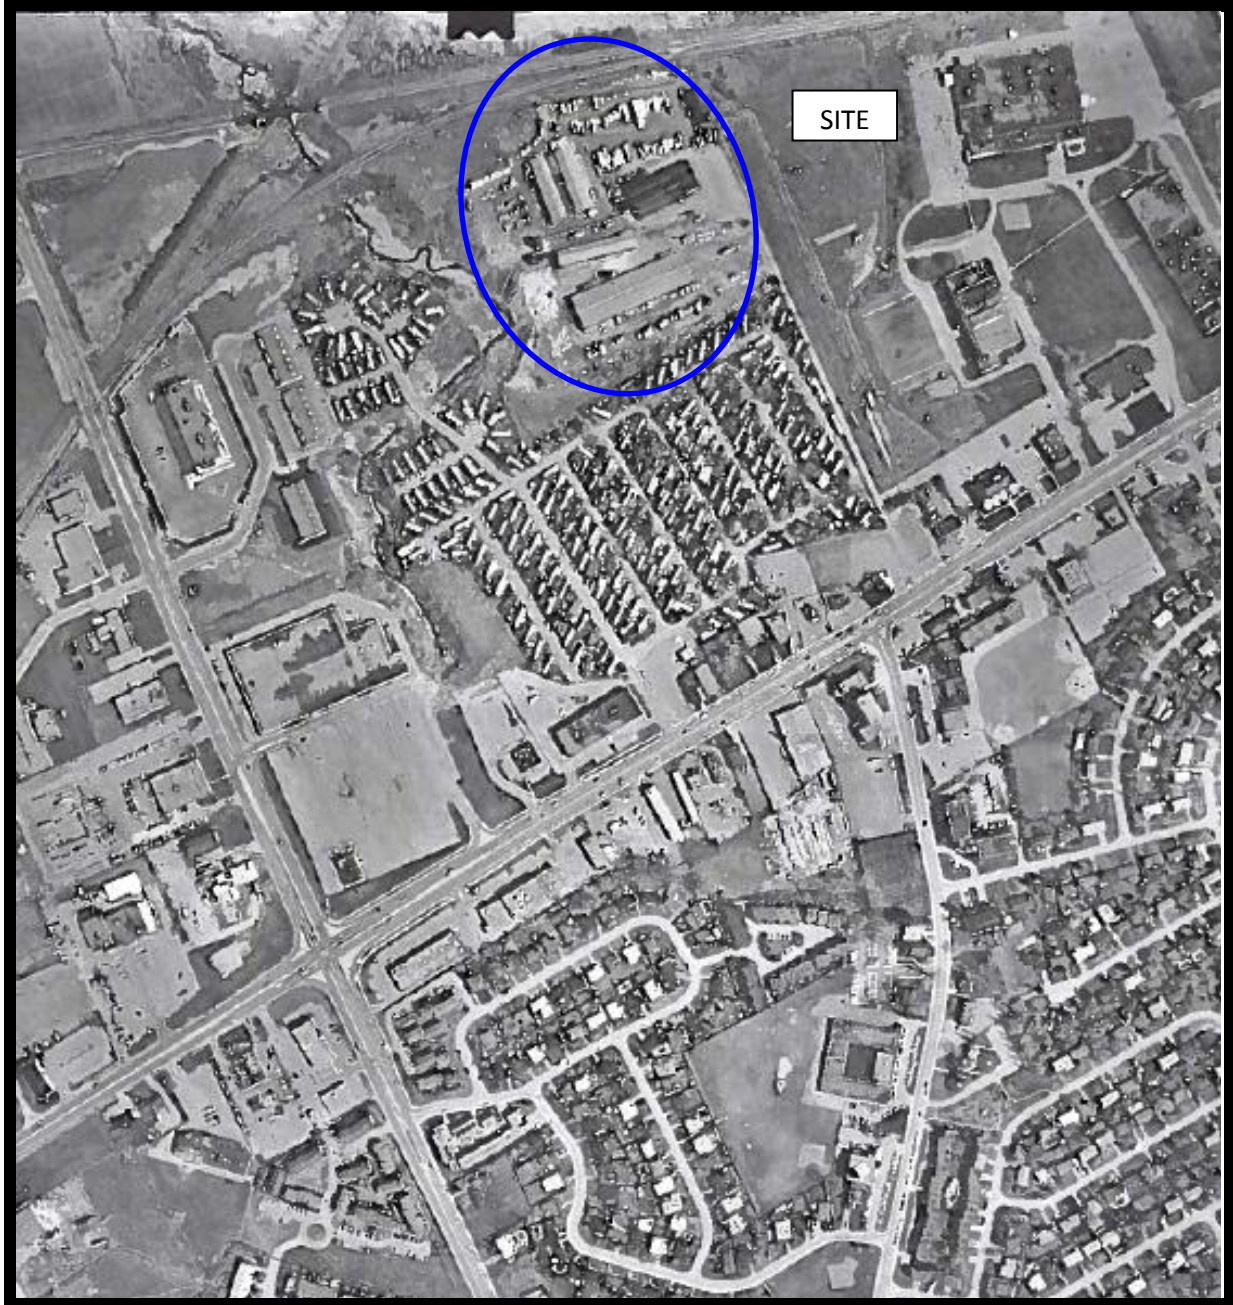
AERIAL PHOTOGRAPH  
1984

| 1984 | The subject and neighbouring properties are relatively unchanged from the previous photo. |

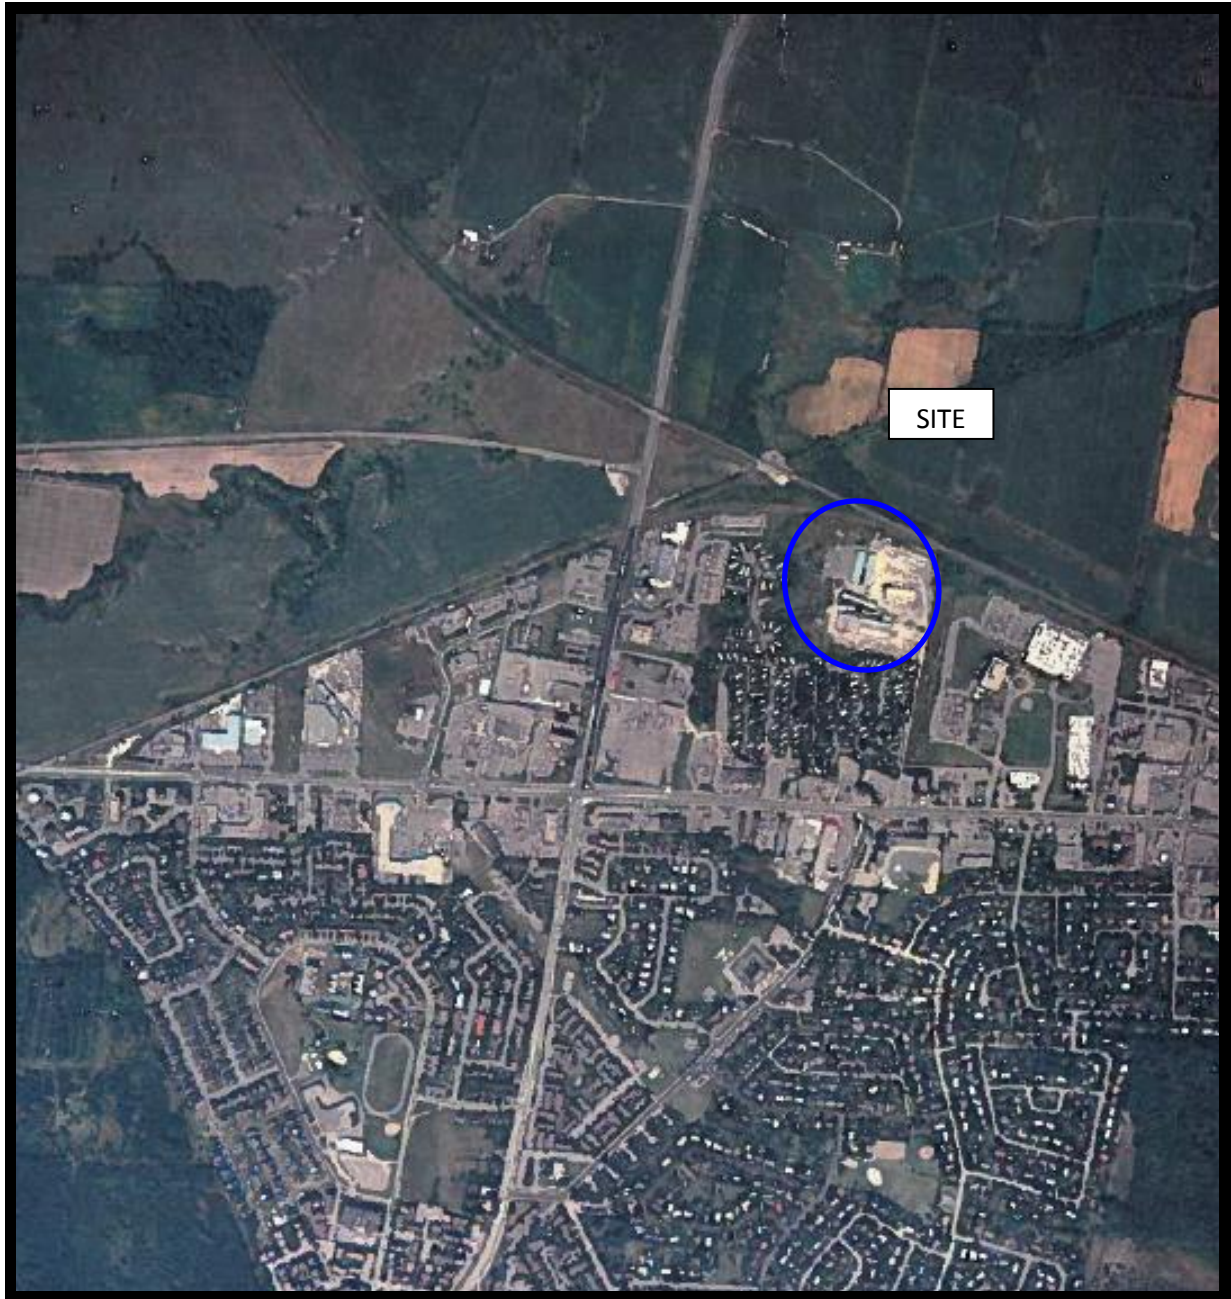
AERIAL PHOTOGRAPH  
1993

| 1993 | The subject and neighbouring properties are unchanged from the previous photo. |

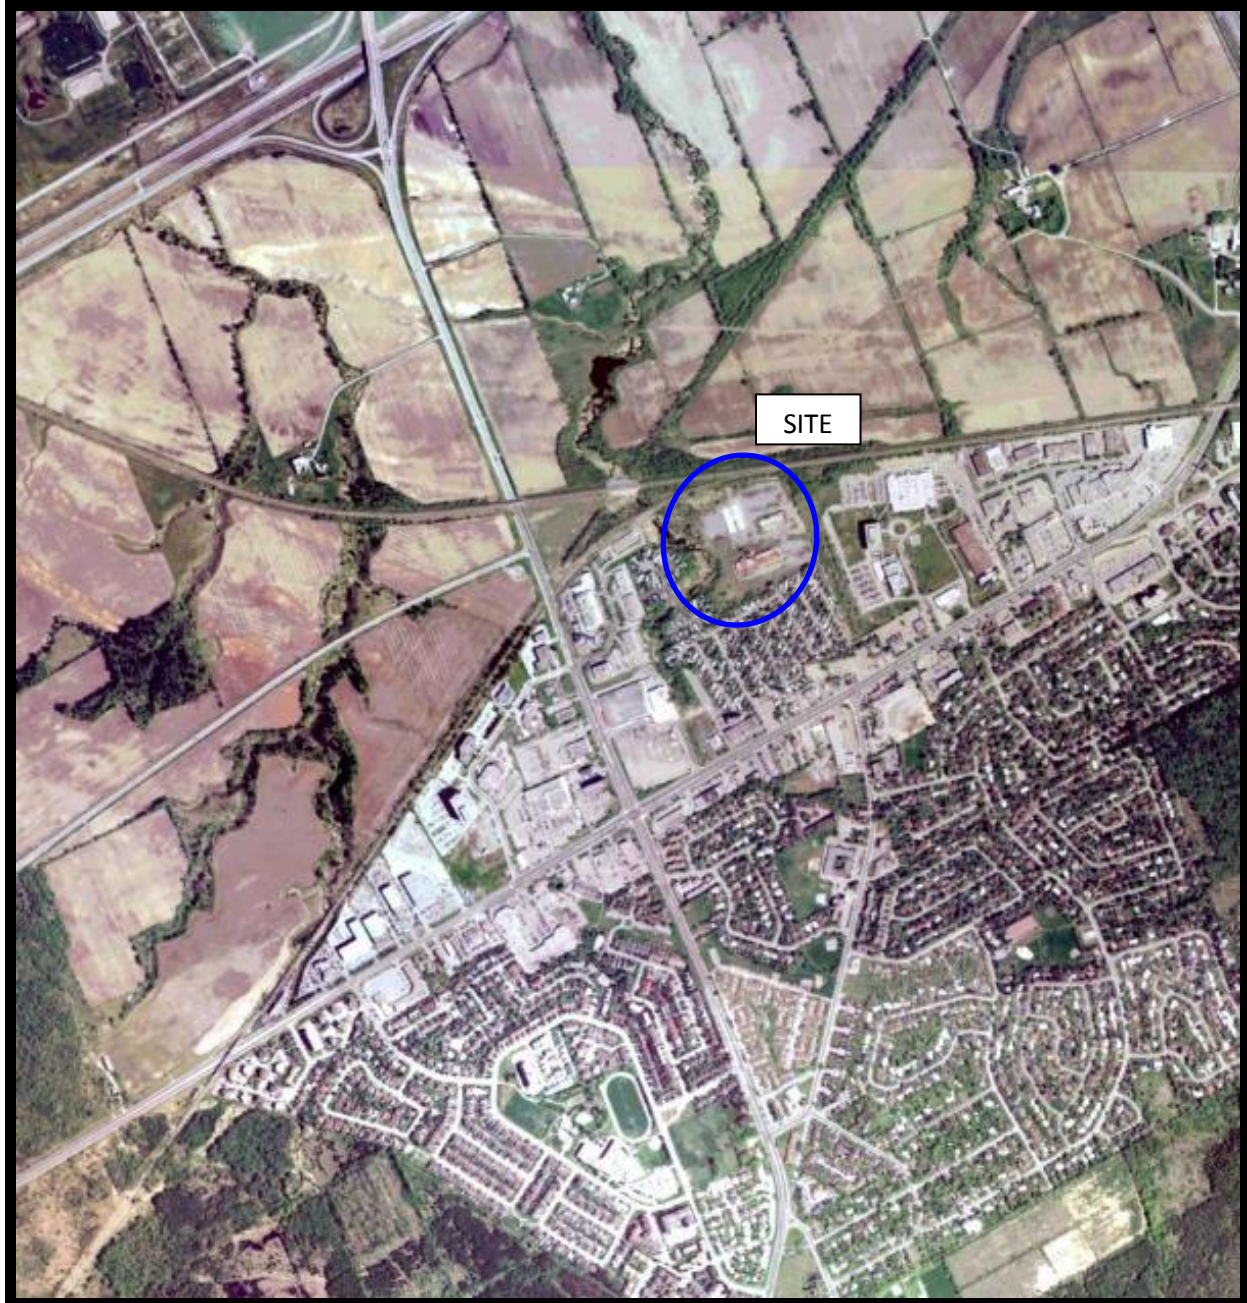
AERIAL PHOTOGRAPH  
1999

| 1999 | The subject property appears to have gone through significant changes – three (3) warehouse structures no longer exist on the site as |

they have been removed. The concrete pads where two (2) buildings existed are what is left of the buildings, an increase in residential density south and southwest of the subject property is noticeable.

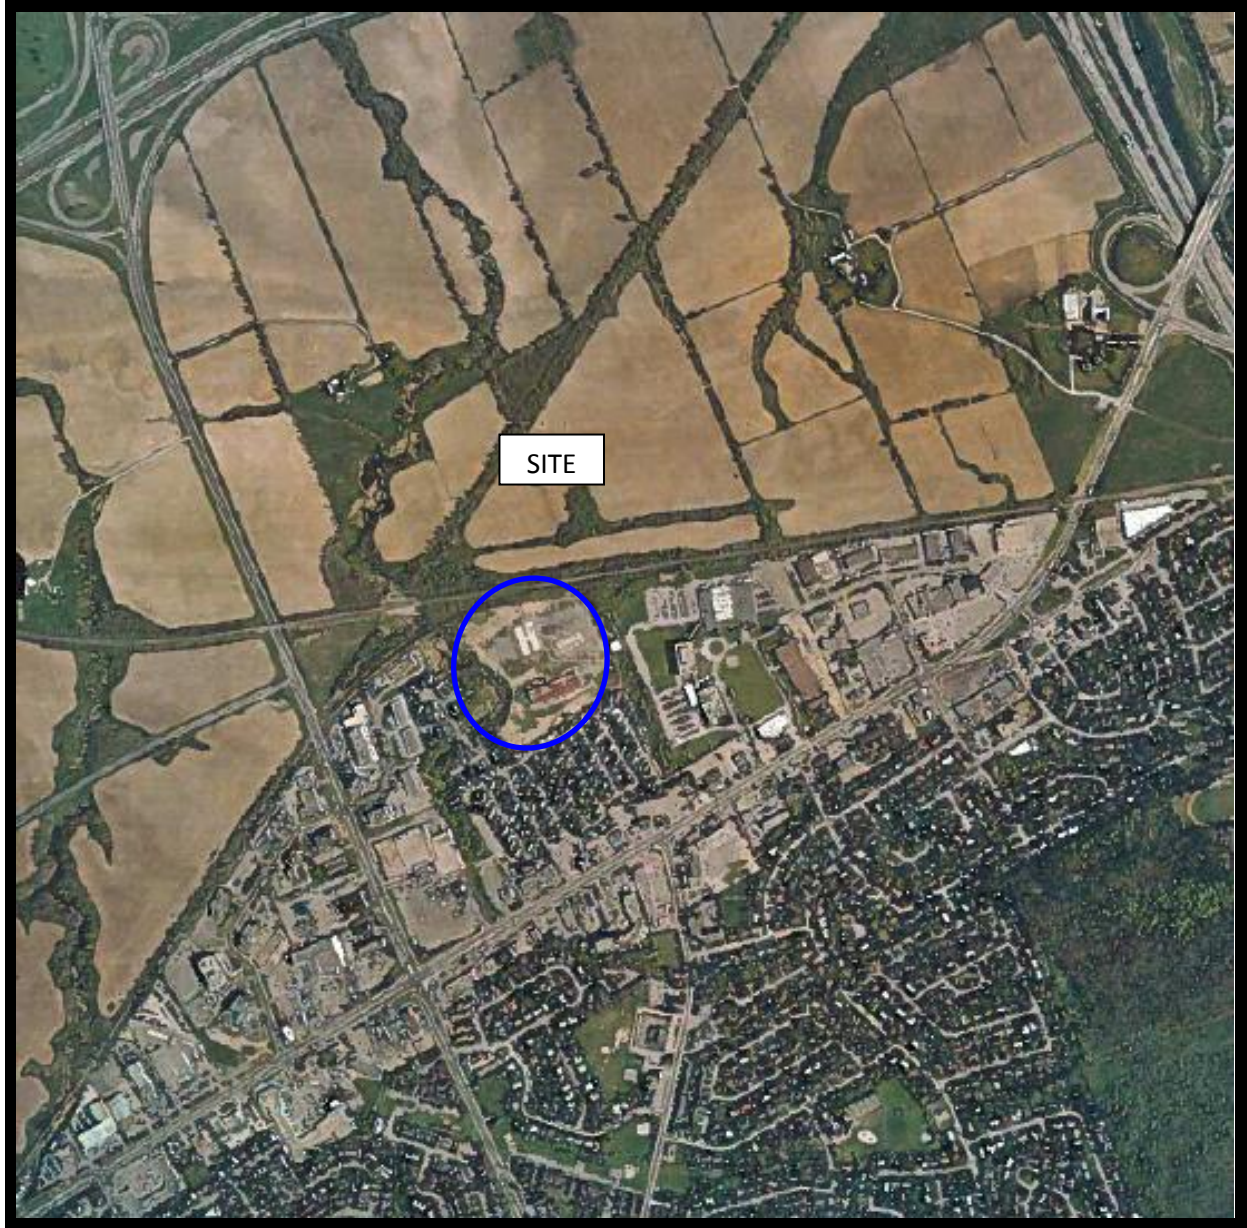
AERIAL PHOTOGRAPH  
2002

| 2002 | The subject and neighbouring properties are unchanged from the previous photo. |

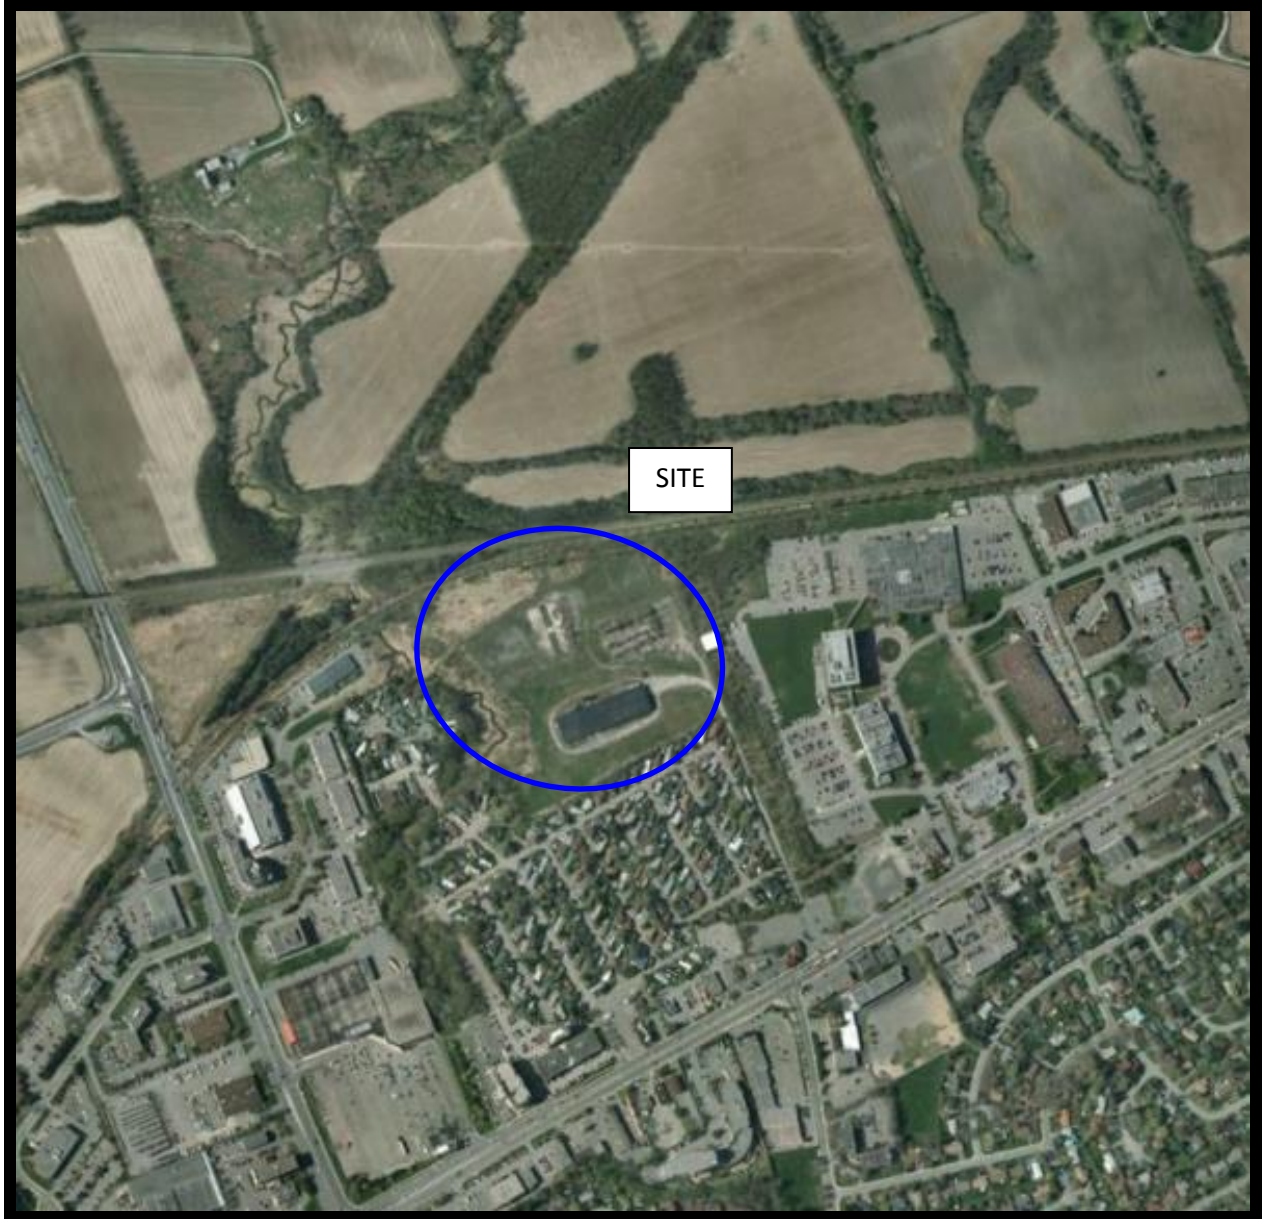
AERIAL PHOTOGRAPH  
2011

| 2011 | The subject and neighbouring properties are unchanged from the previous photo. |

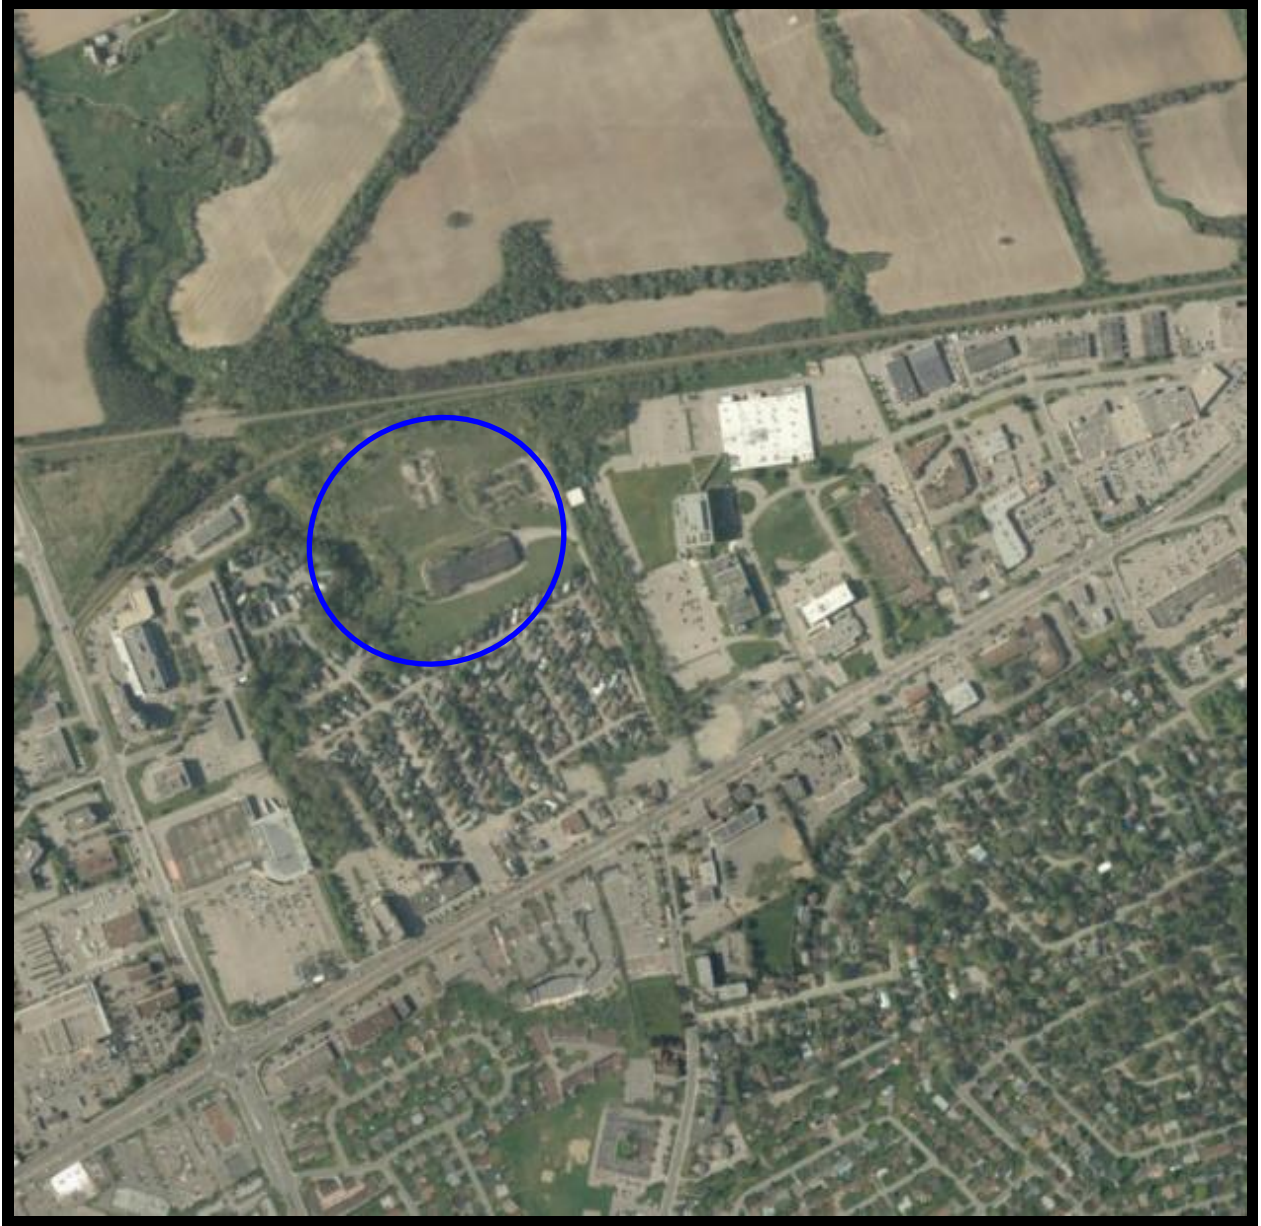
AERIAL PHOTOGRAPH  
2017

| 2017 | A property east of the subject property has been developed, but otherwise, no significant changes have been made to the surrounding area or subject property. The subject and neighbouring properties are depicted as they appear today. |

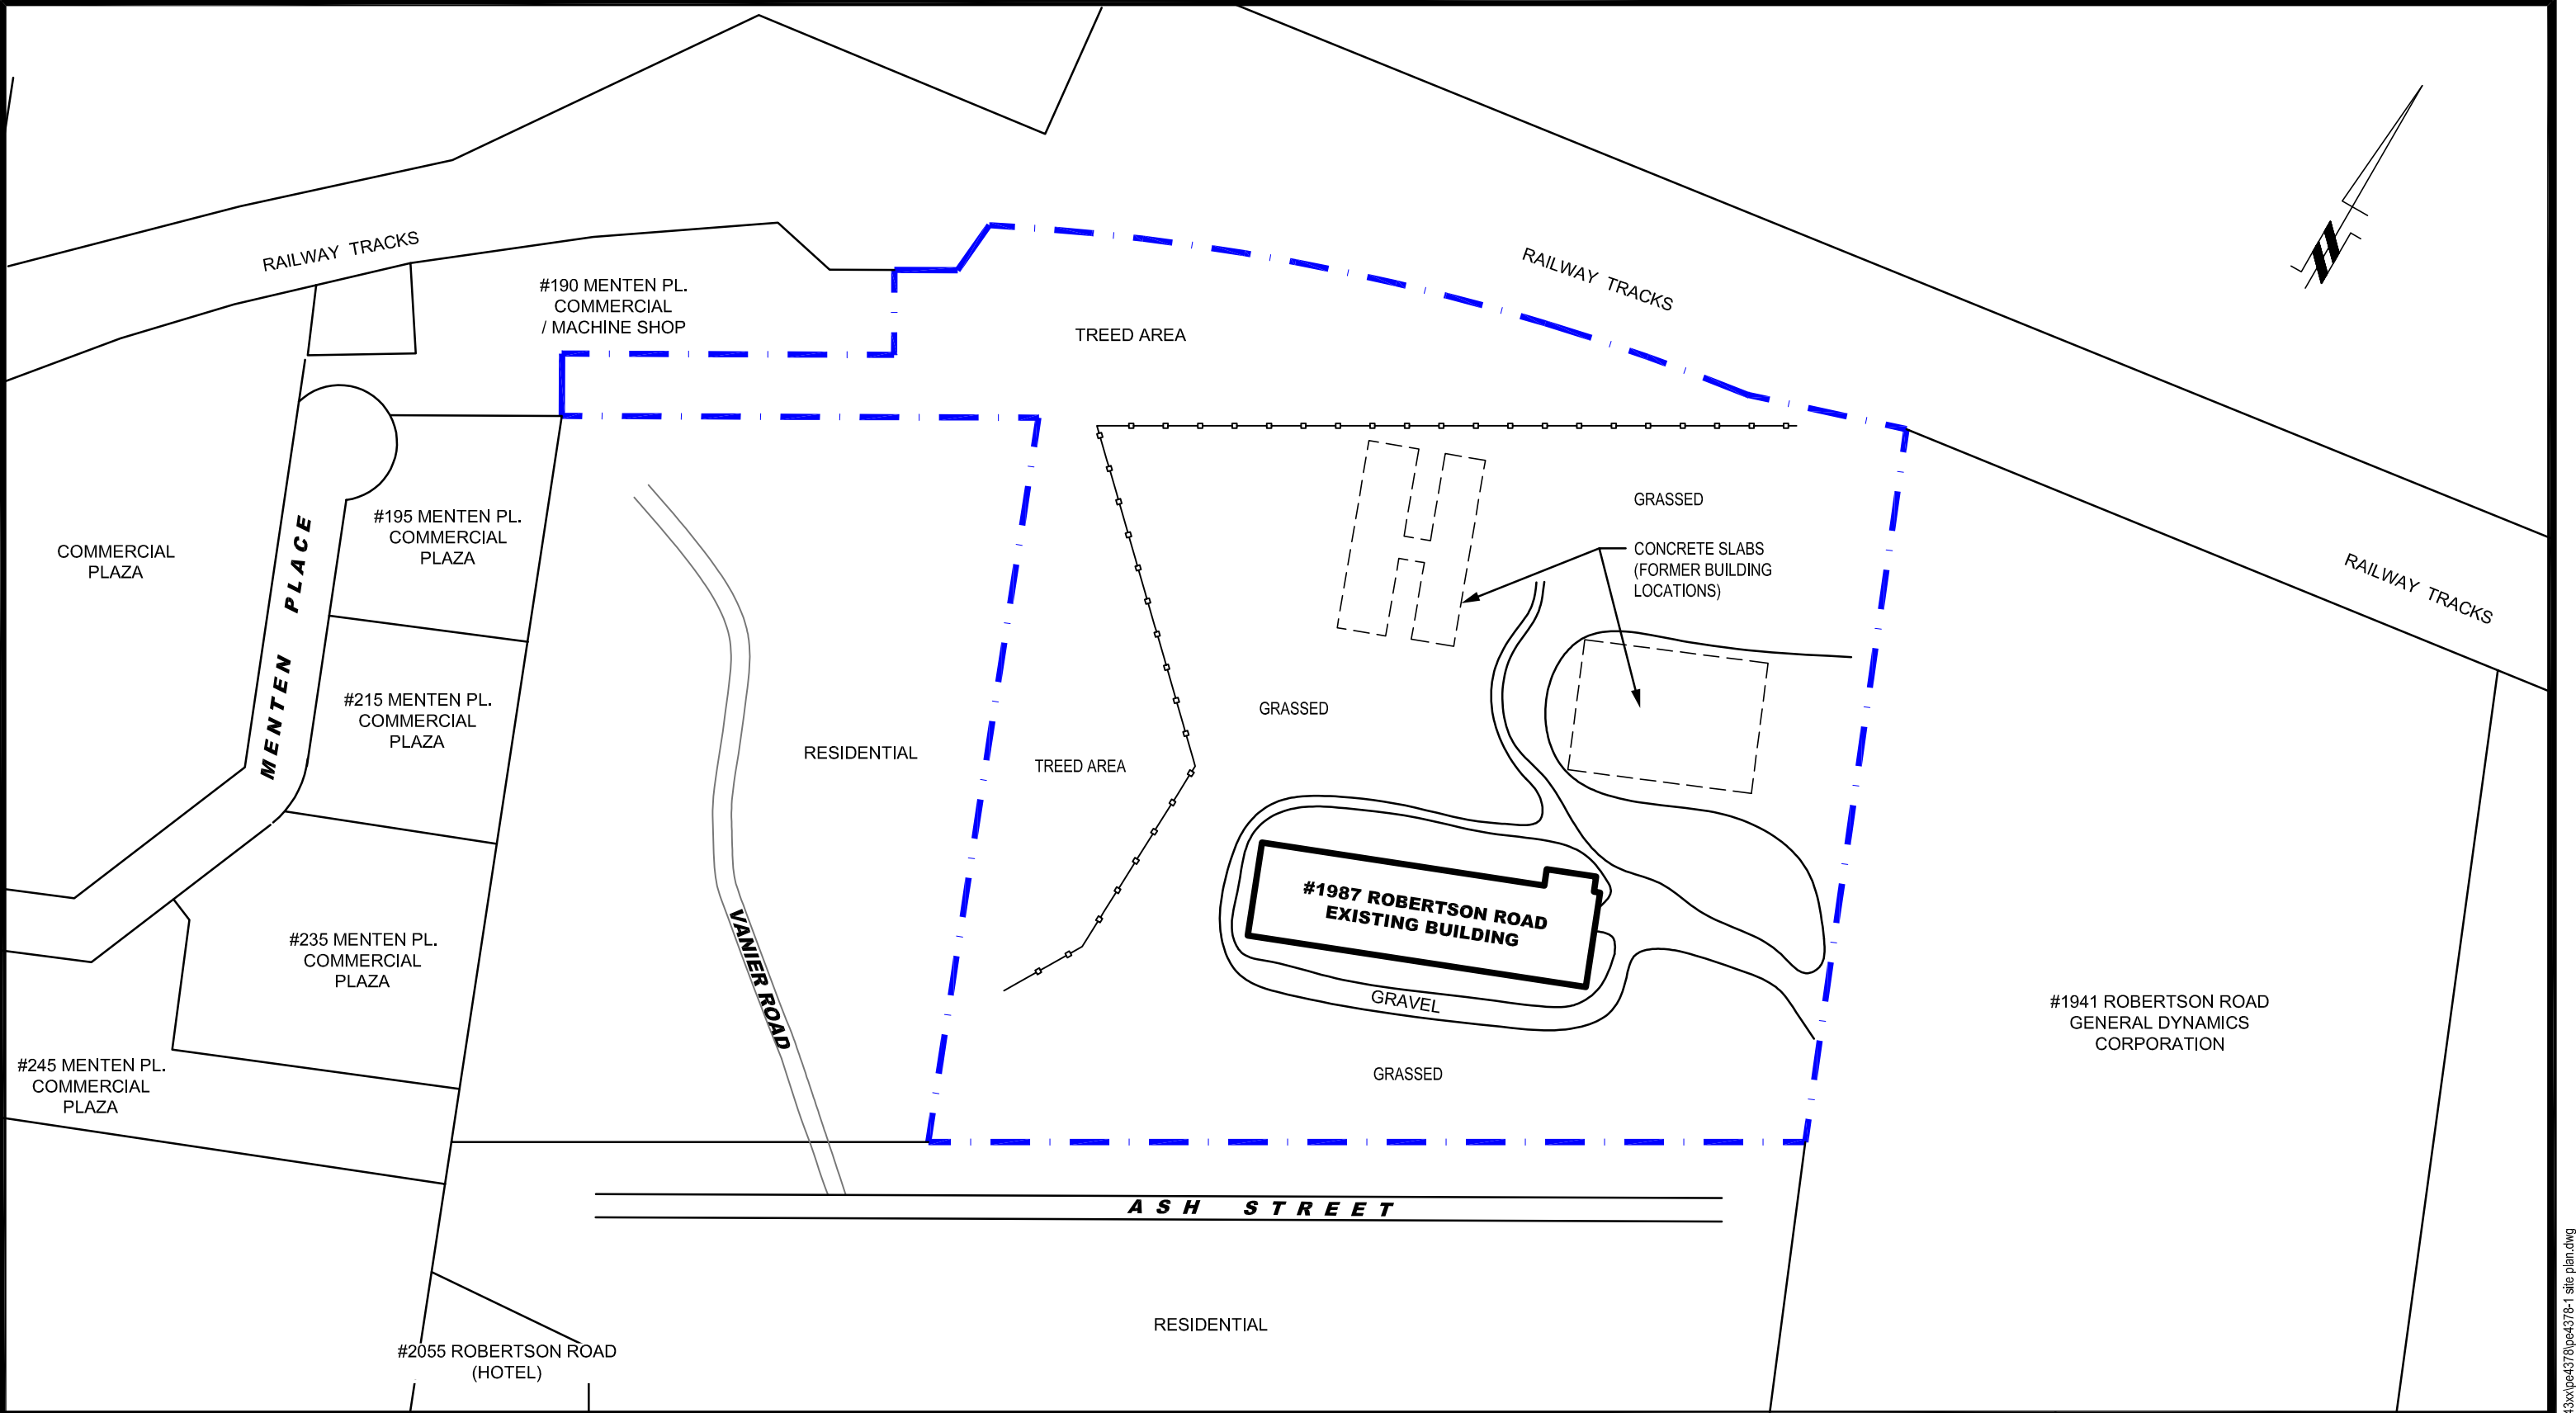
- ☐ North – Railway line followed by vacant land;
- ☐ South – Residential trailer park;
- ☐ East – Office complex;
- ☐ West – Residential trailer park, followed by commercial office spaces, No concerns were identified regarding the adjacent properties. Current land use adjacent to the subject site is illustrated on Drawing PE4378-1 – Site Plan in the Appendix.
