# SCOPED HERITAGE IMPACT ASSESSMENT

## 1 MAPLE LANE & 1112 LISGAR ROAD

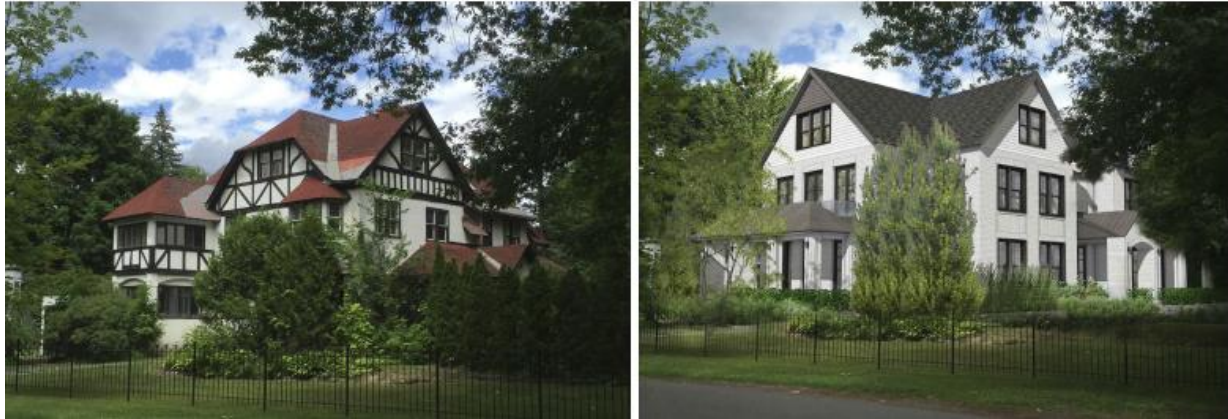
The two views (before and after) captures the spirit and character of the original building and maintains the parklike attributes, qualities, and atmosphere of the HCD with generous front yards and the retention of the existing trees, shrubs, hedges, and landscape features on public and private property.

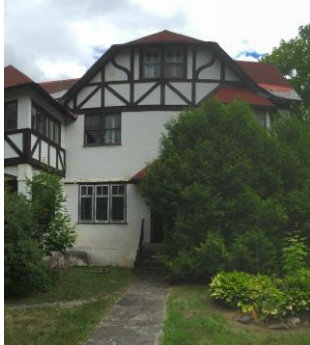
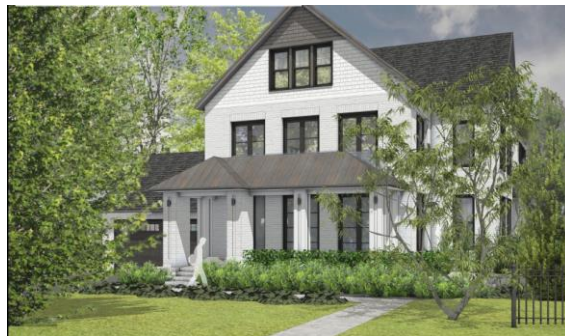
*Views of the existing and proposed house illustrating the preserved Lisgar and Maple Lane entrance walk.*

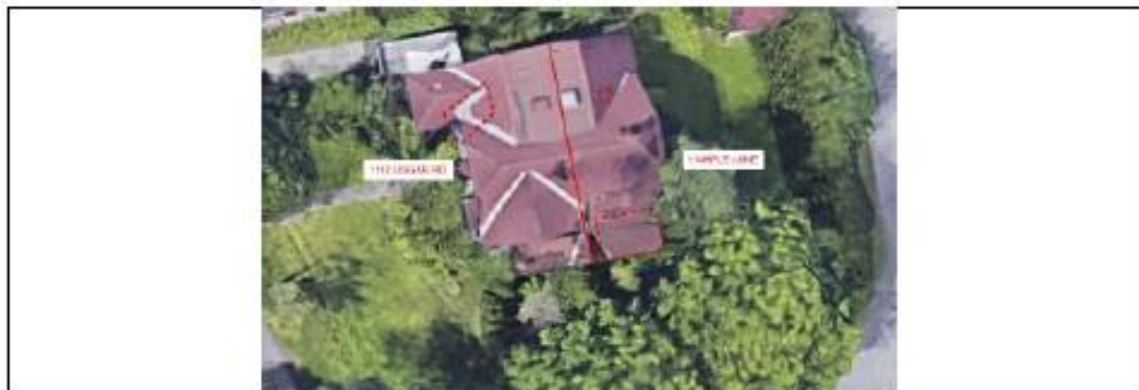
Figure 1: Roof plan with areas of deterioration outlined [JCAL 2021]

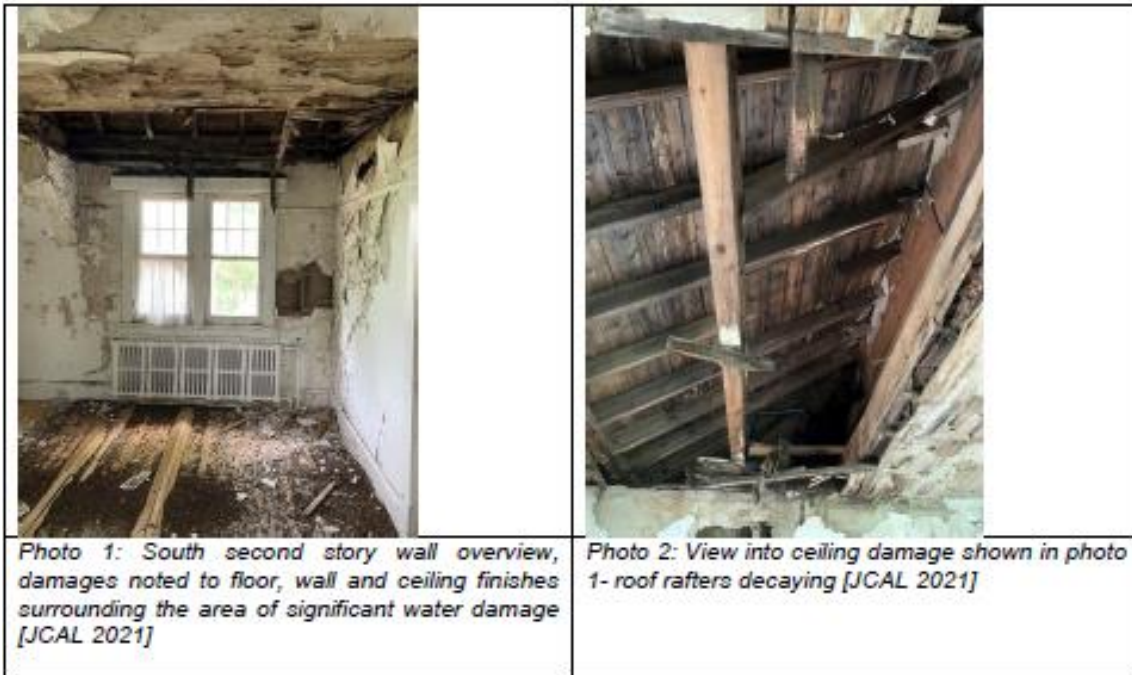
On the exterior of the building, the stucco appears to be generally in fair condition except at the base of the wall. A small opening was made which shows mesh within the stucco, and the finish coats appear to be well bonded in this area. The lower meter of the stucco is in poor condition with debonding and cracking, previous poor quality patching, and peeling paint finish.

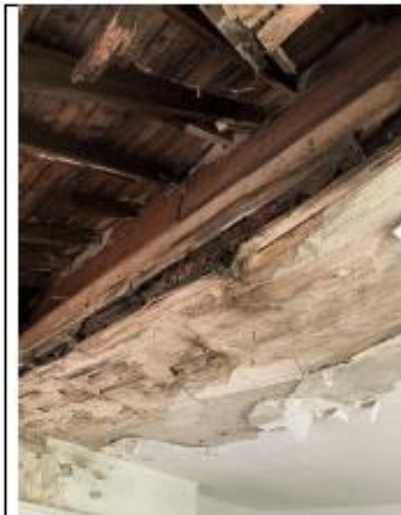
Photo 3: Closer view of damage and decay to edge of third floor framing [JCAL 2021]

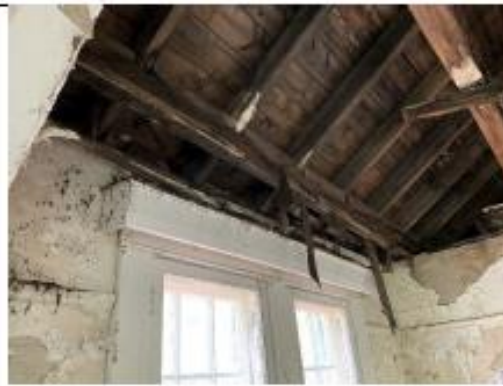
Photo 4: Closer view of damage and decay to top of exterior wall [JCAL 2021]

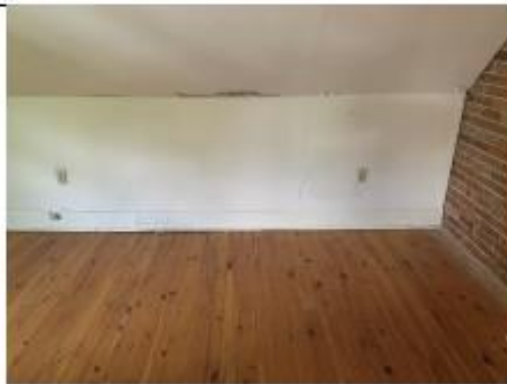
Photo 5: Third story SE corner water damage to finishes [JCAL 2021]

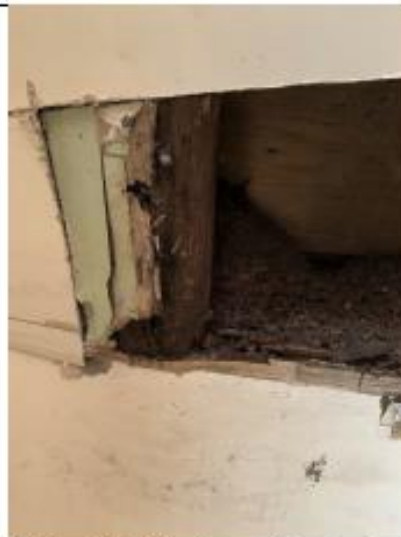
Photo 6: Third story north sloped roof; damage noted within roof and on roof joists [JCAL 2021]

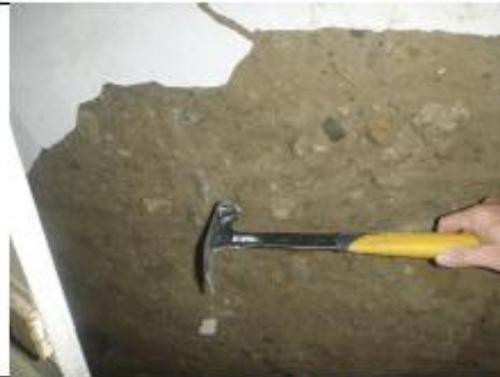
Photo 8: Soft concrete in the interior of the foundation wall [JCAL 2021]

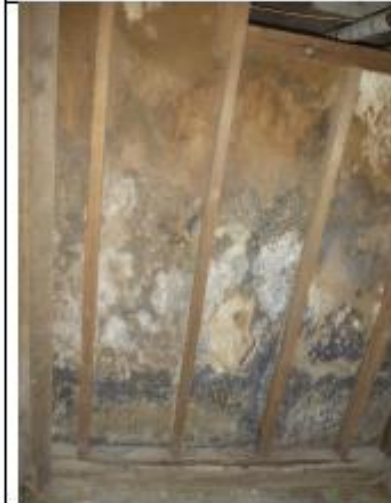
Photo 9: Interior basement wall typical condition with extensive mold. [JCAL 2021]

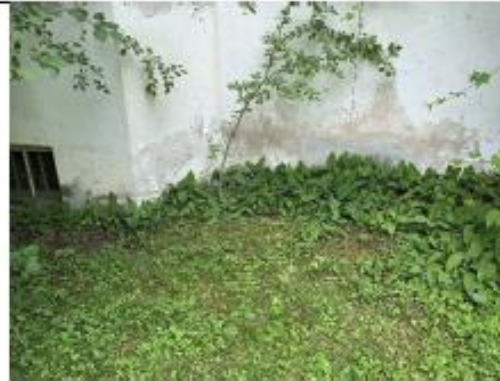
Photo 10: General poor condition of stucco at base of wall [JCAL 2021]

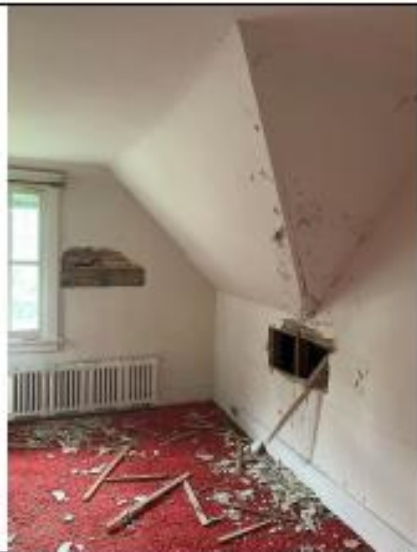
Photo 11: Opening location in west valley [JCAL 2021]

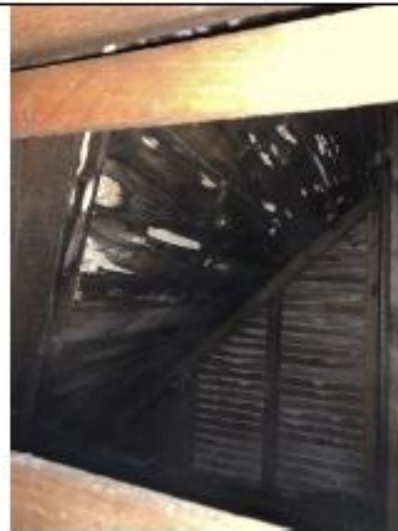
Photo 12: Roof water damage and mold within valley [JCAL 2021]

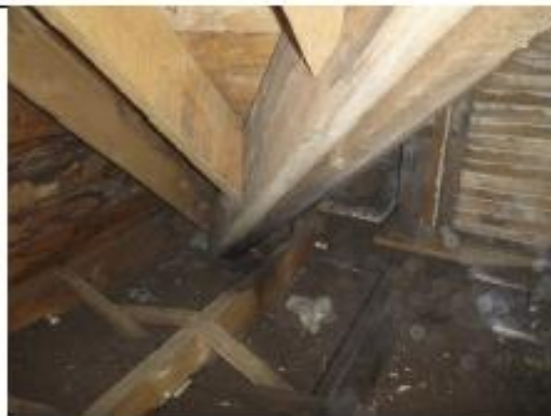
Photo 13: Water damage at base of valley [JCAL 2021]

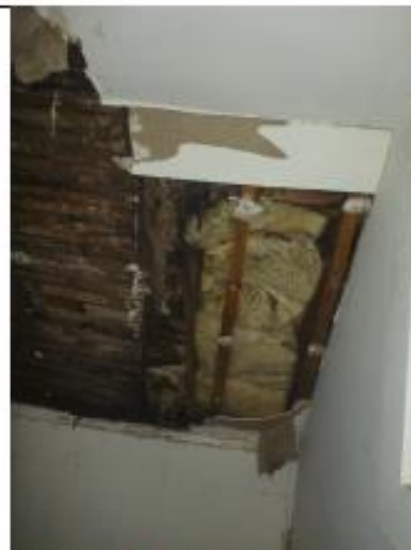
Photo 14: West room closet water damage and mold [JCAL 2021]

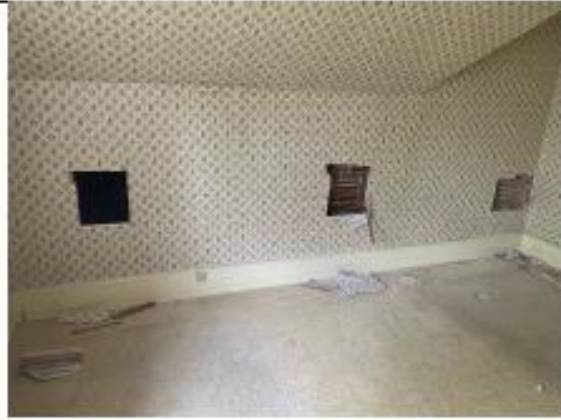
Photo 15: Openings in southern room [JCAL 2021]

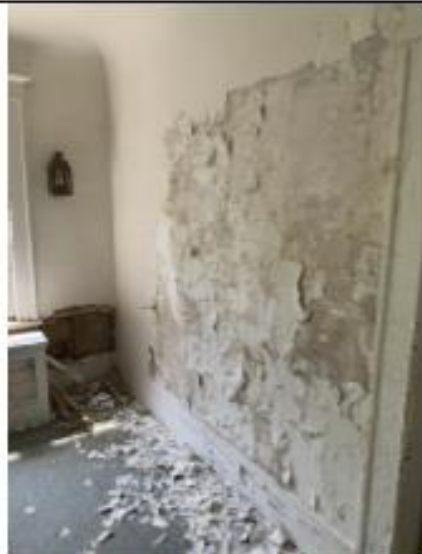
Photo 17: Ground floor west room water damage on interior wall [JCAL 2021]

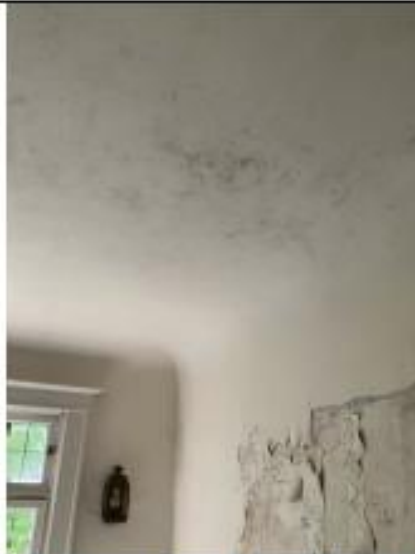
Photo 18: Ground floor west room mold on ceiling finishes [JCAL 2021]

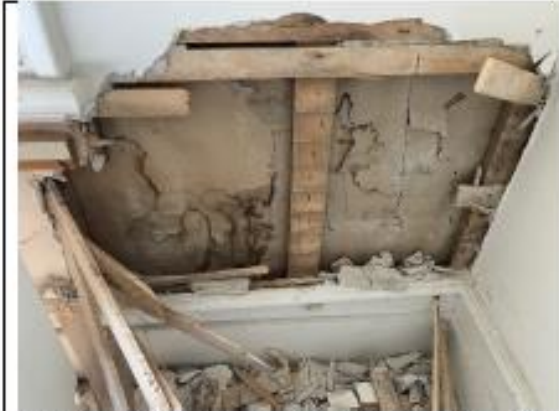
Photo 19: Ground floor wall opening- water damage and mold noted [JCAL 2021]

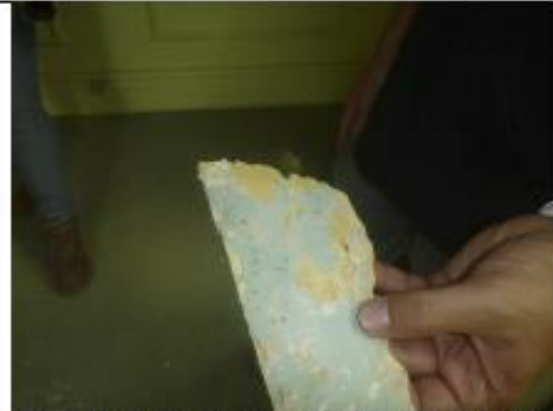
Photo 20: Mold noted on underside of ground floor ceiling wallpaper [JCAL 2021]

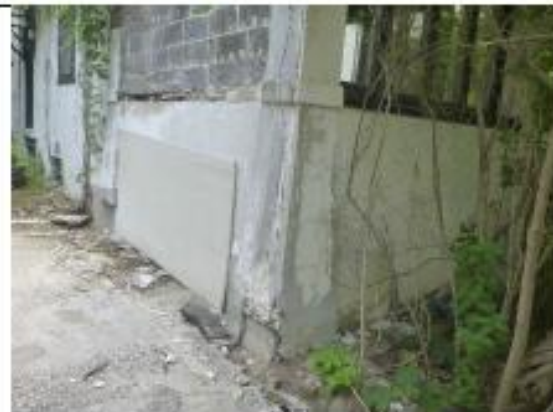
Photo 24: Foundation of sunroom addition in very poor condition. [JCAL 2021]
