CAPACITY ENGINEERING LTD.

# Condition Assessment

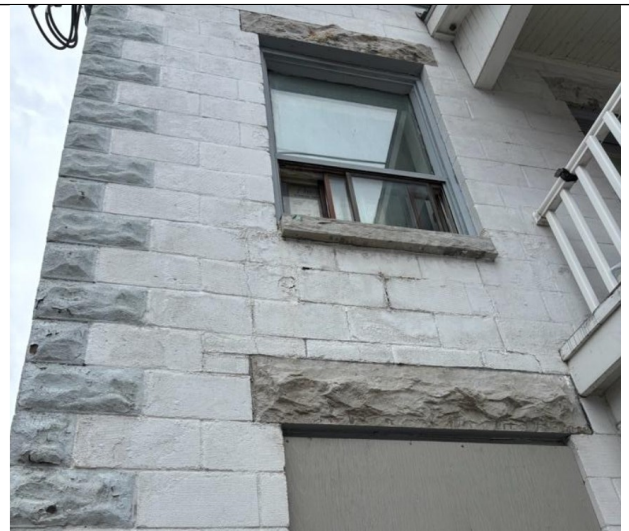
Photo 2: Weathering, vertical cracking and step cracking in cladding.

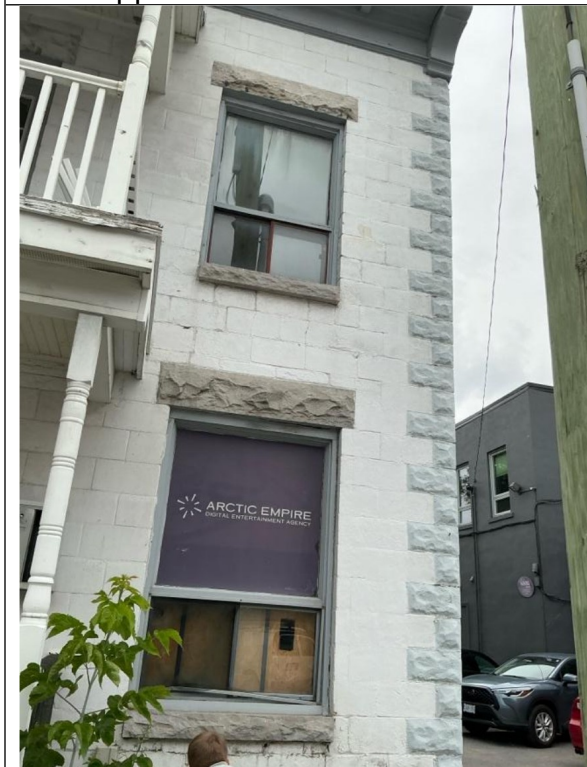
Photo 3: Weathering, vertical cracking and step cracking in faux-stone concrete veneer.

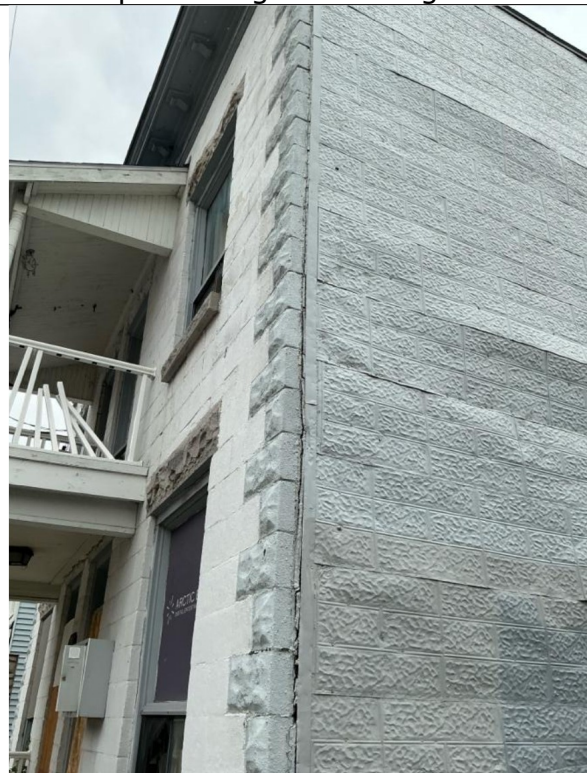
Photo 4: Nail applied tin panelling over timber wall (right) and Faux-stone concrete veneer detaching from underlying structure at South-East corner.

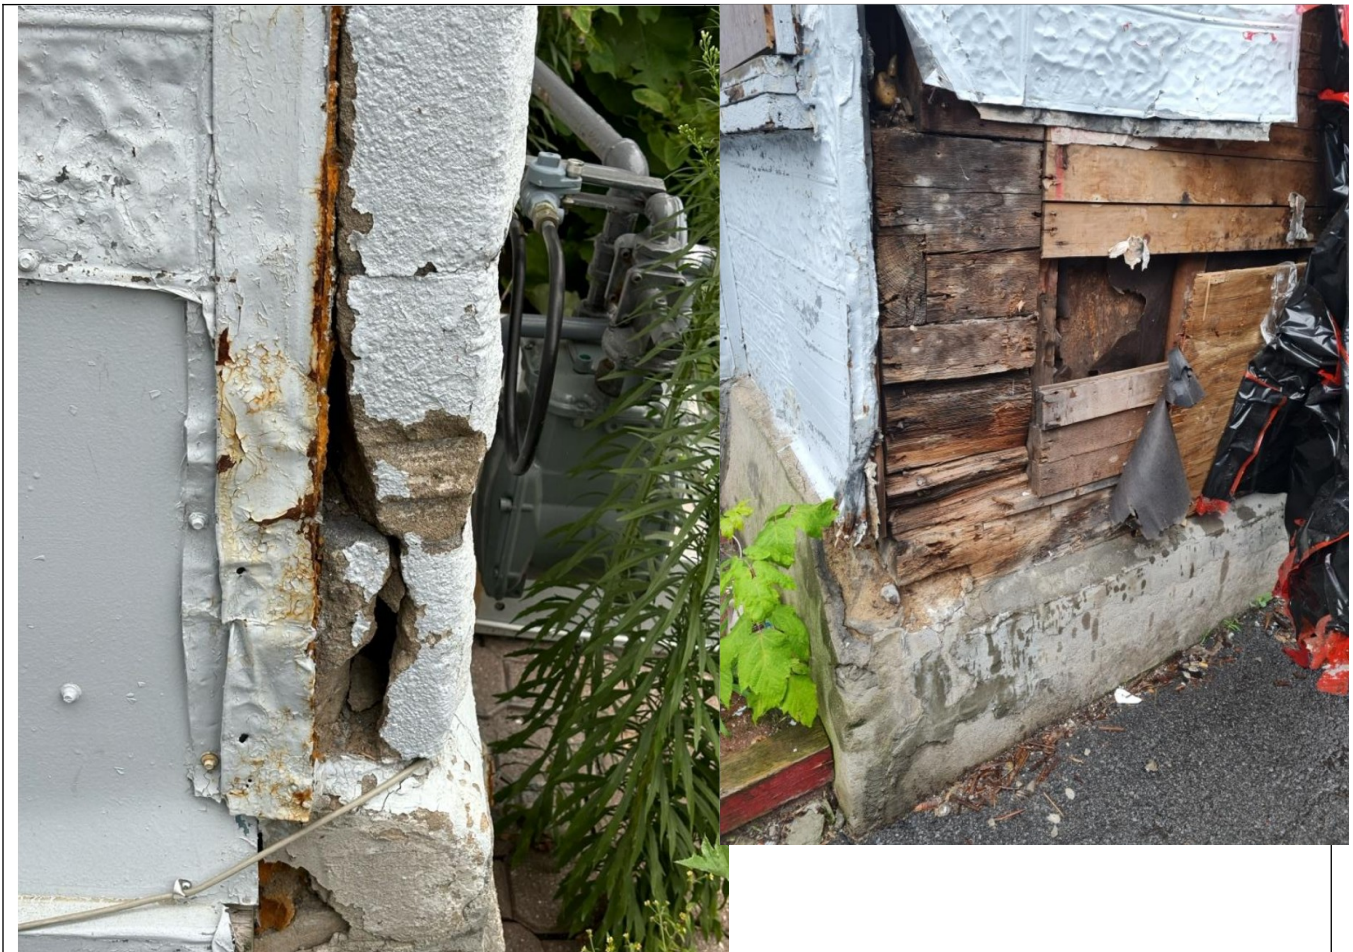
Photo 5: Cladding detaching from structure at South-West corner.

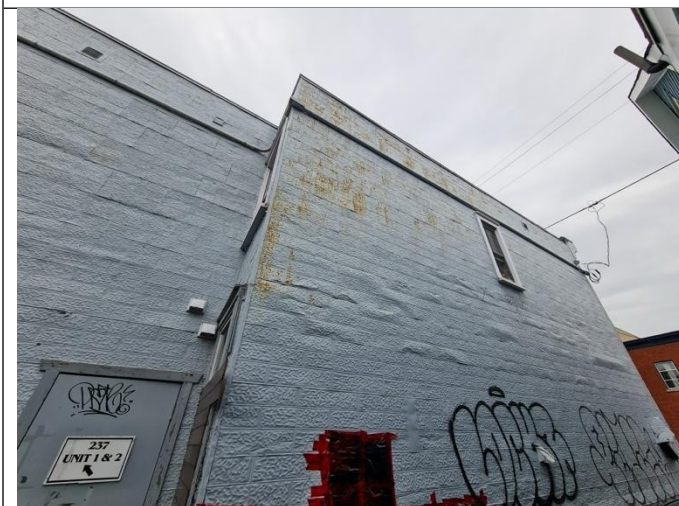
Photo 7: Bulging and peeling of existing cladding on West wall.

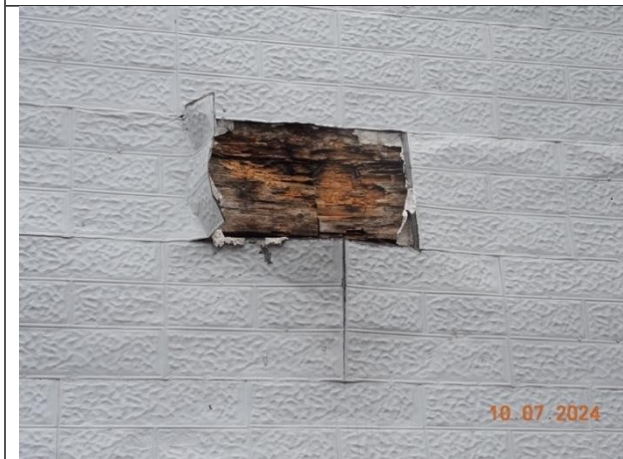
Photo 11: Advanced decay in exterior walls at opening in the cladding on East wall.

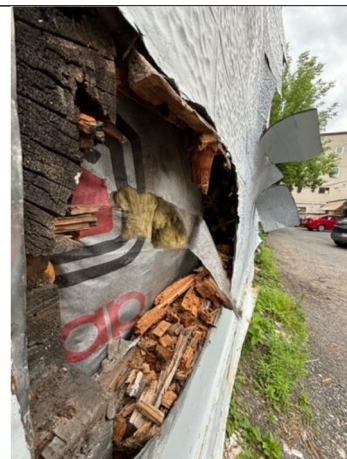
Photo 12: Remains of deteriorated wall are visible piling up at the base of opening in the East wall at the Southern edge.

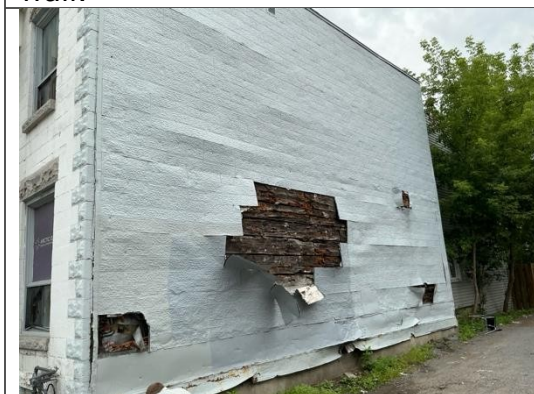
Photo 13: View of East wall.

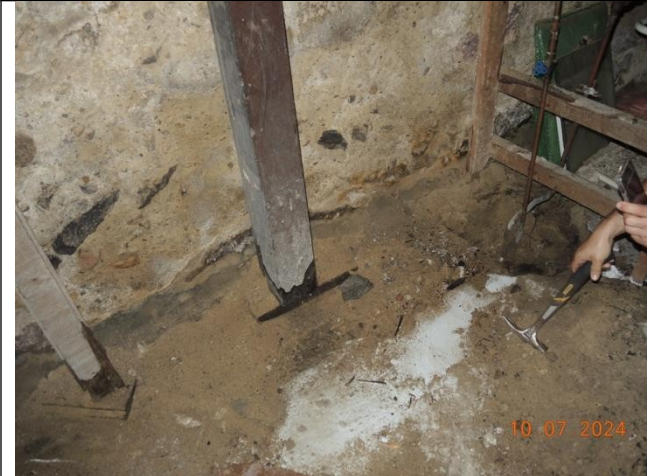
Photo 15: Sand build-up at base of wall due to deterioration.

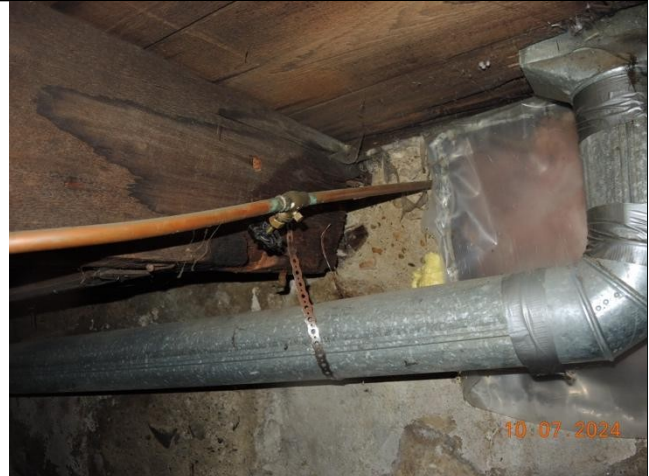
Photo 16: End of beam deteriorated due to rot. Beam has lost all connection to foundation wall.

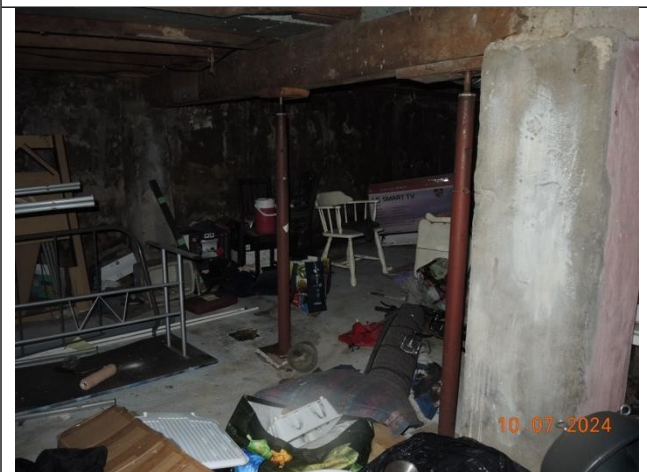
Photo 17: Jackposts and steel beam installed to support sagging floors.

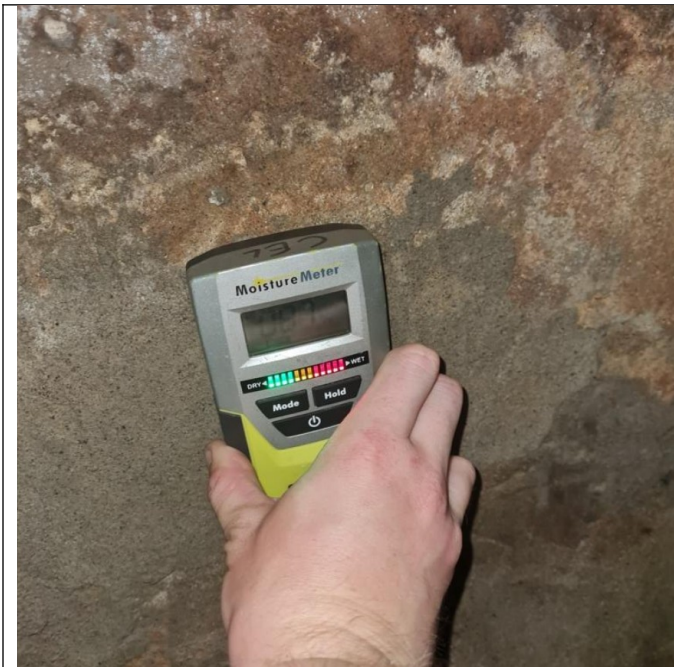
Photo 19: High moisture content near base of foundation wall (87%)

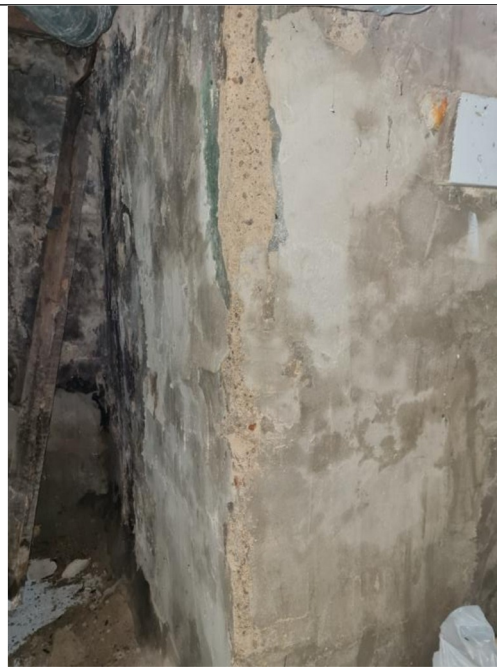
Photo 20: Deterioration of foundation wall.

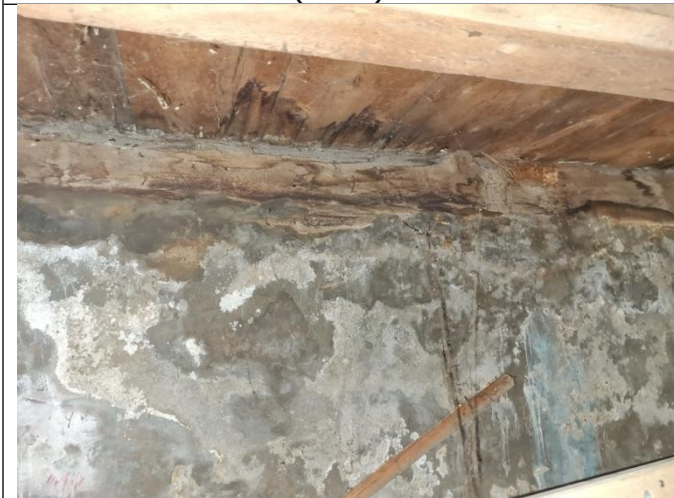
Photo 21: Decayed and stained wood structure on top of foundation wall.

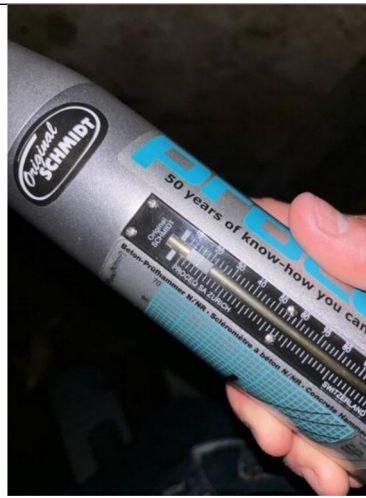
Photo 22: Photo of a Schmidt hammer test of foundation wall compressive strength.

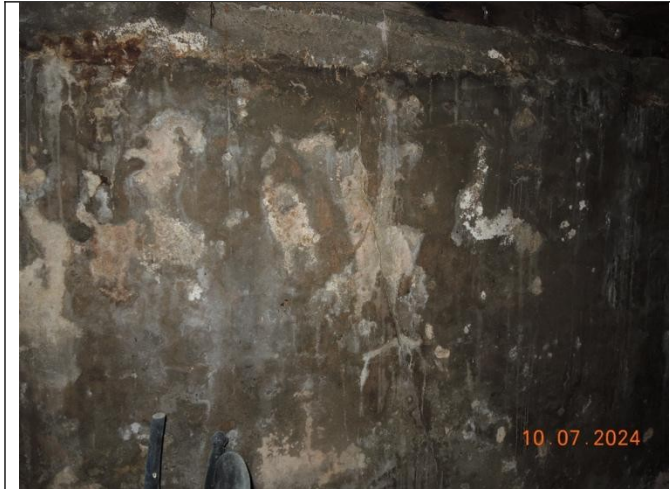
Photo 23: Crack and discolouration in foundation wall.

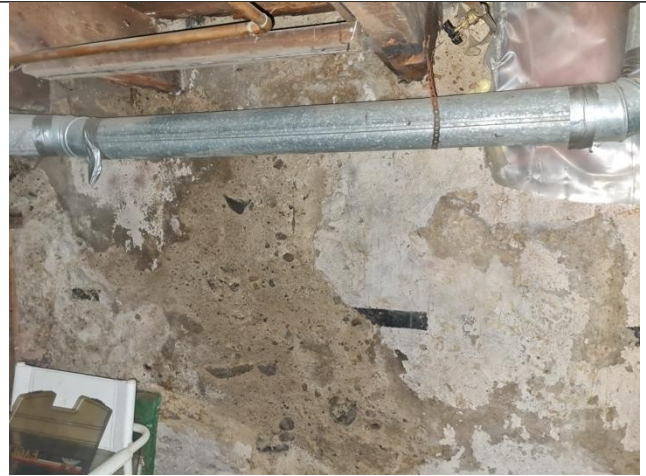
Photo 24: Severe scaling of the wall.

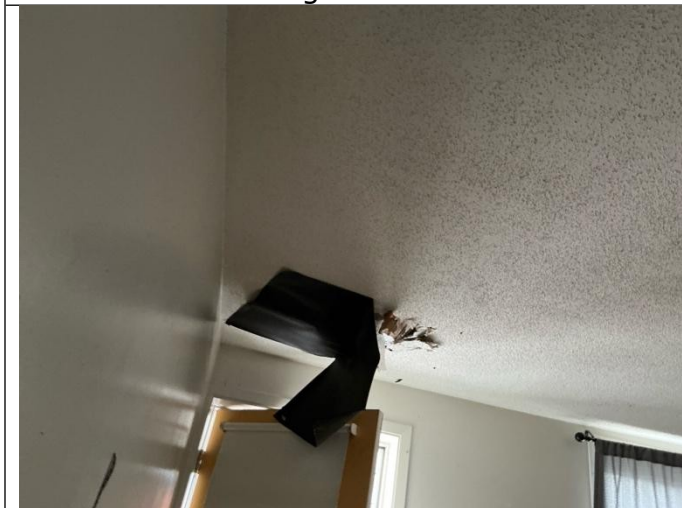
Photo 28: Ceiling damage.

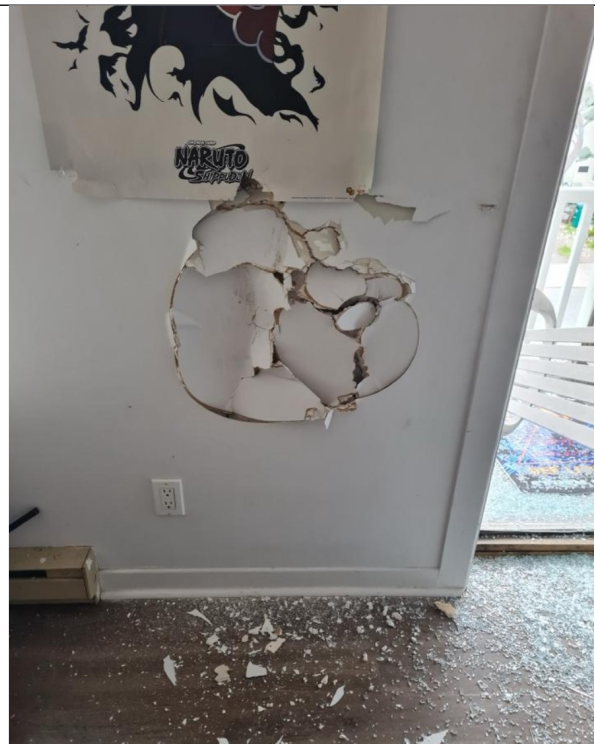
Photo 29: Drywall damage.
