AZURE URBAN DEVELOPMENTS INC.

254 ARGYLE AVENUE

Church Relocation Scenarios Analysis

Project Number: 2023-049-2

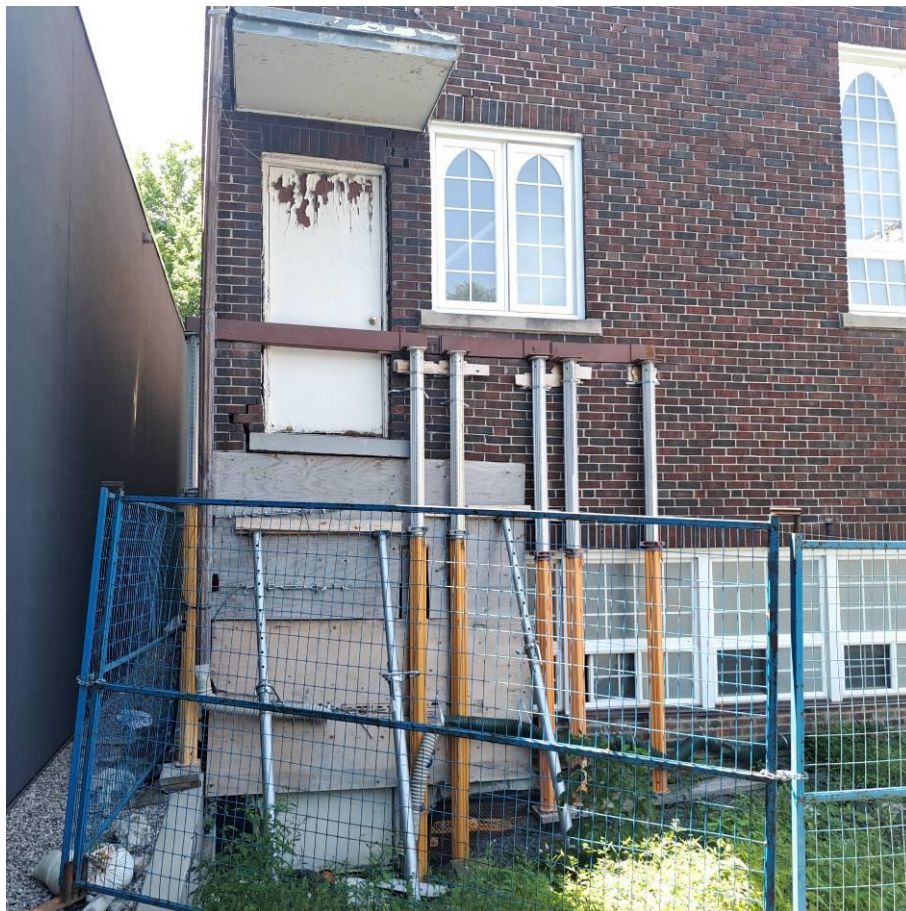
Figure 4: Damage at Rear Left Corner

- There is a substantial settlement in the south-east corner, which is the closest area to the excavation works performed at 203 Catherine Street back in 2015. The total movement at the southeast corner was 72mm when observed by Keller Engineering on February 24, 2017.

- Vertical supports are provided as temporary measures to prevent the whole south-east corner separating from left and back walls (see Figure 3 & 4).
- Some windows have broken glass in the basement level which is additional evidence of the movement of the wall.

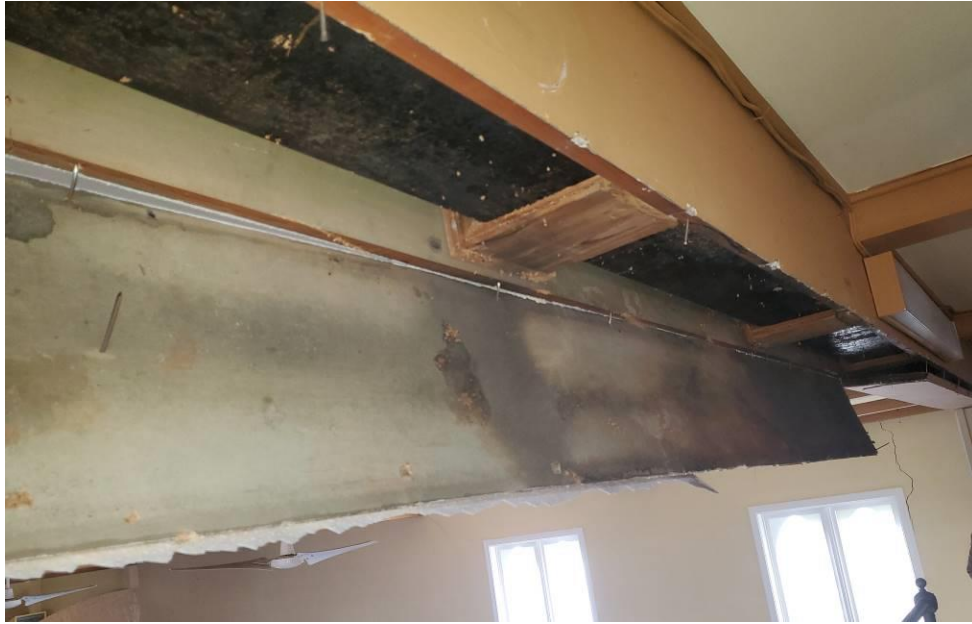
Figure 7: Steel Beam Supporting Roof

- The steel beams are size W460x60 (see Figure 7).
- The total wall thickness is approximately 360 mm (14 inches).

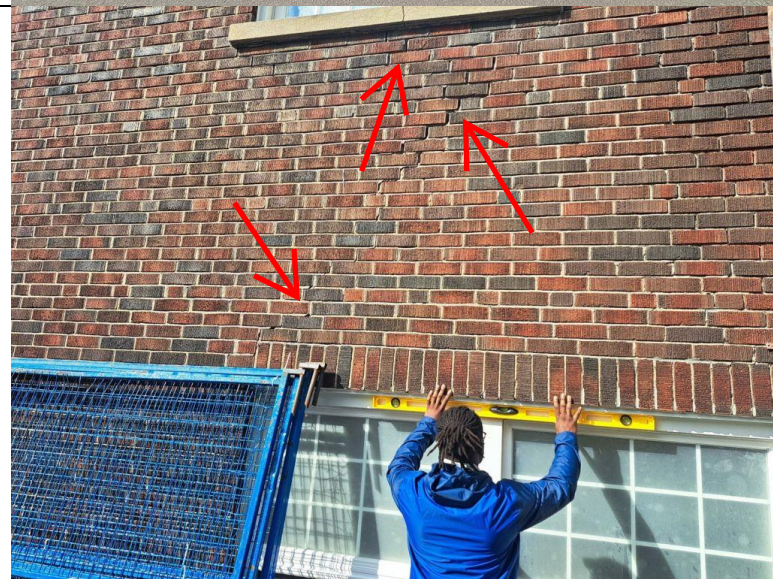
Photo 5
Stepped wide cracks noted along the South wall

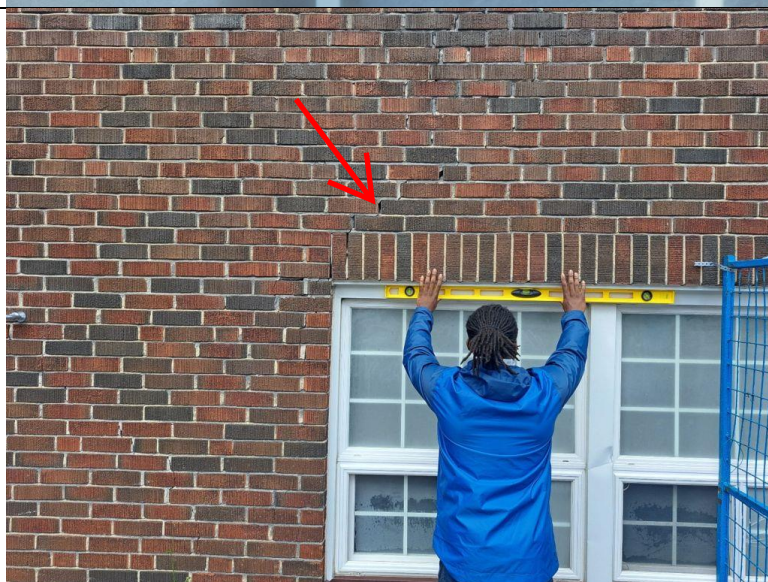
Photo 9

Stepped wide cracks noted along the South wall

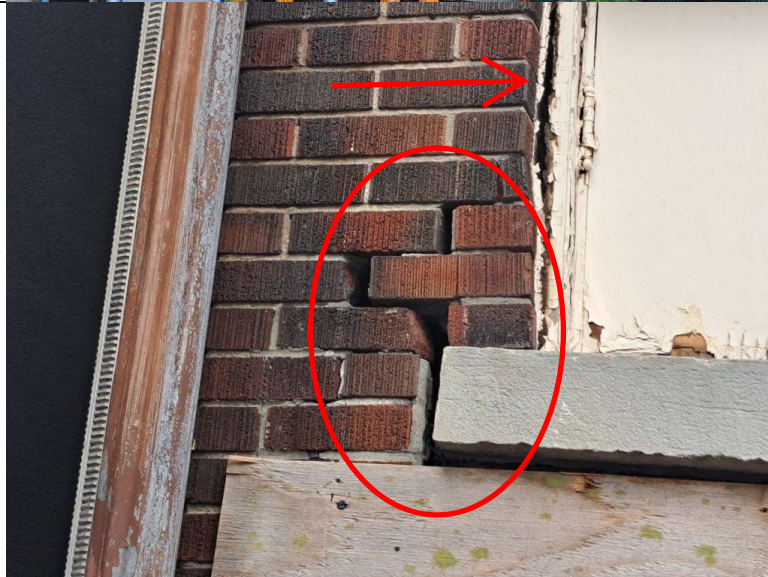
Photo 14

Huge cracks noticed at the Southeast corner

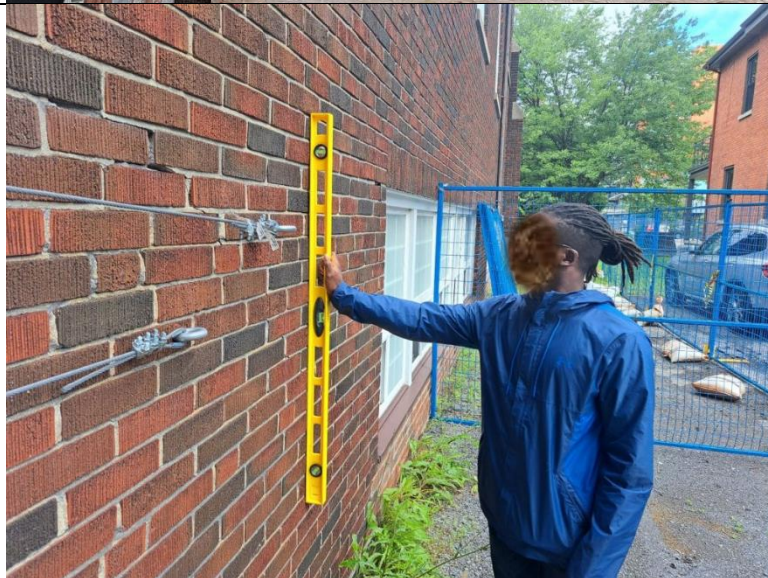
Photo 15

The South wall is leaning to the outside by 1cm for every meter

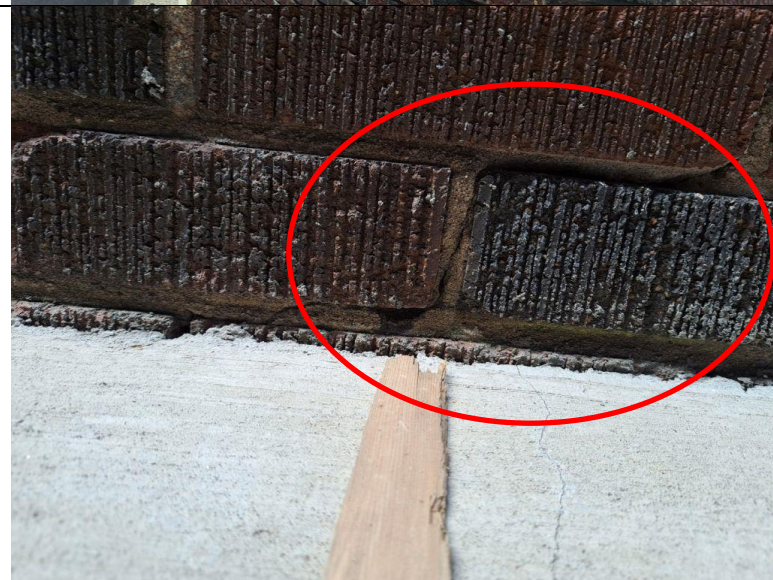
Photo 21

One step crack in the middle of the East wall

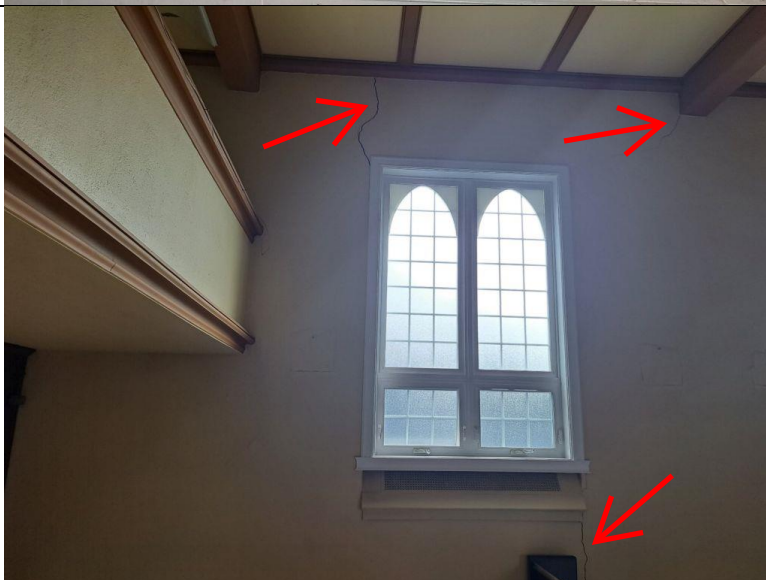
Photo 24

Cracks are noted along the left side (South) wall

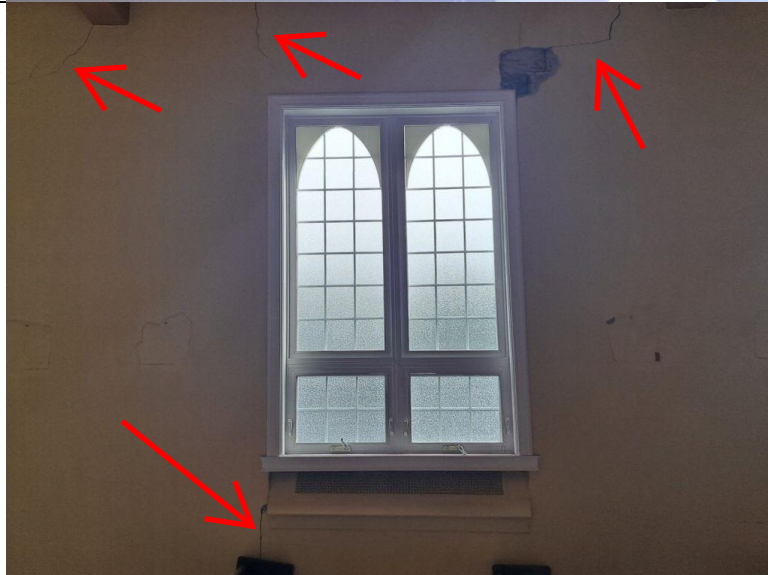
Photo 26
Cracks are noted along the left side (South) wall

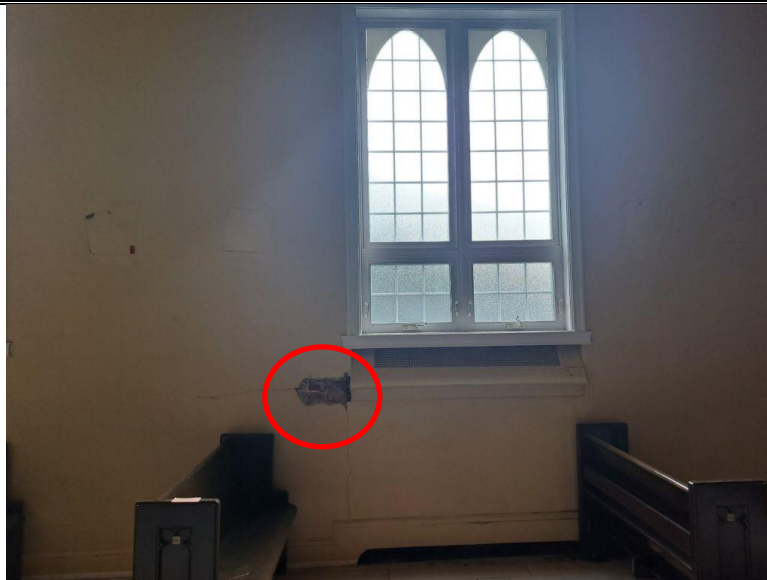
Photo 28
Cracks are noted along the left side (South) wall

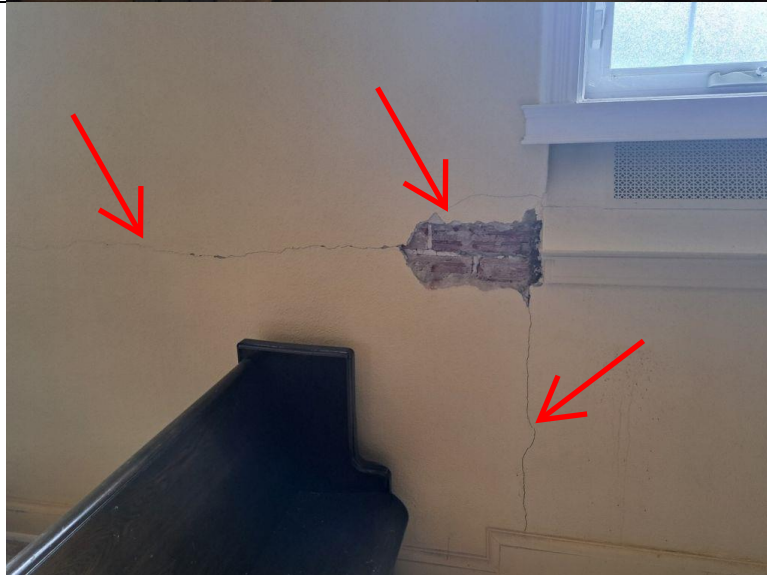
Photo 29
Cracks are noted along the left side (South) wall

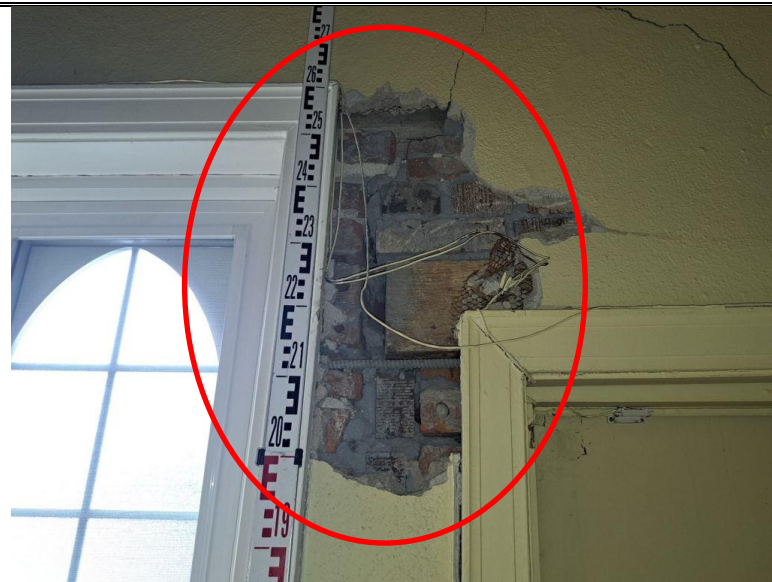
Photo 31

Plaster has spalled exposing the terracotta hollow core blocks and the wood lintel

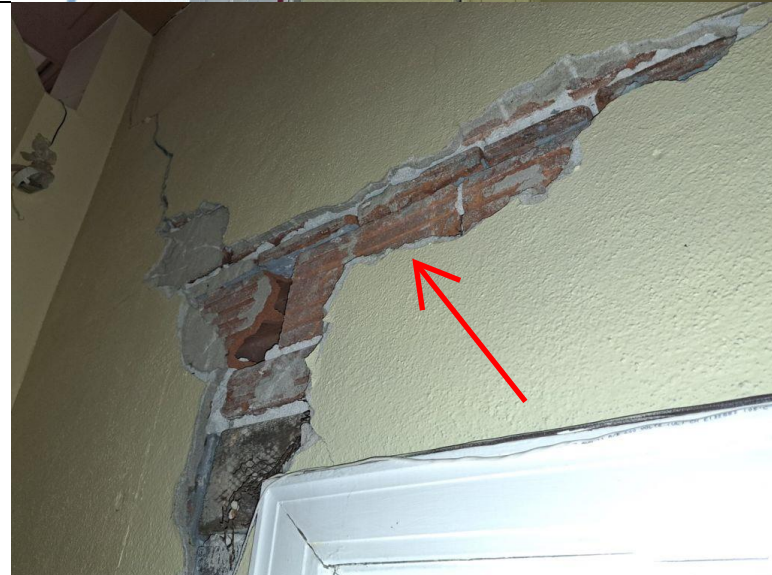
Photo 32

Plaster has spalled exposing the terracotta hollow core blocks and the wood lintel

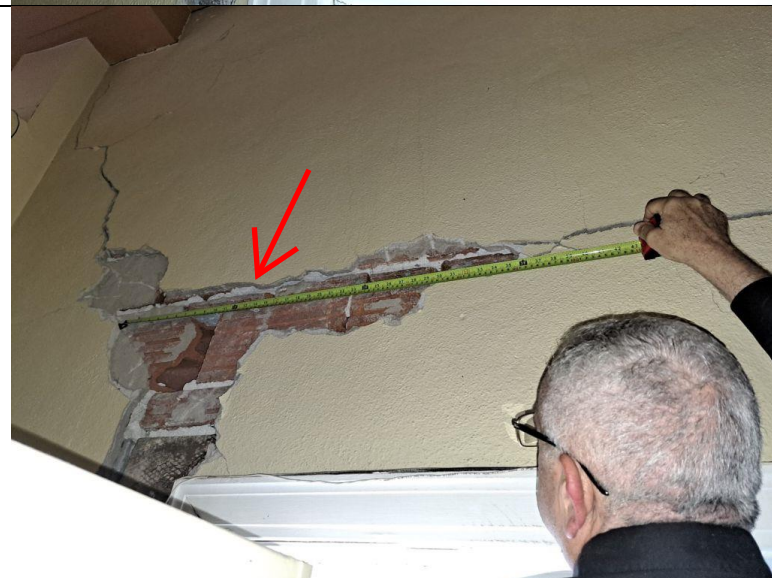
Photo 33

Plaster has spalled exposing the terracotta hollow core blocks and the wood lintel

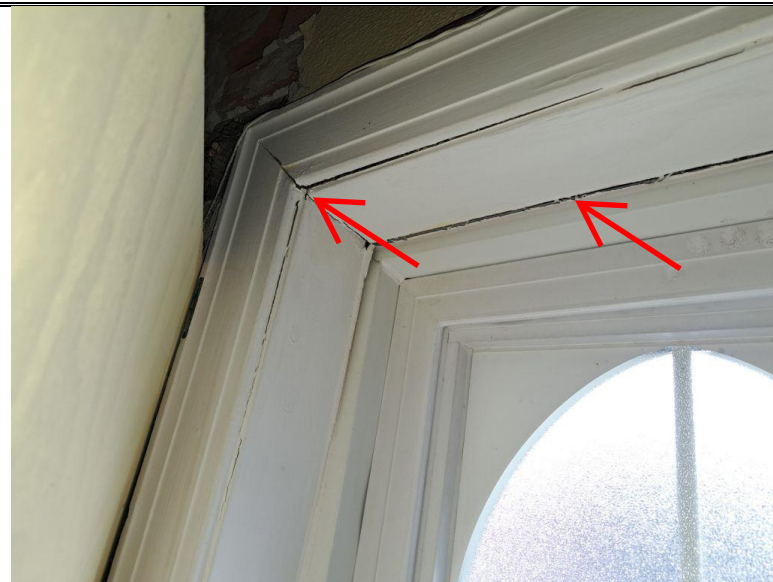
Photo 34
Sever damage and cracks to the fire exit door
at the Southeast corner

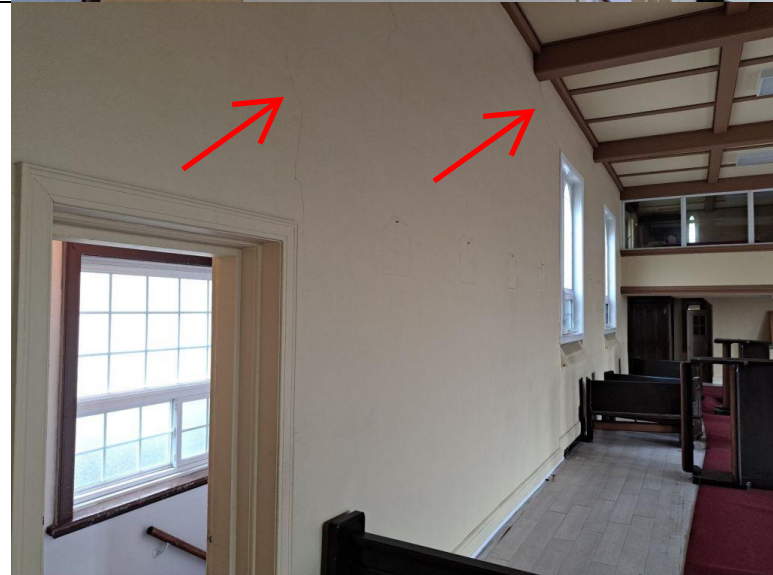
Photo 38

Several hair cracks at the top and the bottom of the windows and door lintel, and painted plaster with average quality

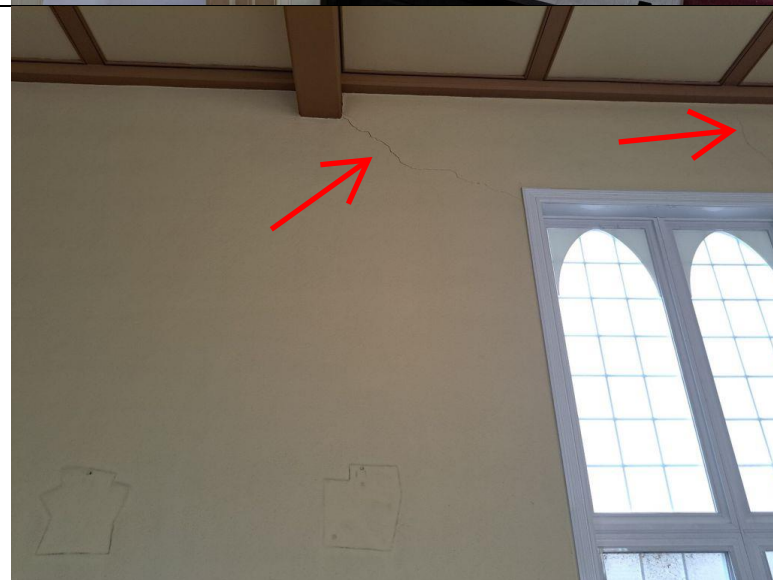
Photo 39

Several hair cracks at the top and the bottom of the windows and door lintel, and painted plaster with average quality

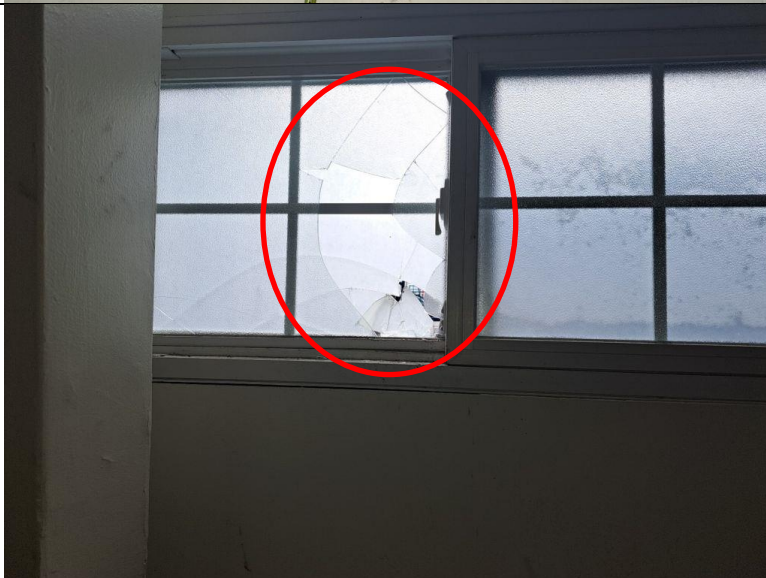
Photo 51
Windows with broken glass

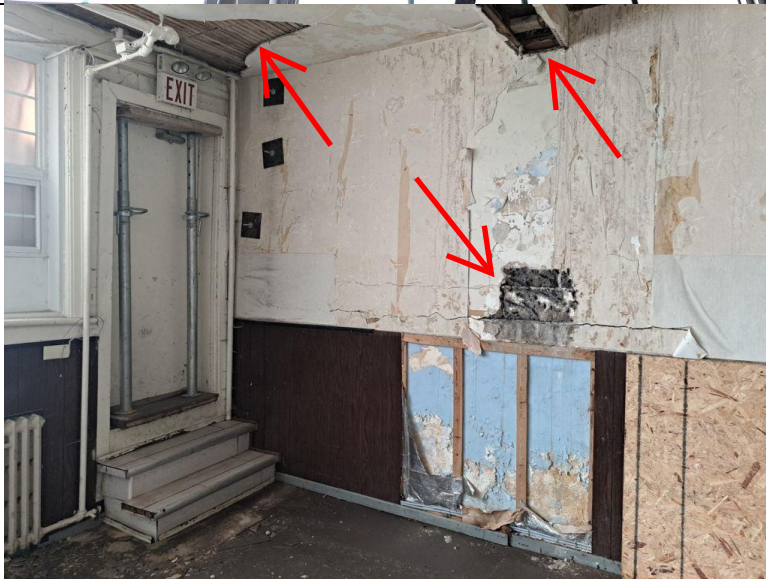
Photo 53
Sever damages at the Southeast corner

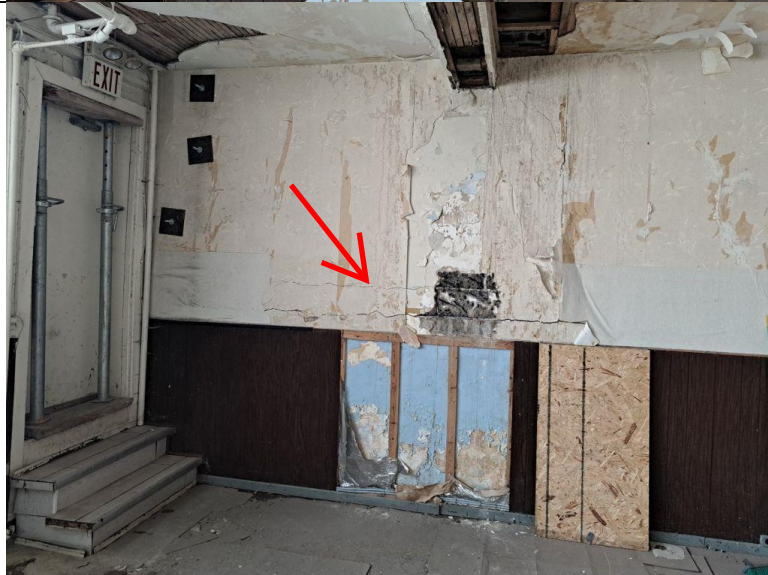
Photo 56
Horizontal crack of at least 5mm width at the
rear side wall (East side) at the basement level

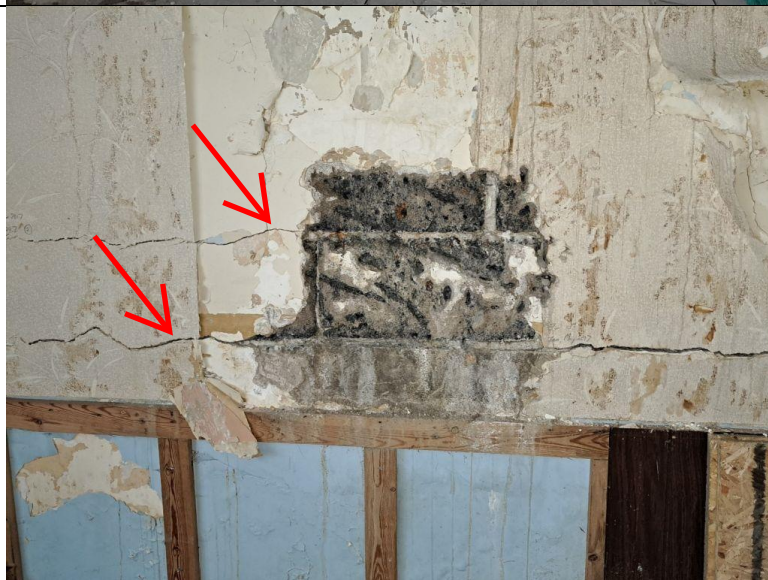
Photo 57
Horizontal crack of at least 5mm width at the
rear side wall (East side) at the basement level

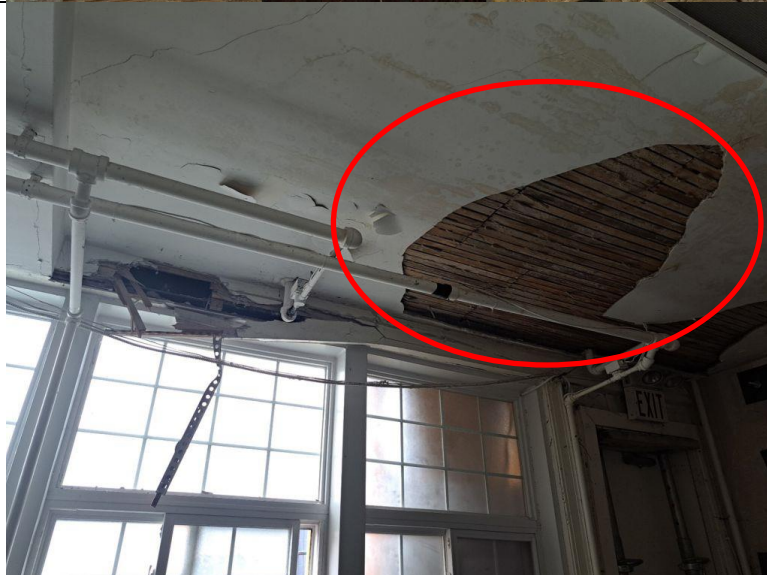
Photo 59
Exposed ceiling due to plaster that fell down, and damaged wood frame by water, wood has started to rot

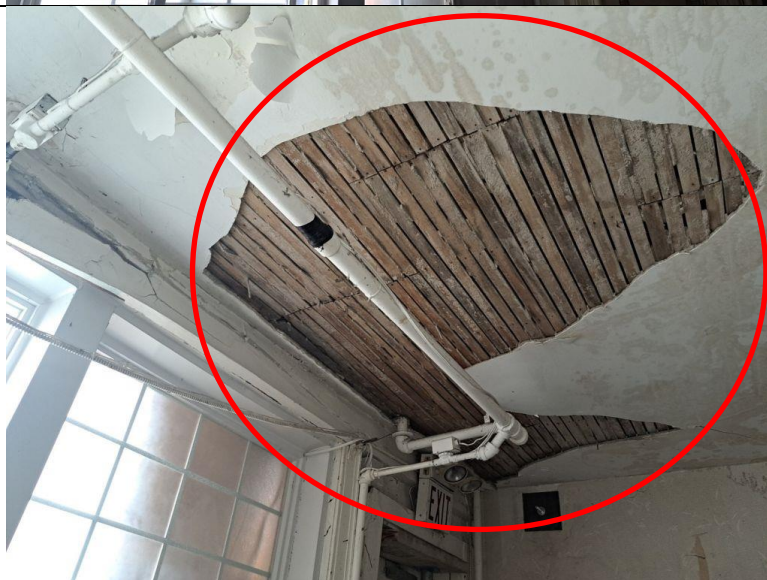
Photo 60
Exposed ceiling due to Gyproc that fell down, and damaged wood frame by water, wood has started to rot

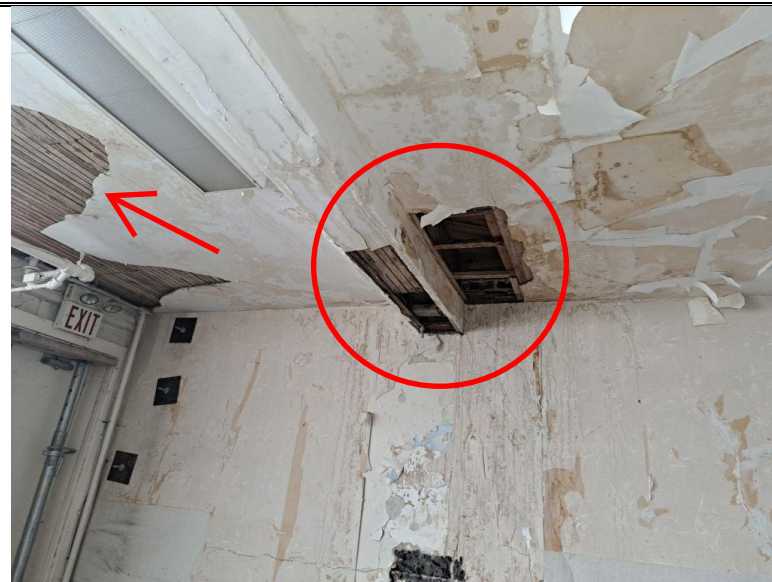
Photo 61

Exposed ceiling due to plaster that fell, and damaged wood frame by water, wood has started to rot

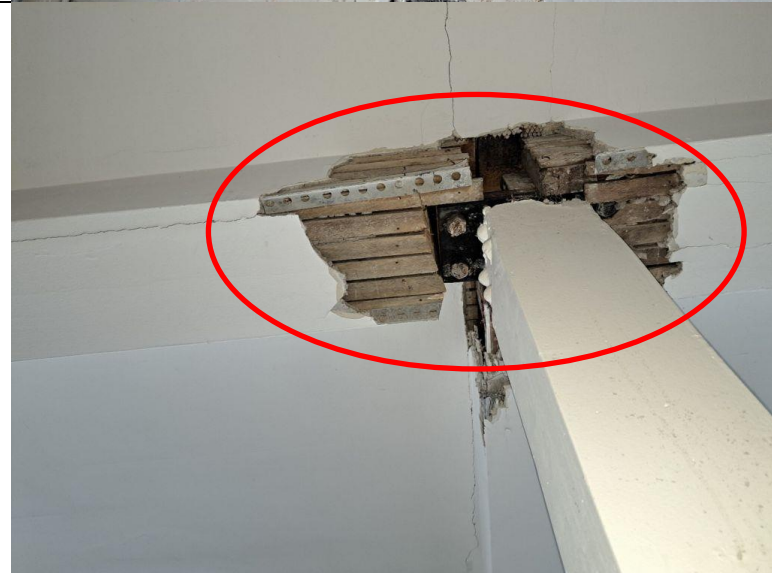
Photo 62

Exposed ceiling due to plaster that fell down, and damaged wood frame by water, wood has started to rot

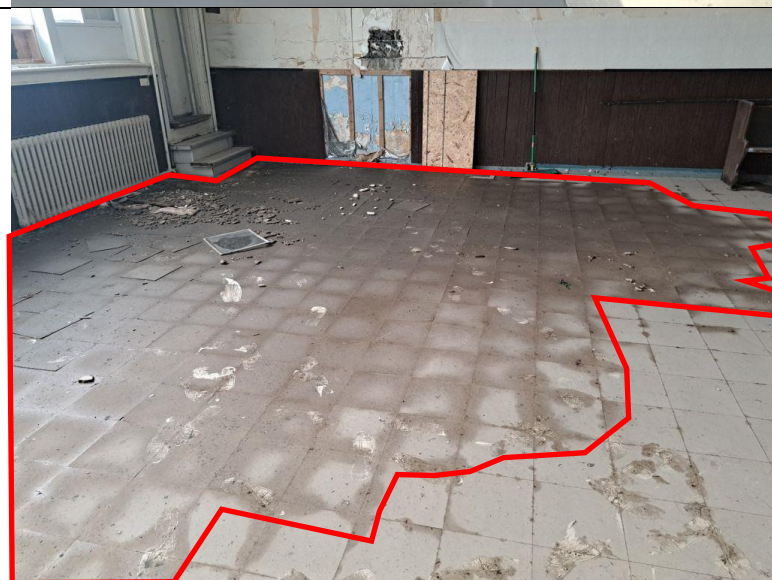
Photo 63

Wet floor due to water leakage

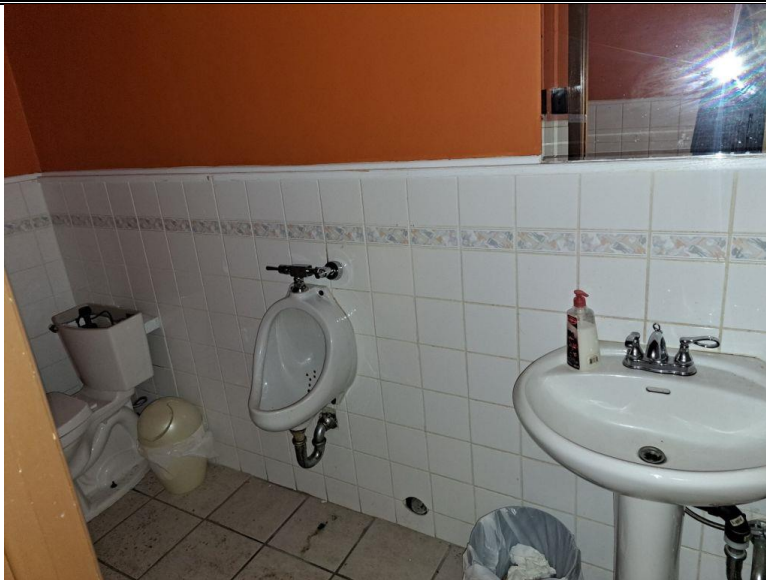
Photo 64
Room view of the washroom, water was disconnected at the time of inspection, and the washroom was dirty and not maintained

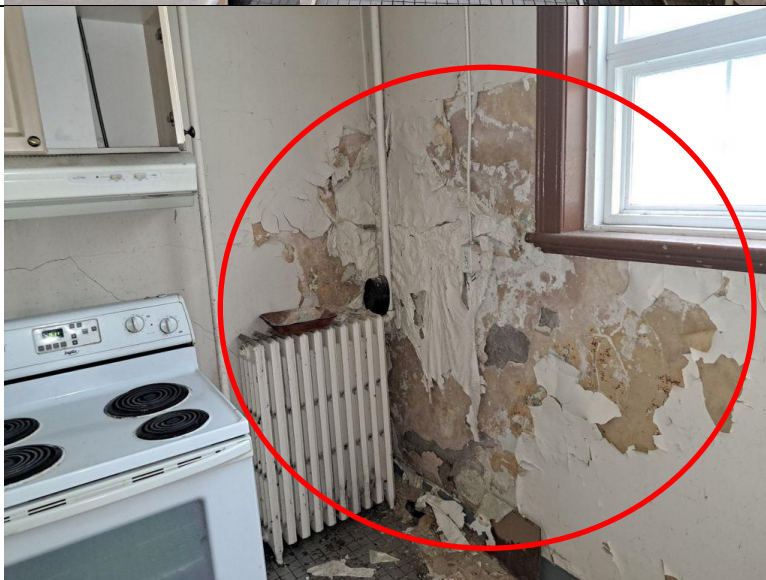
Photo 66
Moisture intrusion, paint peeling off, and water leakage on the floor
