SOMERSET HOUSE
HERITAGE IMPACT ASSESSMENT
352 SOMERSET STREET WEST, OTTAWA

COMMONWEALTH HISTORIC RESOURCE MANAGEMENT
Version 4. JULY 2023

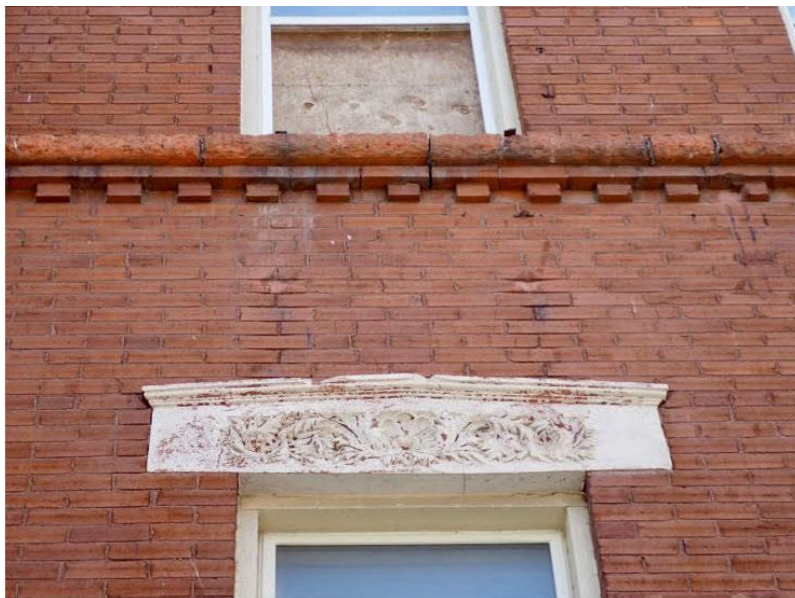
Figure 10: Detail view of the second-floor sill course on the Somerset Street elevation. Note the rusticated terracotta sill (belt) course above the brick dentil band and the painted terracotta window lintels. Source: Heritage Ottawa / Archives Ottawa.

The decorative lintels on the north façade appear to be in fair condition, with expected levels of wear and tear according to their age. There is evidence of water infiltration into the building through the skyward facing joints at the stone windowsills. Flashings should be introduced at the stone windowsills to ensure that the water is directed away from the windows. The joints of the sill (belt) course above the brick dentil band needs repointing. (See Figure 10.)

- Painted terra cotta lintels should be cleaned and loose paint removed and repainted to match the existing colour.
- Joints at the windowsills should be fully repointed, and capped. (Lead “T” flashing caps could be used for this purpose. R. Martin)
- Open joints (such as at the string courses, or pilasters) should be repointed.
- Any cracks or fractures in the terra-cotta should be pinned or epoxied depending on the condition.

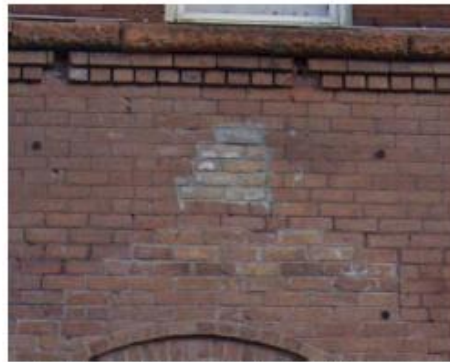
Figure 7: Incompatible previous repair above north façade door and deteriorated brick corbelling above.

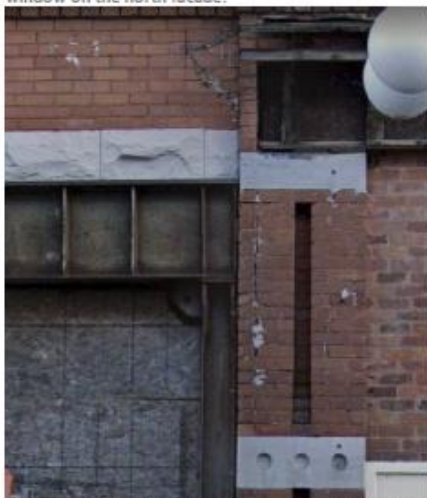
Figure 8: Cracking and open joints on the north façade.

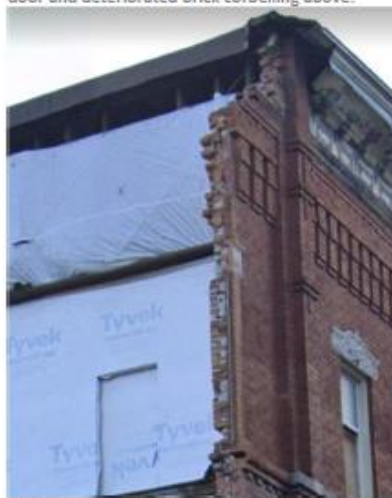
Figure 9: Exposed masonry at east end of north façade.

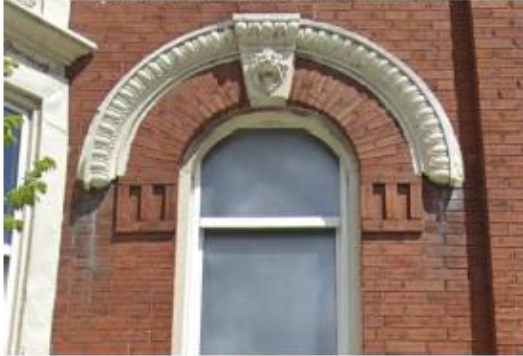
Figure 12: Moisture staining below window lintels

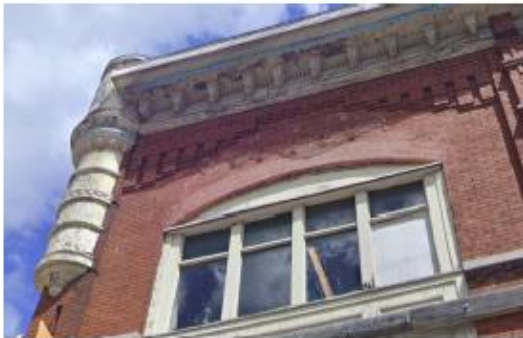
Figure 14: Deteriorated brick above previous location of bay windows on the west façade.

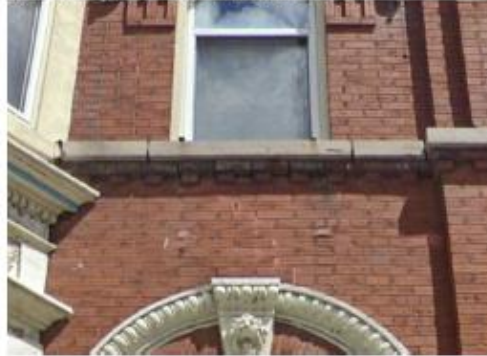
Figure 13: Open skyward facing joints on the stone stringcourse with stained and eroded brick dentils below.

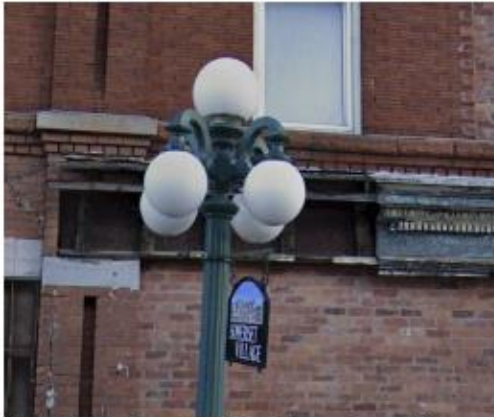
Figure 15: Missing section of first floor cornice and frieze.

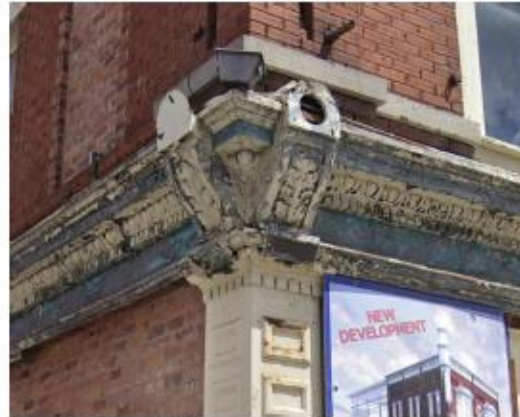
Figure 16: General deteriorated condition of first floor cornice.

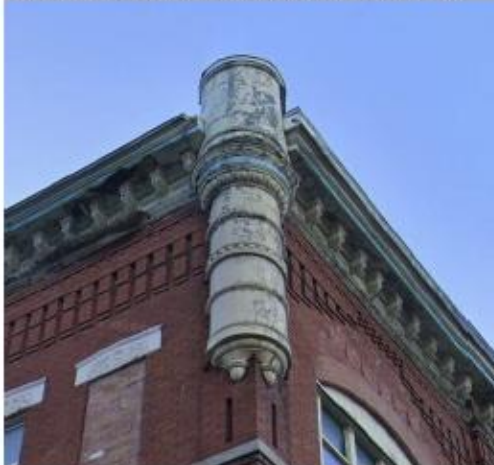
Figure 17: Peeling paint, open soffit, and general deteriorated condition of corner turret.

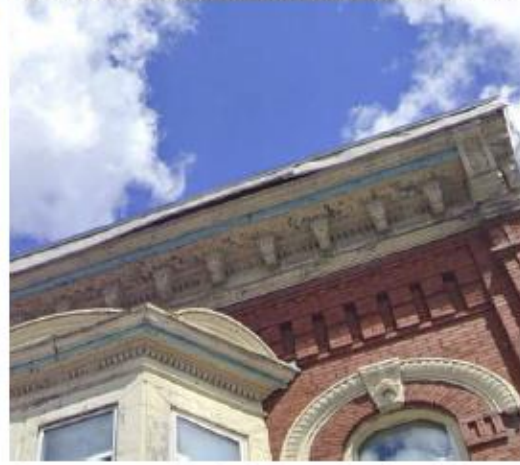
Figure 18: Separated fascia, deteriorated cornice and frieze.

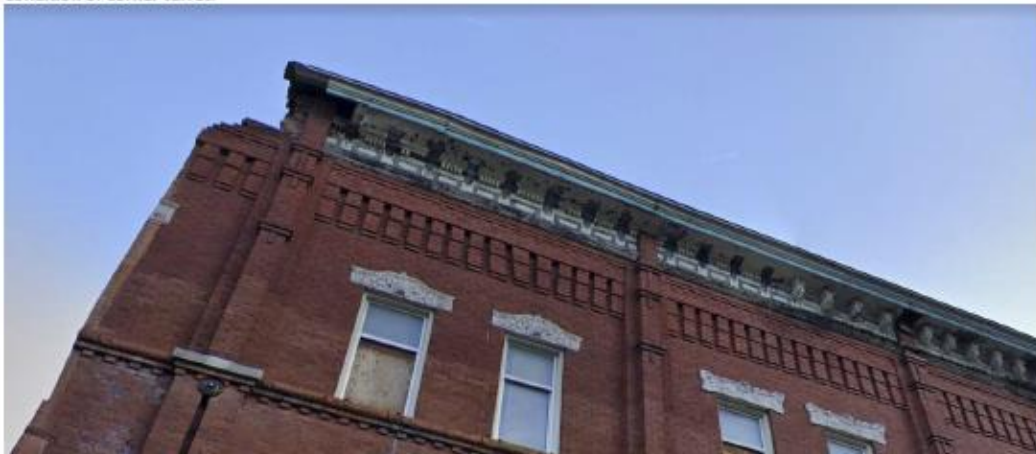
Figure 19: Missing cornice brackets, and general deteriorated condition on the north façade.

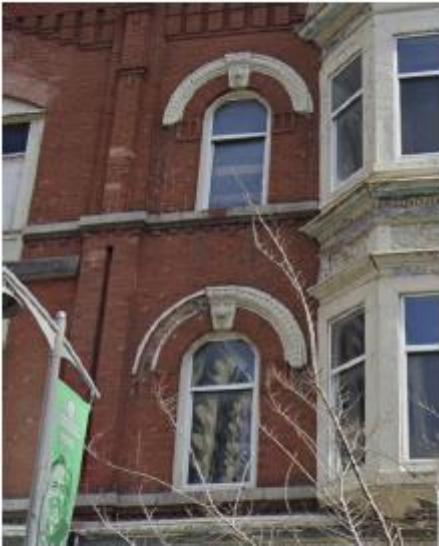
Figure 20: Missing arched metal lintel on west façade.

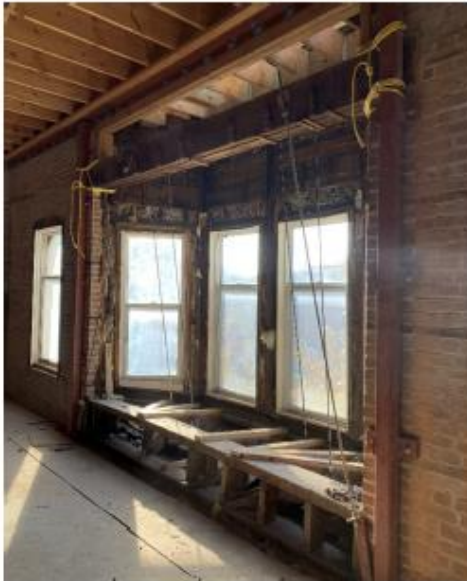
Figure 25: The interior of the bay window on the first floor with steel cable supports.

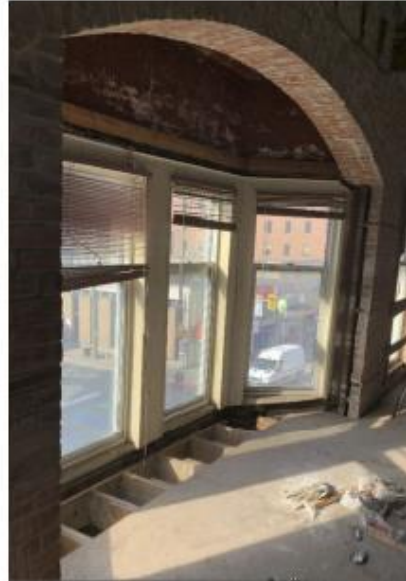
Figure 26: Detached base framing of the bay window on the second floor.

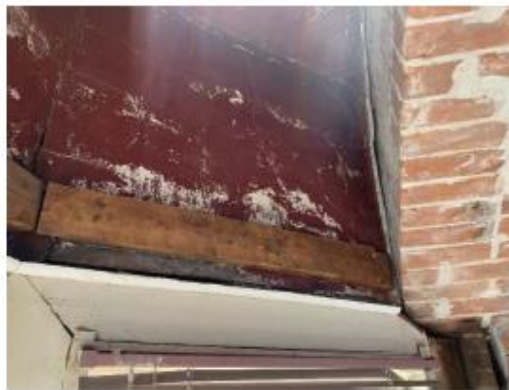
Figure 28: Separated joints and condition of interior finishes at the bay window.

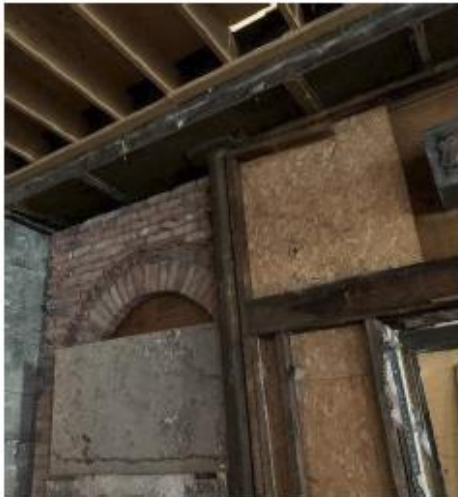
Figure 29: west façade window blocked with fiberboard.

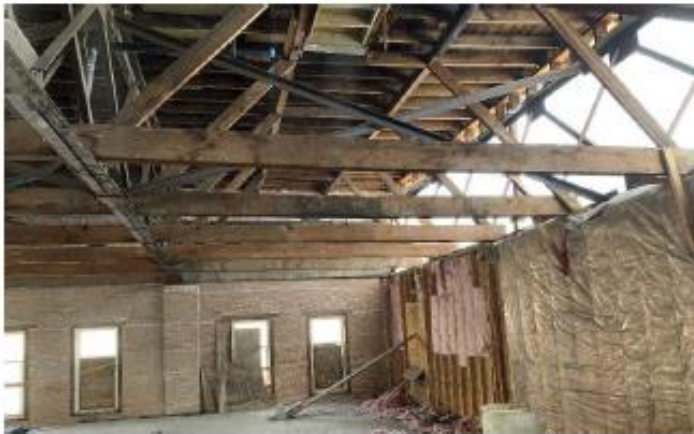
Figure 35: Roof condition

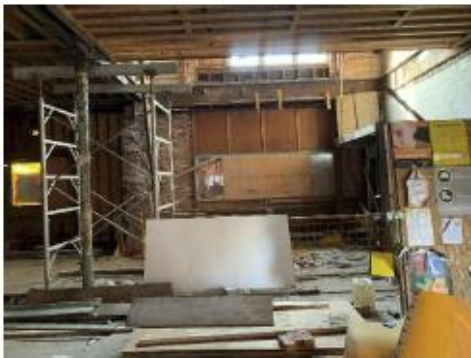
Figure 37: Deteriorated brick pier.

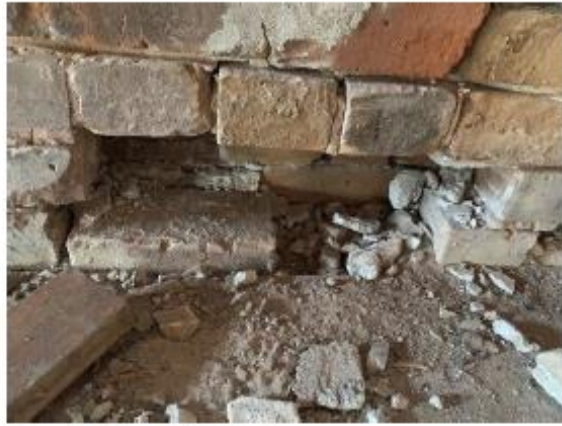
Figure 40: Debonded brick wythes.

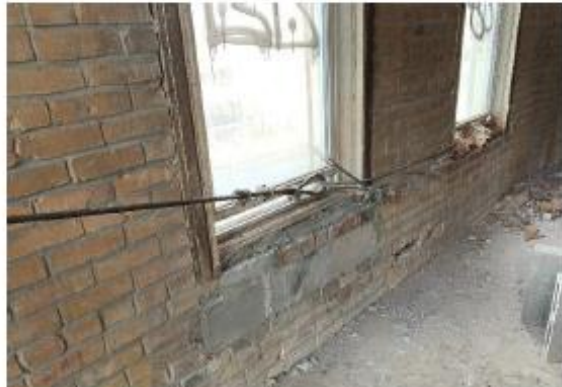
Figure 42: Steel cable between brick pier and window.

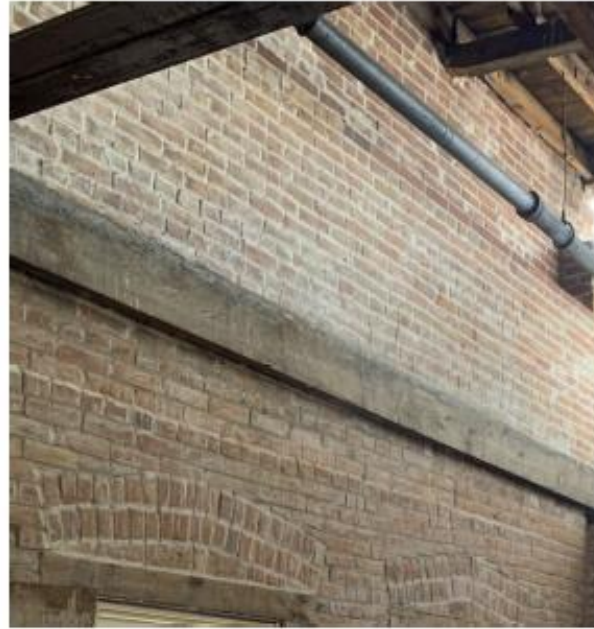
Figure 46: Deteriorated brick on interior of third floor with debonded wythes, frost damage, and surface damage.

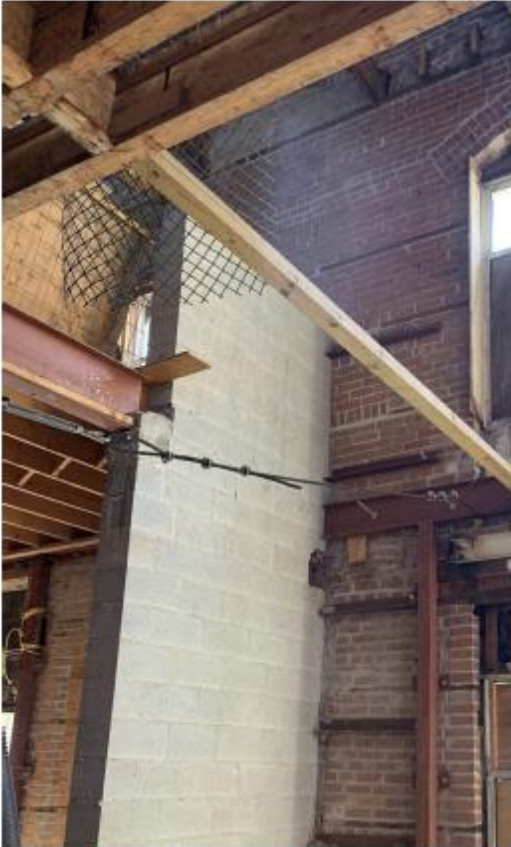
Figure 47: Second floor steel beam is supported at the edge of the wall.

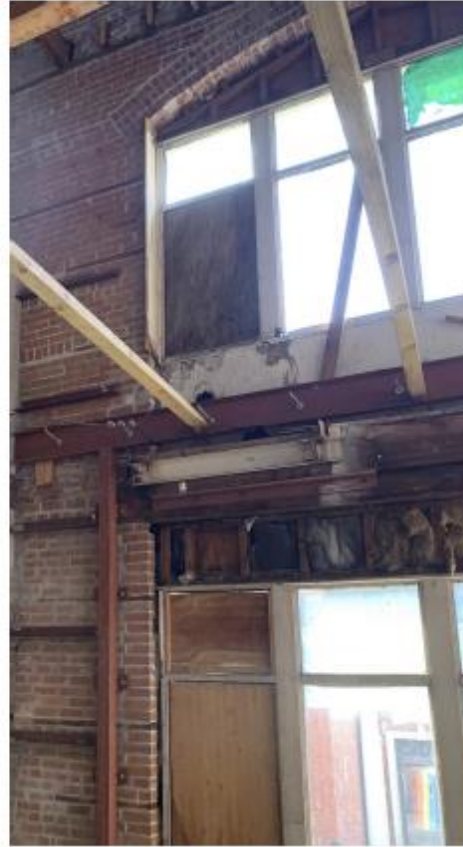
Figure 48: Gaps around the window.

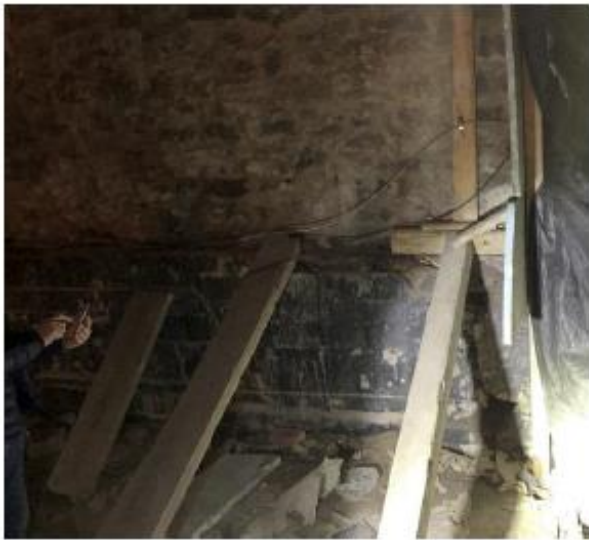
Figure 49: Deteriorated condition of the north foundation wall.

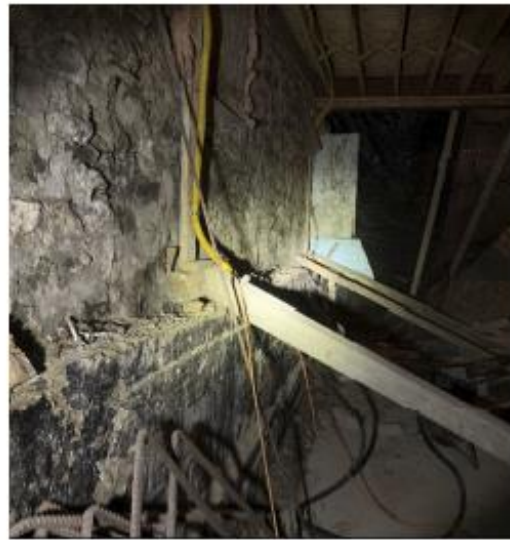
Figure 50: Cracks in the concrete foundation wall.

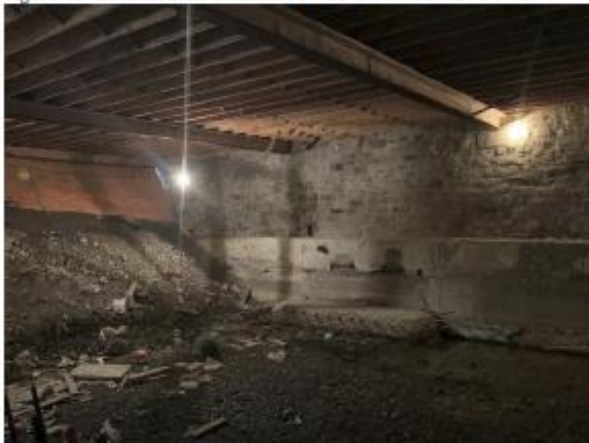
Figure 51: Backfilling at the previous east wall and voids in the south foundation wall.

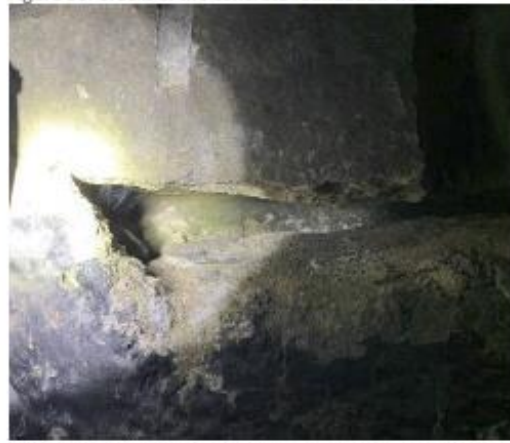
Figure 52: Deteriorated condition of mortar and voids in the stone foundation.

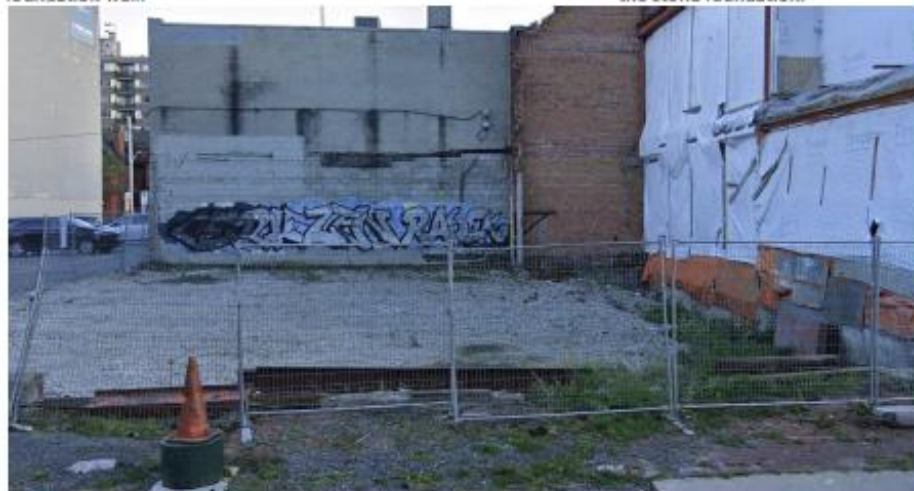
Figure 53: Backfilled location of previous addition, sloping towards the remainder of Somerset House.
