A: Pre-project conditions

B: Building Envelope condition prior to project

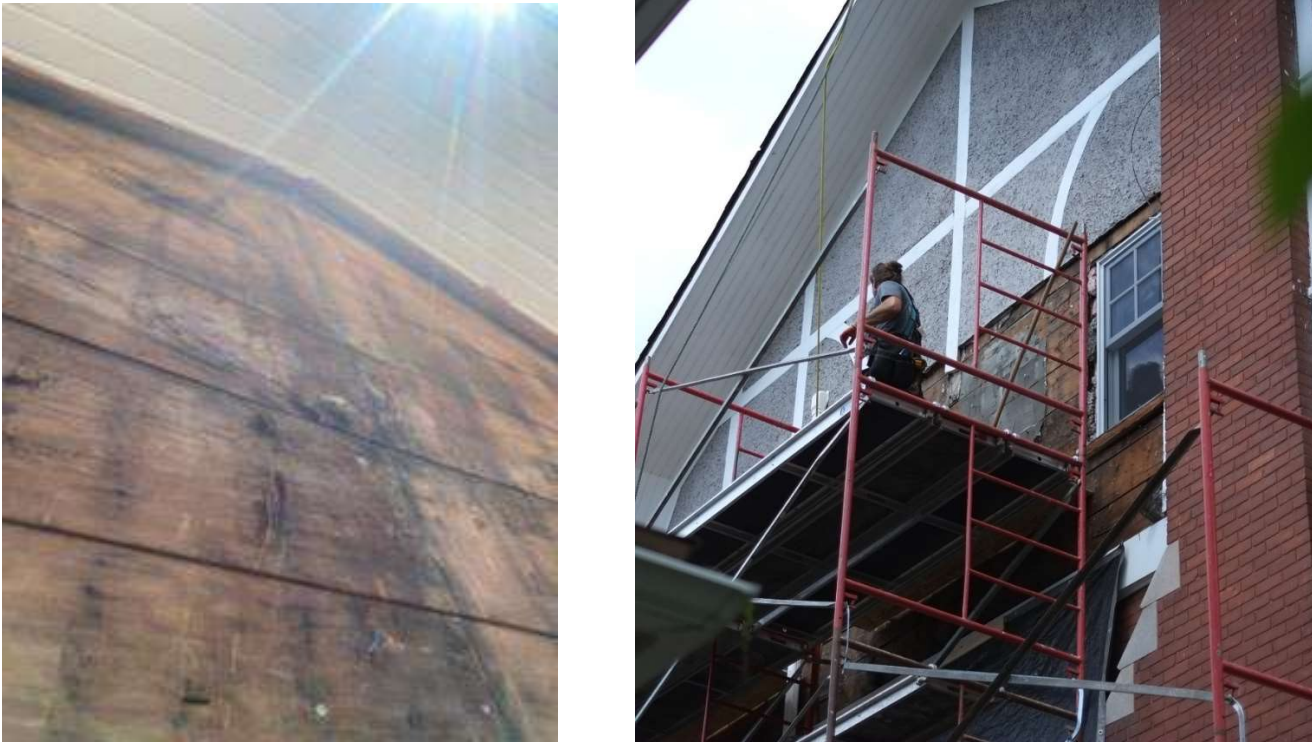
B.3 Condition of sub-structure boards

Fig. 6 and Fig. 7: Exposed boards after stucco panels were removed

- Darkened boards indicate that stucco panels were no longer waterproof and not protective of the sub-structure of the house which will lead to accelerated deterioration of the boards.
- Many of the sub-structure boards were loose and had to be renailed – whole exterior wall assembly was no longer safe

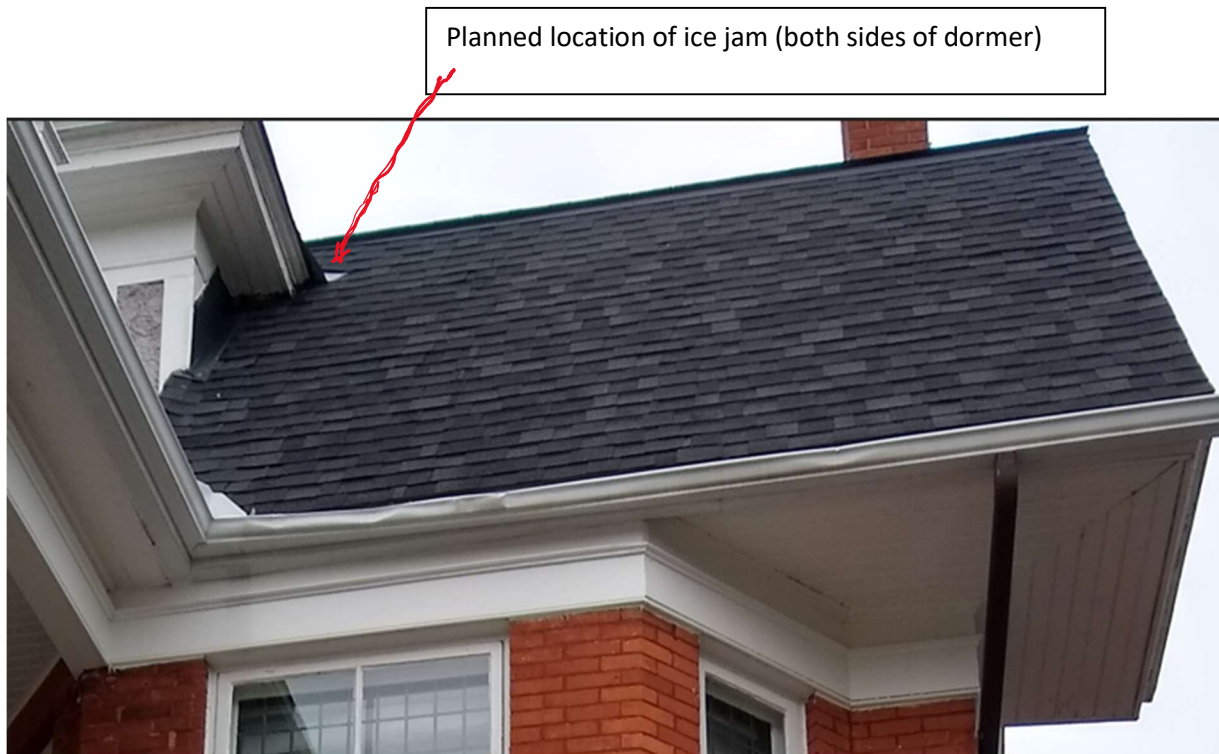
B.9 Ice damage to eavestroughs

Fig. 16: Eavestroughs damaged from ice sliding down from above

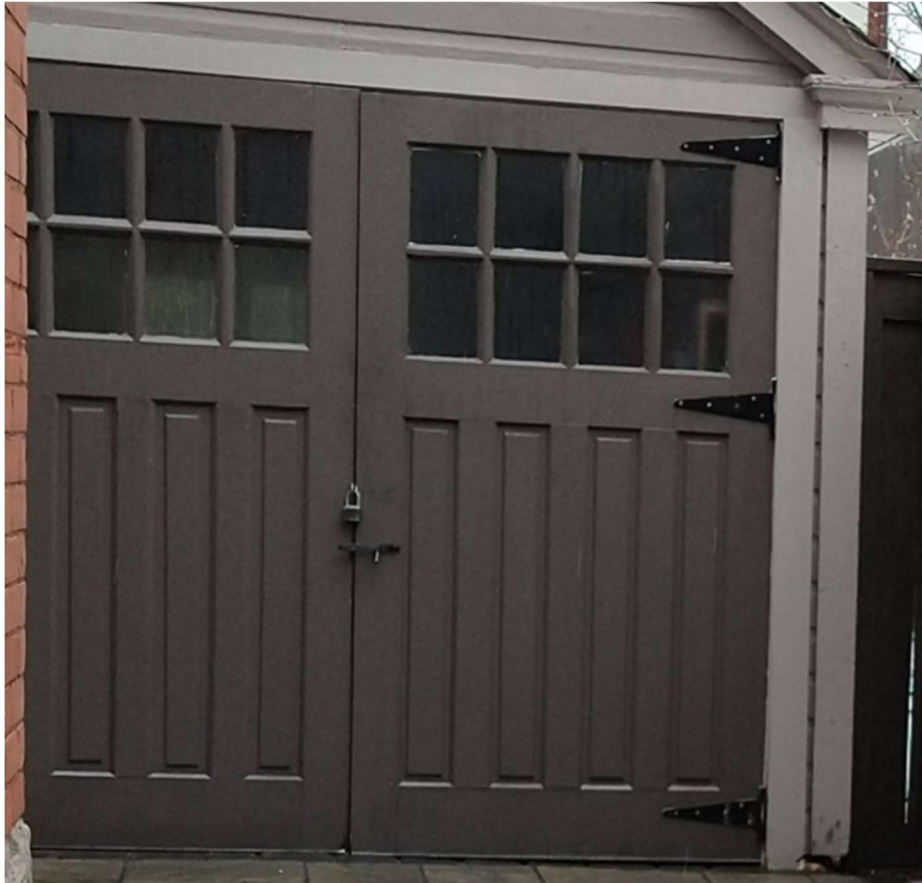
D. Garage door

Fig. 21. Garage doors were replaced by then owner in the 1990's as original doors were finished. Doors swing sideways and cannot be opened during the winter months due to frost heave of the driveway in front of the garage. Doors were cut 2 inches last year to attempt to correct issue, but another 2 inches would need to be cut from the bottom so that they could swing open properly.
