Subject: **Letter of Reliance
Environmental Assessment Update
2688 Carp Road - Ottawa**

October 6, 2016
File: PE1579-LET.03

**Subject: Environmental Assessment Update
2688 Carp Road
Ottawa, Ontario**

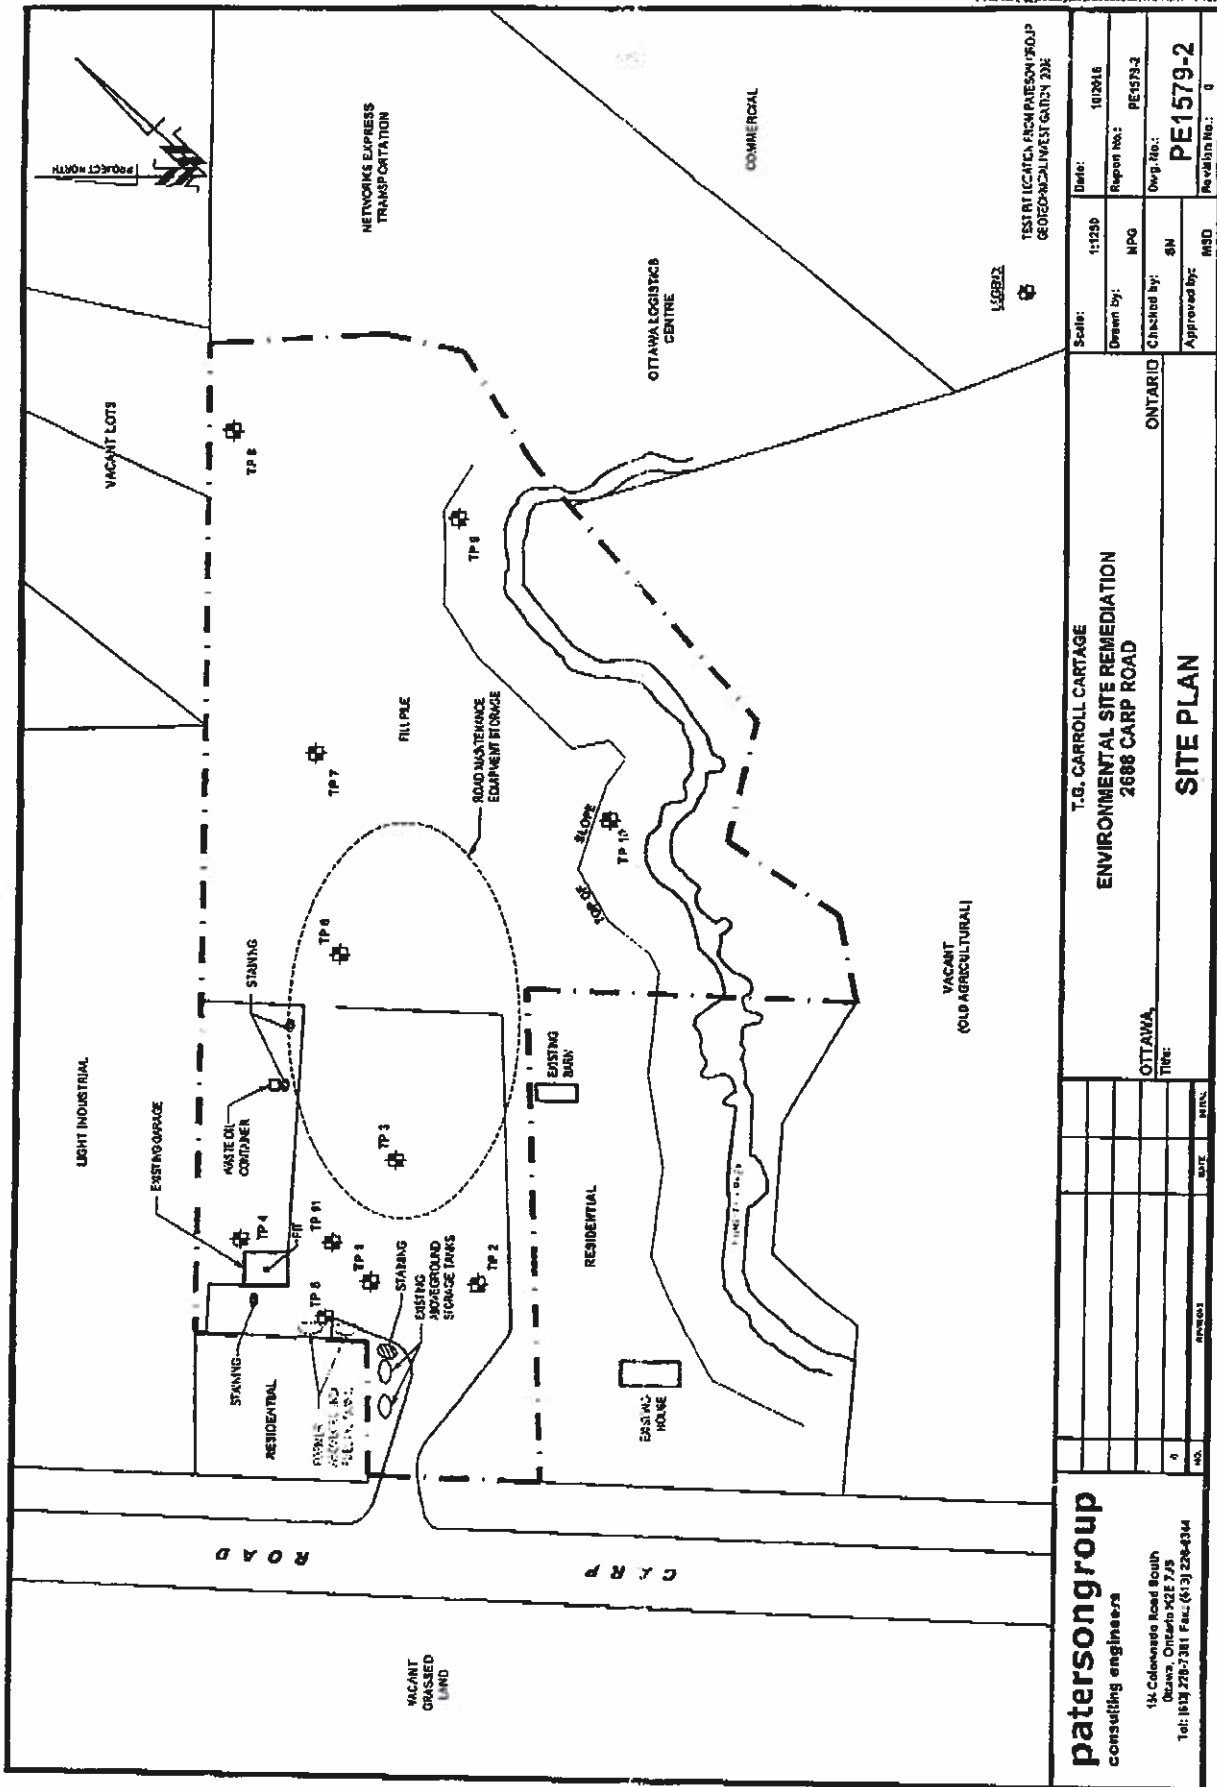
Scale:	1:1250	Date:	10/26/16
Drawn by:	MPG	Report No.:	PE1579-2
Checked by:	SN	Drawn No.:	PE1579-2
Approved by:	MSD	Revising No.:	0

At the time of the site visit, winter road-maintenance vehicles, various pieces of equipment, construction supplies, waste oil containers, two 2,500 L diesel aboveground storage tanks (ASTs) and a large fill pile were stored on the subject site. Several areas of limited surficial staining was observed on the subject site around the garage and vehicle/equipment parts storage areas. One stain beneath the clear diesel AST pump with an approximate 2 m diameter, was considered to be of greater concern. The locations of the above noted features are presented in Drawing PE1579-2 - Site Plan.
