Phase I - Environmental Site Assessment

Proposed Neighbourhood 5 Residential Development
Mer Bleue Road and Tenth Line Road
Ottawa, Ontario

November 14, 2005

Report: PE0644-1

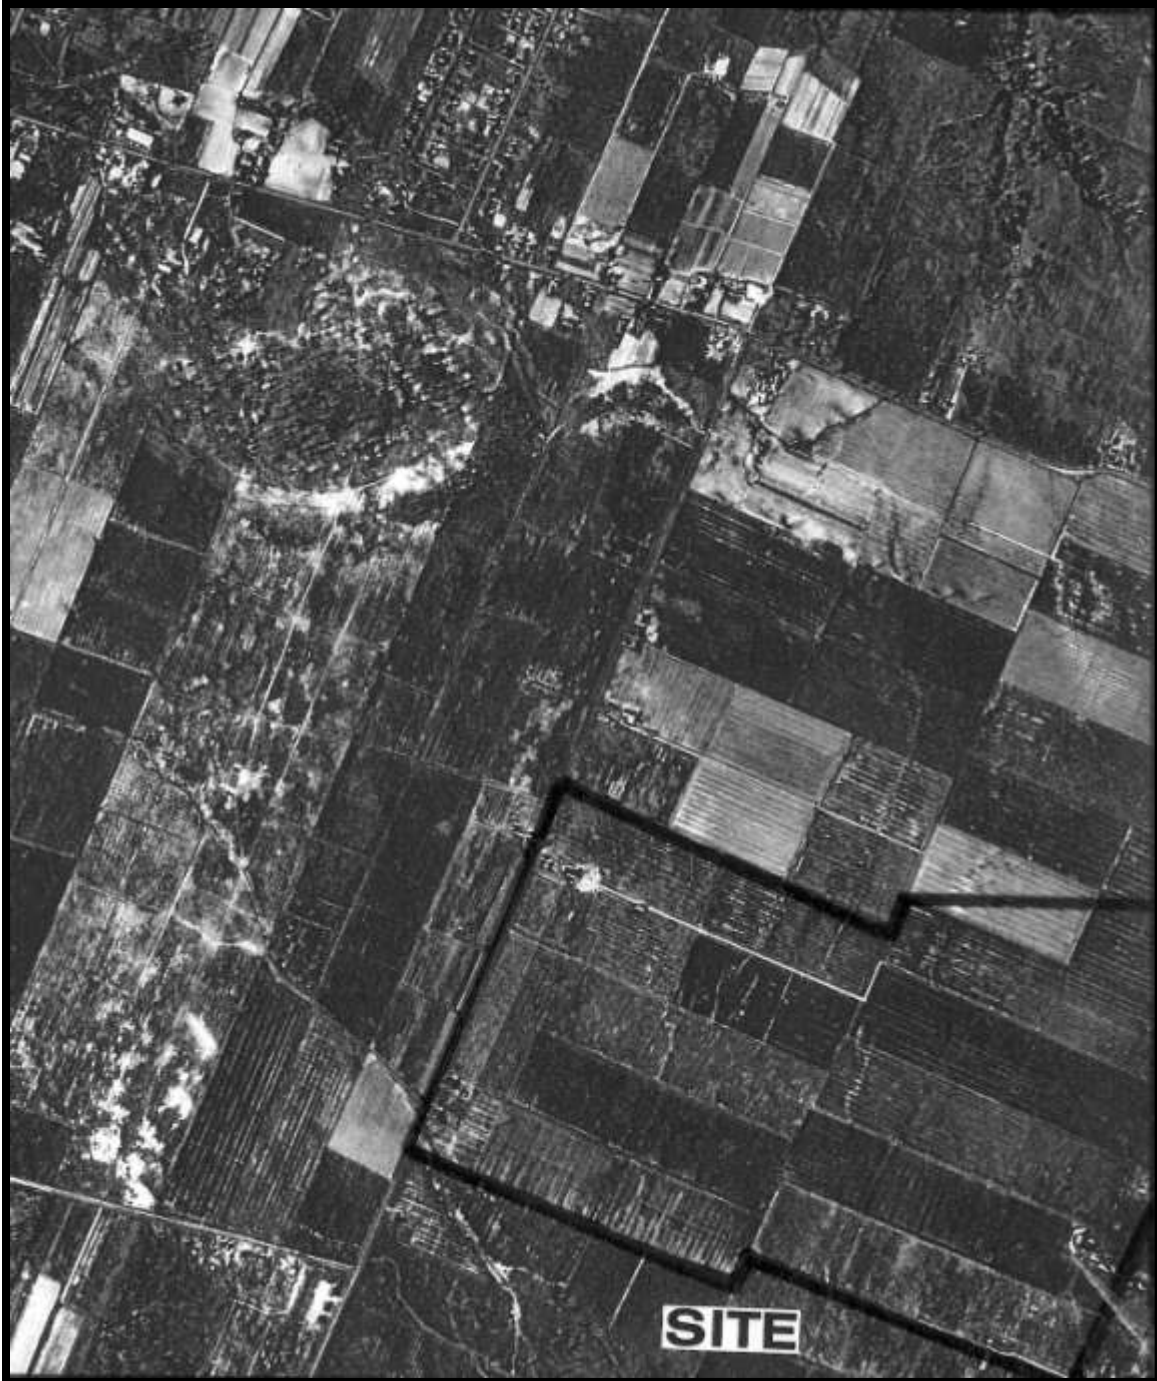
AERIAL PHOTOGRAPH
1967

| 1967 | The subject site was vacant, agricultural land. Several residential properties/farmsteads were located along Mer Bleue and Tenth Line Roads. (As mentioned previously, these properties are not part of this assessment.) A ditch, transects the southwest corner of the subject site in a northwest-southeast direction. Adjacent properties are mostly vacant, agricultural lands with several farmsteads south, west and north of the subject site. The adjacent property east of the site is not shown on this photograph. |

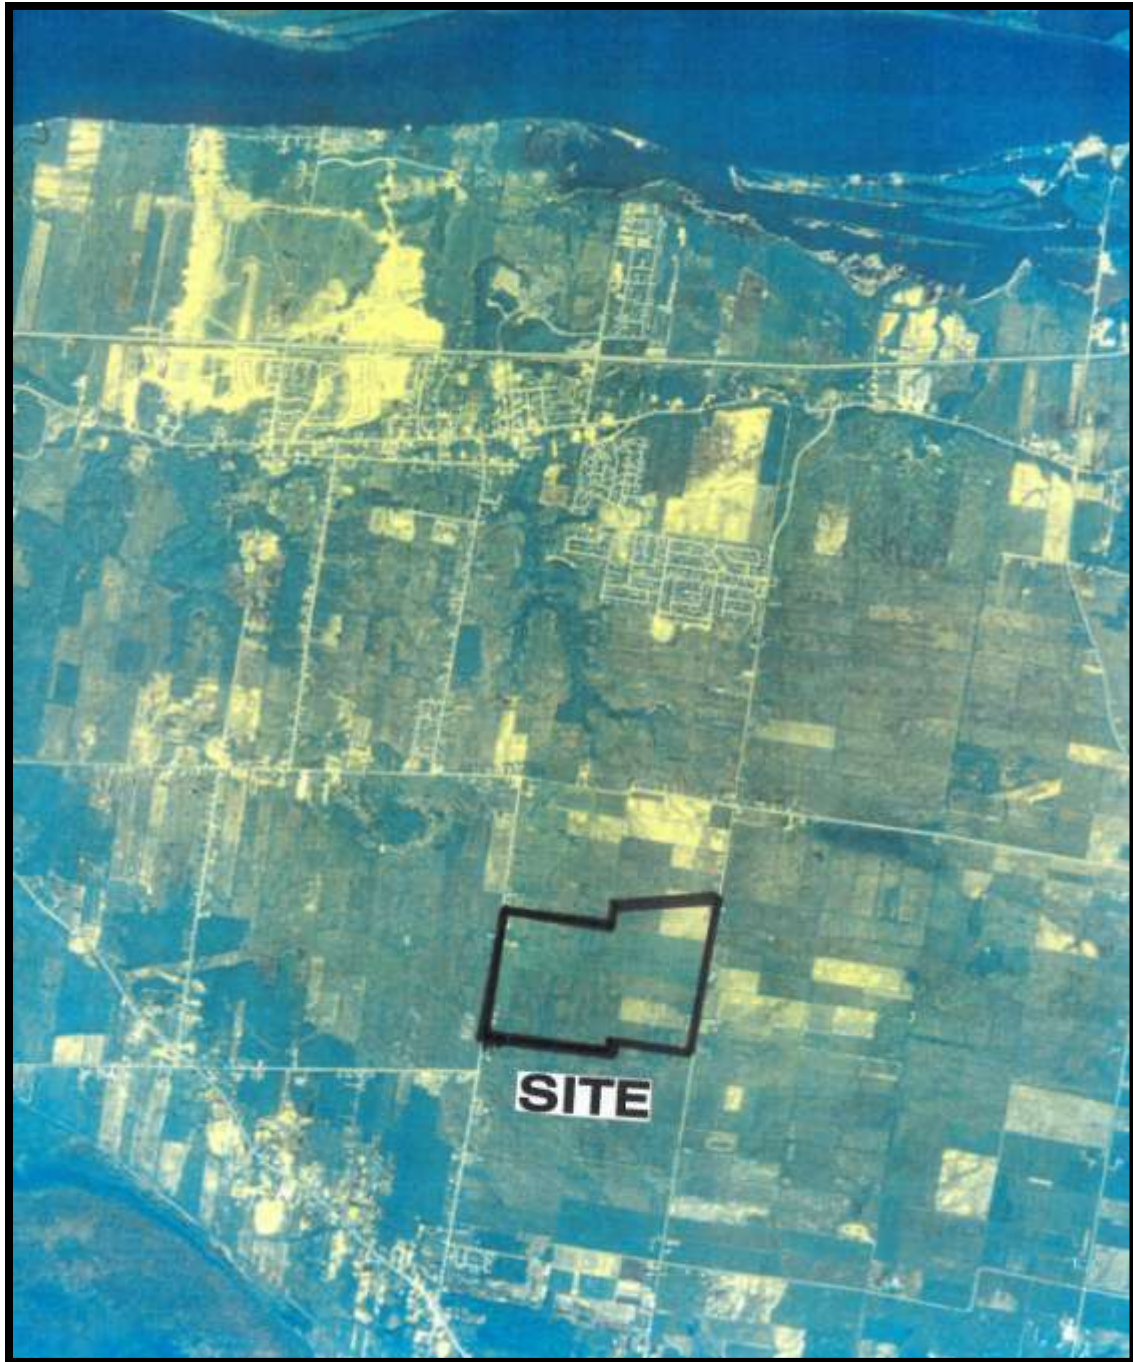
AERIAL PHOTOGRAPH
1976

| 1976 | No significant changes have been made to the subject site or to the adjacent properties. The adjacent property east of the subject site, not seen in the previous photograph, was a combination of vacant, agricultural land and residential dwellings. |

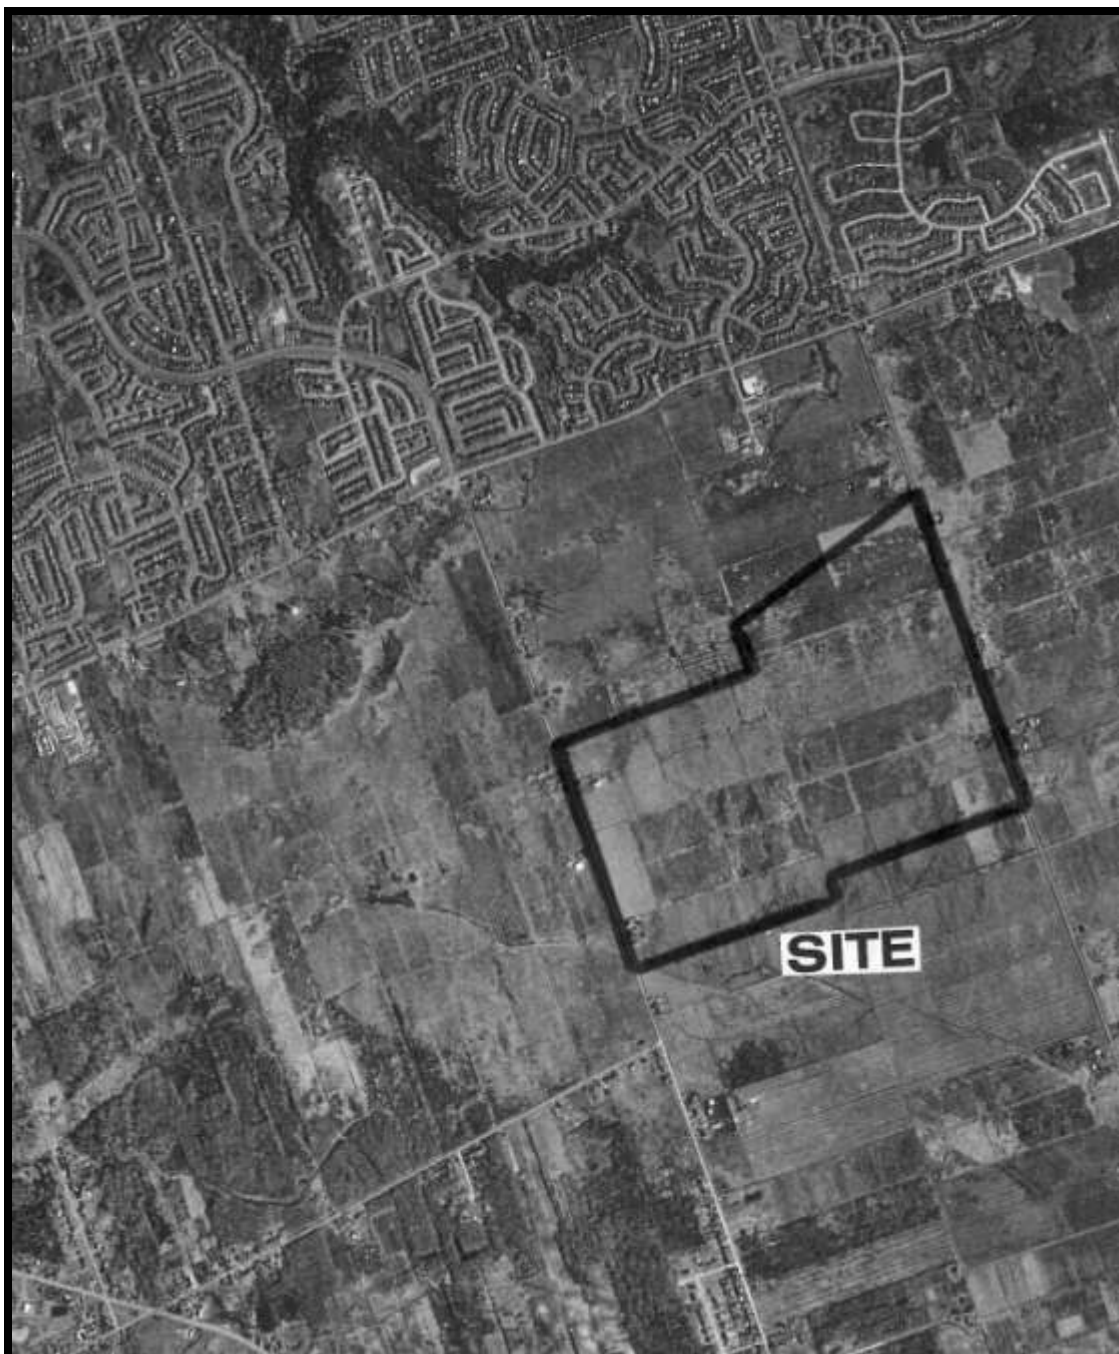
AERIAL PHOTOGRAPH
1989

| 1989 | No significant changes have been made to the subject sites or the adjacent properties. |

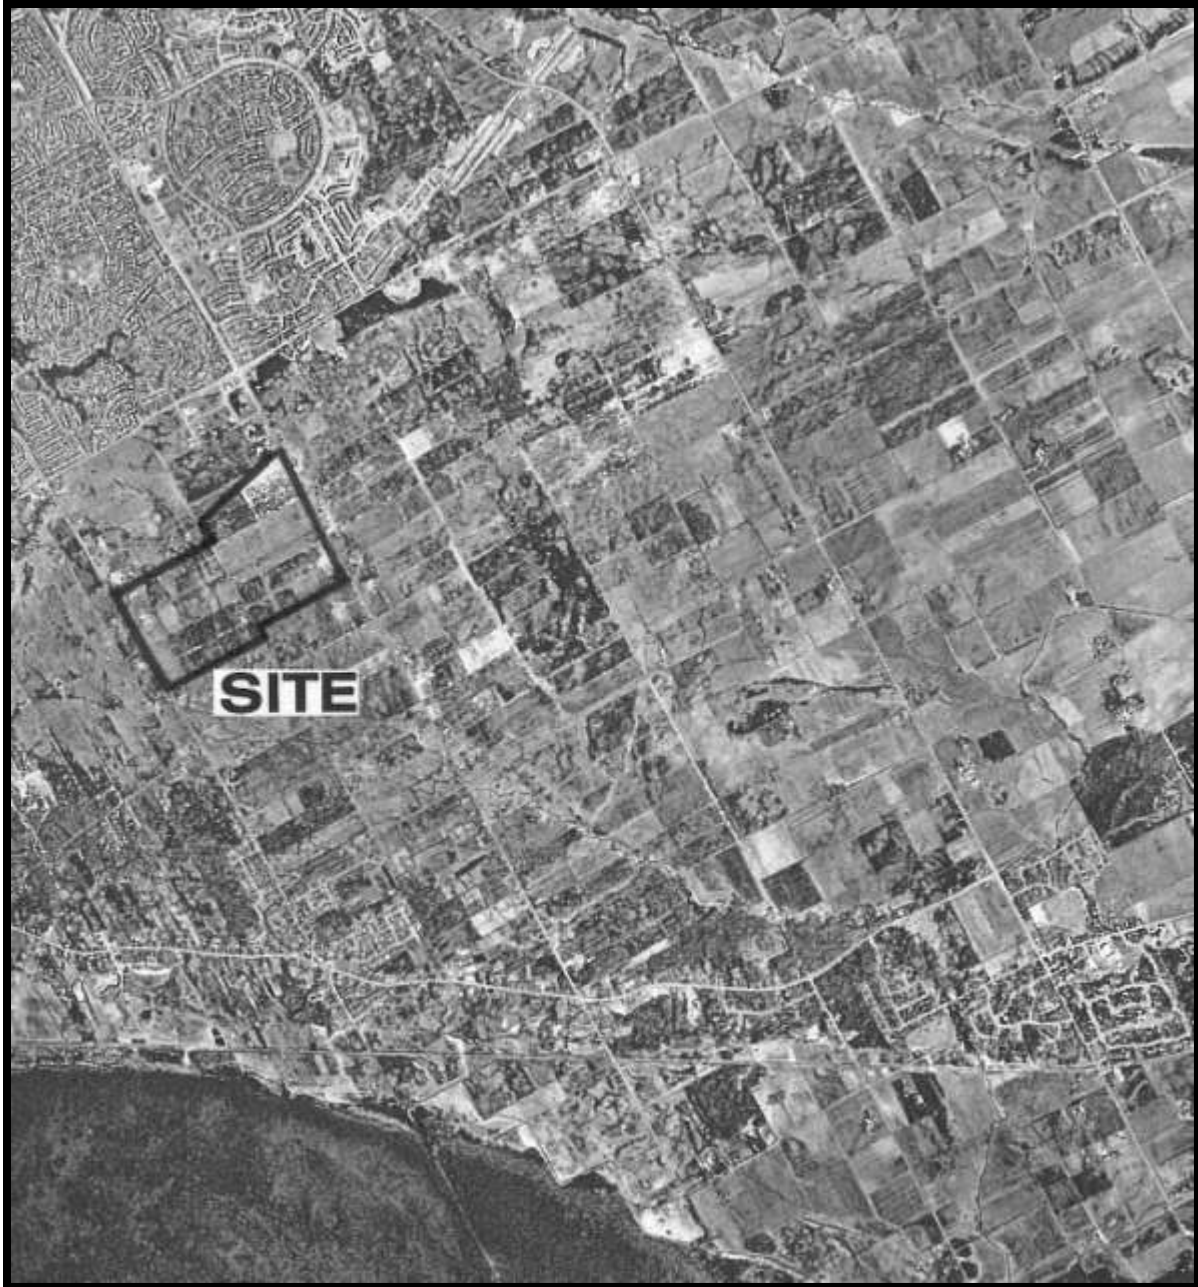
AERIAL PHOTOGRAPH
1994

| 1994 | No significant changes have been made to the subject or neighbouring properties. Significant residential development has occurred north of Innes Road. |

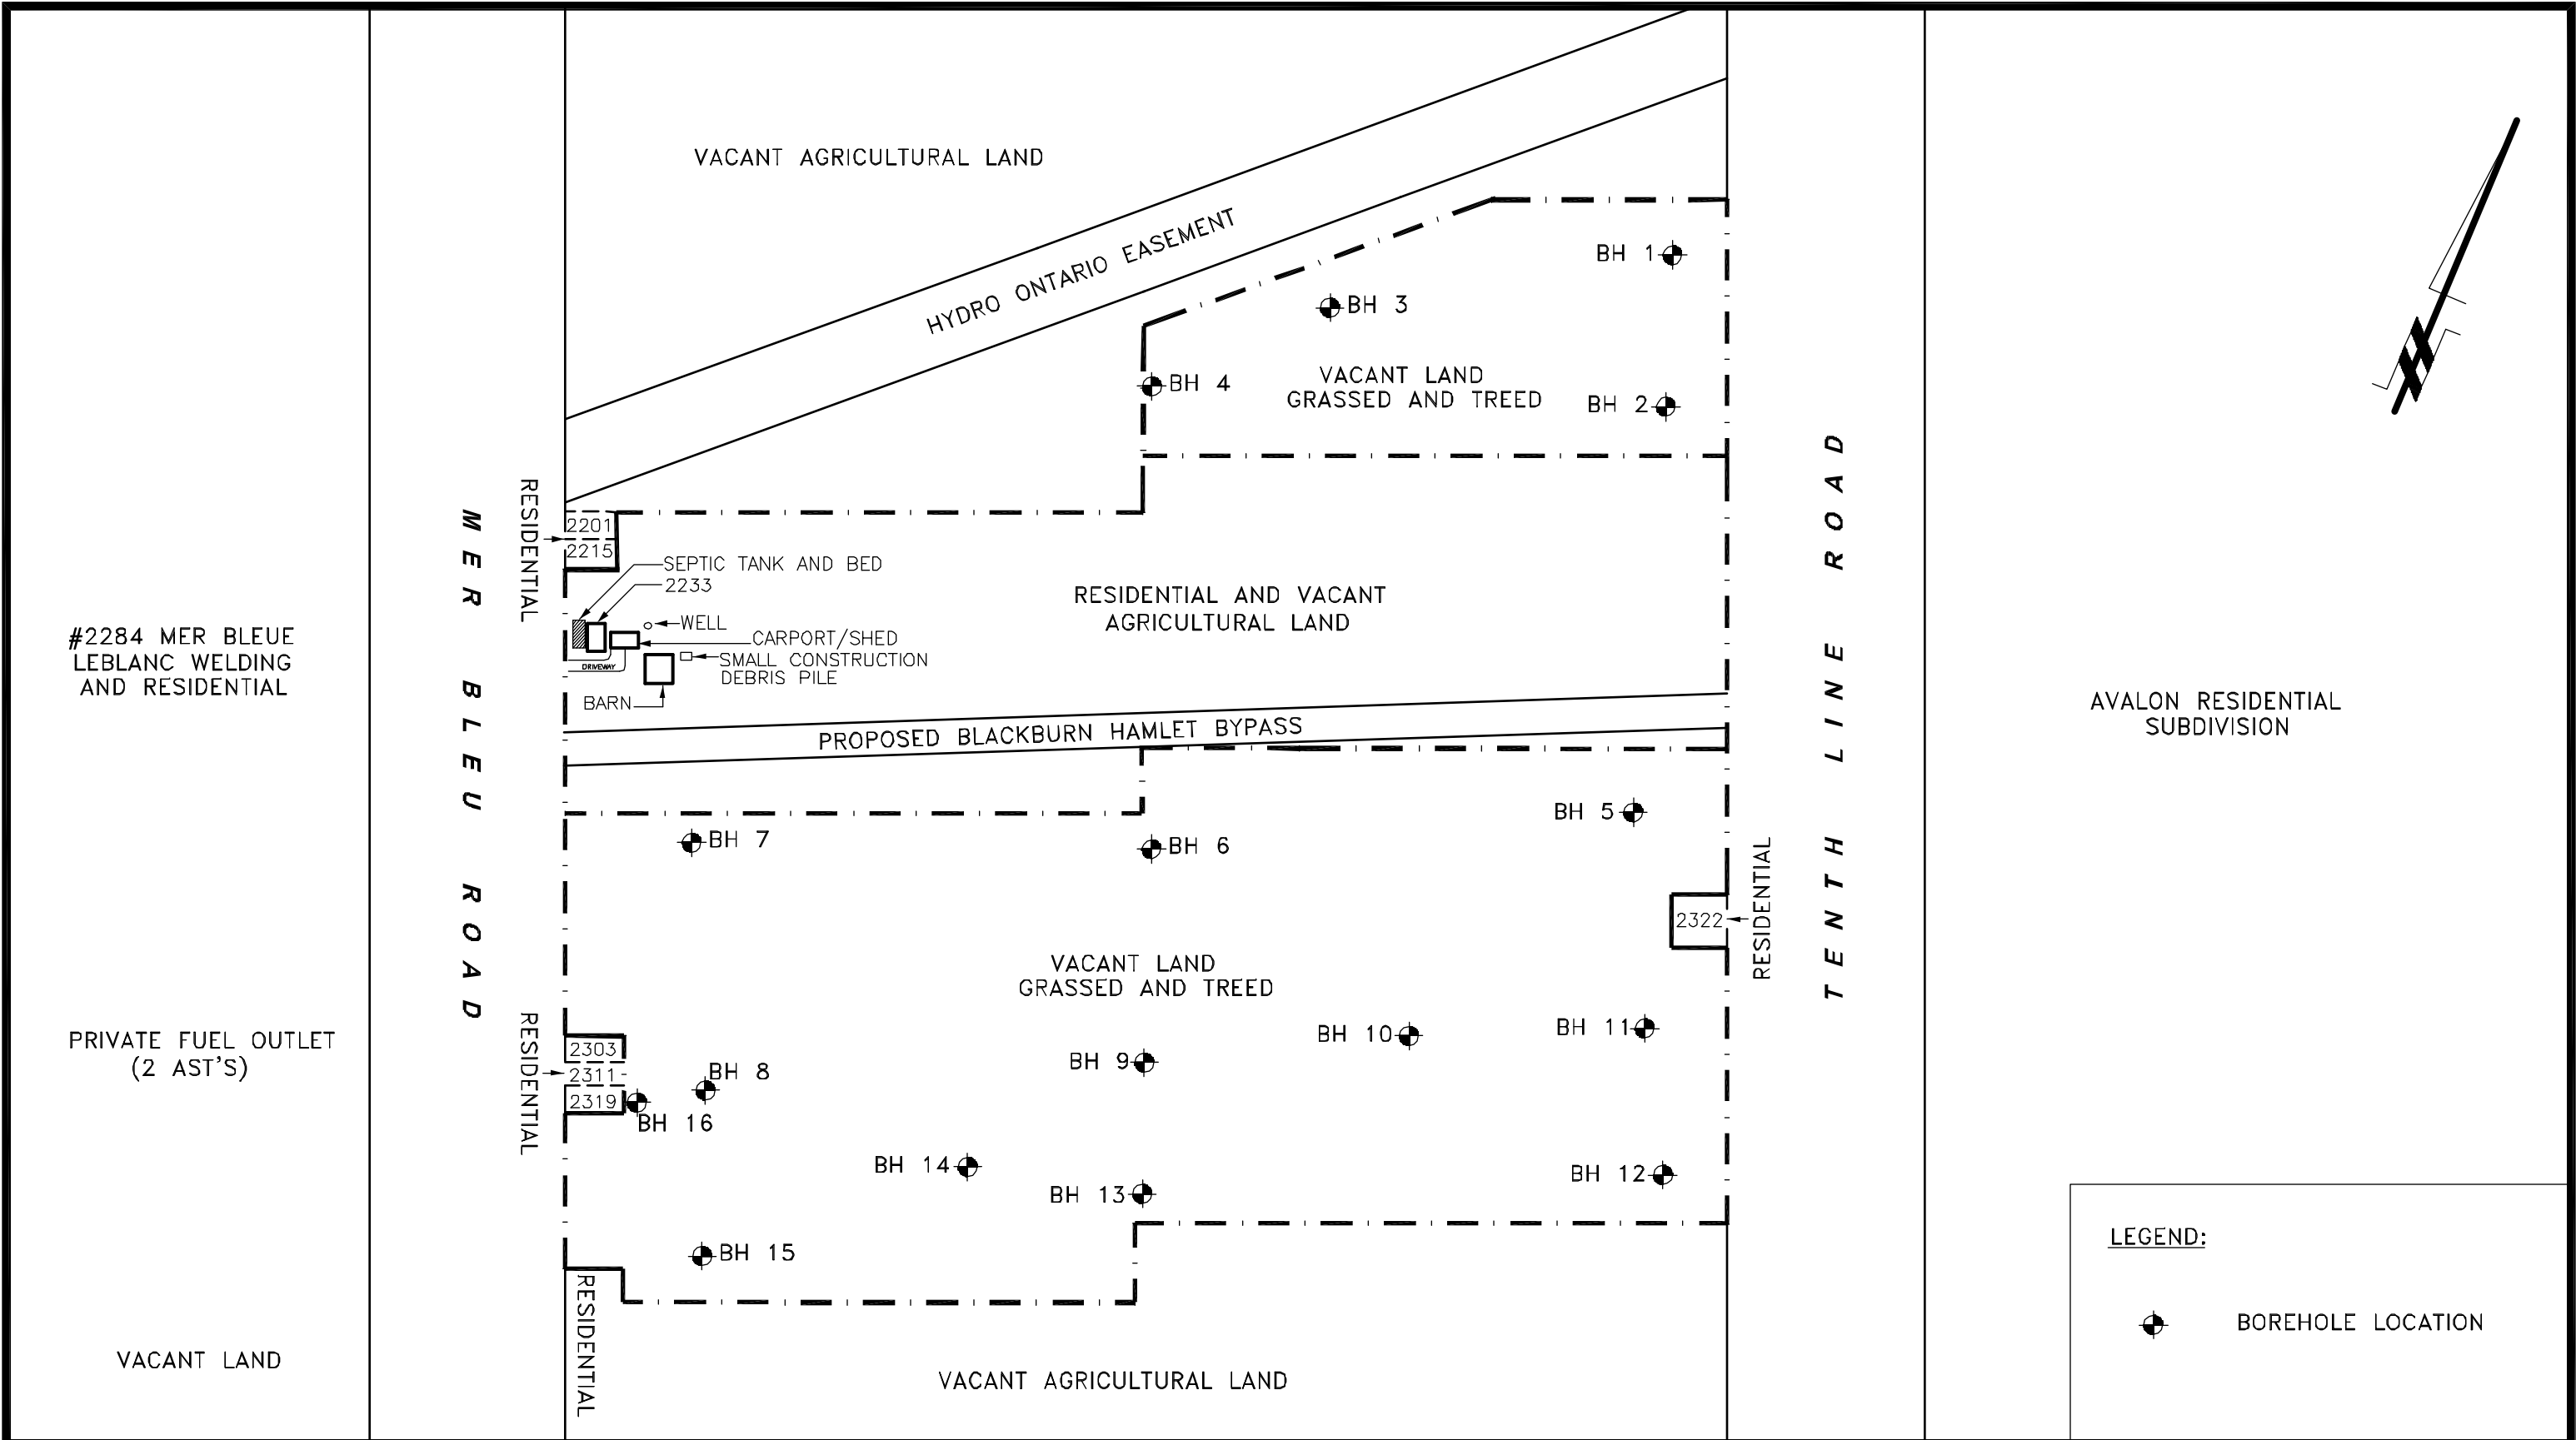
SITE PLAN

The remaining adjacent properties are not considered to have had an environmental impact on the subject site. Land use adjacent to the subject site is illustrated on Drawing No. PE0644-1 - Site Plan in the Appendix.
