May 8, 2018

Re: Post-construction Tree Conservation Report – Kanata Lakes Plaza

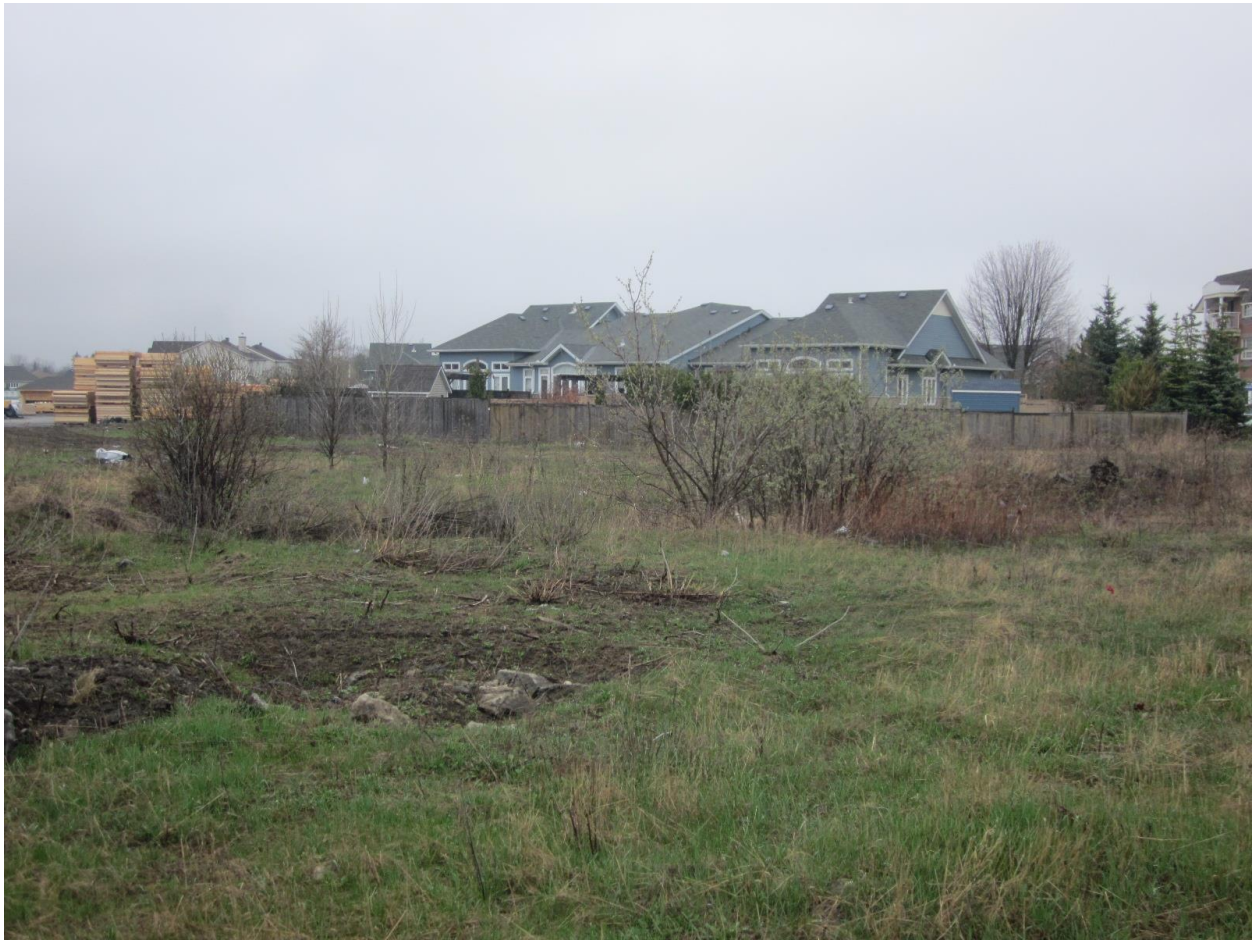
Upon arrival at the site it is quickly obvious the site was cleared of vegetation some time ago as the site is now fully under construction. An inspection of the site found no trees over 10cm in diameter still remaining. In fact, the only vestiges of the pre-clearing vegetation are root sprouts from previously removed trees. However, even these are under the 10cm diameter threshold for tree conservation reports.

Picture 1. Regenerating vegetation, including root sprouts, present on the subject property.

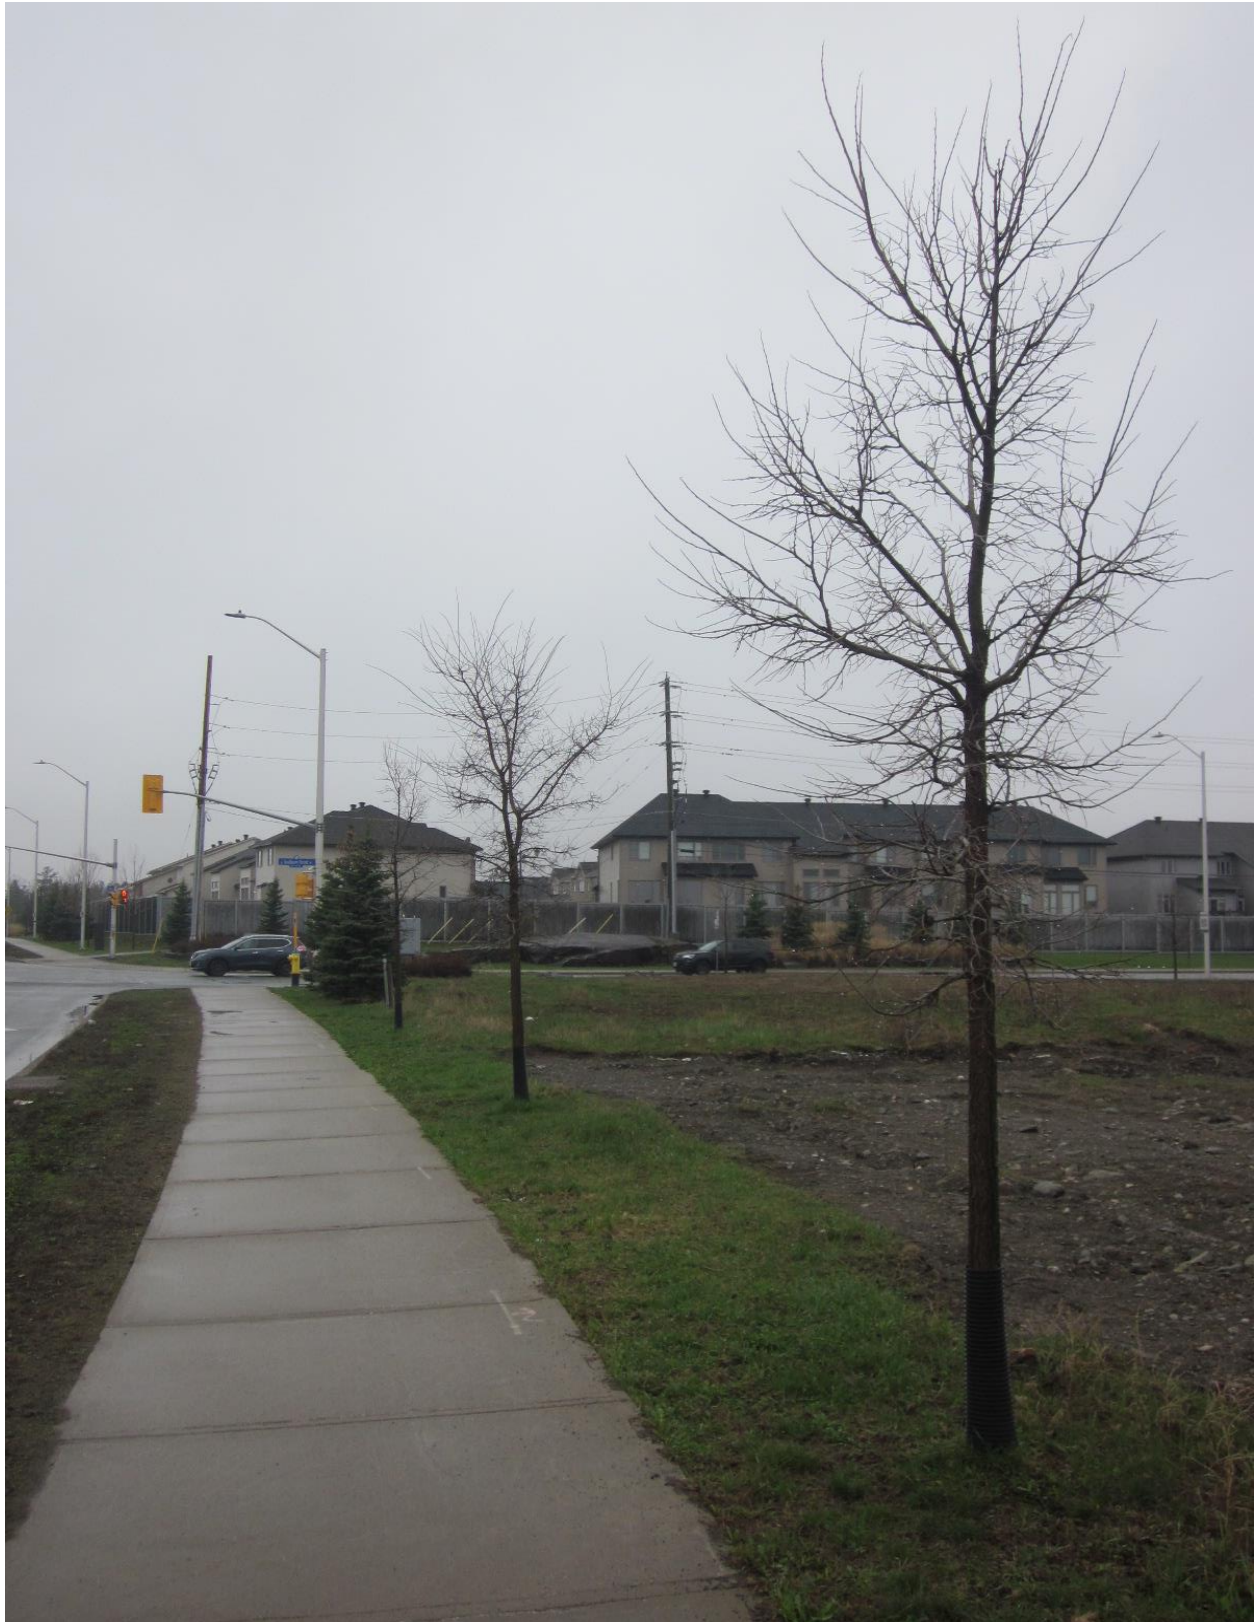
As shown in Pictures 1 and 2 on page 2 and 3, existing trees are now restricted to city lands adjacent to the subject property. A total of seven hackberry (*Celtis occidentalis*), six Colorado spruce (*Picea pungens*) and three red maple (*Acer rubrum*) varieties were found on city lands adjacent to Kanata Avenue and Goulbourn Forced Road. The deciduous trees range in diameter from 70-80mm, while the spruce are an average of 4m in height. All of these trees except for one spruce are in good condition.

Picture 2. Hackberry and Colorado spruce on city land along Kanata Avenue adjacent to the subject property.

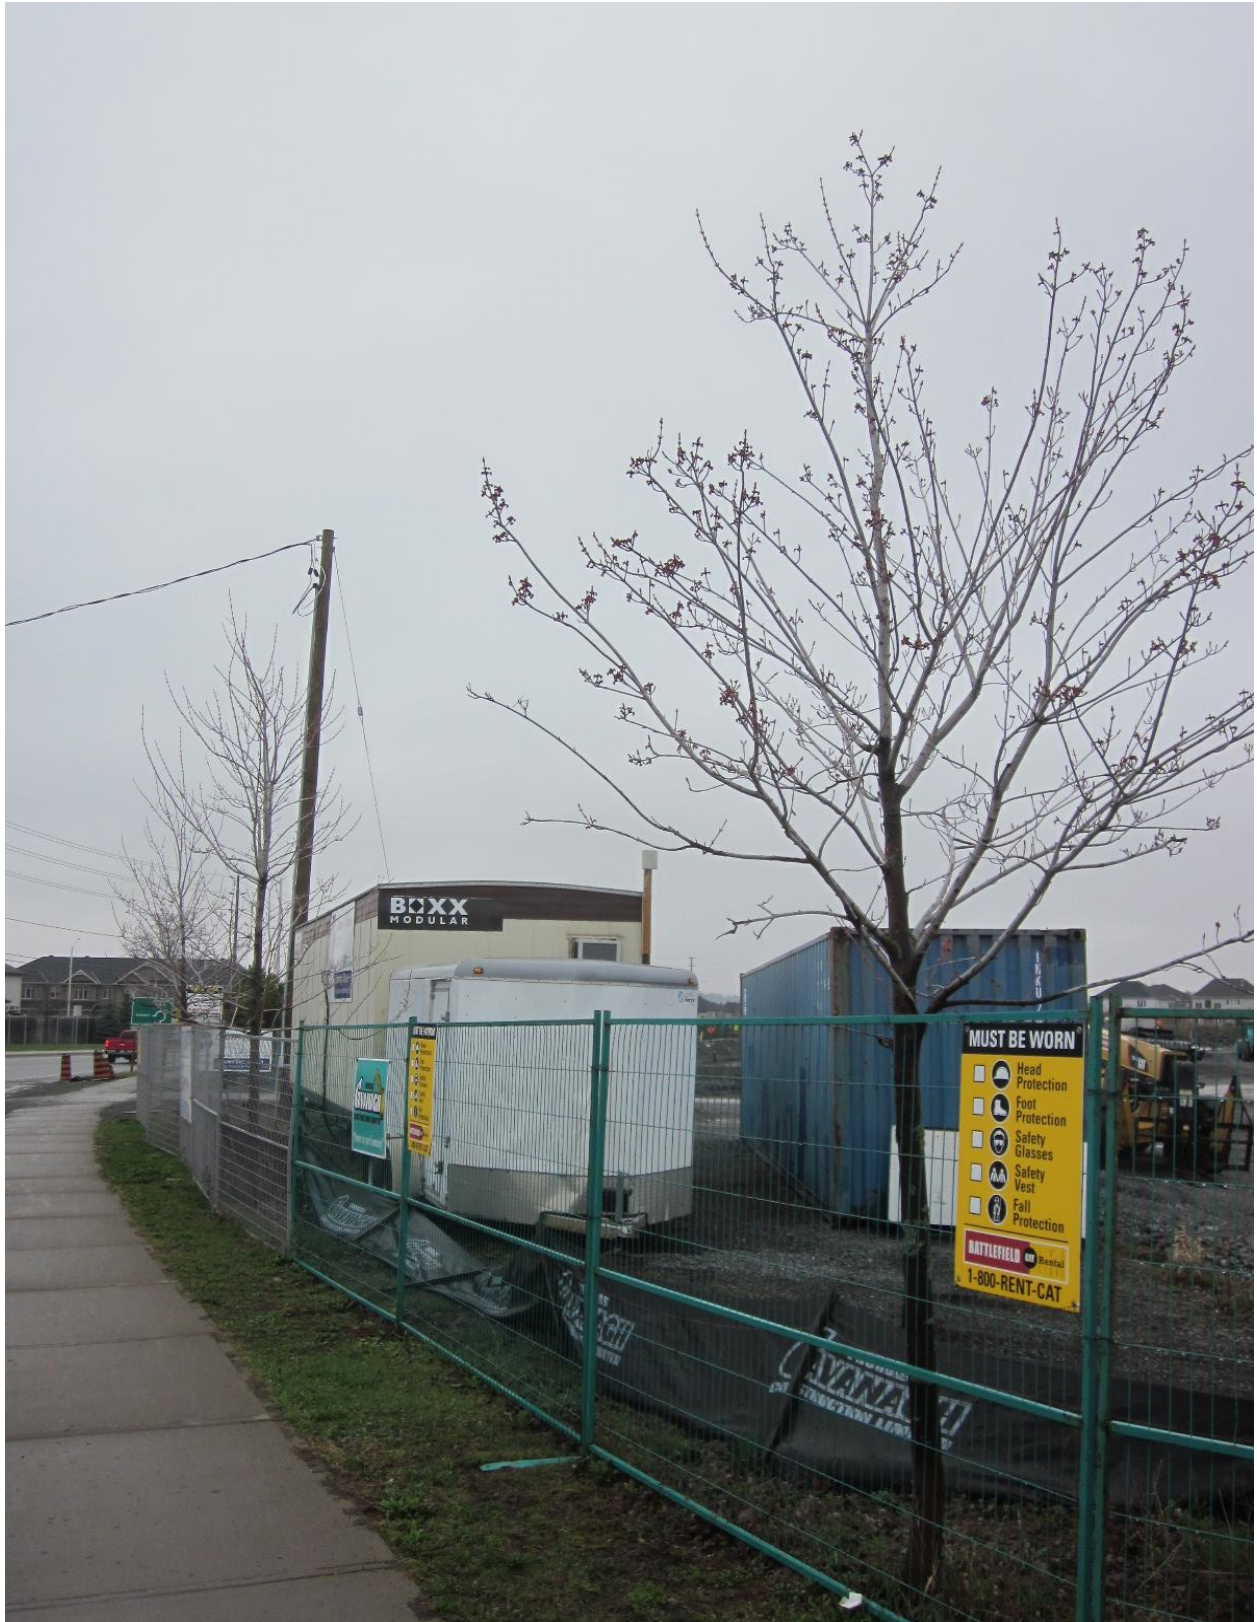
Picture 3. Red maple varieties on city land along Goulbourn Forced Road adjacent to the subject property.
