Urban Forestry & Forest Management Consulting

December 5, 2017

**RE: TREE CONSERVATION REPORT – 541-545 RIDEAU STREET, OTTAWA**

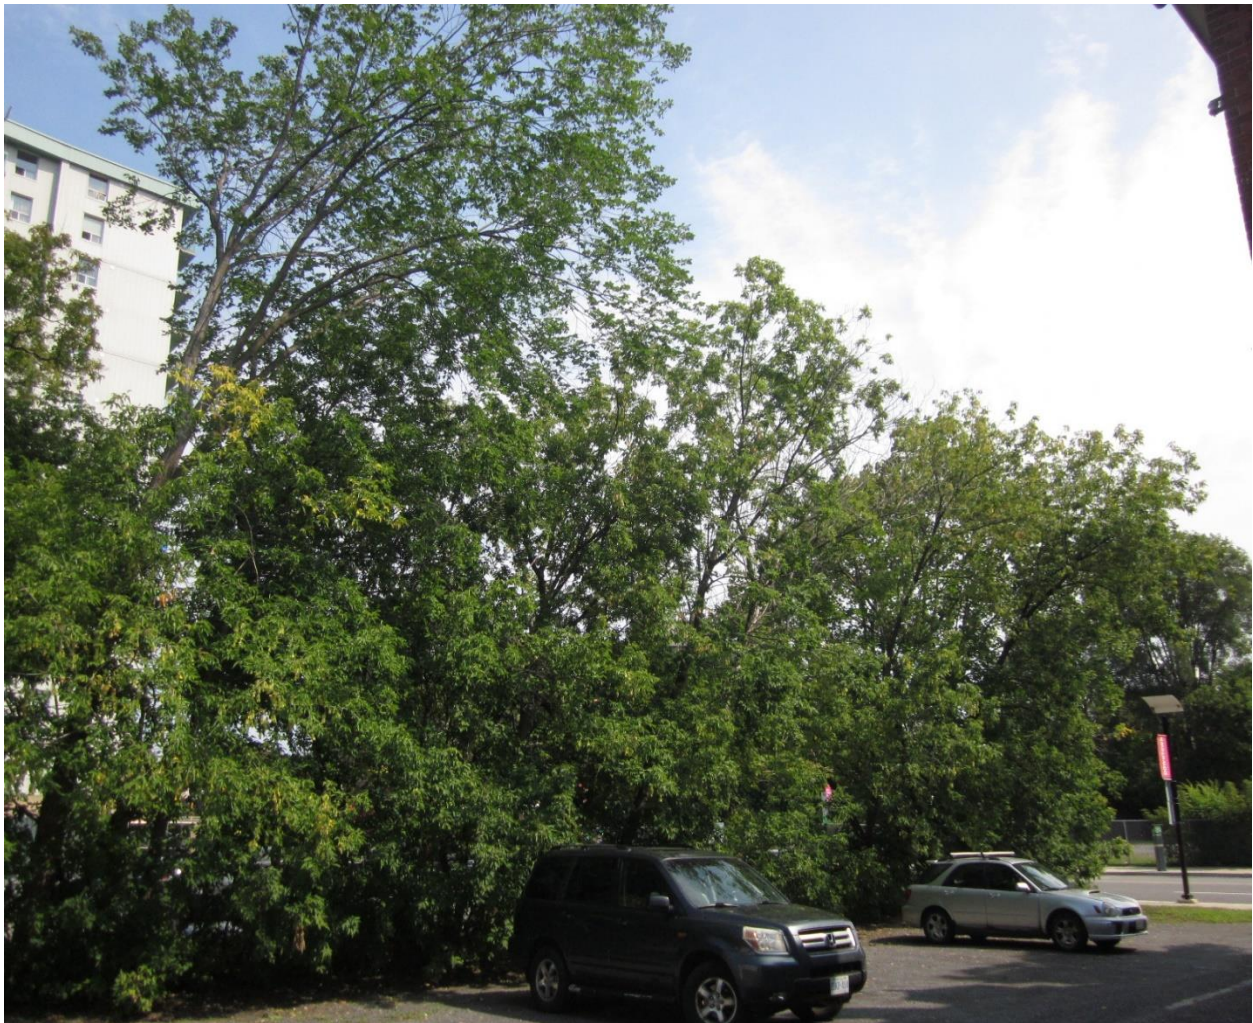
Picture 1. Trees present within grouping #1 at 541-545 Rideau Street, Ottawa

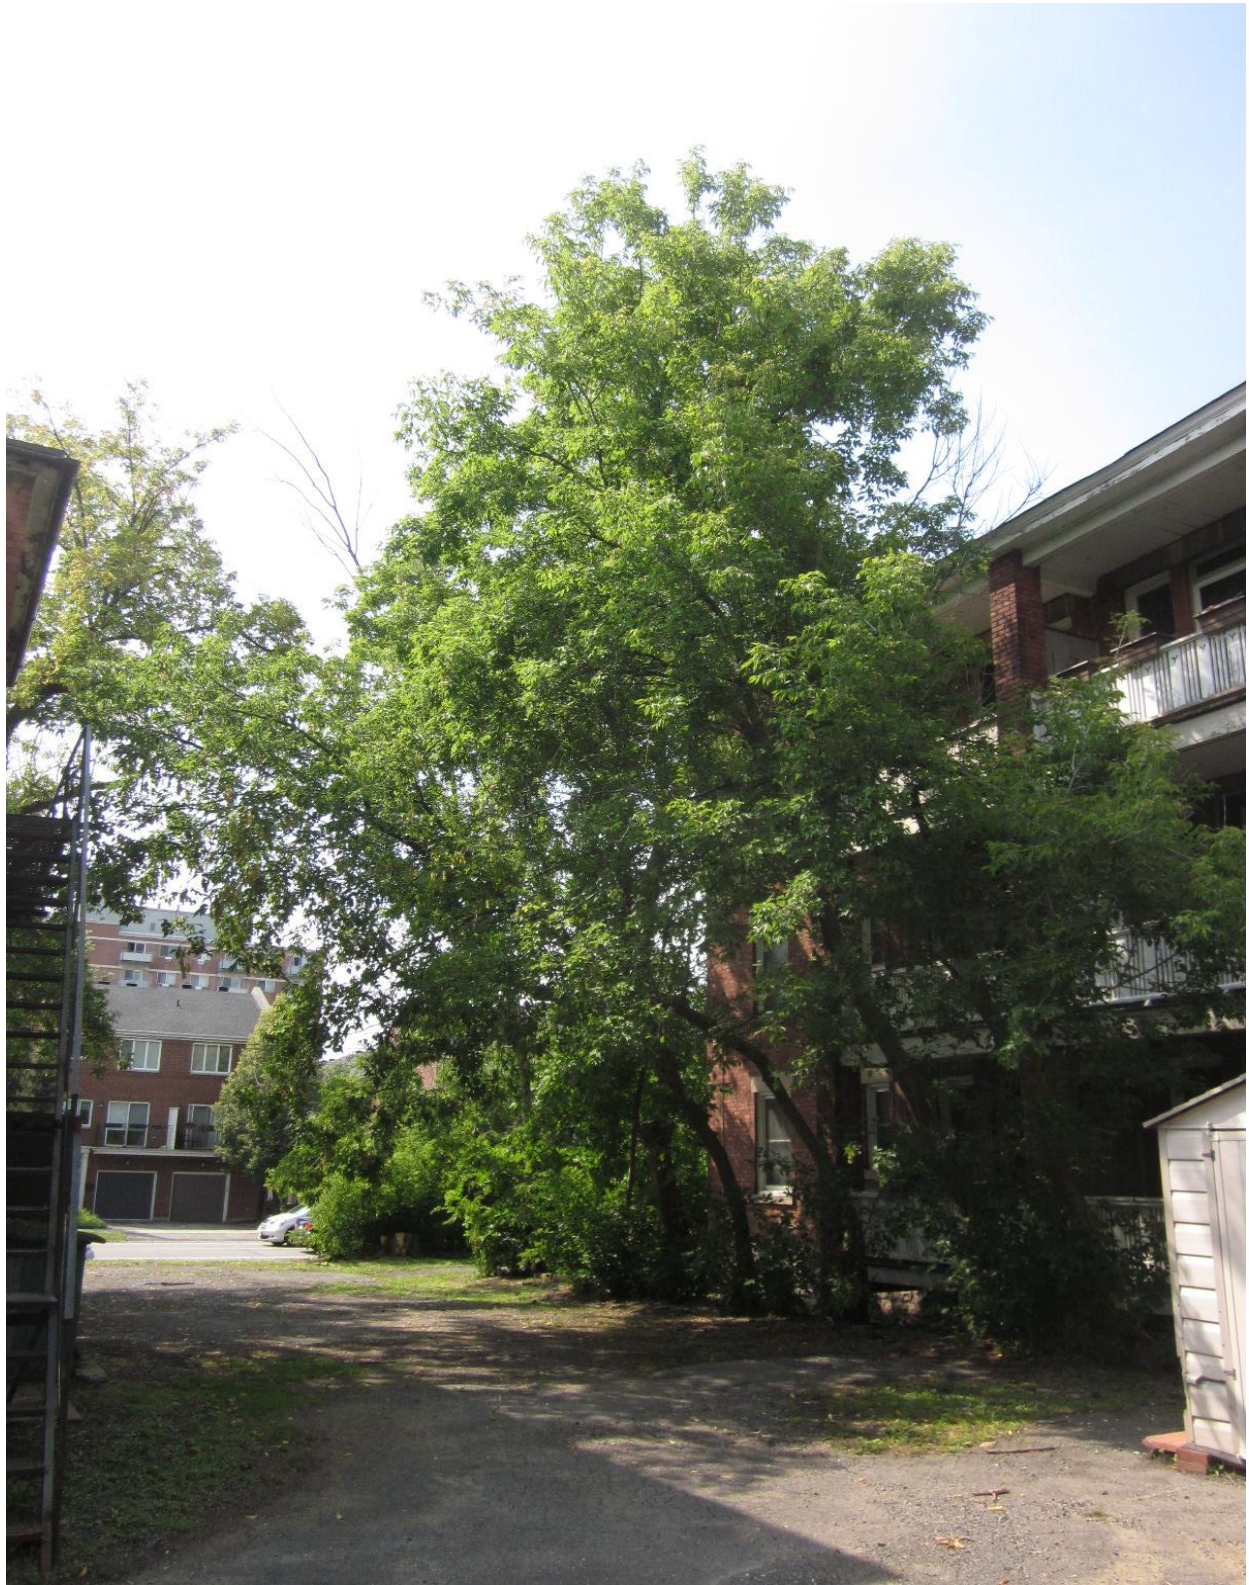
Picture 2. Trees present within grouping #2 at 541-545 Rideau Street, Ottawa (note divergent growth forms).

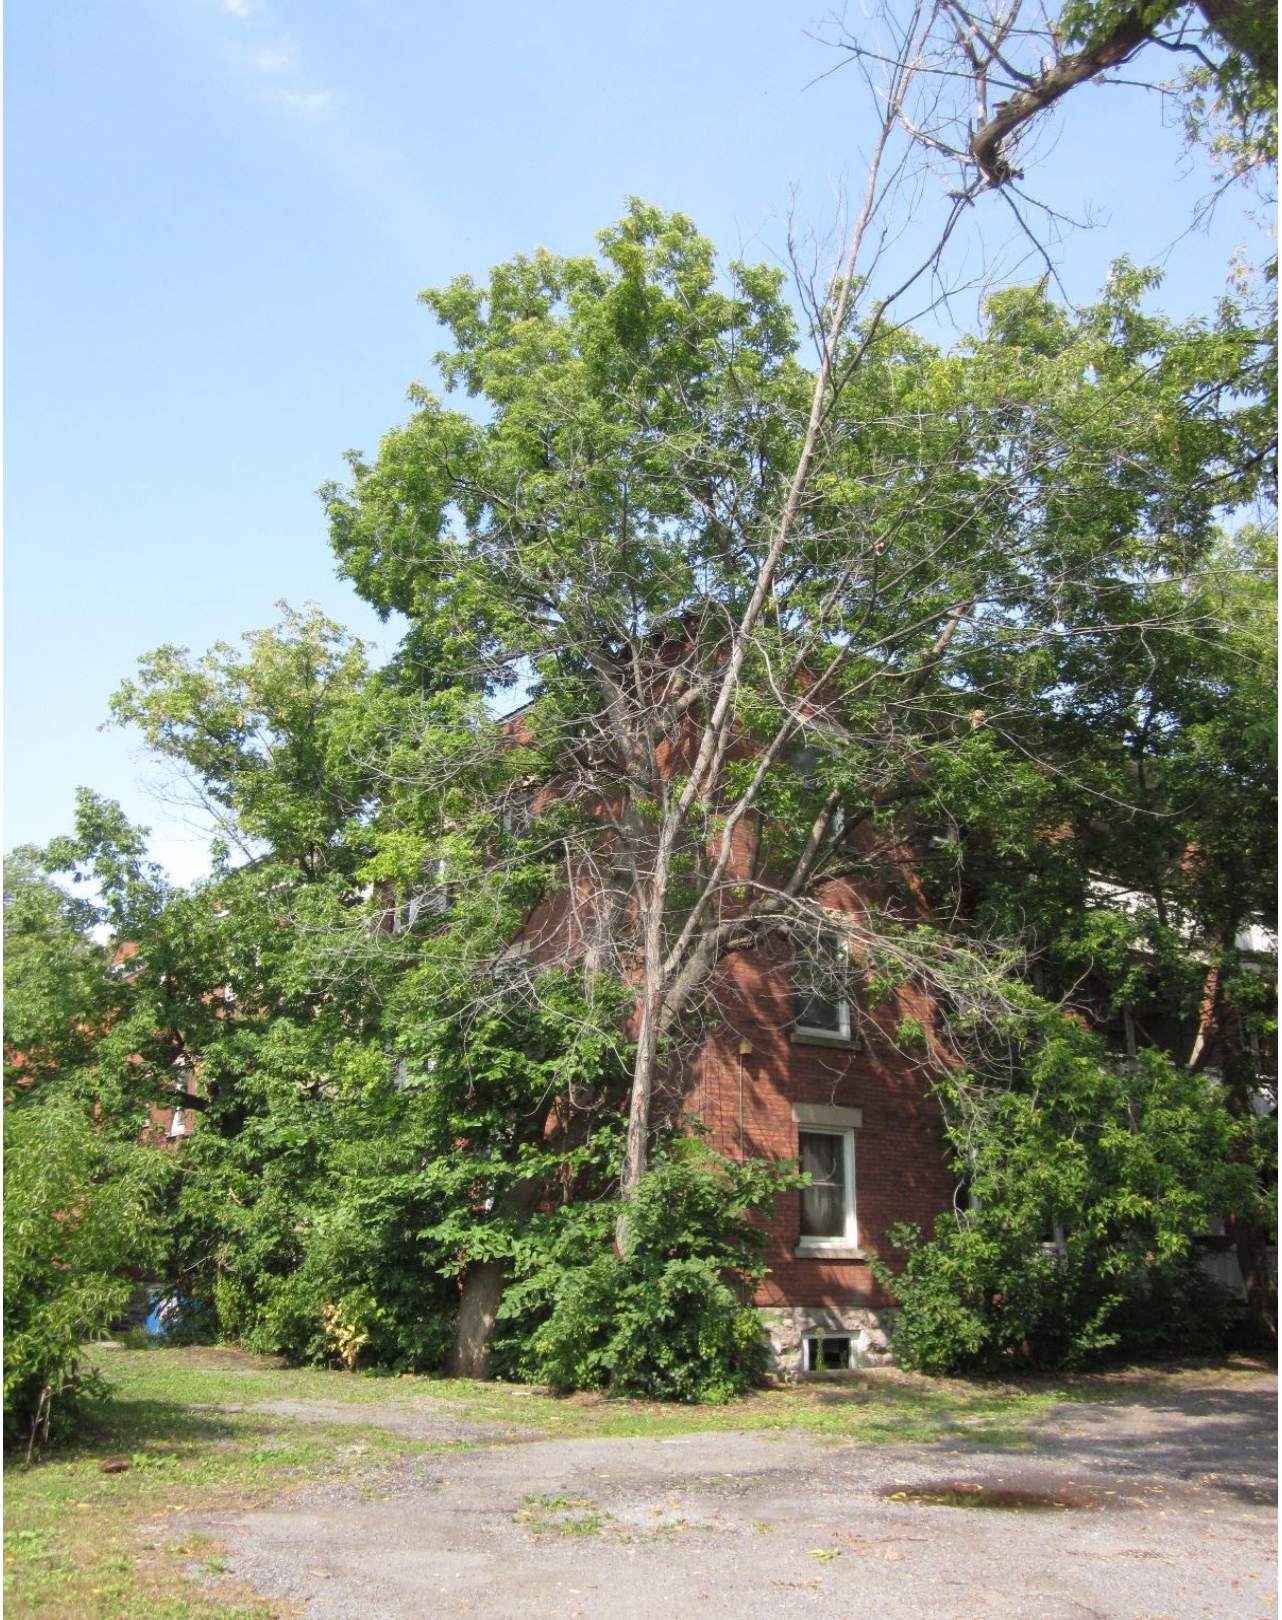
Picture 3. Dead elm within grouping #2 at 541-545 Rideau Street, Ottawa

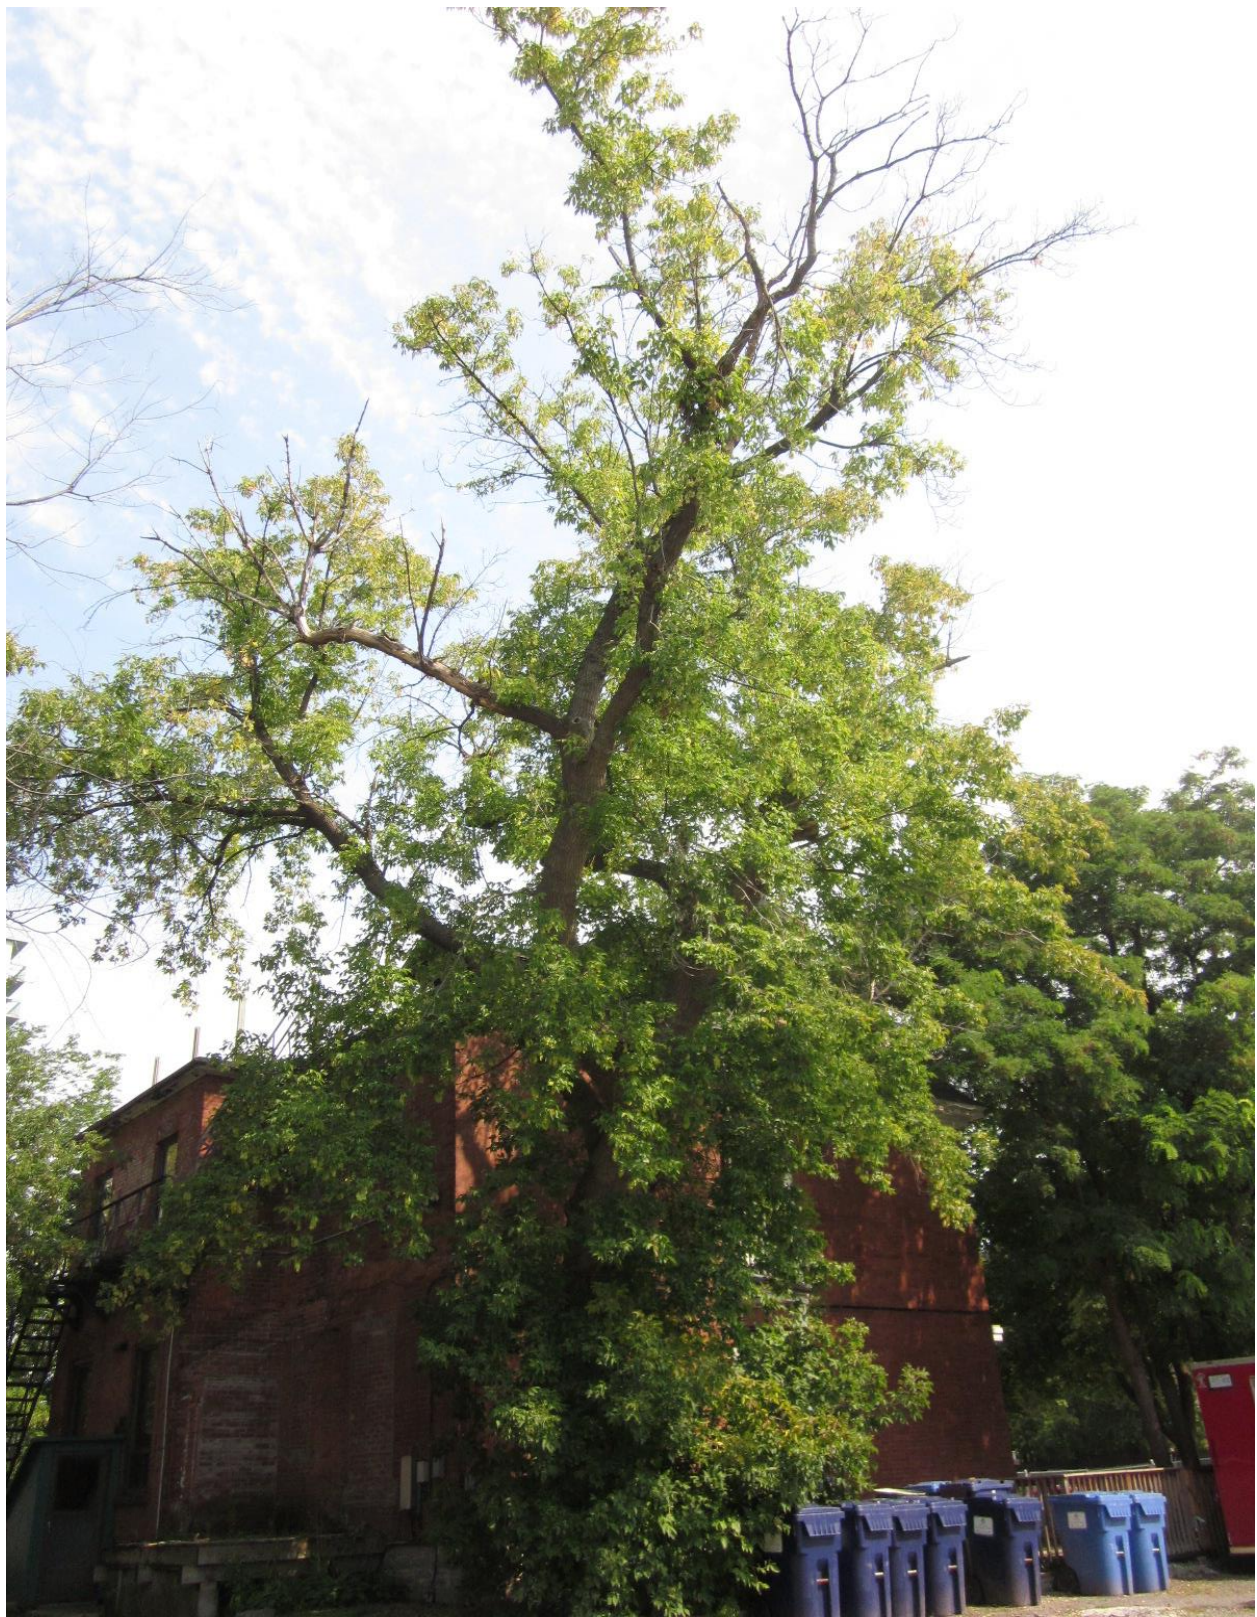
Picture 4. Manitoba maple #6 at 541-545 Rideau Street, Ottawa (note dieback in upper crown).

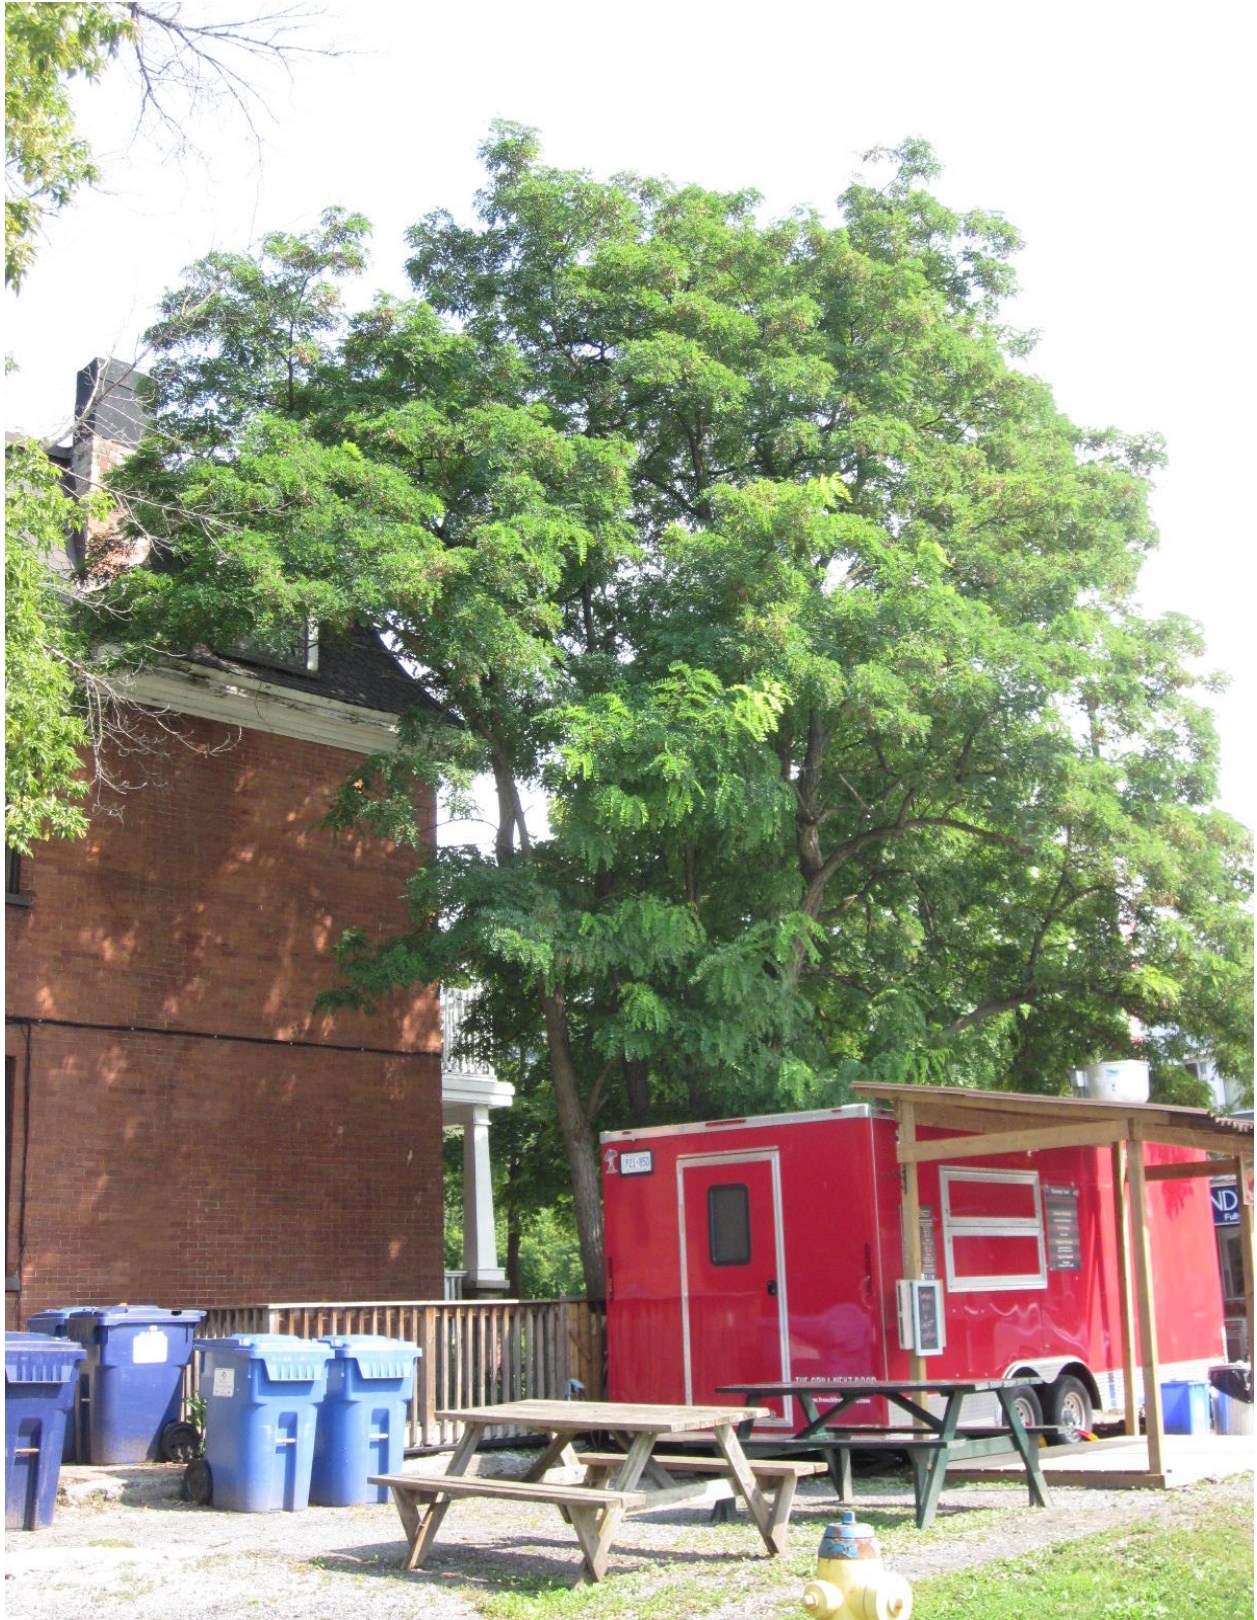
9	Black locust ( <i>Robinia pseudoacacia</i> )	Fair	21-34cm	Grouping of 5 maturing trees; privately owned; 2 single trees and 1 tri-stemmed from grade; likely originated from root sprouts; undesirable, naturalized species; <b>to be removed</b>

Picture 5. Black locust trees within grouping #9 at 541-545 Rideau Street, Ottawa

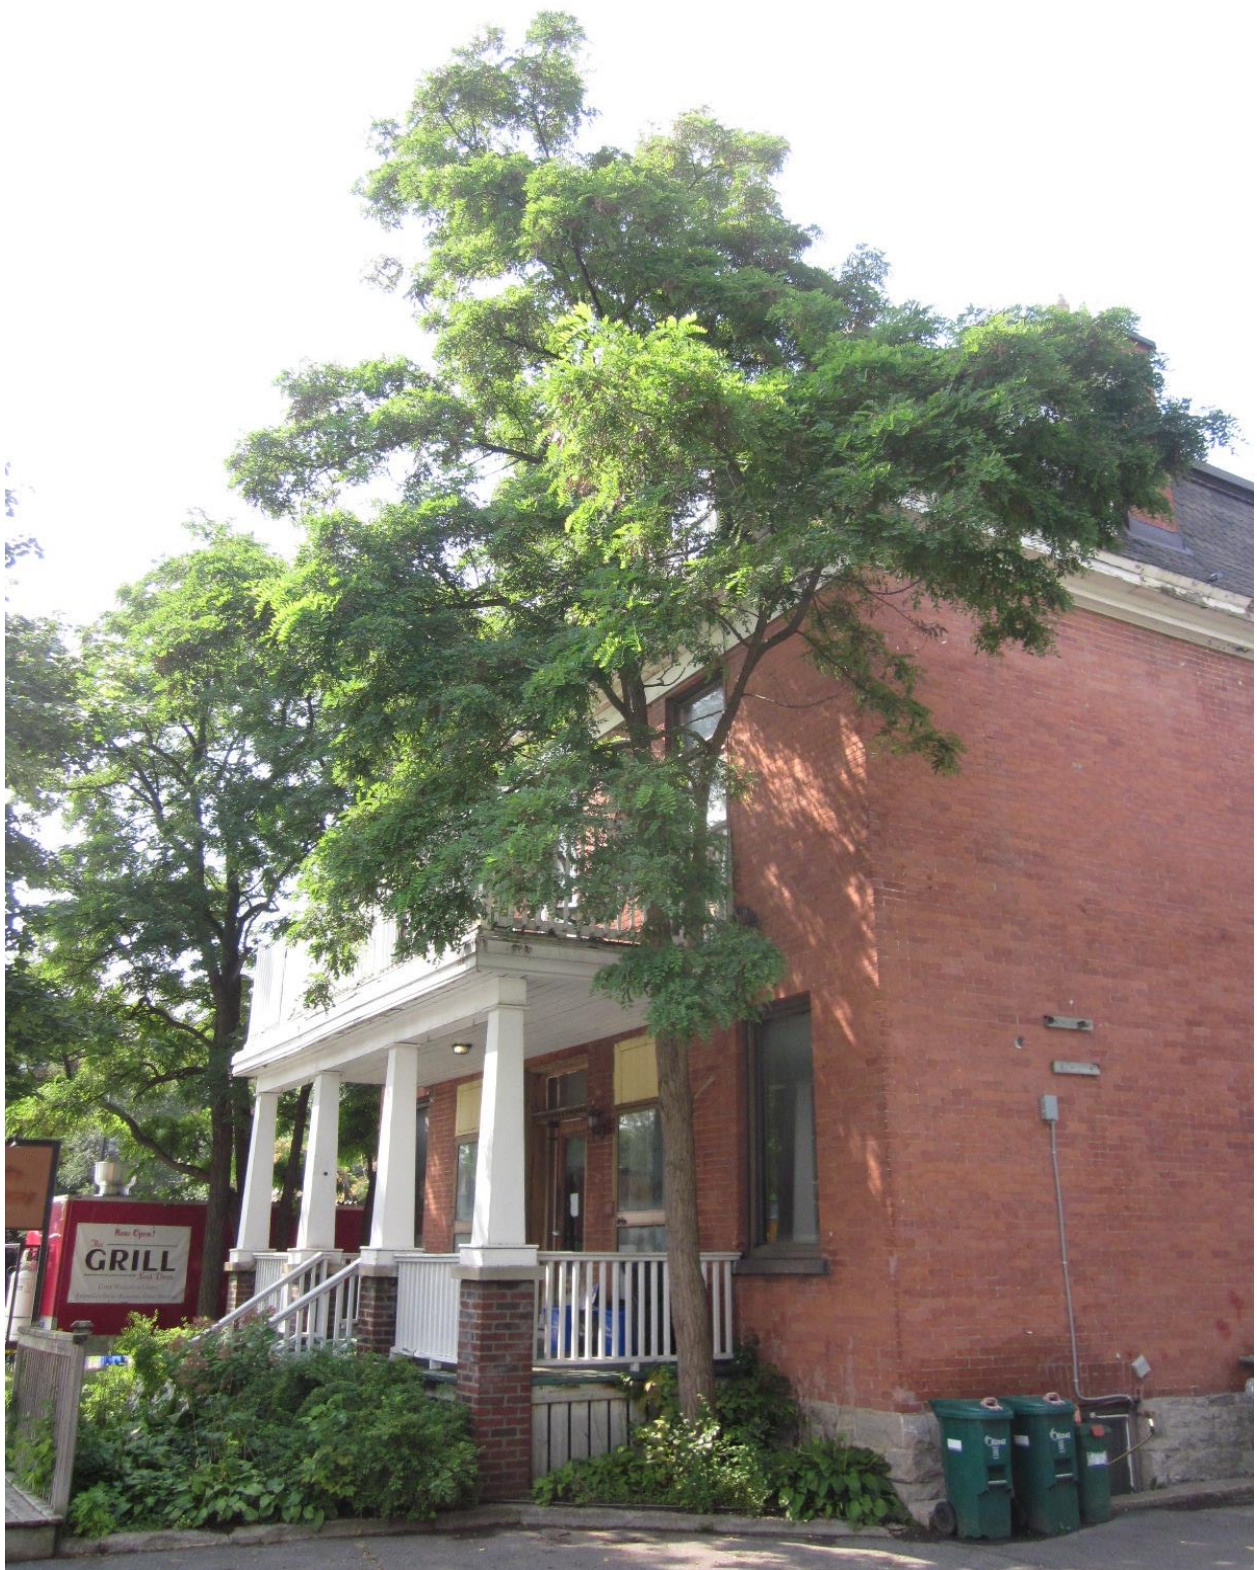
Picture 6. Black locust tree #12 at 541-545 Rideau Street, Ottawa
