July 23, 2018

RE: TREE RETENTION ANALYSIS – 419/423 McLEOD STREET, OTTAWA

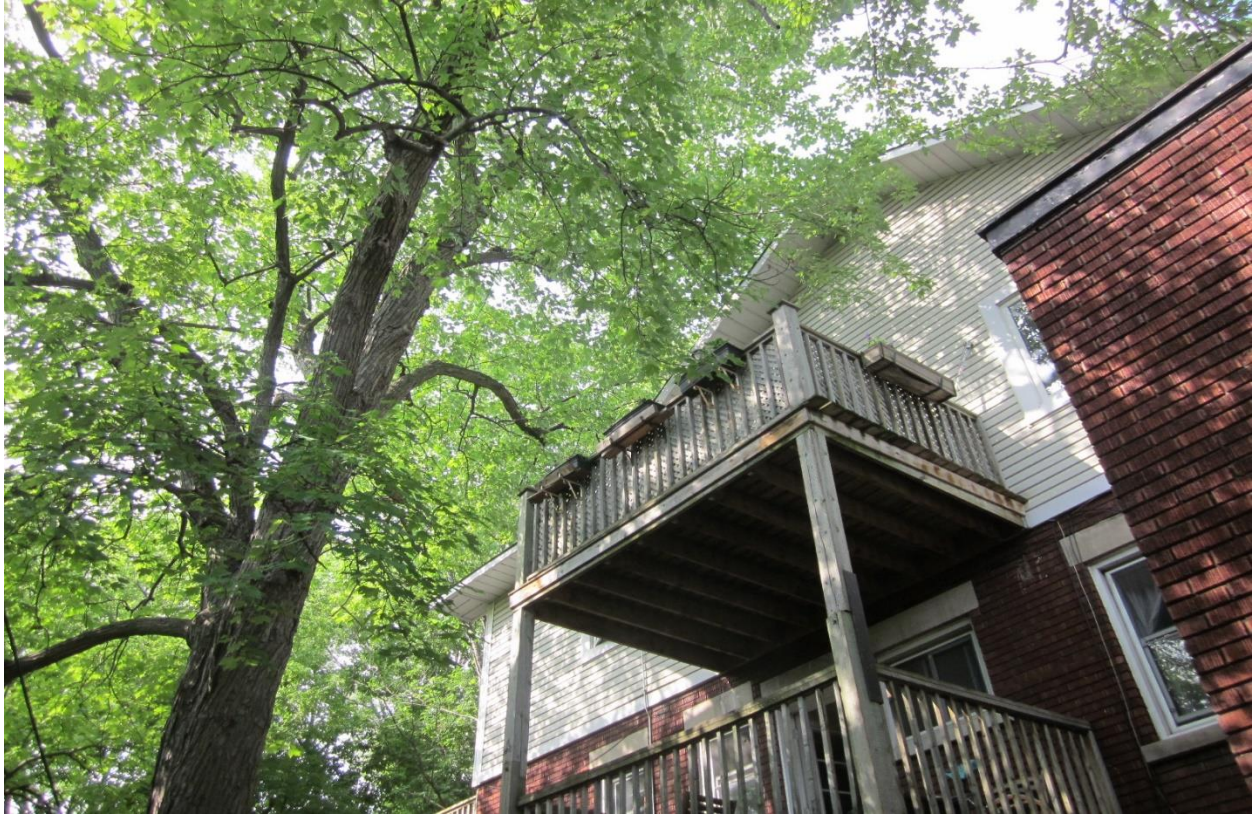
The diameter at breast height of the tree is 83.9cm. Co-dominant stems arise at approximately 2.5m from grade orientated north-northwest/south-southeast. The living crown is held above three stories on the northeast side (*i.e.* over 419 McLeod St) and at two stories on the southwest over 423 McLeod St (please see Pictures 1 and 2 on page 3). The co-dominant stems share an acutely-angled union with upright stems holding approximately equal amount of the tree's crown. One thing found missing from the tree is a pronounced root collar. The root collar of a tree is the point at which the larger structural (or 'heart') roots meet the tree's lower stem, or bole. When present the root collar of a tree is typically characterized by a series of flares at its base. Flares generally reflect the number, size and general direction of the major supporting roots. In this instance the general lack of visible flares was very obvious (please see Pictures 3 and 4 on page 4). This is most likely due to the growth of major structural roots being suppressed over the years by the adjacent asphalt laneway. While not a definitive analysis by any means, this initial thought could bode well for the future of the tree as a lack of wide-reaching structural roots would avoid some conflict with the nearby excavation for the proposed new building. The loss of structural roots is always a concern as there are two separate but related impacts: 1) in severe cases potentially compromising the tree's stability and, 2) separating the tree from the distal absorbing root hairs through which it draws sustenance.

Picture 1. Crown of red maple over three-storey roof of 419 McLeod Street.

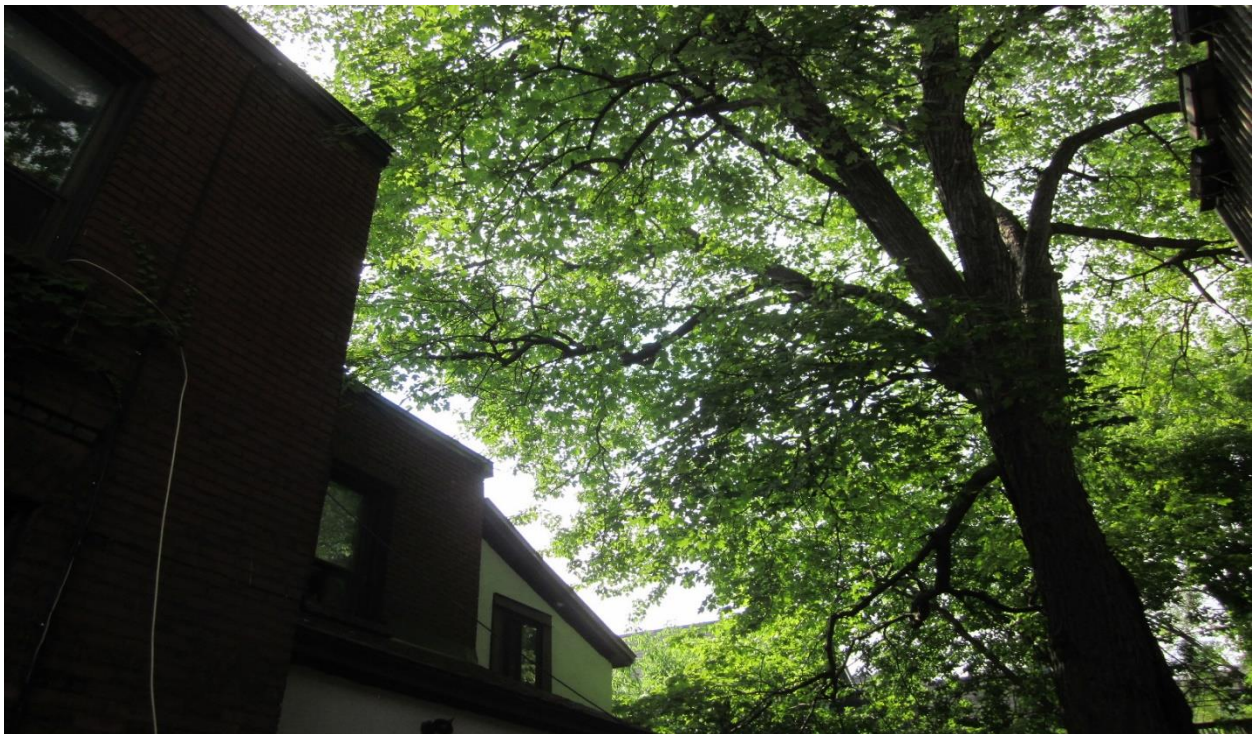
Picture 2. Crown of red maple over two-storey roof of 423 McLeod Street.

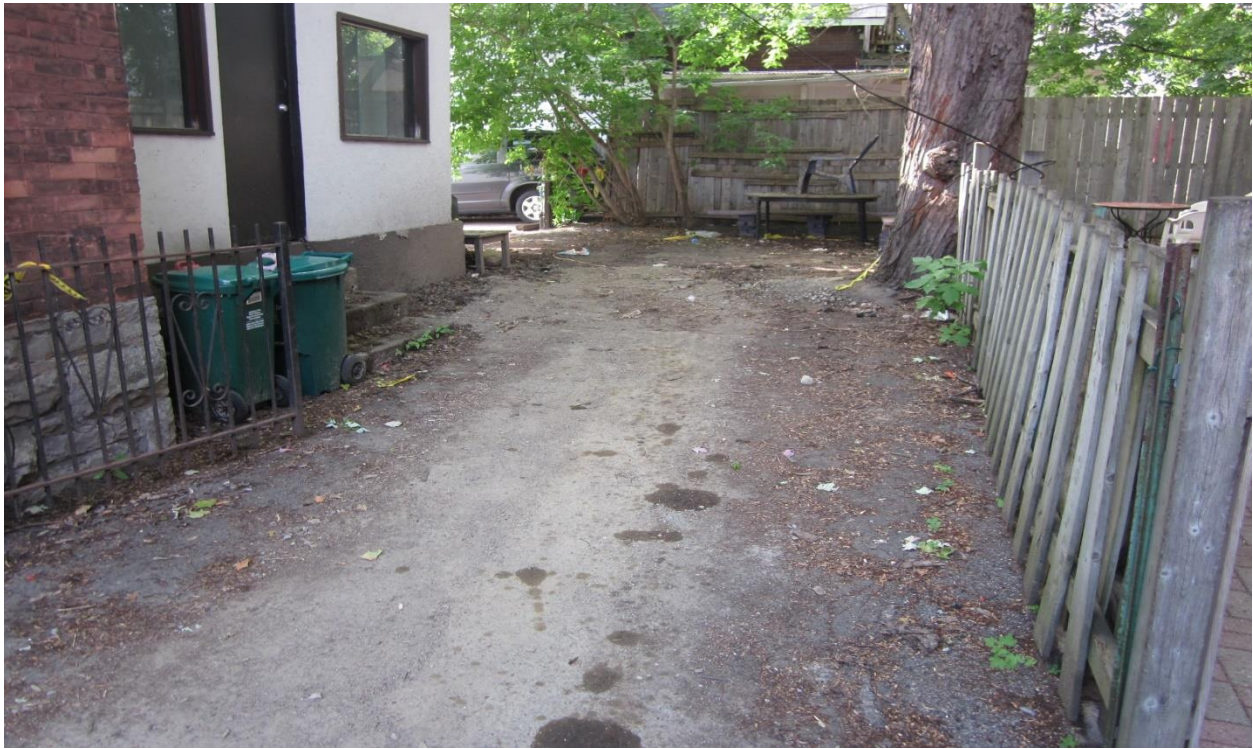
The foundation of the one-storey addition at the rear 423 McLeod St. sits 3.9m away from the centre of tree. Behind and extending further from the one-story addition is a two-storey addition which sits 5.6m from the tree. A paved laneway runs beside 423 McLeod St. and the tree, with asphalt right from the edge of the foundation to the base of the tree.

Picture 3. Paved laneway between red maple and 423 McLeod Street.

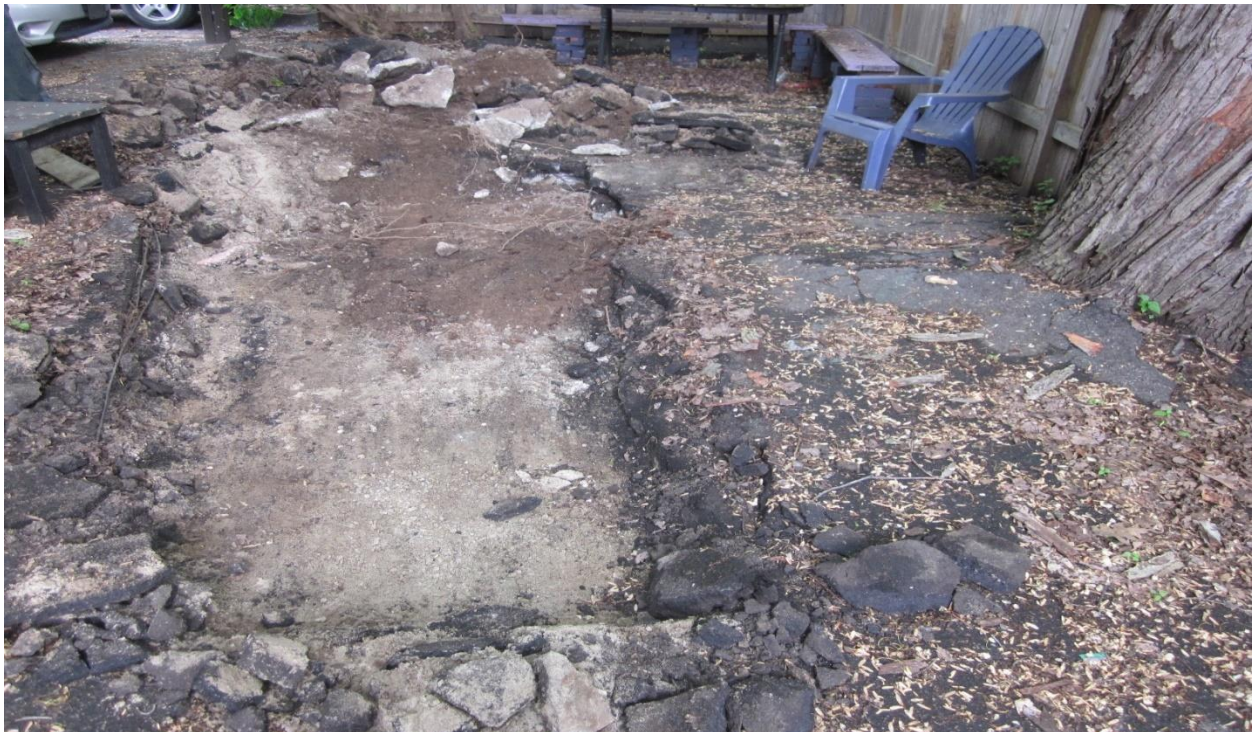
The latest proposed 3m setback of the building from the tree came as a result of a root investigation, the intent of which was to determine the exact morphological characteristics of the tree's roots under asphalt. After removing several layers of asphalt the subbase beneath was carefully removed with a combination of high pressure water and high volume vacuum. This service was provided via a Hydrovac truck.

Picture 4. Layers of asphalt removed prior to root investigation of red maple shared between 419 and 423 McLeod Street. Note lack of pronounced flaring at base of tree on right. Also note soil and fine roots directly beneath asphalt layer.

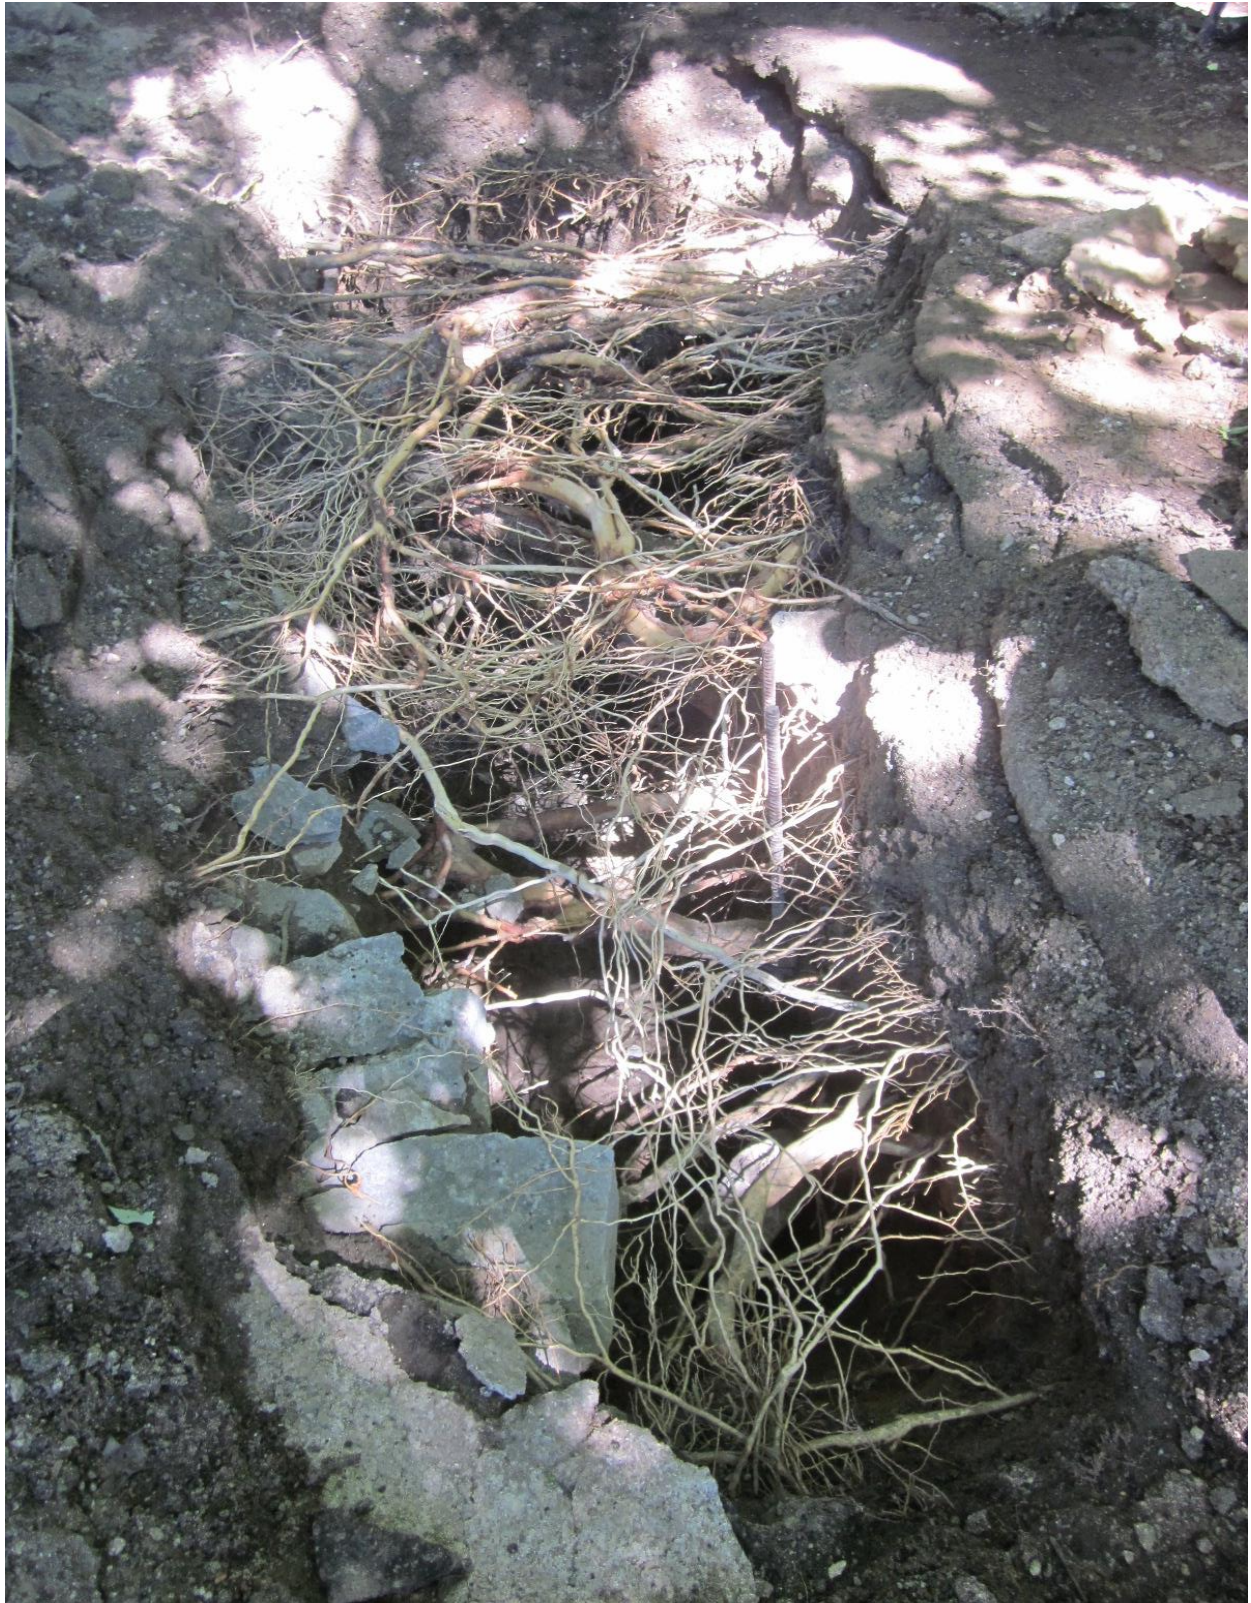
The pattern root growth and development of any species of tree under such an unnatural surface treatment would be impossible to predict. Initially the presence of an impermeable surface layer was predicted to have suppressed all root growth beneath – both structural and absorbing. In fact, the opposite was found to be true – the density and range of root diameters was greater than usually found in close proximity of a mature tree. As the subbase was washed away a dense mat of many different sizes of intertwined roots became apparent. This is likely due to two factors: 1) the lack of a stone subbase beneath the asphalt (instead of the typical compacted bed of gravel it appears the asphalt was laid directly on top of native soil - which from a very basic ribbon test appeared to be a sandy clay loam); 2) root growth was uncommonly high in the soil profile – due to the impervious nature of asphalt all the roots would tend to grow close to the surface in order to capture what the little moisture makes it through. Picture 5 on page 5 shows the results of the root investigation.

Picture 5. Exposed roots of red maple shared between 419 and 423 McLeod Street. Note density of roots and lack of large structural roots.
