Phase One Environmental Site Assessment

5592, 5606 and 5630 Boundary Road and 9460 Mitch Owens
Road
Ottawa, Ontario

February 28, 2019

Pinchin File: 233280.001

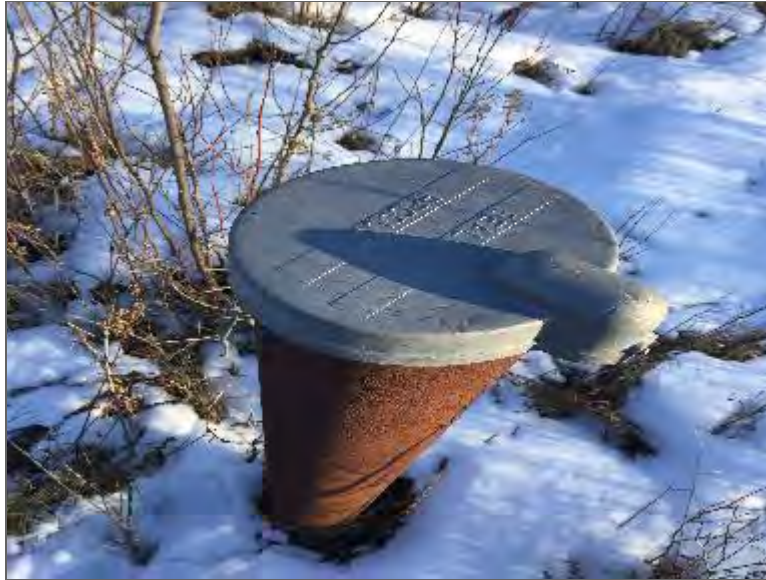
Photo 5 – Drilled water well located on the northeast portion of the Phase One Property.

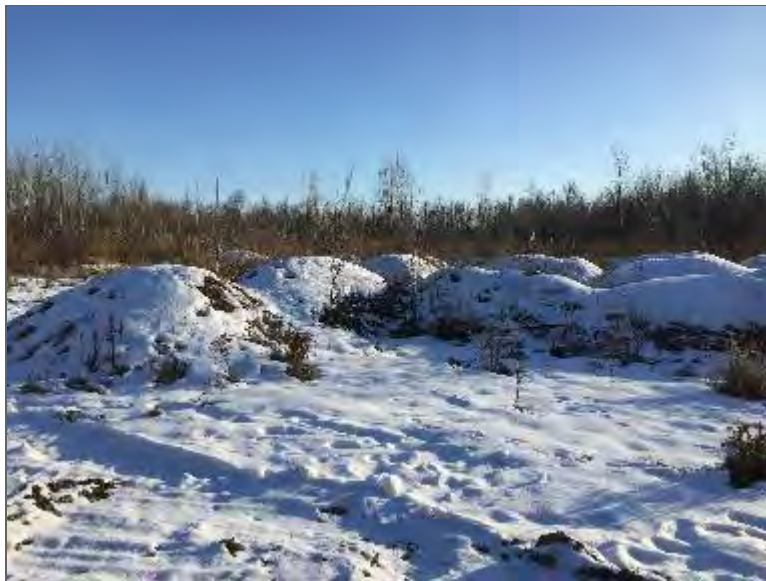
Various stockpiles of fill material, inferred to consist of soil, wood, brick and gravel and be non-deleterious in nature, were observed on the northwest and southeast portions of the Phase One Property. The quality of these fill piles is unknown. As such, these fill piles represent a PCA for the Phase One Property; however, it is Pinchin's opinion that the fill piles can be removed from the Phase One Property during redevelopment activities.

Photo 6 – General view of fill piles observed on the northwest portion of the Phase One Property.

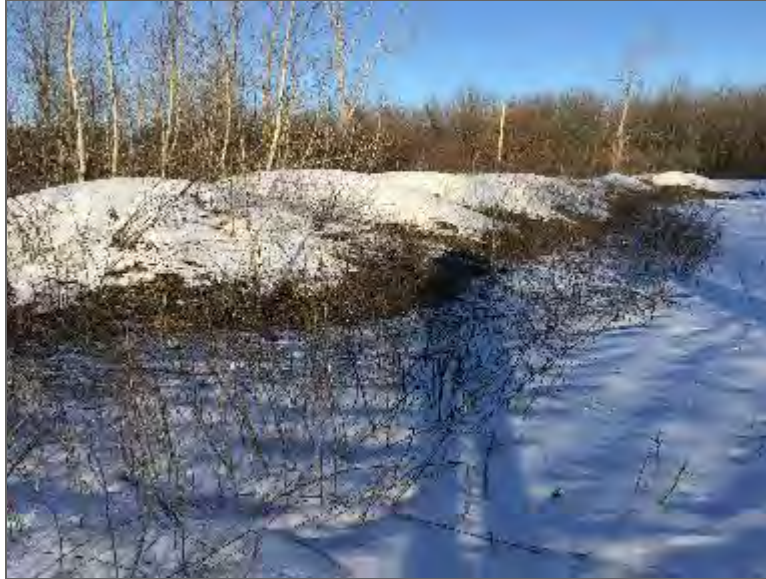
Photo 7 – General view of the fill piles observed on the southeast portion of the Phase One Property.
