April 25, 2019

Version 2.0
Matrix 27873-504

Subject: 762 March Road – Shirley's Brook Meander Belt Width

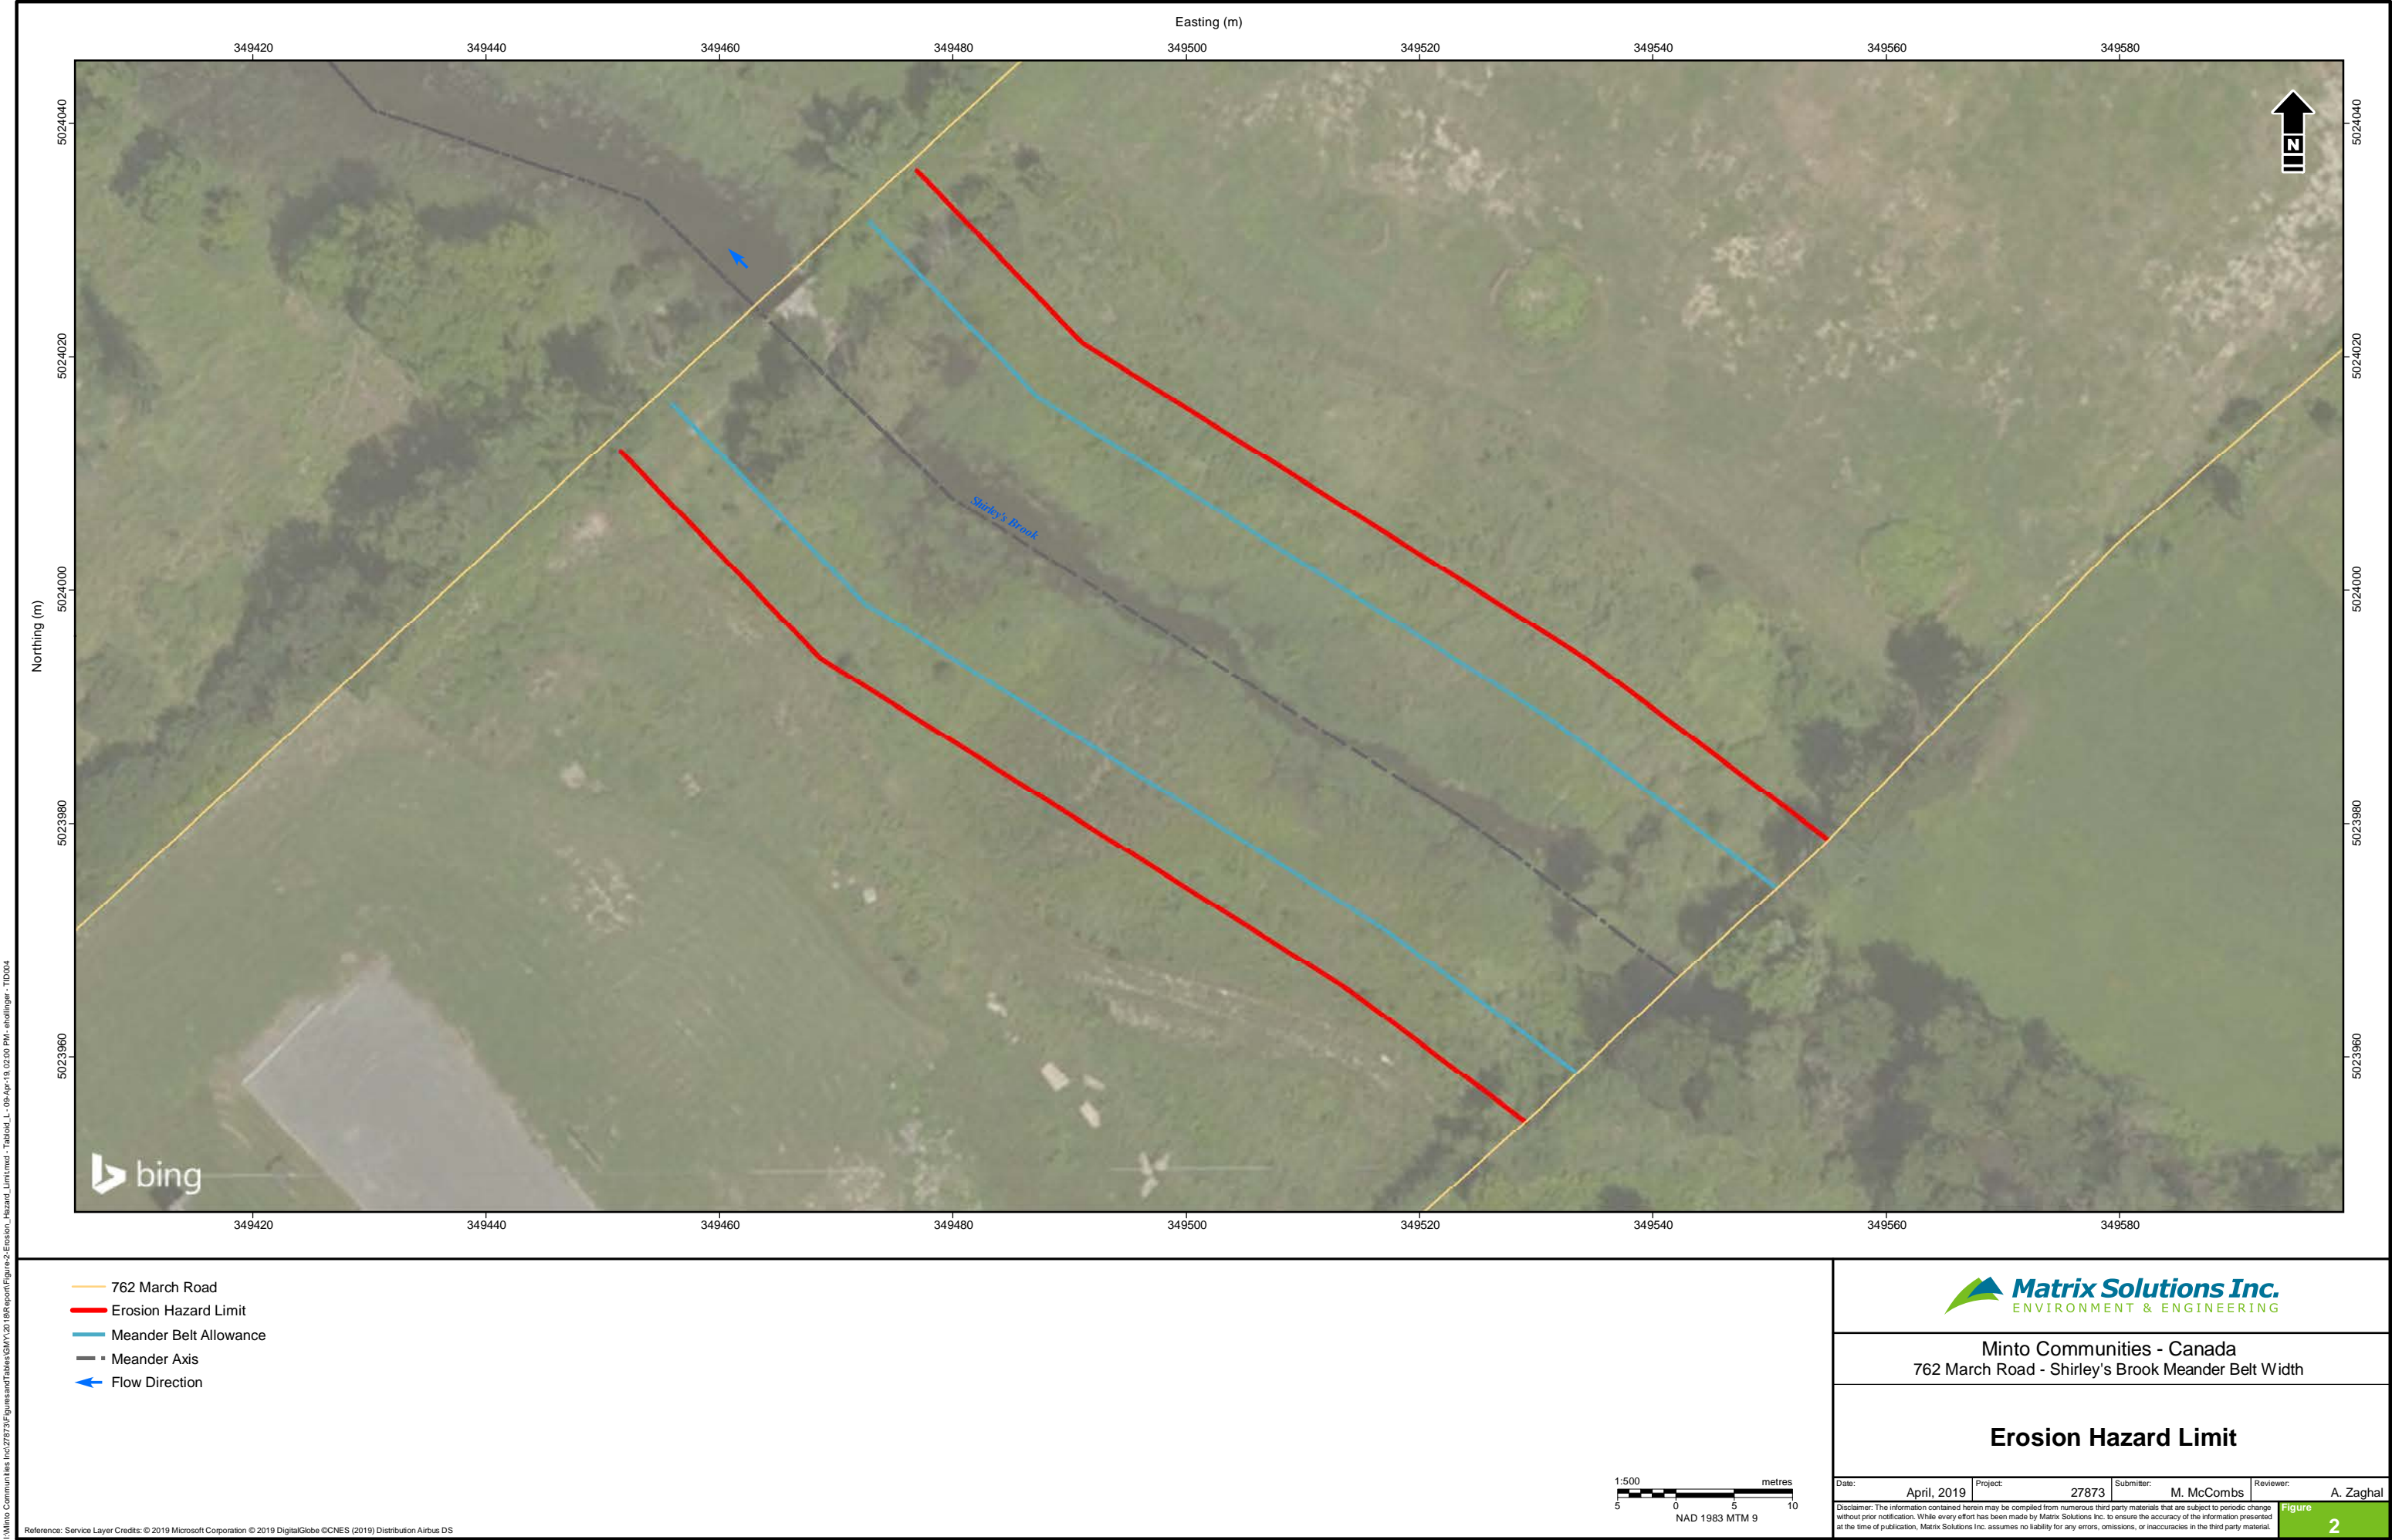
Erosion Hazard Limit

Based on the finding presented in Table 3 and the comparability to up and downstream meander belt widths, a preliminary meander belt width of 23 m is recommended for the study reach. This value represents the total width. A 6 m erosion access allowance is added on each side of the preliminary meander belt width for a total erosion hazard limit of 35 m.

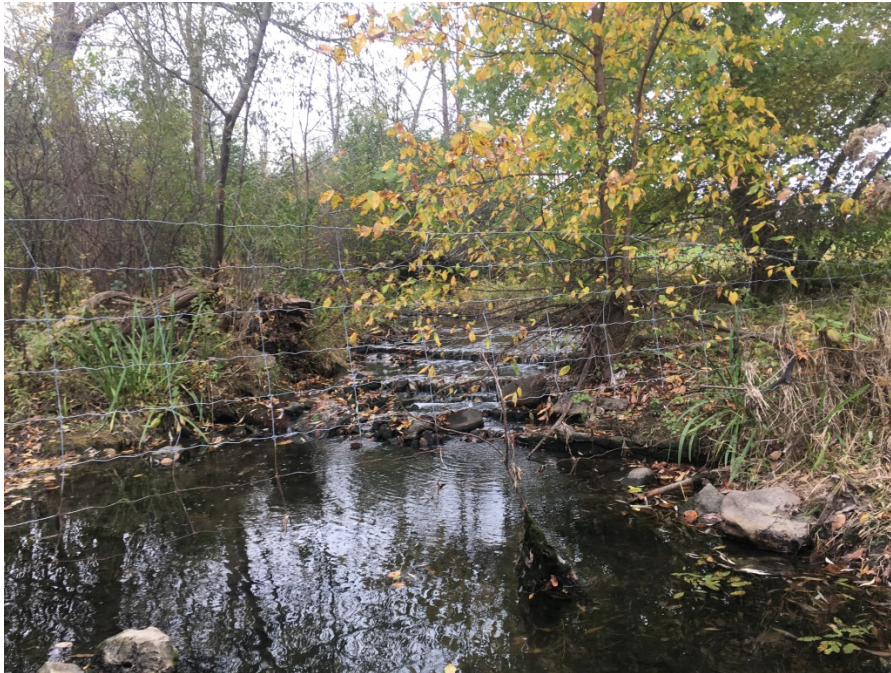
The section of Shirley's Brook through the study area is approximately 93 m in length and appeared to have been maintained as a straight channel for farming purposes. The channel had an average bankfull top width and depth of approximately 3.0 m and 0.5 m, respectively. At the upstream extent, on the adjacent property east of 762 March Road, a small shale knickpoint produces higher velocities which have created a small pool leading into the study area.

1. Fence marking the upstream extent of the site with knickpoint/waterfall upstream forming pool at start of the study area.

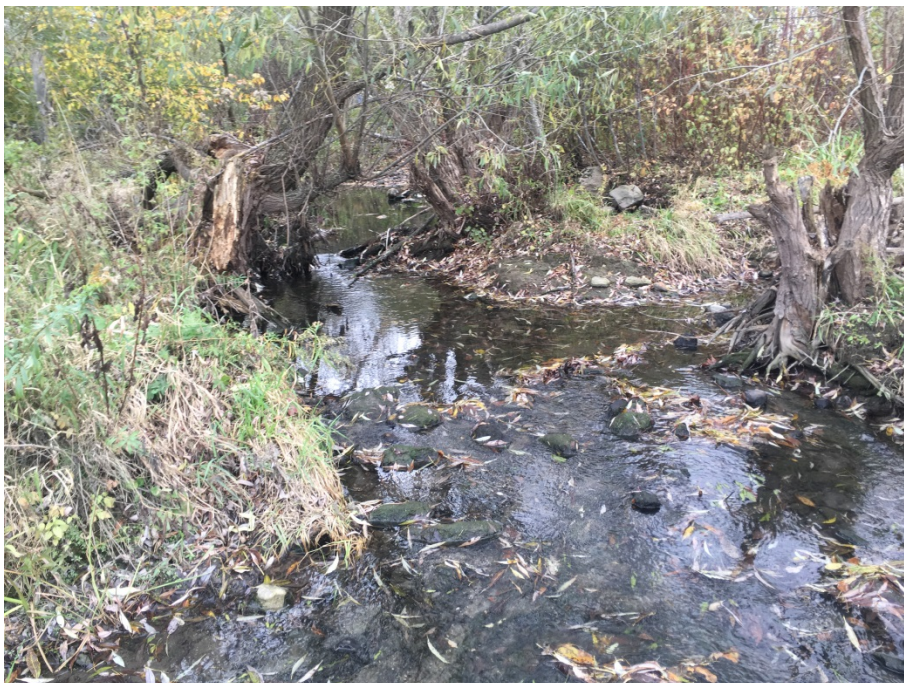
2. Island forming at downstream end of pool to start of riffle/run features downstream.

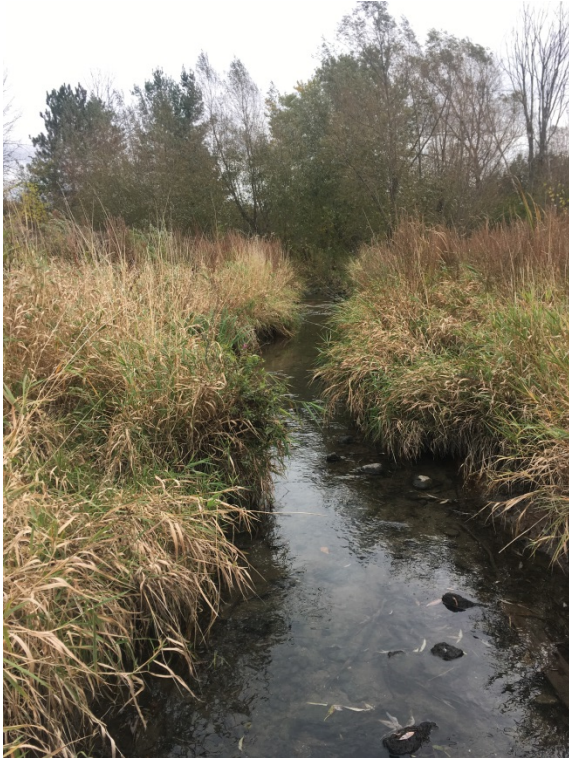
The upstream half of the section of channel investigated as part of this assessment appears to be adjusting more actively than the downstream half. In the upstream half, active lateral migration can be observed into the riparian zone which is composed of tall grasses, herbs, and shrubs. In this area the cross-section is slightly narrower and is composed of small runs and pools. Active adjustment was observed as the channel begins to establish a more natural form.

3. Typical cross-section through upstream ~45 m of site where slight sinuosity observed with signs of active channel erosion and relatively coarse bottom.

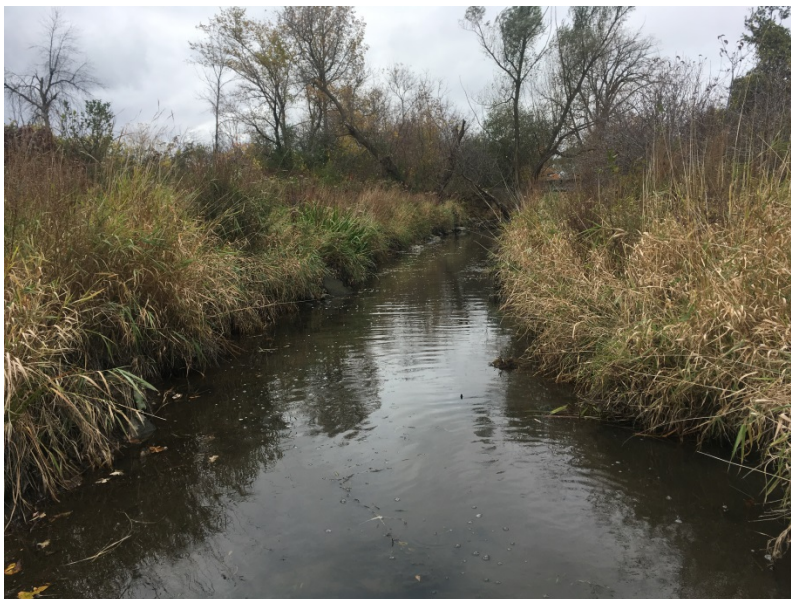
4. Typical cross-section through downstream ~ 50 m of site where the channel is wider, straight and aggrading

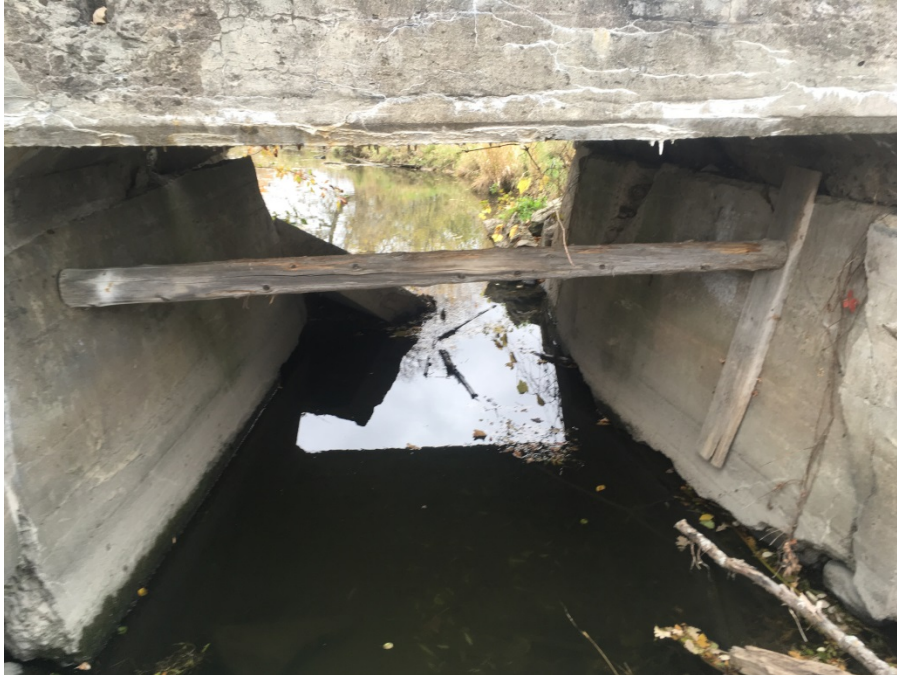
Downstream of this narrower section, the channel widens (4.3 m bankfull width in areas) and the bottom is composed of unconsolidated silt and organic materials. With a wider cross-section and a lower longitudinal slope, the downstream half of the channel is much more depositional. It is expected that the upstream active adjustment will migrate downstream with time as meanders continue to migrate. These observations of active channel adjustment are in general agreement with the finding by AECOM (2015) that the watercourse is in the process of equilibrating and that these adjustments are likely due to land use changes. At the downstream extent of the reach is an open bottom concrete box culvert approximately 3 m wide in very poor condition. The concrete wing walls on the downstream side of the crossing have completely collapsed and the walls of the structure have partially collapsed and have been braced with a wood beam to prevent them from falling into the channel. The structure is undersized and is likely outflanked seasonally.

5. Open bottom concrete box culvert marking the downstream extent of the site. The culvert is undersized and in very poor condition as a result of outflanking.

1. Shirley's Brook will likely continue to migrate laterally and downstream, especially as development continues to expand within its watershed. Given the on-going migration of the channel and the condition of the downstream culvert, culvert removal would prevent the further collapse of the structure into the channel which could obstruct flows resulting in flooding and forcing a re-alignment of the channel. Future culverts should consider a span with consideration for fluvial geomorphic processes to account for future channel evolution.
