Phase One Environmental Site Assessment

5592, 5606 and 5630 Boundary Road and 9460 Mitch Owens
Road
Ottawa, Ontario

**Touchstone Contracting &
Engineering Ltd.**

February 28, 2019

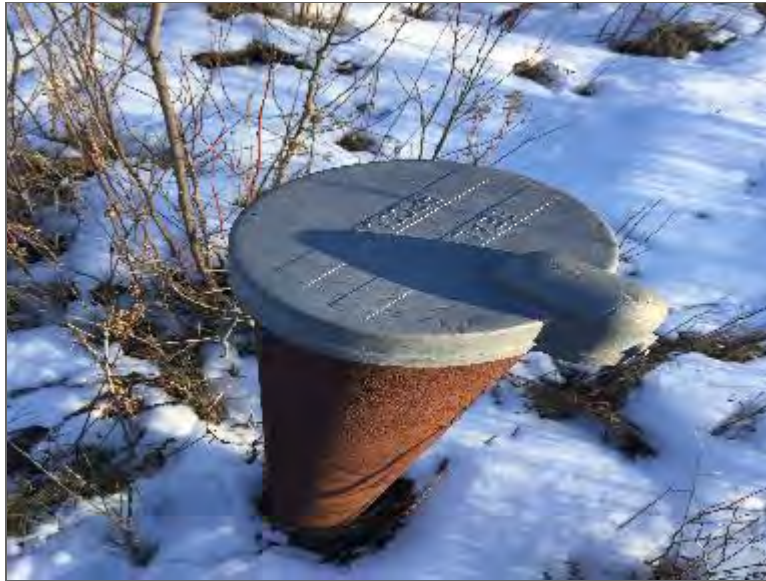
Photo 5 – Drilled water well located on the northeast portion of the Phase One Property.

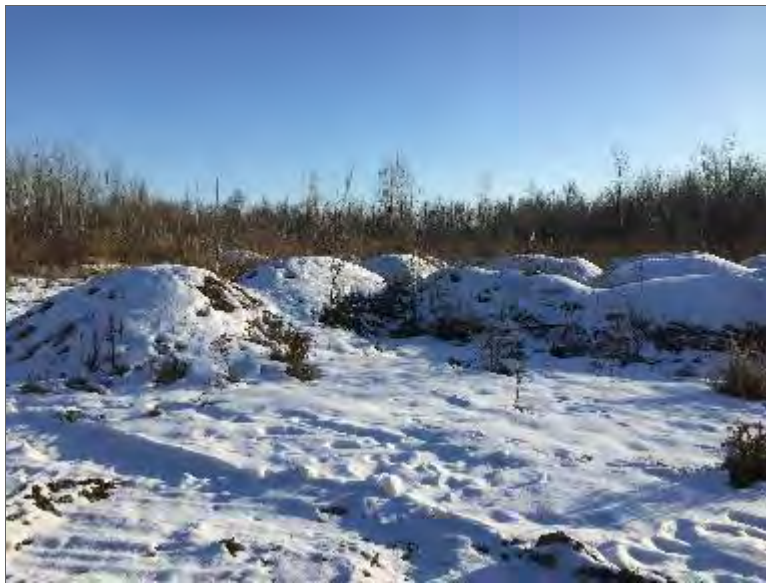
Various stockpiles of fill material, inferred to consist of soil, wood, brick and gravel and inferred to be non-deleterious in nature, were observed on the northwest and southeast portions of the Phase One Property. The quality of these fill piles is unknown. As such, these fill piles represent a PCA for the Phase One Property; however, it is Pinchin's opinion that the fill piles can be removed from the Phase One Property during redevelopment activities.

Photo 6 – General view of fill piles observed on the northwest portion of the Phase One Property.

Based on these findings, nothing was identified that would require the completion of a Phase Two ESA. As such, it is Pinchin's opinion that the Phase One Property is suitable for filing a Site Plan Approval application with the City of Ottawa based only on the completion of this Phase One ESA report. However, if the Client intends to potentially utilize the existing on-Site fill piles during development activities at the Phase One Property, Pinchin recommends that the fill piles be sampled to confirm their inferred non-deleterious nature.

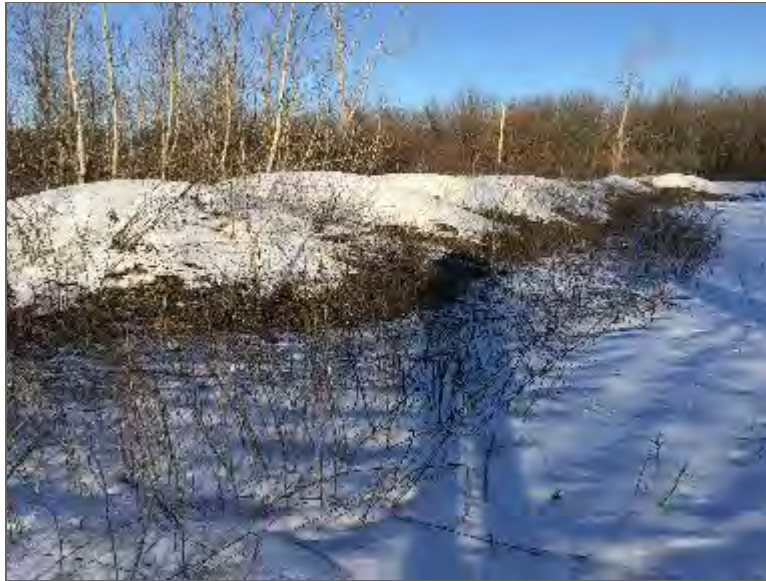
Photo 7 – General view of the fill piles observed on the southeast portion of the Phase One Property.
