April 23, 2019

RE: TREE CONSERVATION REPORT FOR 701 CHURCHILL AVENUE NORTH, OTTAWA

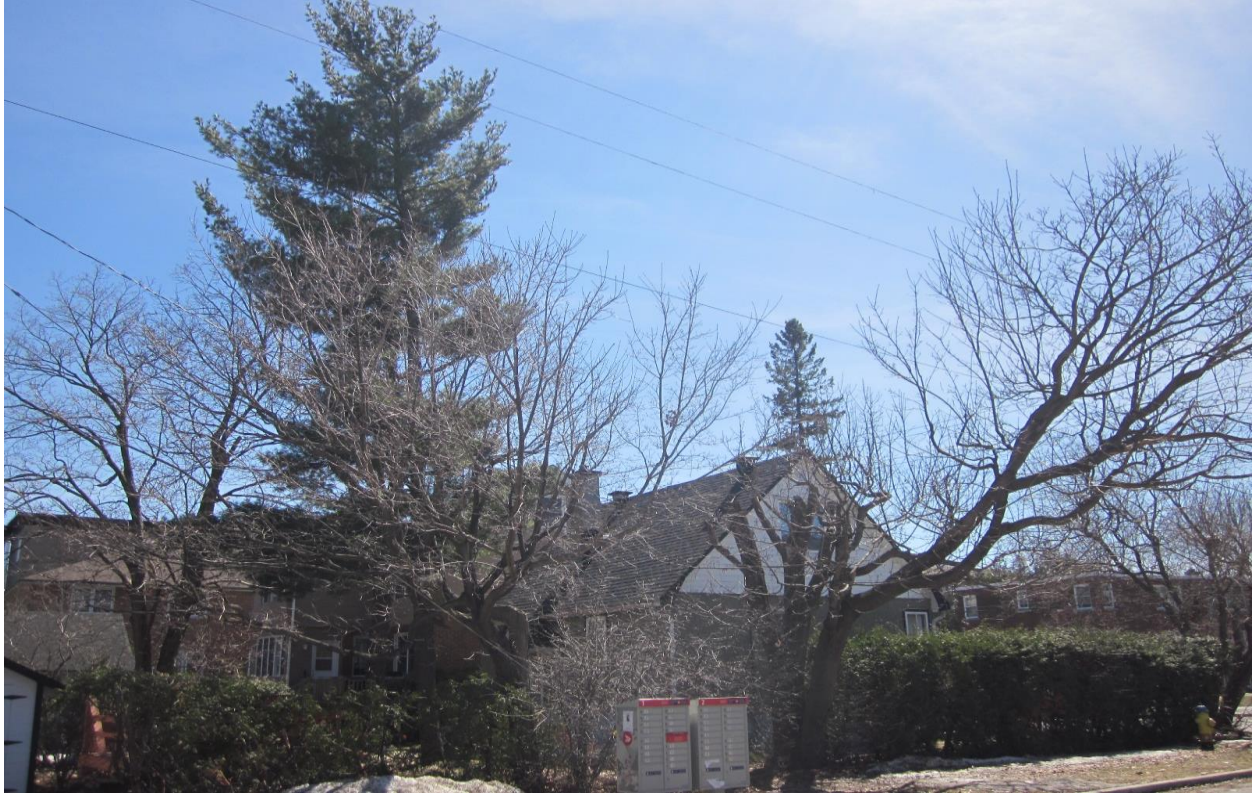
Picture 1. Trees #3 through 9 at 701 Churchill Avenue North.

Tree No.	Tree Species	DBH ¹ (cm)	Tree condition, age class and Status (to be removed or preserved and protected)
1	Norway maple (<i>Acer platanoides</i>)	23	Poor; maturing; located close to neighbouring curb – recent root loss likely; embedded wire at 0.75m on east; major wound resulting from removal of lateral at 2m on southeast; introduced, invasive species; to be removed due to poor condition
2	Norway maple	26	Poor; maturing; located close to neighbouring curb – recent root loss likely; crown asymmetric due to proximity of adjacent new building; introduced, invasive species; to be removed due to poor condition
3	Sugar maple (<i>Acer saccharum</i>)	55 avg.	Fair; mature; double stemmed from grade; included bark to 1.5m; major deadwood in western stem – in advanced decline; native species; to be removed (conflicts with construction)
4	White pine (<i>Pinus strobus</i>)	42	Good; mature; upright stem form; asymmetric crown due to competition with tree #5; good crown density, growth increment and needle colour; native species; to be removed (conflicts with construction)

5	White pine	38	Fair; mature; upright stem form; asymmetric crown due to competition with tree #4; fair crown density, growth increment and needle colour; sunscald damage to east side of main stem – living crown held high; native species; to be removed (conflicts with construction)
6	White spruce (<i>Picea glauca</i>)	30	Fair; upright, generally symmetric crown; fair crown density (scattered dead branches), growth increment and needle colour; heavy cone crop in 2018; native species; to be removed (conflicts with construction)
7	Manitoba maple (<i>Acer negundo</i>)	23 avg.	Poor; maturing; four-stemmed from grade; central stems topped by hydro, others divergent; introduced species; to be removed due to poor condition
8	Norway maple	47 avg.	Very poor; mature; double stemmed from grade – one topped by hydro, other divergent over Currell Ave with advanced decay in old pruning wounds; introduced, invasive species; to be removed due to very poor condition (hazardous)

9	Sugar maple	36	Poor; mature; main stem topped by hydro at 2.5m creating a dog's leg with decay in wound; co-dominant stem at 2m divergent toward southeast; entire crown asymmetric toward south and east – very poor form; native species; to be removed due to poor condition

Due to a combination of the size of the proposed new building, construction of a retaining wall, changes to grades and the current poor condition of some trees, all existing trees on the subject property will be removed prior to the start of construction.
