Urban Forestry & Forest Management Consulting

September 10, 2019

RE: TREE CONSERVATION REPORT – PHASE 2, QWEST (114 RICHMOND ROAD, OTTAWA)

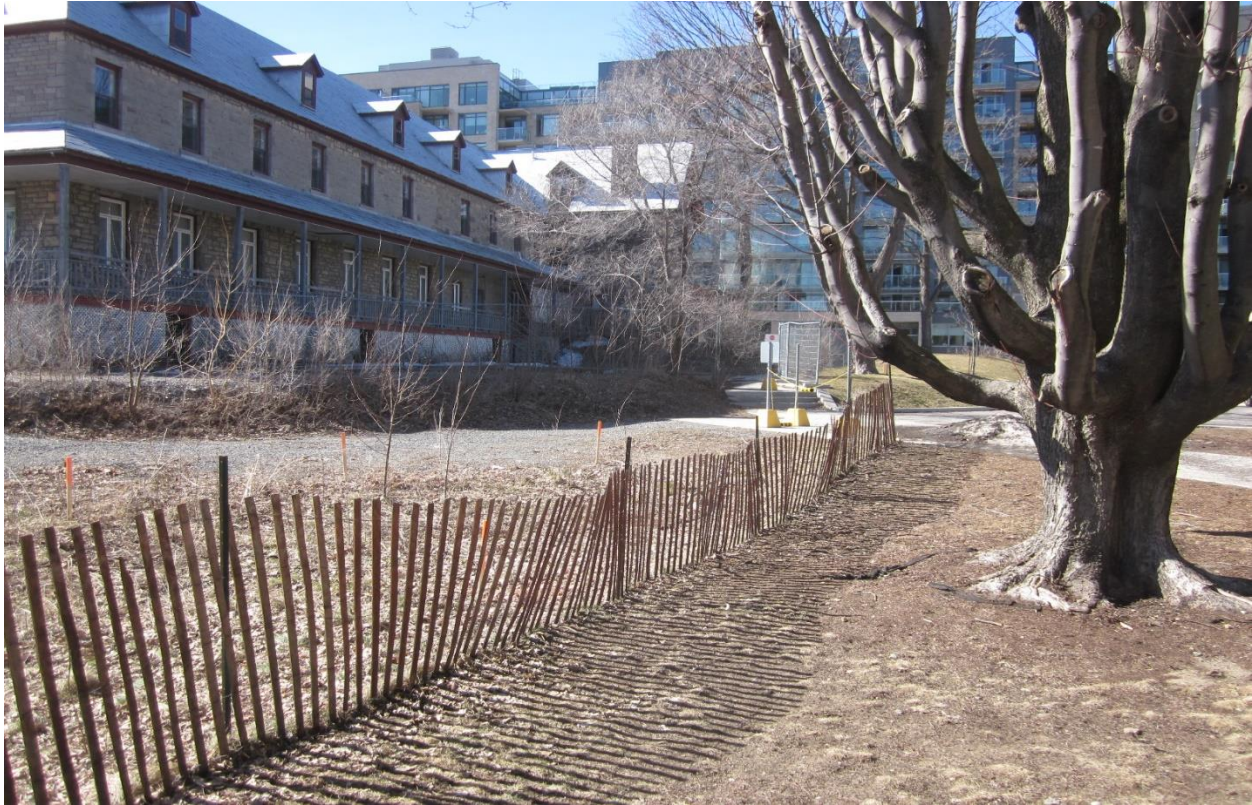
Tree No.	DBH ¹ (cm)	CRZ ² (m)	Distance to excavation ³ (m)	Tree condition
38	77.8	7.8	+/-6	Very mature; multiple co-dominant stems arising at 1.0m from grade – broad crown; good crown density, growth increment and leaf colour; multiple exposed surface roots
41	102.5 (at 0.5m)	+/-10	+/-4.5	Very mature; central stem with co-dominant leaders at 3.5m and competing laterals at 1.2m on north and east sides; crown raised to 7m on west; good crown density, growth increment and leaf colour; multiple exposed surface roots
44	57.4	5.7	+/-3.5	Mature; central stem with competing lateral at 2.5m on east; tri-dominant leaders at 3.5-4m - central stem with competing laterals on north and south sides; major surface root damaged by mowers
46	54.9	5.5	+/-3.5	Mature; central stem with competing lateral at 2m on west and suppressed laterals at 2.5m on north and 3.25m on west side; co-dominant leaders at 4m; two binding roots present

Picture 2. Silver maple tree #38 in Phase 2 of Qwest development (looking northward). Stakes on left indicated set back of future fire route. Picture taken April 2019.

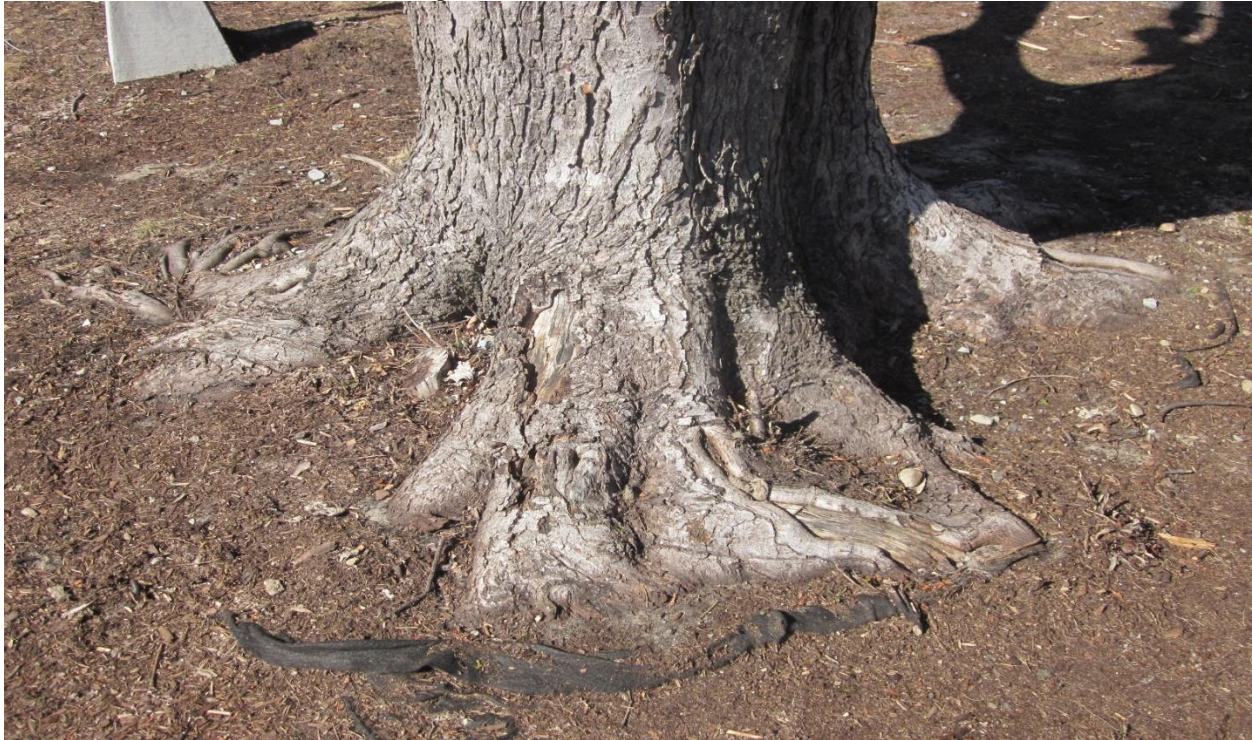
Picture 4. Root collar of tree #38 in Phase 2 of Qwest development (note damaged root flares and landscape fabric). Picture taken April 2019.

The landscape fabric presently around the trees should be removed and replaced with a layer of topsoil in direct contact with the native soil. This soil should then be covered by woodchip mulch. The combined depth of soil and mulch should not exceed 10cm and should not be spread to the point that any tree's root collar is obscured. This treatment should extend for the length of the tree line so to encompass all seven trees and cover all exposed surface roots. If desired this area can be made into a garden bed containing low-growing herbaceous vegetation.
