January 16, 2020  
File: PE4809-LET.02

**John Howard Society of Ottawa**  
550 Old St. Patrick Street  
Ottawa, Ontario  
K1N 5L5

Subject: **Phase II - Environmental Site Assessment Update**  
**289 Carling Avenue**  
**Ottawa, Ontario**

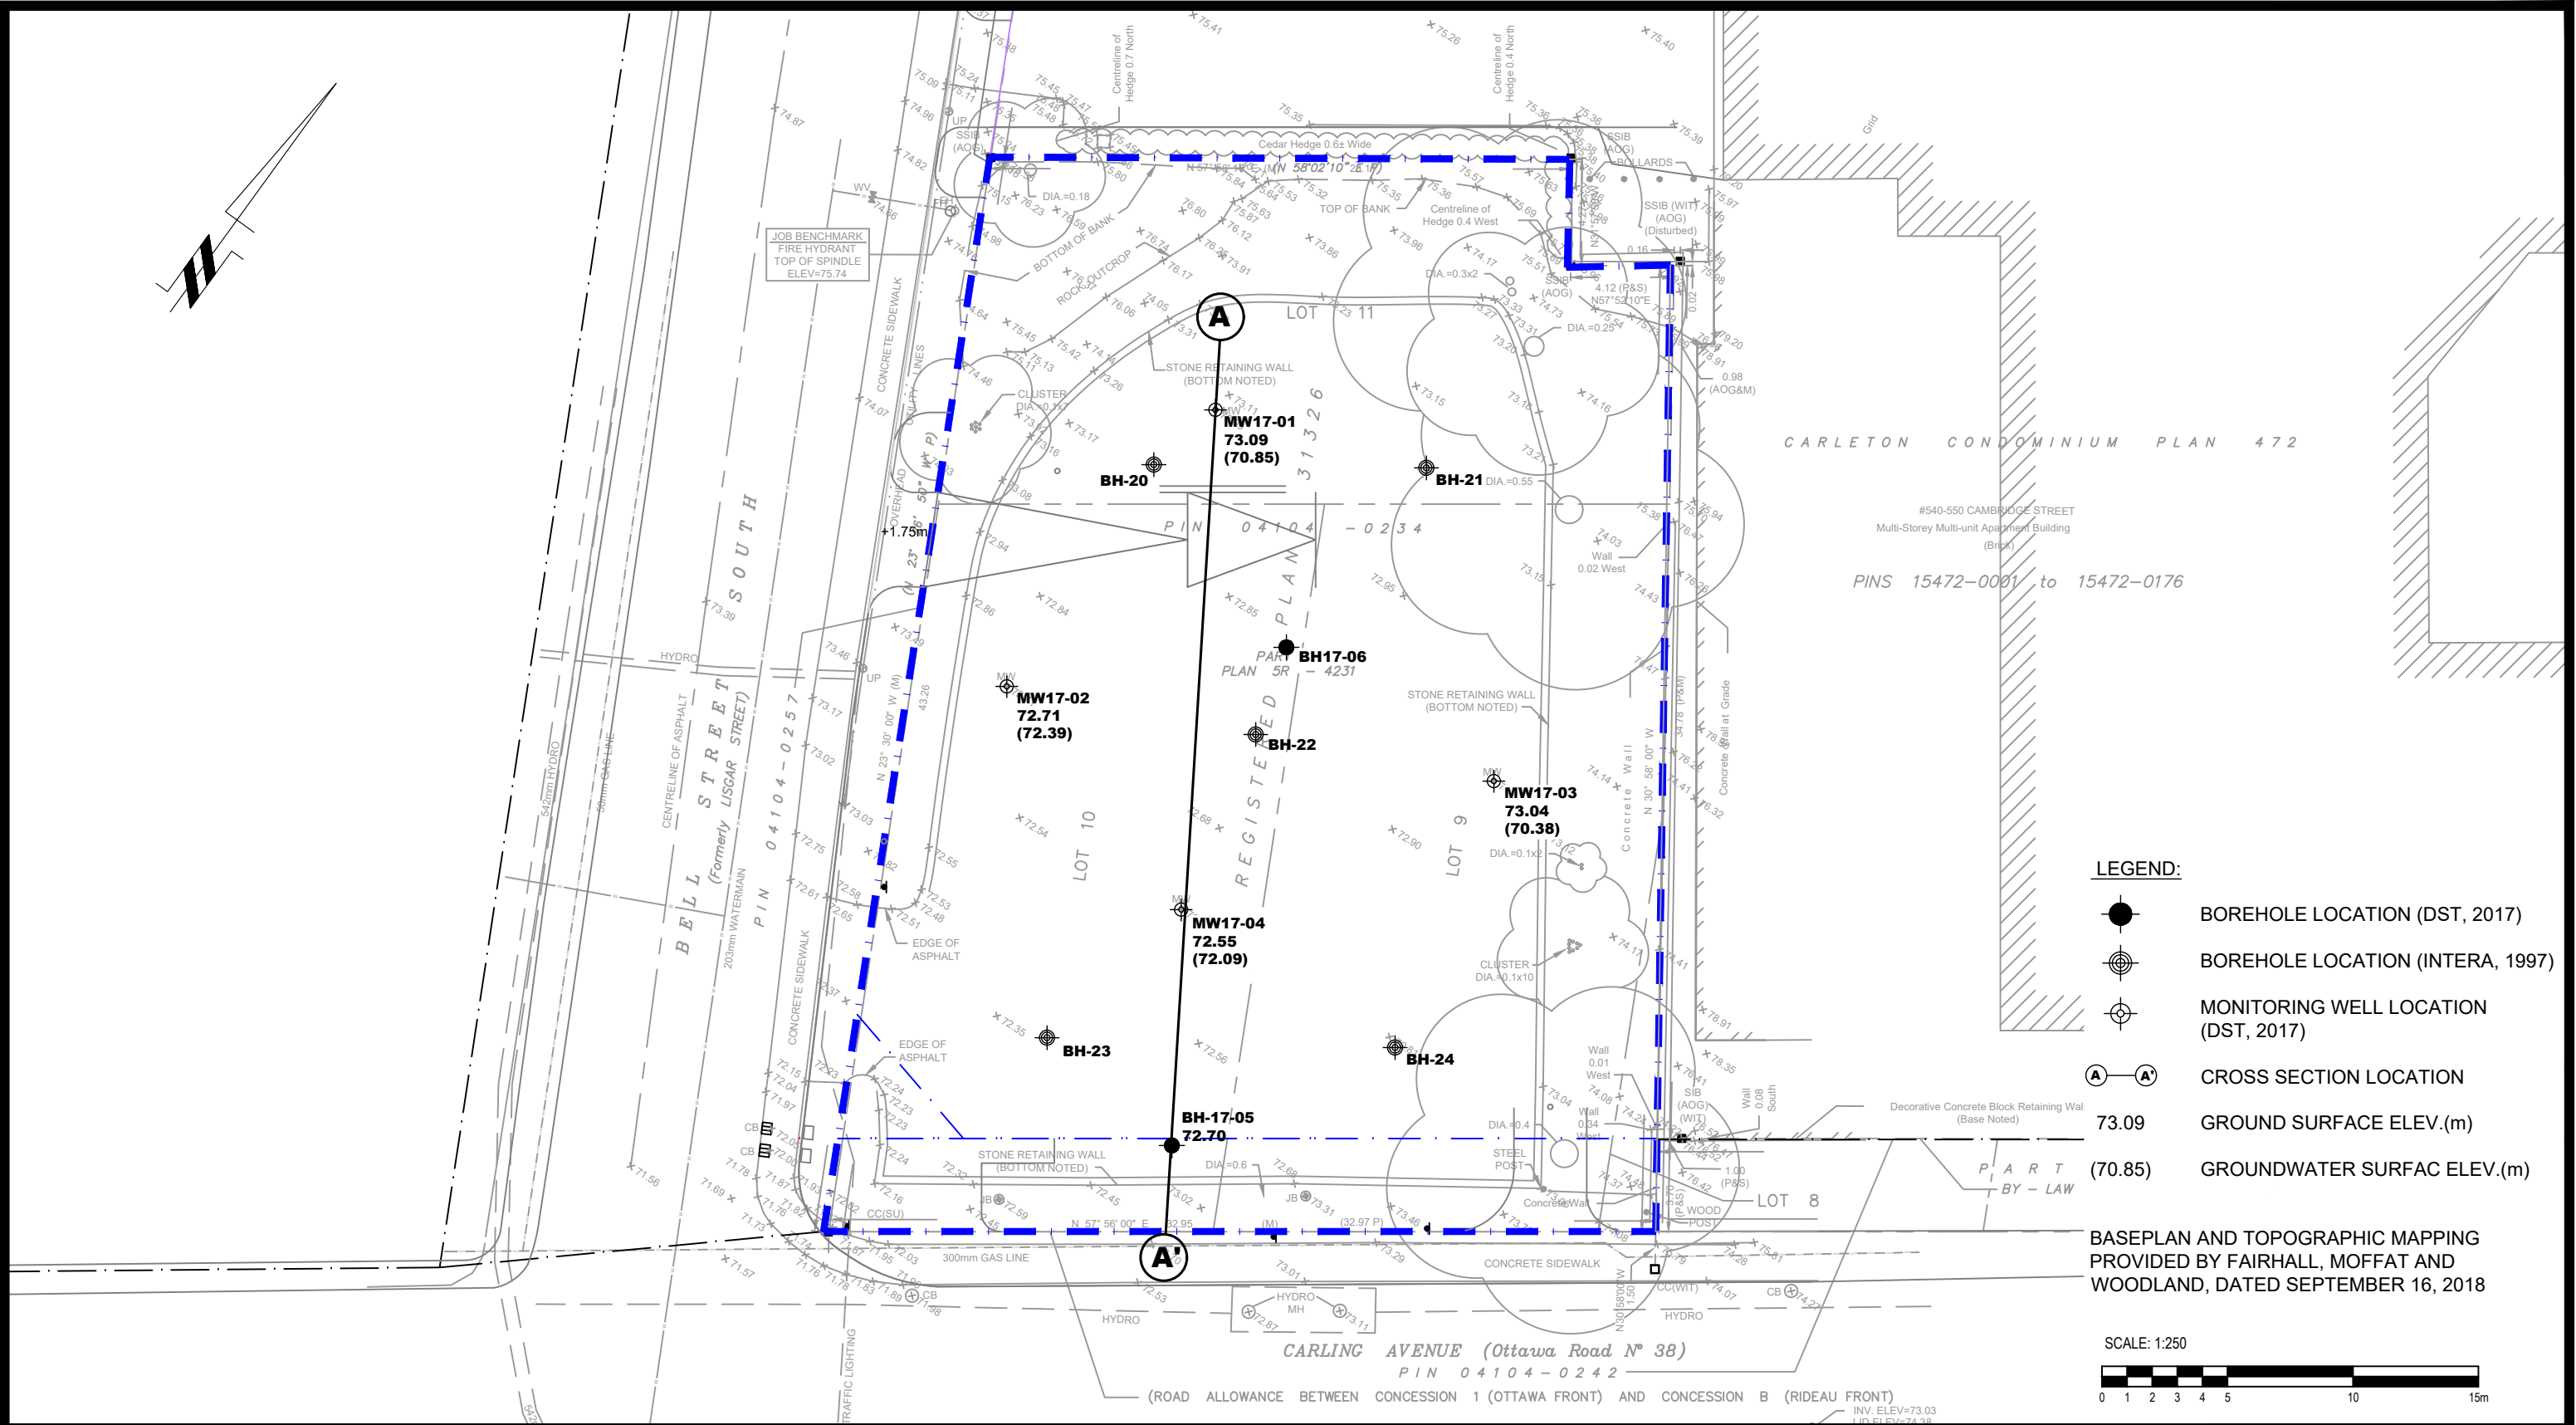
Title:  
**TEST HOLE LOCATION PLAN**

Four (4) groundwater monitoring wells were installed in 2017, as part of the original Phase II ESA. As part of this update, all monitoring wells were viable for sampling. There were no impediments with regard to the work carried out for this update. All drilled boreholes and monitoring wells on the Phase II Property are shown on Drawing PE4809-3 – Test Hole Location Plan, appended to this report.

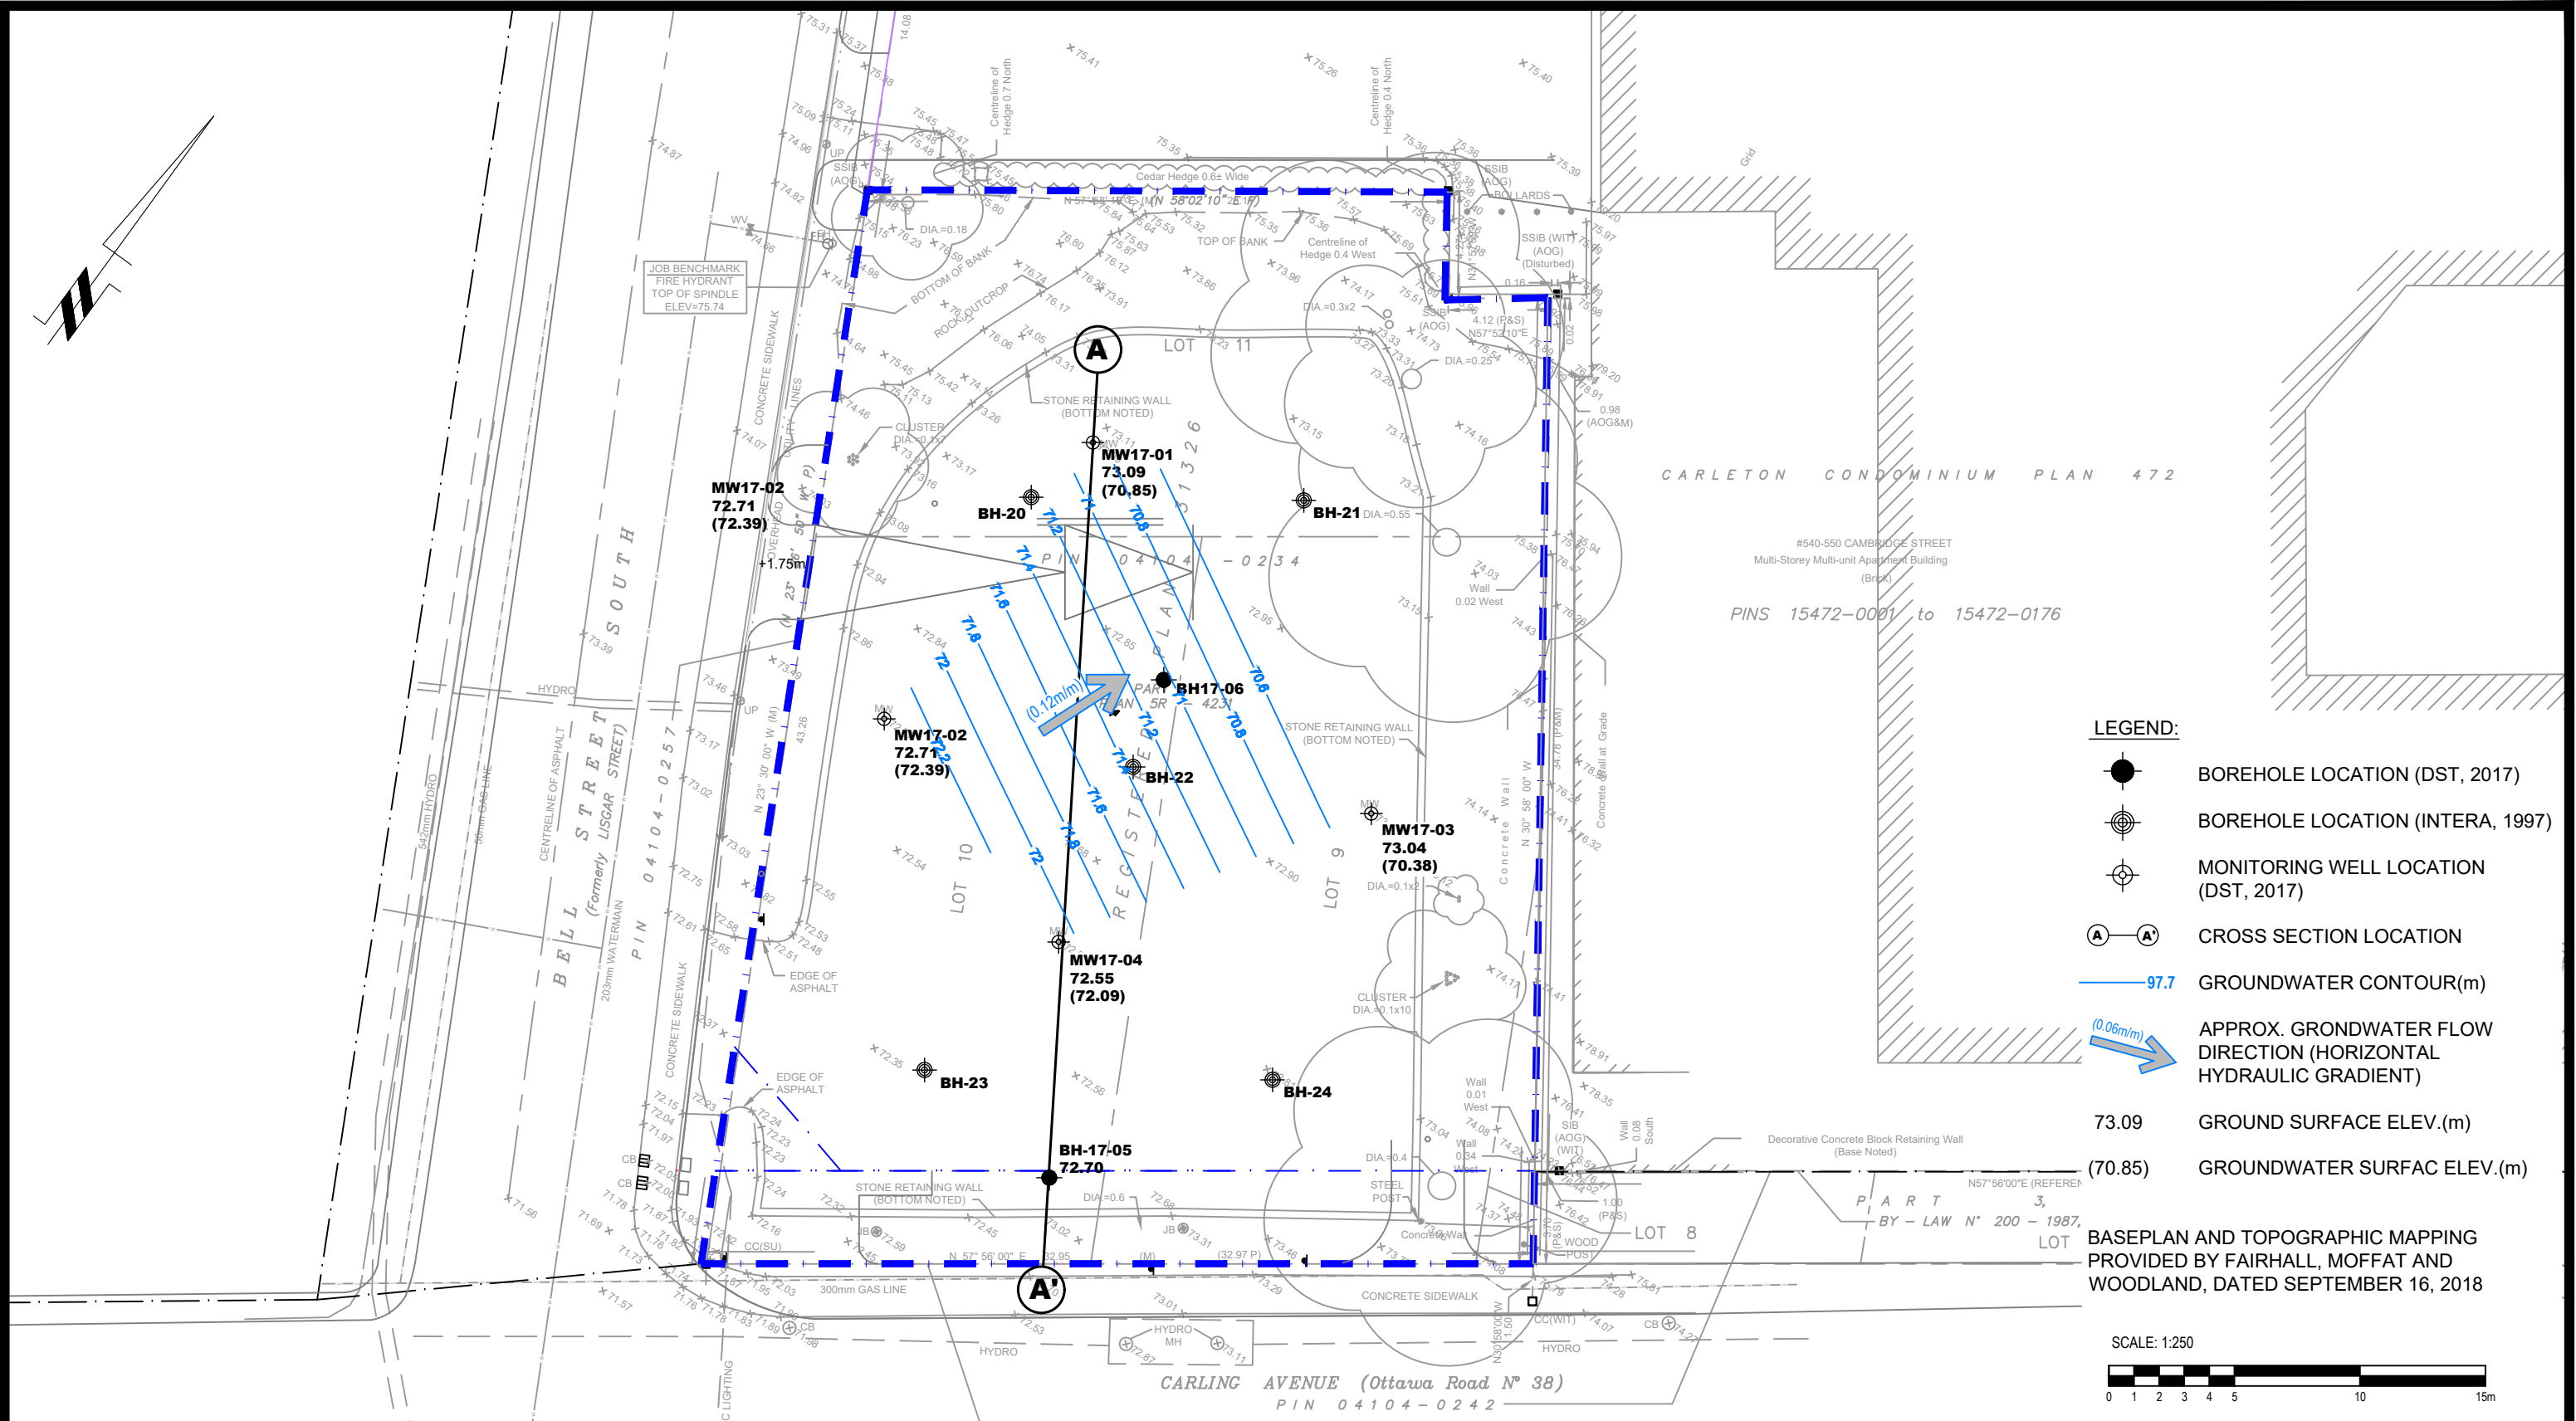
Title: **GROUNDWATER CONTOUR PLAN**

The groundwater contour mapping is shown on Drawing PE4809-4 –Groundwater Contour Plan. Based on the contour mapping, groundwater flow beneath the Phase II Property is in a northerly direction. A horizontal hydraulic gradient of approximately 0.12 m/m was calculated.

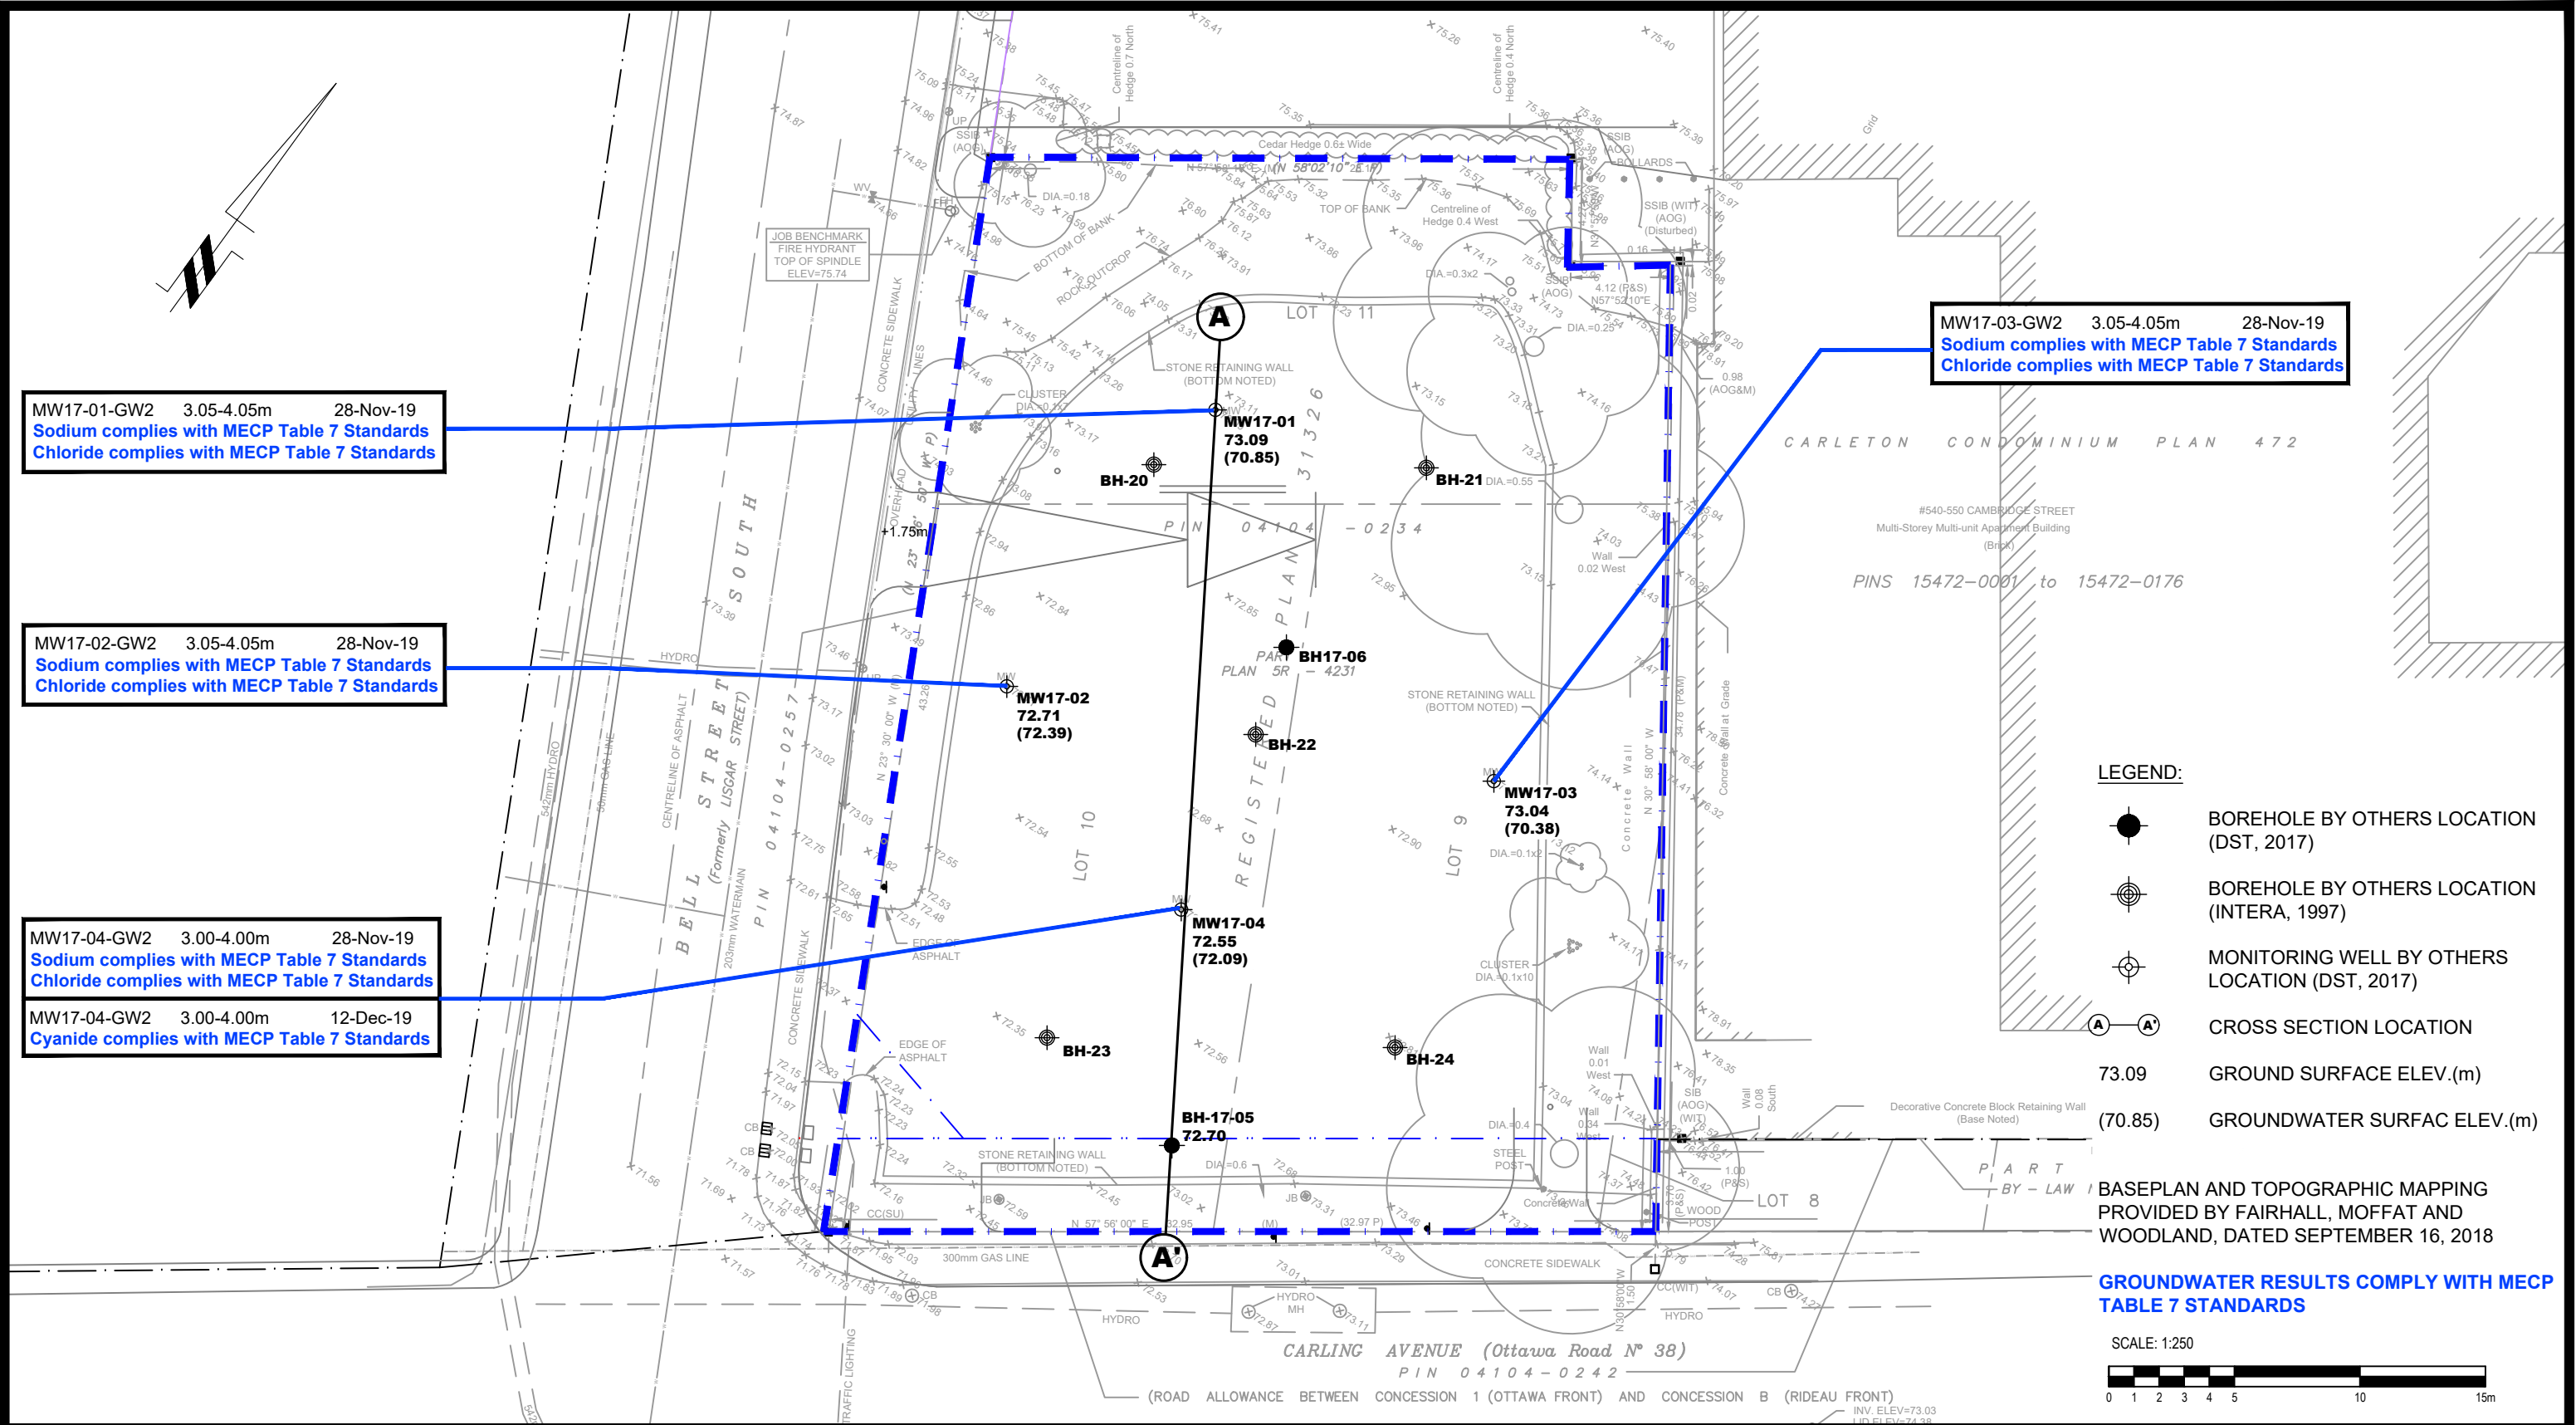
MW17-01-GW2 3.05-4.05m 28-Nov-19  
Sodium complies with MECP Table 7 Standards  
Chloride complies with MECP Table 7 Standards

MW17-02-GW2 3.05-4.05m 28-Nov-19  
Sodium complies with MECP Table 7 Standards  
Chloride complies with MECP Table 7 Standards

MW17-04-GW2 3.00-4.00m 28-Nov-19  
Sodium complies with MECP Table 7 Standards  
Chloride complies with MECP Table 7 Standards

MW17-04-GW2 3.00-4.00m 12-Dec-19  
Cyanide complies with MECP Table 7 Standards

MW17-03-GW2 3.05-4.05m 28-Nov-19  
Sodium complies with MECP Table 7 Standards  
Chloride complies with MECP Table 7 Standards

GROUNDWATER RESULTS COMPLY WITH MECP TABLE 7 STANDARDS
