TCR  
TREE  
CONSERVATION  
REPORT

2487 INNES  
ROAD OTTAWA

May 4, 2020

**RE: TREE CONSERVATION REPORT FOR 2487 INNES ROAD, OTTAWA**

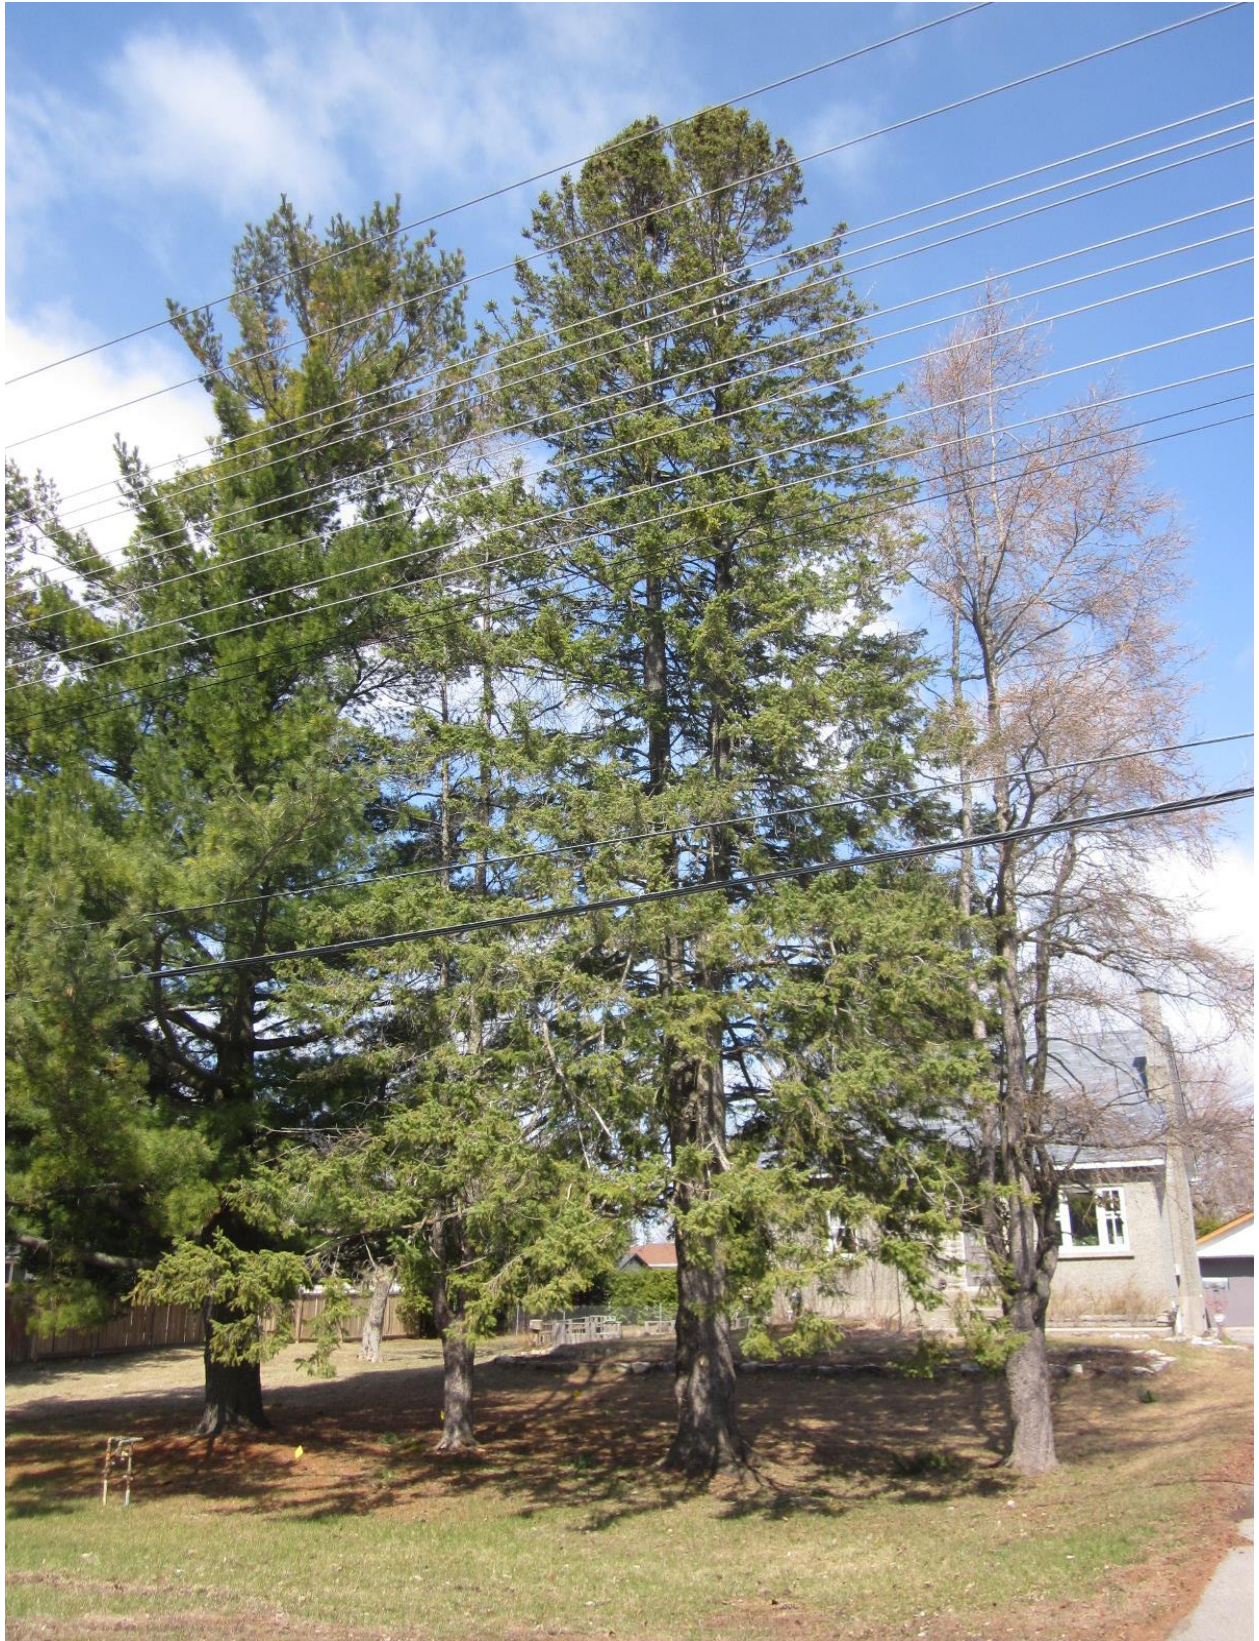
Tree No.	Tree species	Condition (VP→E)	DBH <sup>1</sup> (cm)	Age class, tree condition notes & <b>preservation status</b> (to be removed or preserved and protected)
1	Eastern larch ( <i>Larix laricina</i> )	Poor	44	Mature; tri-stemmed at 2.5m from grade; all three upright, southernmost stem dominant; open seam with exposed xylem in lower bole; native species; <b>to be removed</b>

2	White spruce ( <i>Picea glauca</i> )	Fair	67	Mature; co-dominant stems at 3.-3.5m from grade; included bark within primary union; good crown density, annual increment and needle colour; native species; <b>to be removed</b>
3	Eastern larch	Very poor	37	Mature; double stemmed at 2m – northernmost stem dominant; very narrow crown, only apex alive; heavy woodpecker activity; tree is in advanced decline; native species; <b>to be removed</b>
4	White pine ( <i>Pinus strobus</i> )	Good	95	Mature; single dominant stem for most of height; crown very asymmetric due to unequal competition for sunlight; native species; <b>to be removed</b>
5	White spruce	Fair	67	Mature; tri-dominant stems at 3-3.5m from grade; good crown density, annual increment and needle colour; native species; <b>to be removed</b>
6	Balsam fir ( <i>Abies balsamea</i> )	Fair	+/-30	Mature; co-dominant leader lost in recent past – major stem wound; good crown density, annual increment and needle colour; located on adjacent private property; native species; <b>to be preserved and protected</b>

Picture 1. Trees #1-4 (right to left) located at 2487 Innes Road, Ottawa

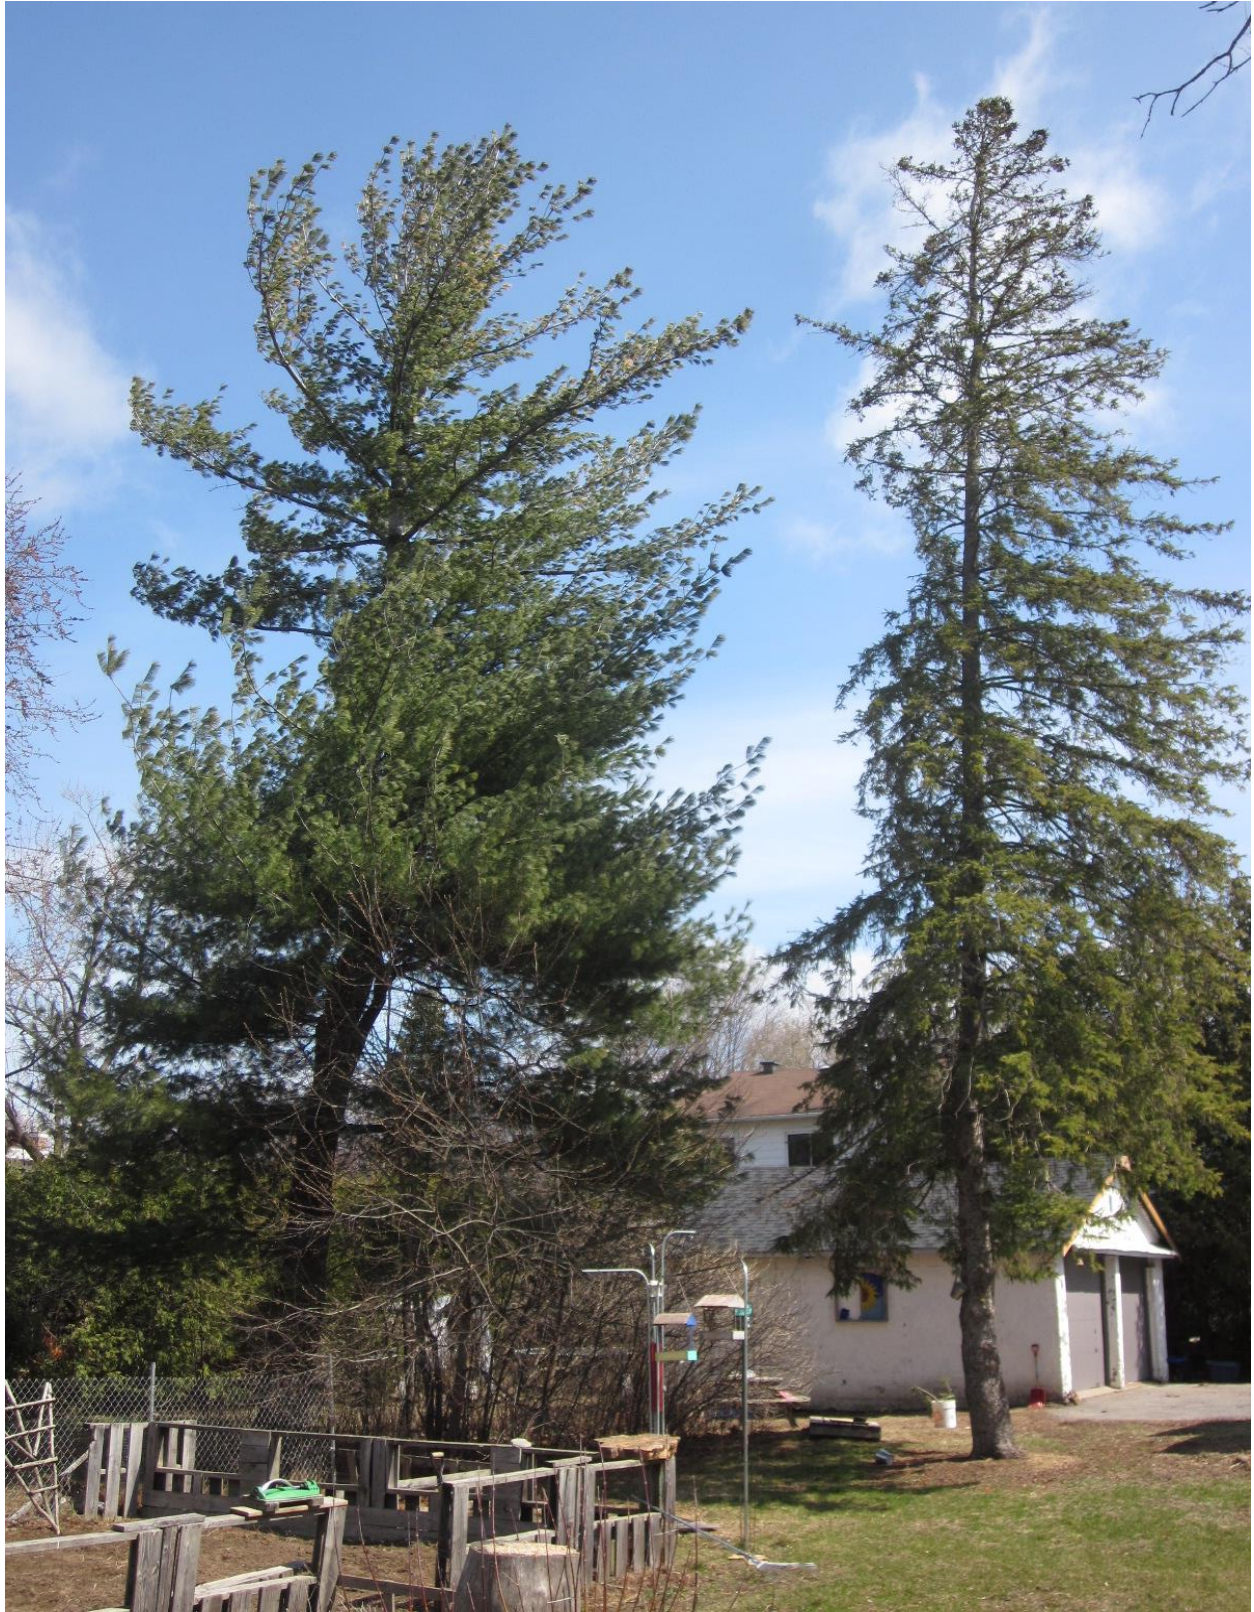
7	Manitoba maple ( <i>Acer negundo</i> )	Very poor	52	Mature; extensive basal wounding and decay; majority of crown is dead; tree is in advanced decline and hazardous; naturalized species; <b>to be removed</b>
8	White spruce	Fair	36	Mature; upright, narrow crown form; poor crown density, fair annual increment and needle colour; tree is in early decline; native species; <b>to be removed</b>
9	White pine	Good	60	Mature; single dominant stem for most of height; lower laterals removed leaving major wounds; crook in main stem at 6m; fair crown density, annual increment and needle colour native species; <b>to be removed</b>
10	White cedar ( <i>Thuja occidentalis</i> )	Good	+/-10	Mature; majority of length maintained in hedge form, certain portions allowed to grow into full-sized trees; straddles property lines – some stems likely fully on adjacent private property; native species; <b>to be preserved and protected</b>

Picture 2. Trees #8 (right) and 9 located at 2487 Innes Road, Ottawa

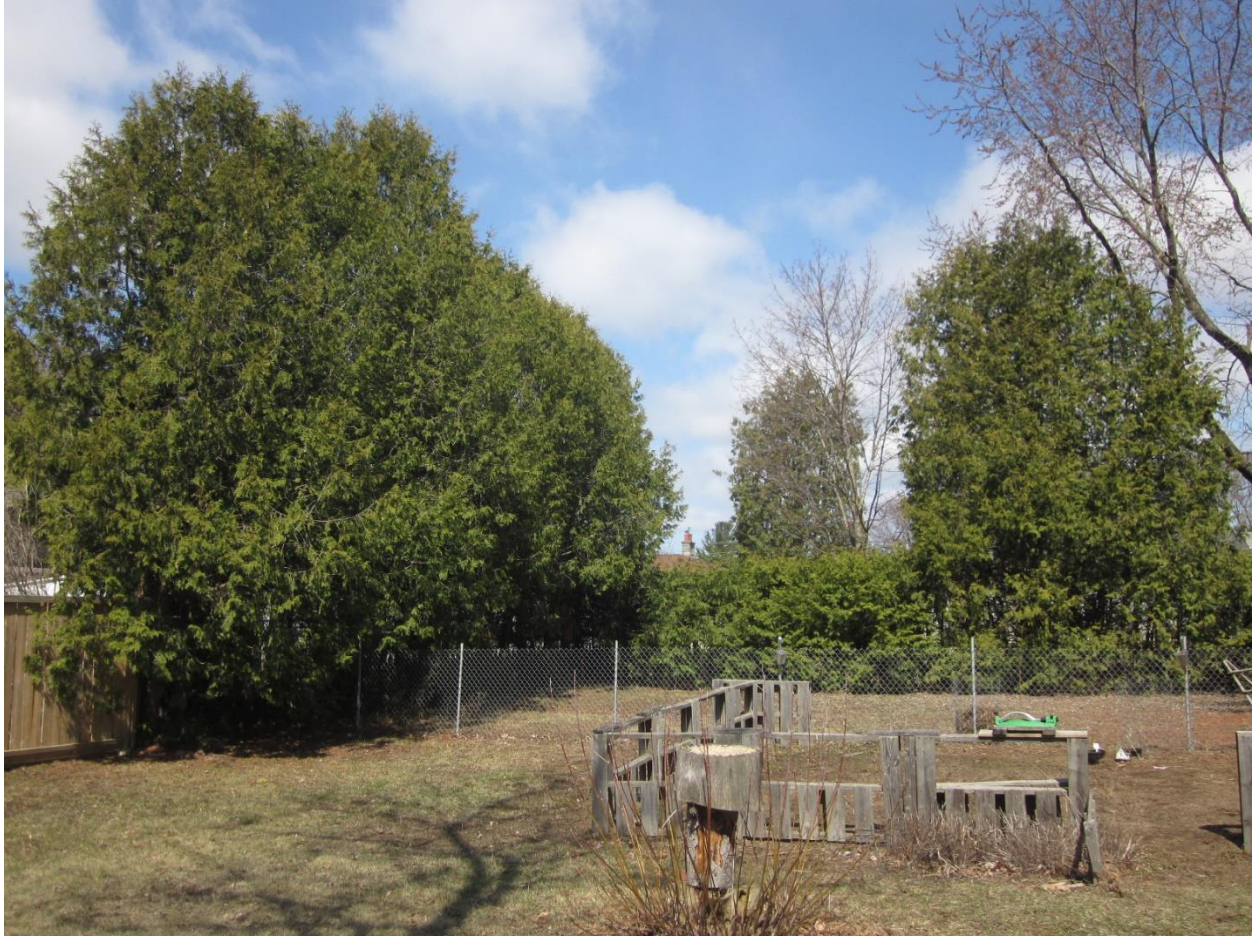
All of the trees on the subject property are slated for removal either due to conflicts with the proposed building or surrounding parking. Tree #6, the nearby balsam fir fully on an adjacent private property, and cedar hedge (#10) which surrounds the property, and is on or shared with adjacent private properties, will remain in place.

Picture 3. Portion of cedar hedge surrounding 2487 Innes Road, Ottawa (note maintained hedge and fully grown trees)

Preservation and protection measures intended to mitigate damage during construction will be applied for the hedge surrounding the subject property. The following measures are the minimum required by the City of Ottawa to ensure tree survival during and following construction:

1. Erect a fence at the critical root zone (CRZ<sup>1</sup>) of trees;
2. Do not place any material or equipment within the CRZ of the tree;
3. Do not attach any signs, notices or posters to any tree;
4. Do not raise or lower the existing grade within the CRZ without approval;
5. Tunnel or bore when digging within the CRZ of a tree;
6. Do not damage the root system, trunk or branches of any tree;
7. Ensure that exhaust fumes from all equipment are NOT directed towards any tree's crown.
