Muncaster
Environmental
Planning Inc.

RE: 5455 Boundary Road
Review of Channels

Michelle Muncaster and I reviewed the channels present on the above site on June 5th and offer these comments.

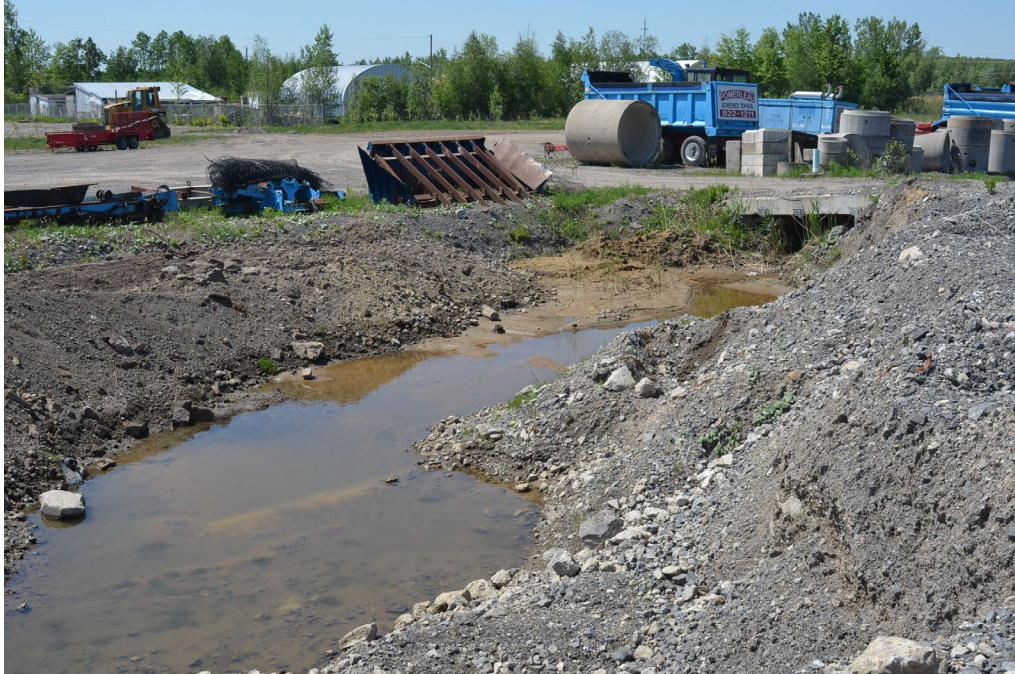
The south channel does not show on the aerial photography until 2014. It does not continue to the east of the site (Photo 2) and appears to have been recently dug as part of the on-site activities. The south channel extends for approximately 200 metres and confined entirely on the site (Photo 1). The south channel begins about 200 metres east of Boundary Road and ends approximately 40 metres west of the east site edge. There is no natural habitat of note along the banks or adjacent to the south channel, with some cattails in the channel. On June 5th, standing clear water was present in the south channel, with widths up to four metres wide and water depths up to 25cm. There appeared to be no outlet for the standing water.

Photo 1 – South channel with view looking west to upstream end of the channel on-site

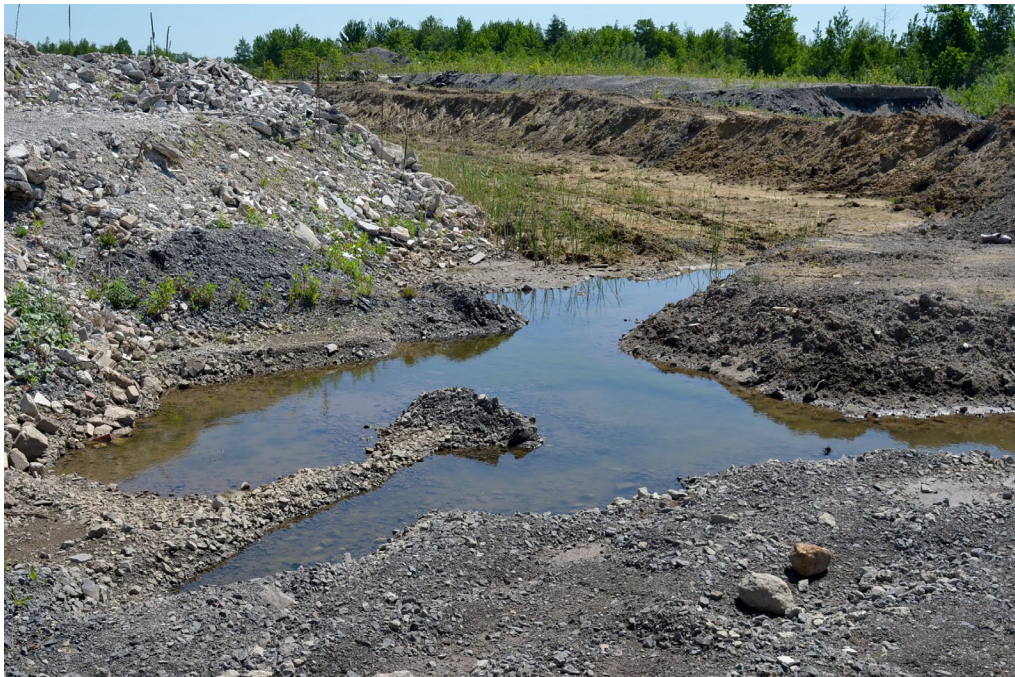
Photo 2 – South channel with view looking east showing no connection to a downstream channel further to the east

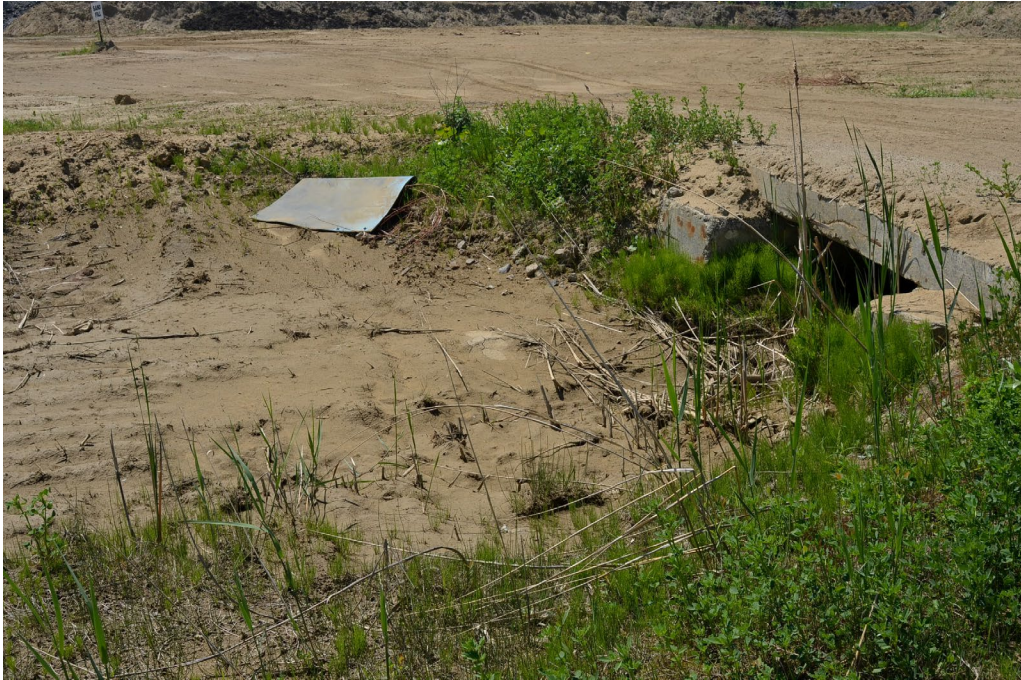
The middle channel also does not appear present on historical aerial photography, though a scratch swale may be between agricultural fields. On June 5th no water was present and there was no evidence of a low flow channel or standing water of note (Photos 3 and 4). The length of the middle channel on-site is approximately 135 metres, with the channel beginning about 310 metres east of Boundary Road. Further east of the site, slender willow shrubs were growing in the channel, along with broad-leaved cattails and European bur-reed.

Photo 3 – Middle channel on site at access road crossing. View looking north

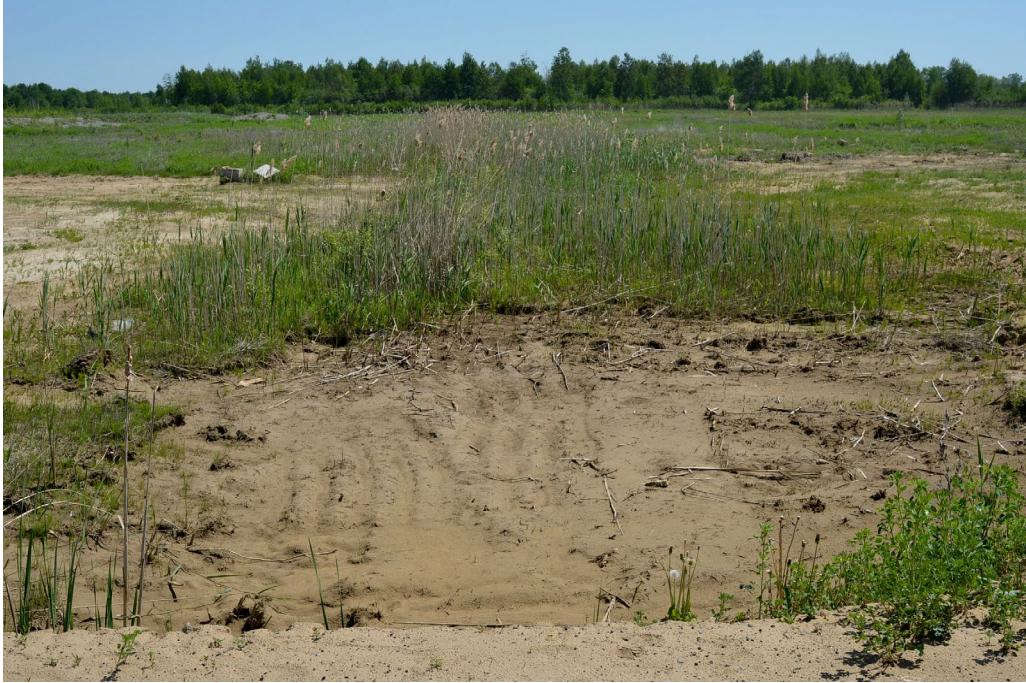
Photo 4 – Middle channel looking east to adjacent land to the east

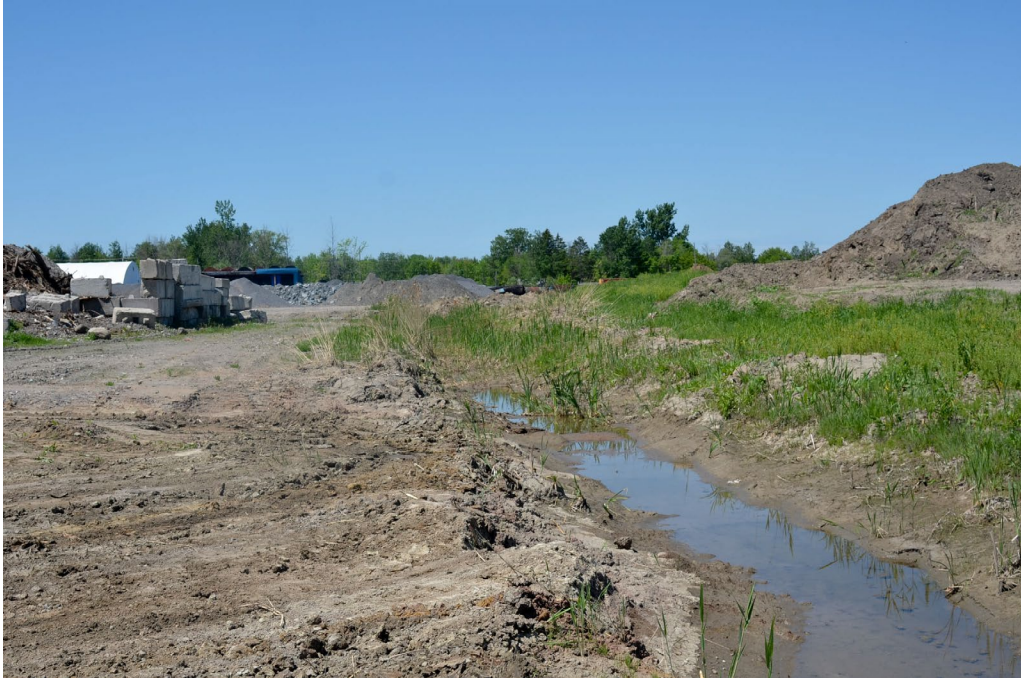
The north channel is present as a straight channel on historical aerial photography, with the channel appearing more defined in 2014 than previous years. Standing water was present in the north channel on June 5th (Photo 5), extending for about thirty metres east of the access road crossing (Photo 6). Aquatic vegetation in the channel included broad-leaved cattail and purple loosestrife. The on-site length of the north channel is approximately 165 metres, with the channel beginning about 270 metres east of Boundary Road.

Photo 5 – North channel, with view looking west to the on-site west end of the channel

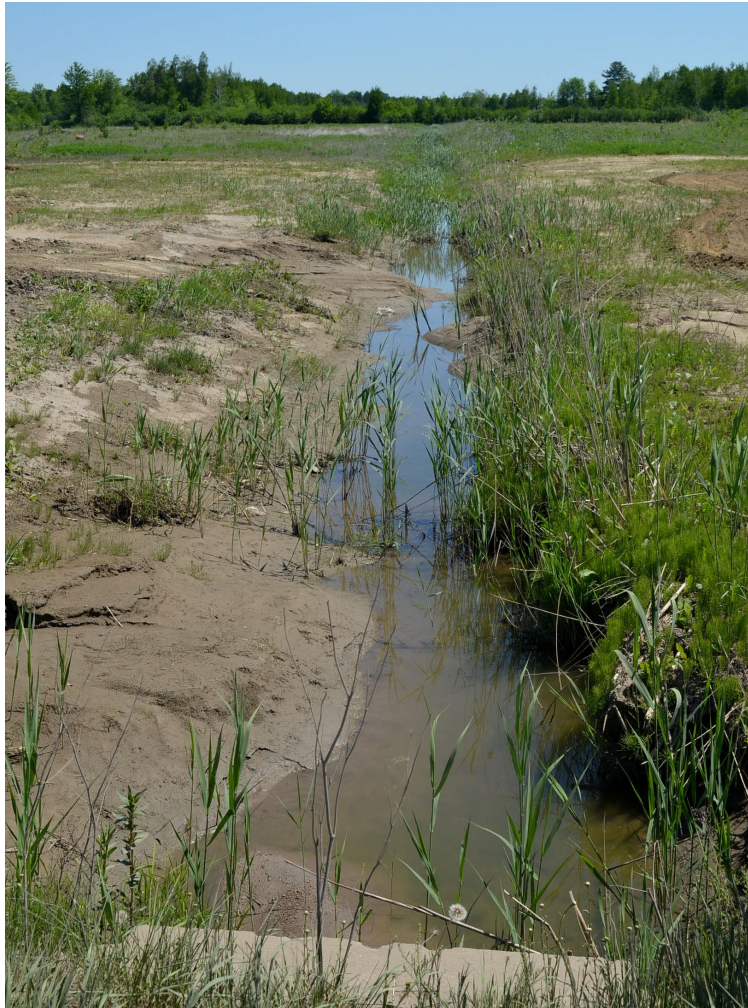
Photo 6 – North channel, with view looking east to the east site edge

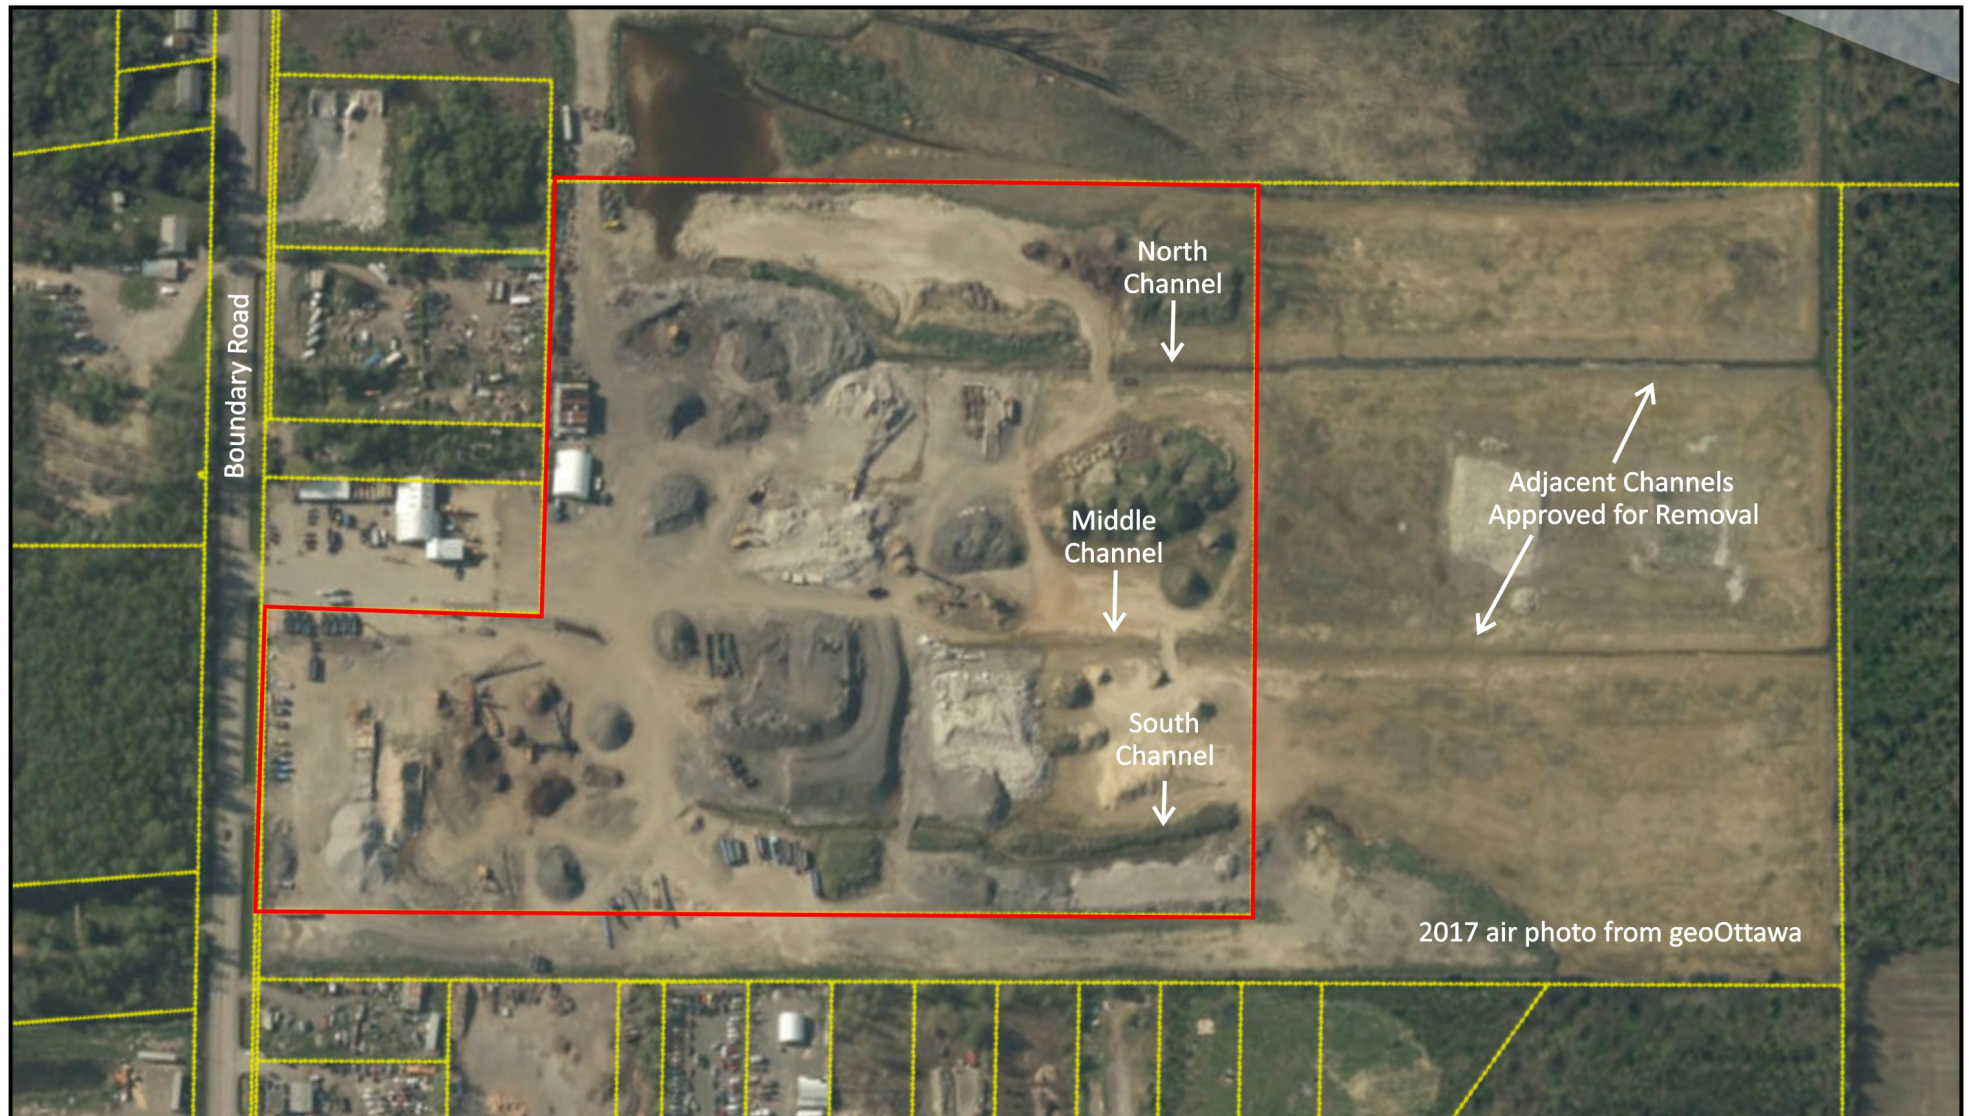
FIGURE 1 – CHANNEL LOCATIONS

There are three channels on the site, as shown on Figure 1 at the end of this assessment. The general topography of the area is a very gentle slope to the east. All three channels originate on the site, with only up to 200 metres of channel length on the site.
