TREE CONSERVATION REPORT

240 Ferland Street

Tree Conservation Report submitted as Partial
Requirements for a Site Plan Control Application

Date: August 10, 2020

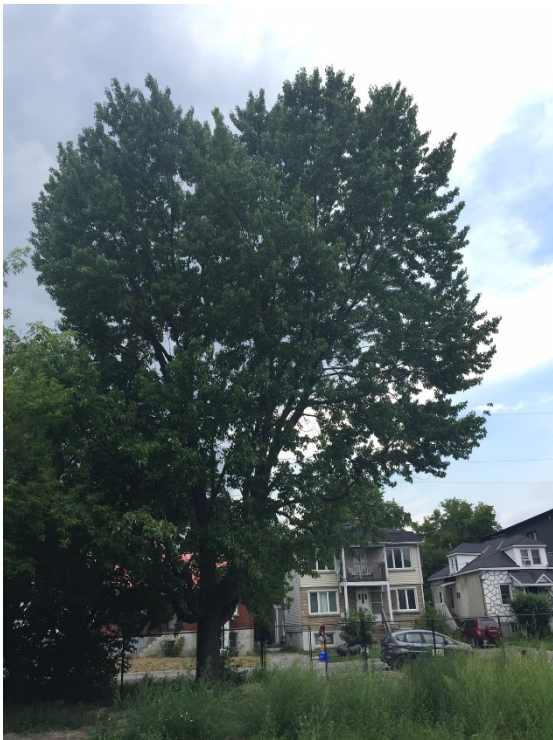
Tree 1, the large silver maple, is in fair condition. The crown is asymmetrical due to pruning by hydro along Ferland. There is decay visible in two of the inner branches as well as dieback (one being almost completely dead). Approximately 20% of the roots would have to be removed to accommodate the excavation for the new building. Furthermore, 25% of the crown would need to be removed to accommodate the three stories. This tree is already compromised and would be negatively impacted by the proposed construction that would likely lead to decline over the next 5-10 years. Furthermore, this species has a poor to medium tolerance to construction (*ISA, 2016, Best Management Practices: Managing Trees During Construction, Second Edition*). Combining all these factors together makes this tree unsuitable for retention on this site and removal and replacement is recommended.

Figure 1: Tree 1 - large silver maple to be removed

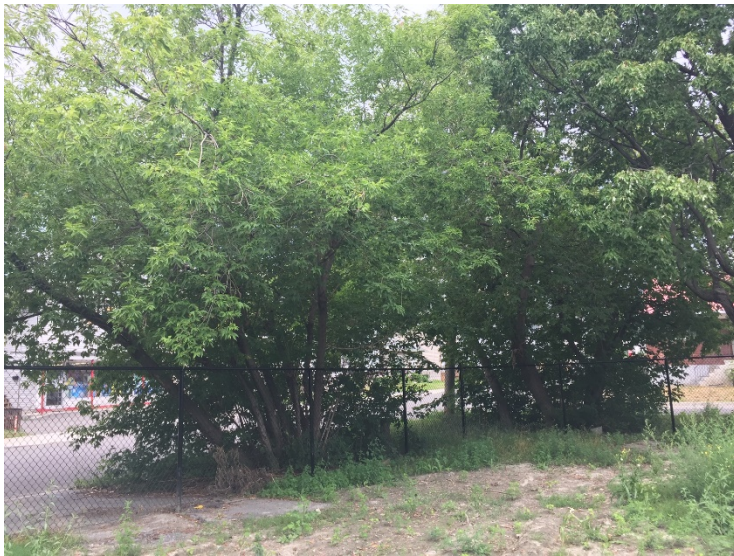
The remaining trees on this site are Manitoba maples that have seeded in naturally. This is a highly invasive species not suitable for retention and removal is recommended. Note that tree 6 is on neighbouring property with a critical root zone that is just on the edge of the excavation. If the neighbour wishes to remove this tree, this would be a good opportunity as the site is accessible. If the tree is retained, some pruning of the branches overhanging the property line will be required.

Figure 2: Trees 2-4 - clumps of Manitoba maples to be removed

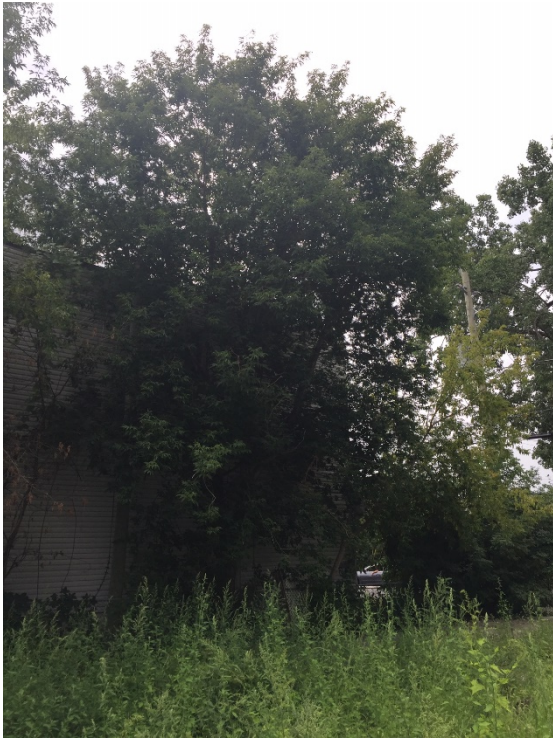
Figure 3: Tree 5 - Manitoba maple close to existing and future building- removal recommended
