URBAN FORESTRY & FOREST MANAGEMENT CONSULTING

August 7, 2020

RE: TREE PRESERVATION REPORT FOR SILVER MAPLE AT 28 PRETORIA AVENUE, OTTAWA

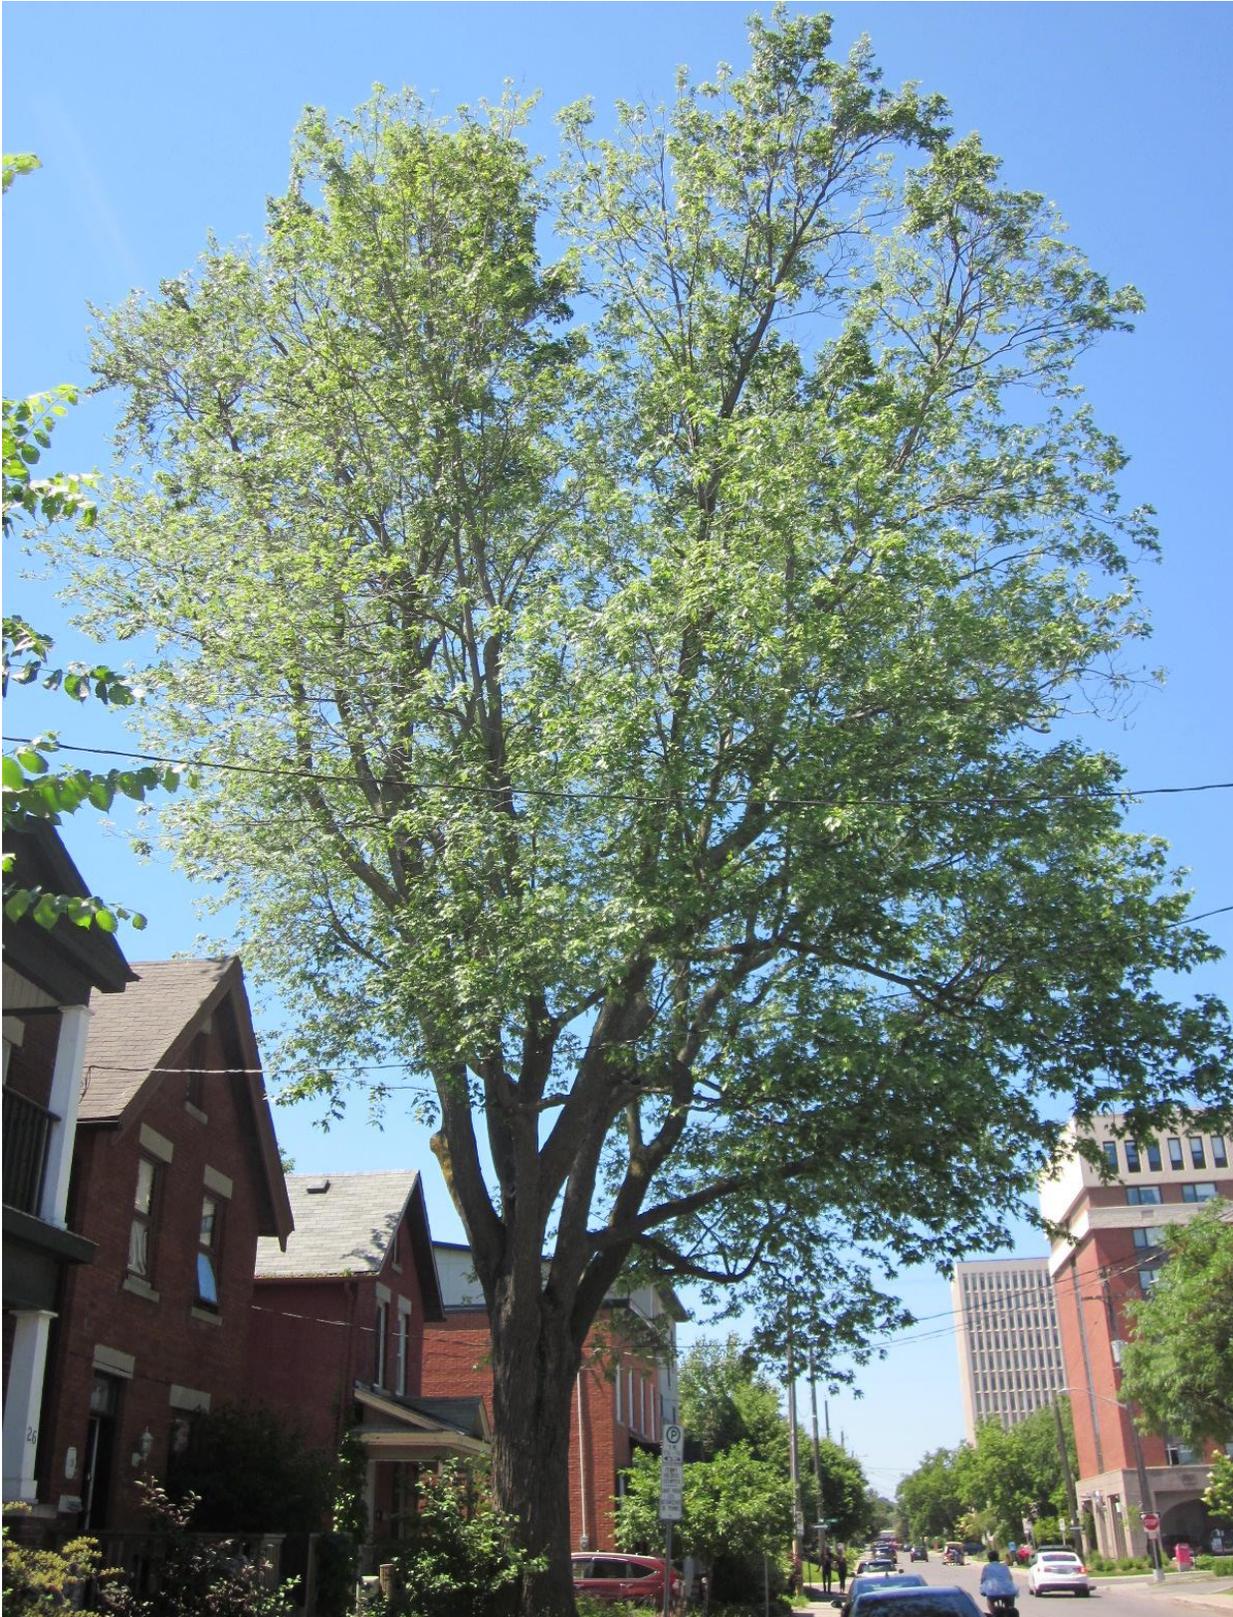
Picture 1. Silver maple on City of Ottawa property in front of 30 Pretoria Avenue (taken July 2019)

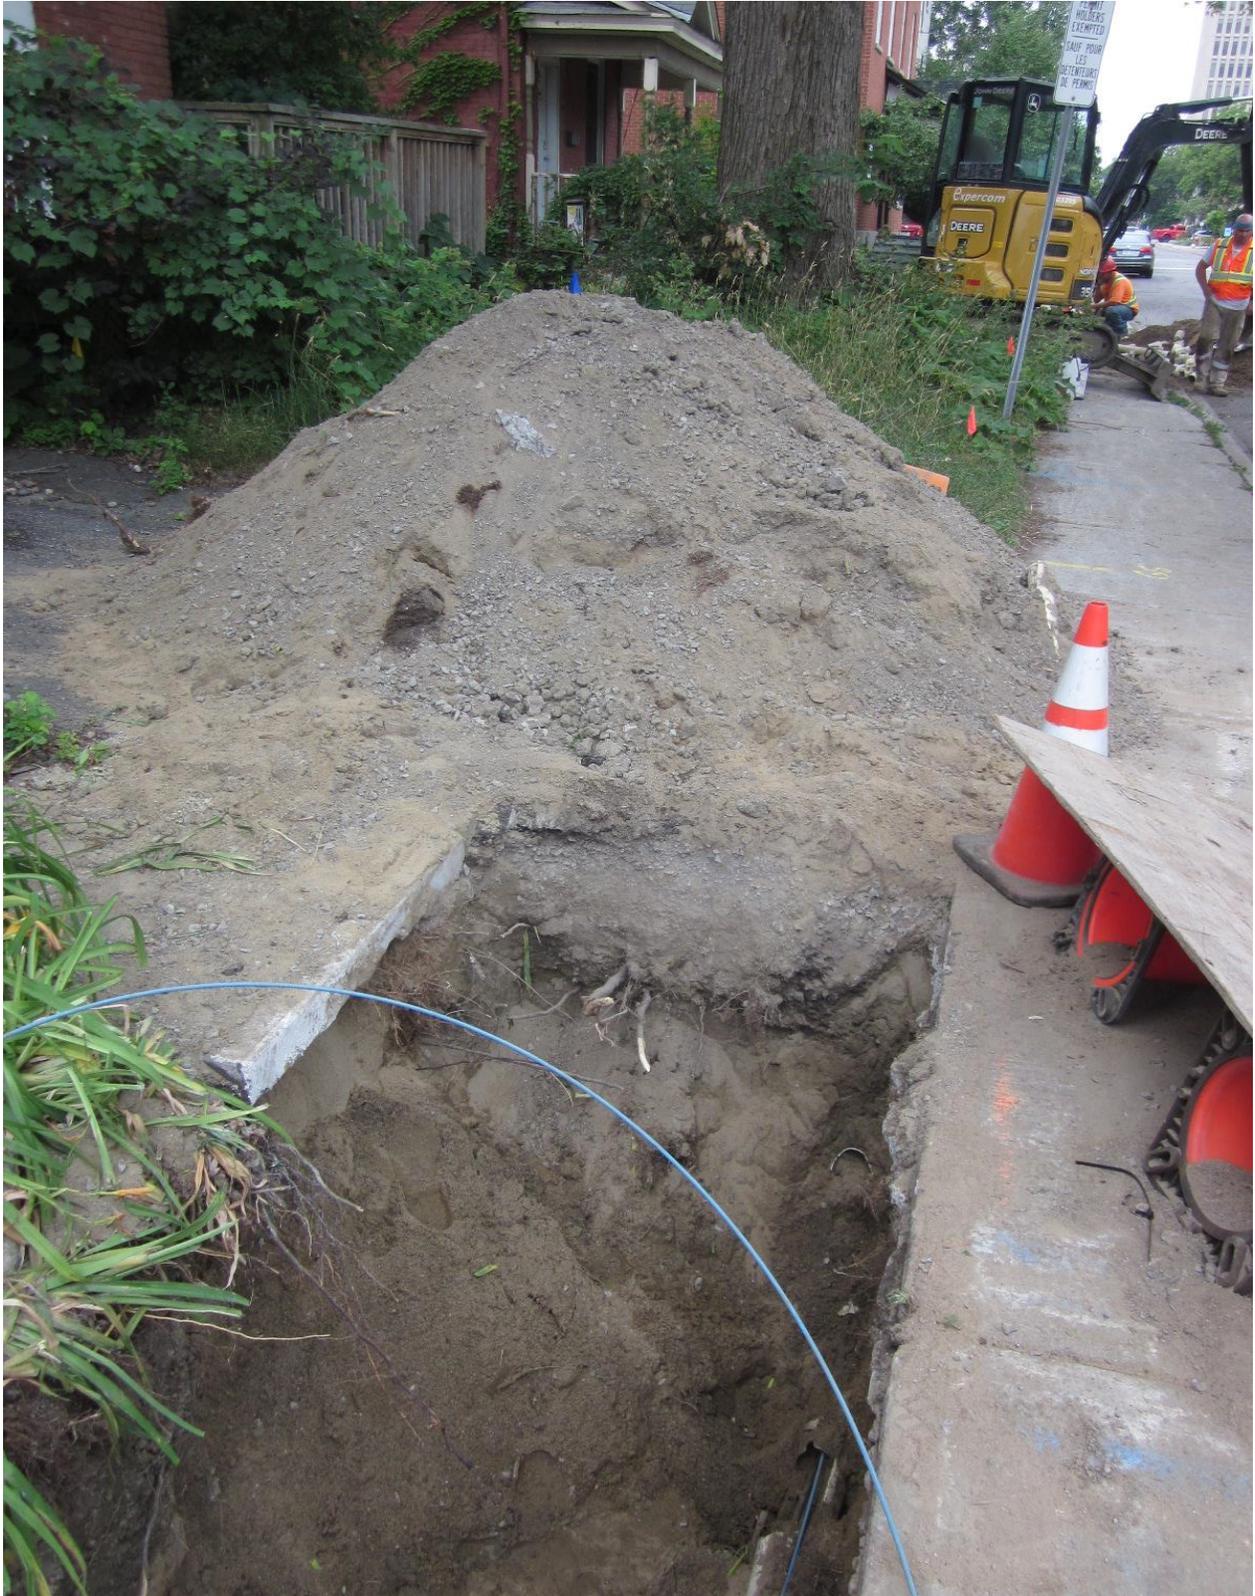
Picture 2. Recent root damage within maple's critical rooting zone due to work on Bell lines (taken July 2020)

- 3) Excavation & Exposed Roots: The use of hydro vacuuming to excavate around the tree will be required in order to carefully expose roots. Roots greater than 1cm in diameter should be cleanly cut at the furthest limits of the driveway. Bypass shears or a hand saw should be used for this work. Each cut root end should be sealed immediately with a beeswax compound. Once the exposed roots are properly treated excavation using traditional equipment can be used to complete the work.
- 4) Watering: Roots exposed during excavation should be immediately reburied with soil or temporarily covered with burlap, filter cloth or woodchips and kept moist (*i.e.* watering with a soft-spray nozzle at least three times a week). A covering of plastic should be used in order to retain moisture during an extended period when watering may not be possible (*i.e.* over long weekends).
