**re:     Geotechnical Response to City Comments**  
          **Proposed Commercial Building**  
          **2 Bill Leathem Drive - Ottawa**

**re:     Geotechnical Review - Slope Conditions**  
          **Proposed Commercial Building**  
          **2 Bill Leathem Drive - Ottawa**

**date:   September 17, 2020**

**file:   PG5257-MEMO.03**

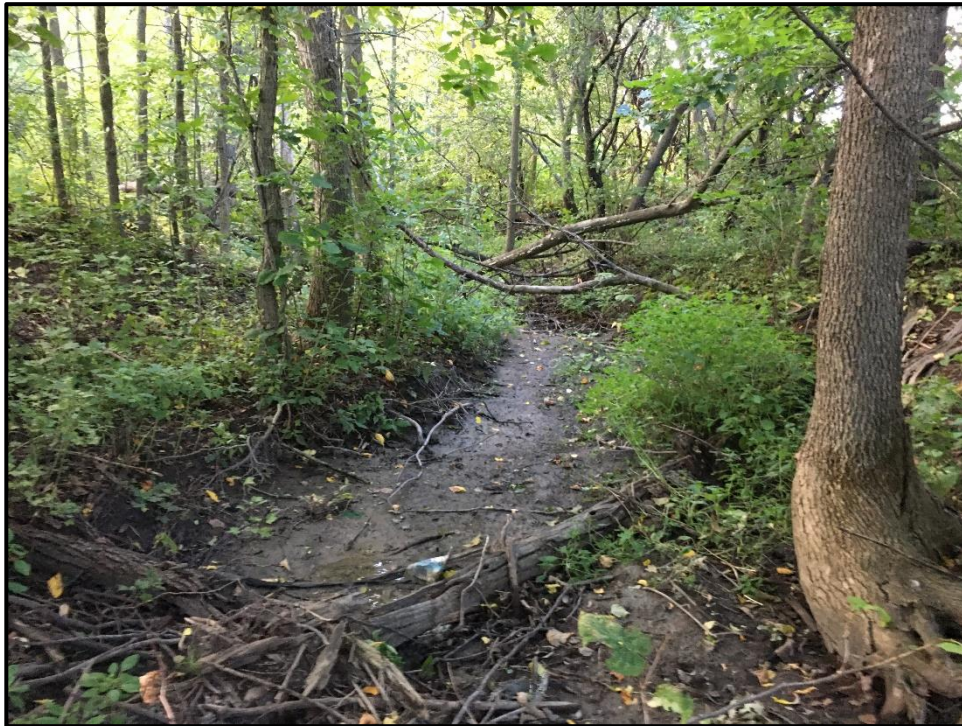
The channel of the ravine consisted of brown silty clay and its width varied between 2 to 8 m. At the time of our visit, the ravine channel was observed to be moist with minor water ponding in some areas, however, was not observed to be active.

Photo 1: General picture showing the vegetated slope and moist conditions of the ravine's channel.

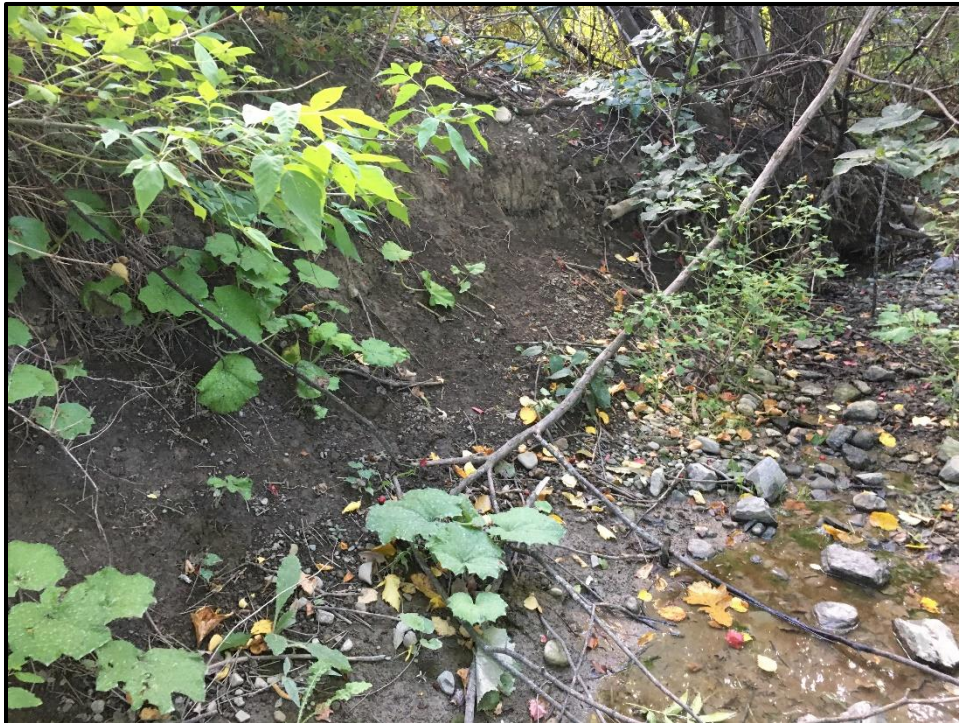
The side-slopes running alongside the ravine was observed to consist of a brown silty clay with some topsoil and being heavily vegetated from top to bottom. The height of the slopes, measured from toe of the slope to the observed top of the slope ranged between 2.5 m to 3.5 m with a maximum inclination of 3H:1V. Furthermore, some minor erosion extending up to 300 mm from the toe of the slopes was observed in some areas of the ravine course.

Photo 2: Close up picture showing one of the areas with minor erosion extending up 300 mm from the toe of the slope.

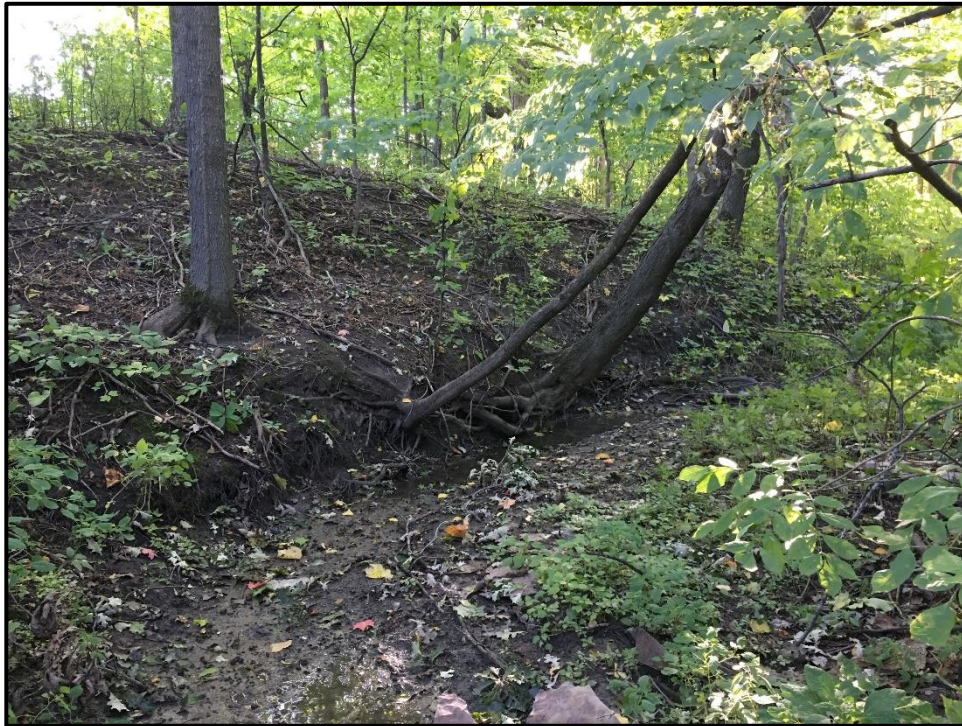
Based on our cursory review, the ravines side-slopes are considered to be stable from a geotechnical perspective.

Photo 3: Showing the 3H:1V inclination of the slope with a height varying from 2.5 m to 3.5 m from top to toe.
