URBAN FORESTRY & FOREST MANAGEMENT CONSULTING

RE. CEDAR HEDGE ADJACENT TO 3368 CARLING AVE.

As per your request, this brief report details a condition assessment of the cedar hedge located south of the subject property at 3368 Carling Avenue.

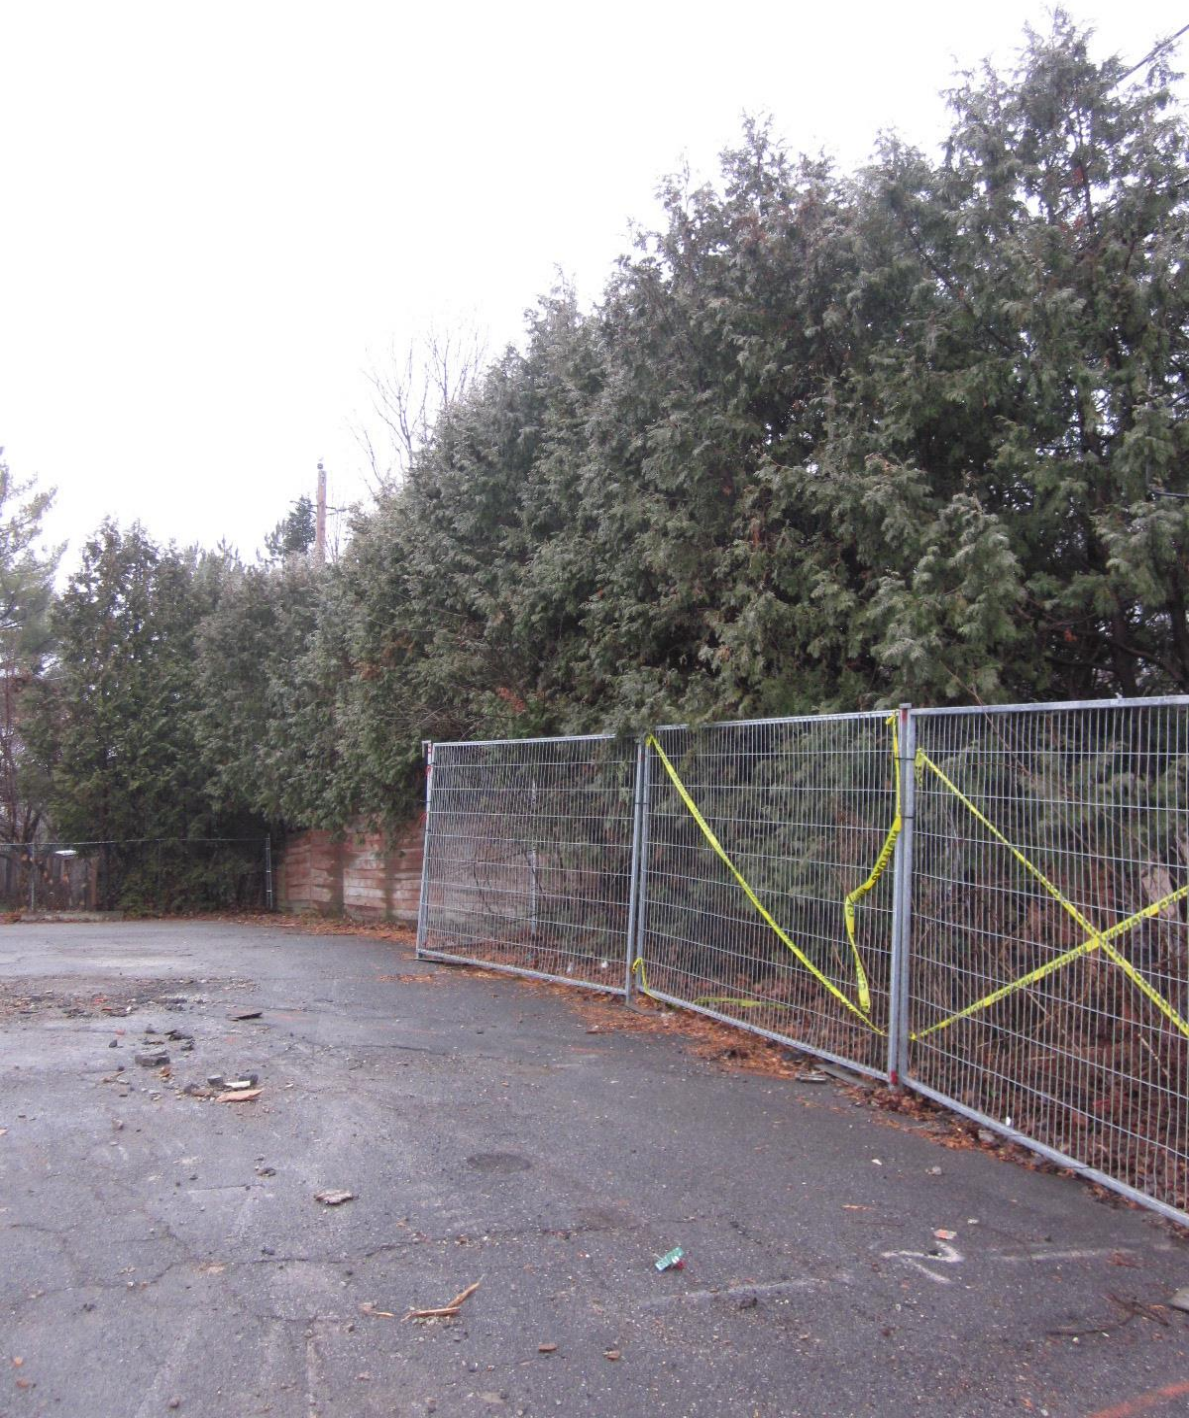
The first assessment of this white cedar (*Thuja occidentalis*) hedge was performed in January of 2016. At that time it was found to be in good condition with an average diameter at breast height of 7cm. In the years since it has suffered disturbance due to the need to excavate and remove infrastructure below the subject property. According to those who were present at the time, this excavation ran for the majority of the length of the hedge and within 50cm from the nearby wooden privacy fence which is located on private property. However, judging from my inspection of the hedge again last month, the impact on its health appears to have been minimal. I suspect the loss of roots was not as much as would normally be anticipated. This is likely the result of the long presence of asphalt over much of the subject property – a surface treatment which tends to prevent the growth and development of roots (see Picture 1 on page 2). In fact, according to at least one person who was present at the time, few exposed roots were observed within the excavated trench.

Picture 1. Cedar hedge to be retained on adjacent private property south of 3368 Carling Ave – photo taken in 2016. Note the presence of asphalt in close proximity to the wooden fence on private property.

Protection and amelioration of the soils within 1.2m of the fence is important, especially during construction. To this end the following measures are recommended:

- 1) Removal of debris from the area within 1.2m of the fence, leveling of soil surface by the addition of topsoil and covering the entire area with 5cm of composted woodchip mulch. This must be done without machinery entering the 1.2m zone.

- 2) Erecting metal construction fence at 1.2m from the wooden fence with signage attached indicating the presence of the fence as a tree protection barrier prohibiting the use of machinery or stock piling of materials within the protected area.
- 3) Once the retaining wall is complete, repeating the soil levelling and mulching between 1.2-3m from the wooden fence and moving the metal construction fence so that it is against the back of the retaining wall. This fence is to remain in place until the completion of all construction.
