December 15, 2020

**RE: TREE CONSERVATION REPORT FOR 78-90 BEECHWOOD AVENUE & 69-93 BARRETTE STREET, OTTAWA**

This report details a pre-construction Tree Conservation Report (TCR) for the above-noted cluster of properties in Ottawa. The need for this TCR is related to the proposed demolition of multiple commercial buildings along Beechwood Avenue and residential dwellings along Barrette Street, and in their place construction of a 9-storey mixed-use building with two levels underground parking.

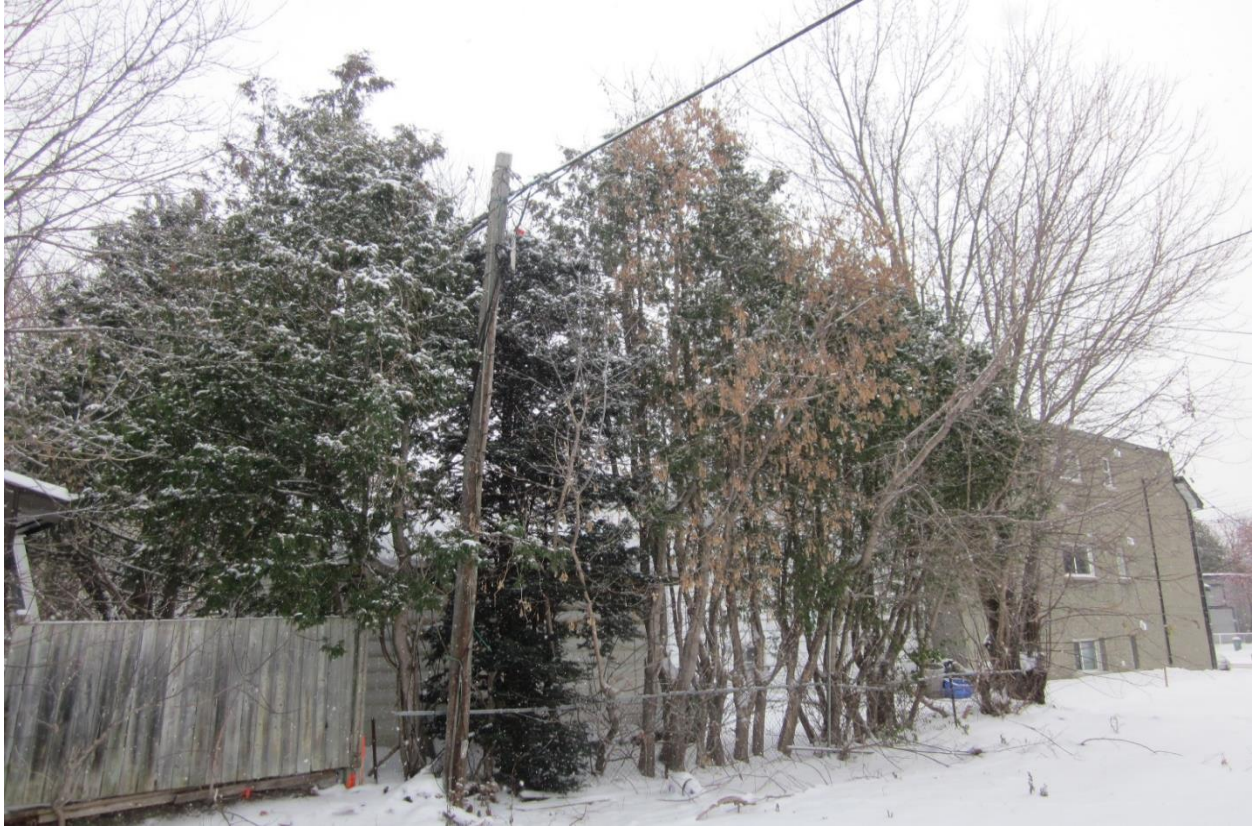
Picture 1. Trees #2, 3 and 4 (left to right), shared with adjacent property (taken November 2019)

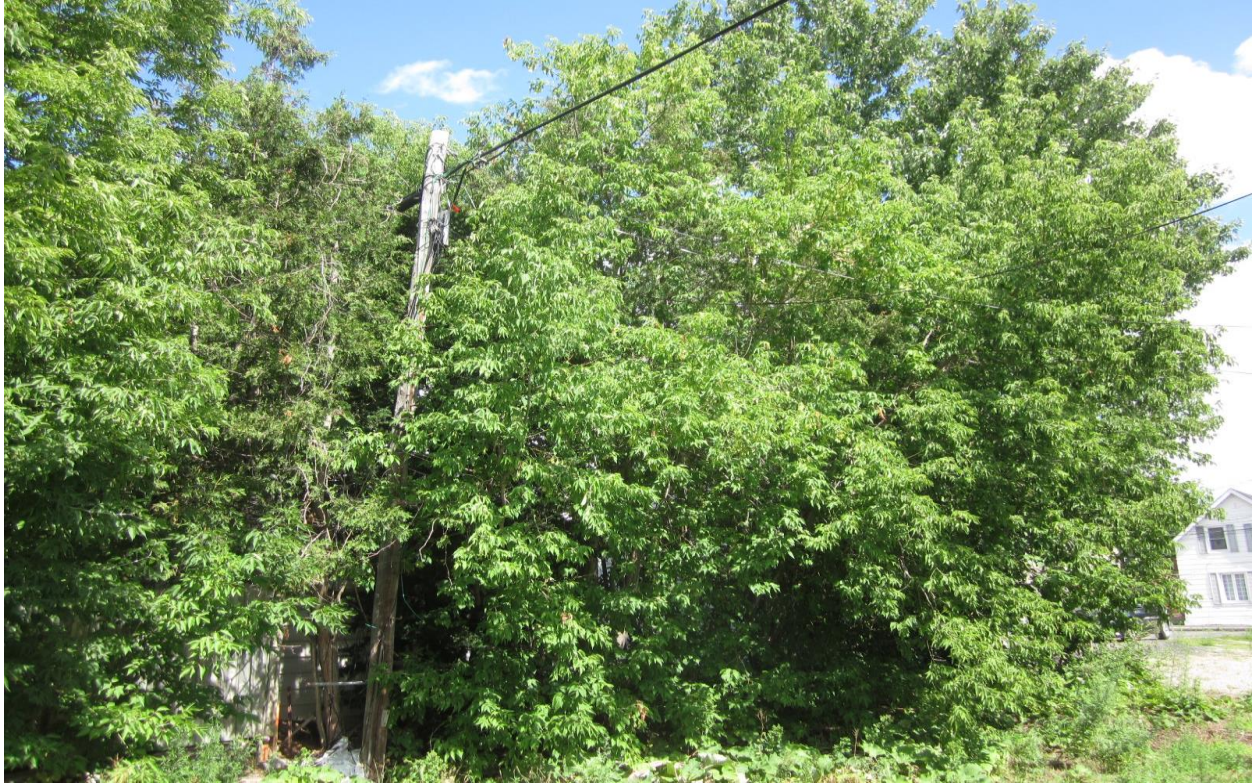
Picture 2. Same picture as above taken in July 2020

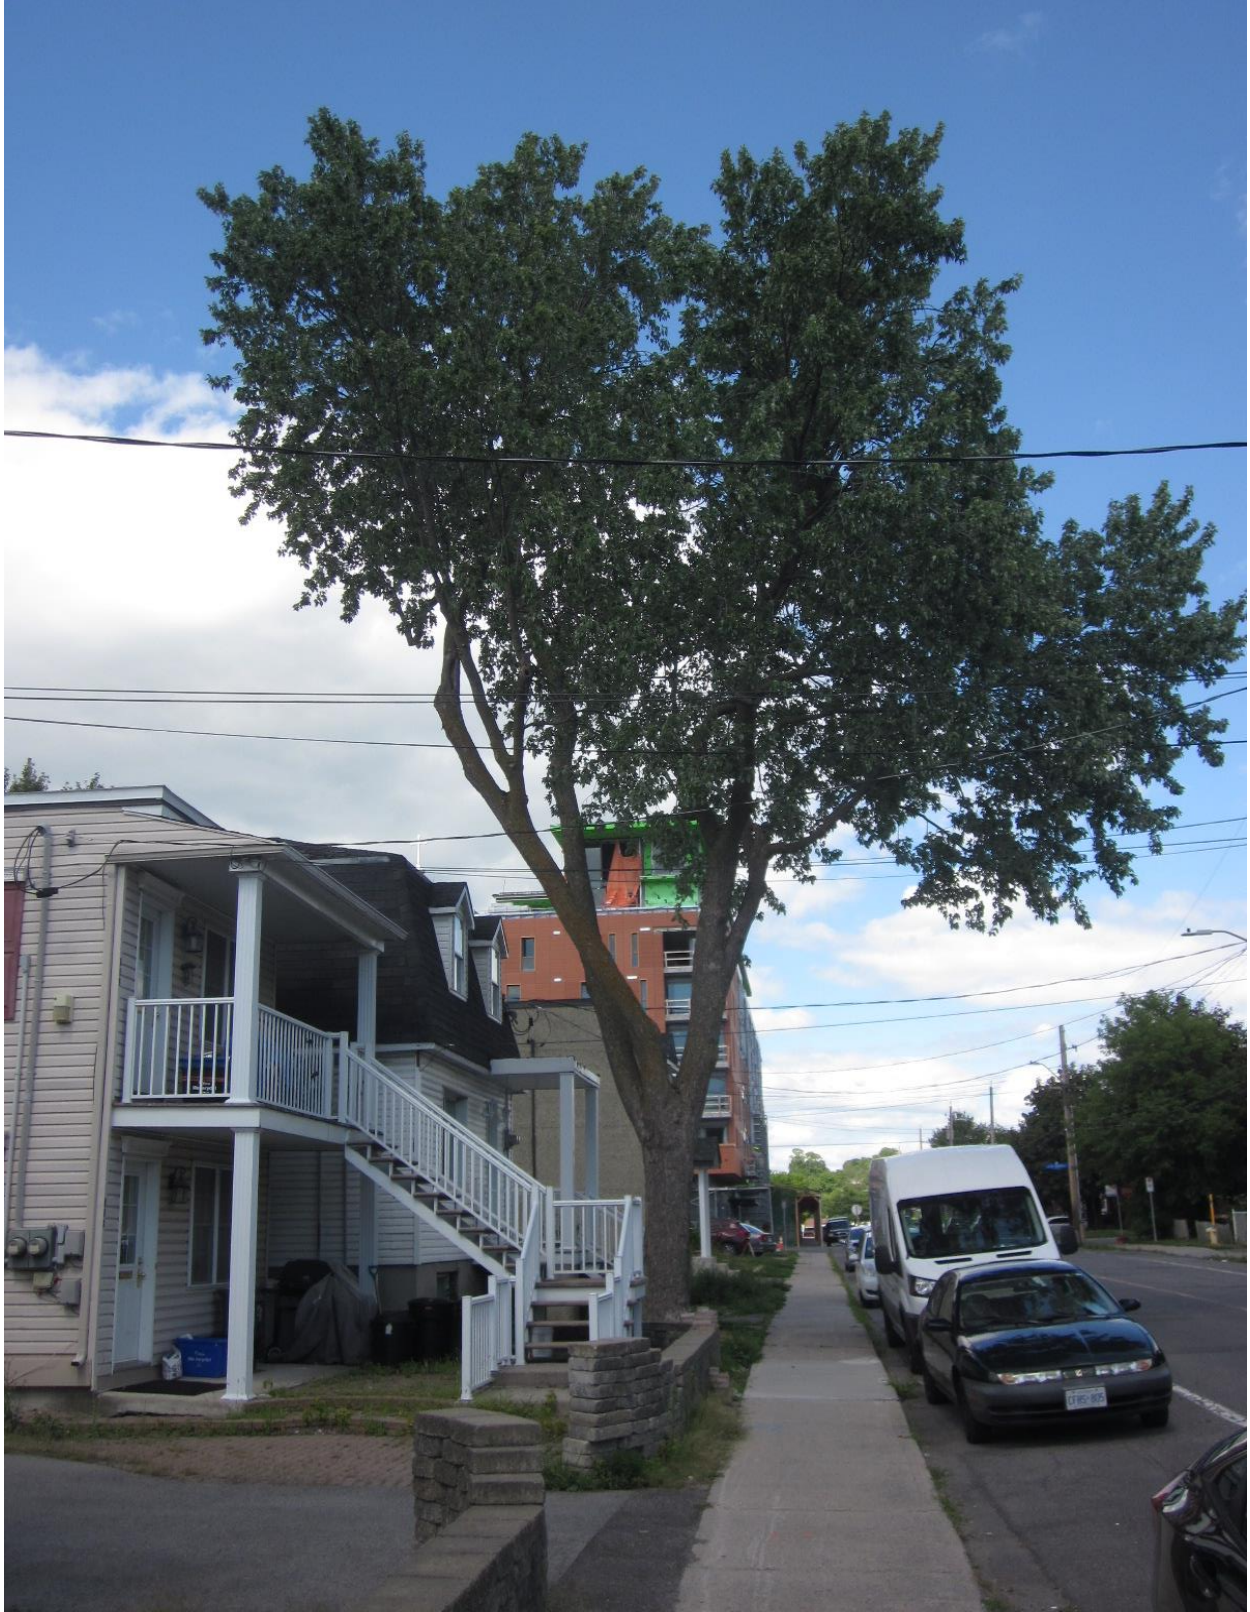
5	Silver maple	Good	64	City	Mature; tri-stemmed at 3m from grade; generally upright form due to past pruning from house and over road; very limited rooting area between foundation and sidewalk; native species; <b>to be removed</b> (conflicts with construction)
6	Manitoba maple	Fair	55 & 60	Private	Mature; double-stemmed from grade; crown divergent towards northwest due to past pruning from house; broad, dense crown; originated from seed; naturalized species; <b>to be removed</b> (conflicts with construction)

Picture 3. Tree #5 – city owned silver maple (taken July 2020)

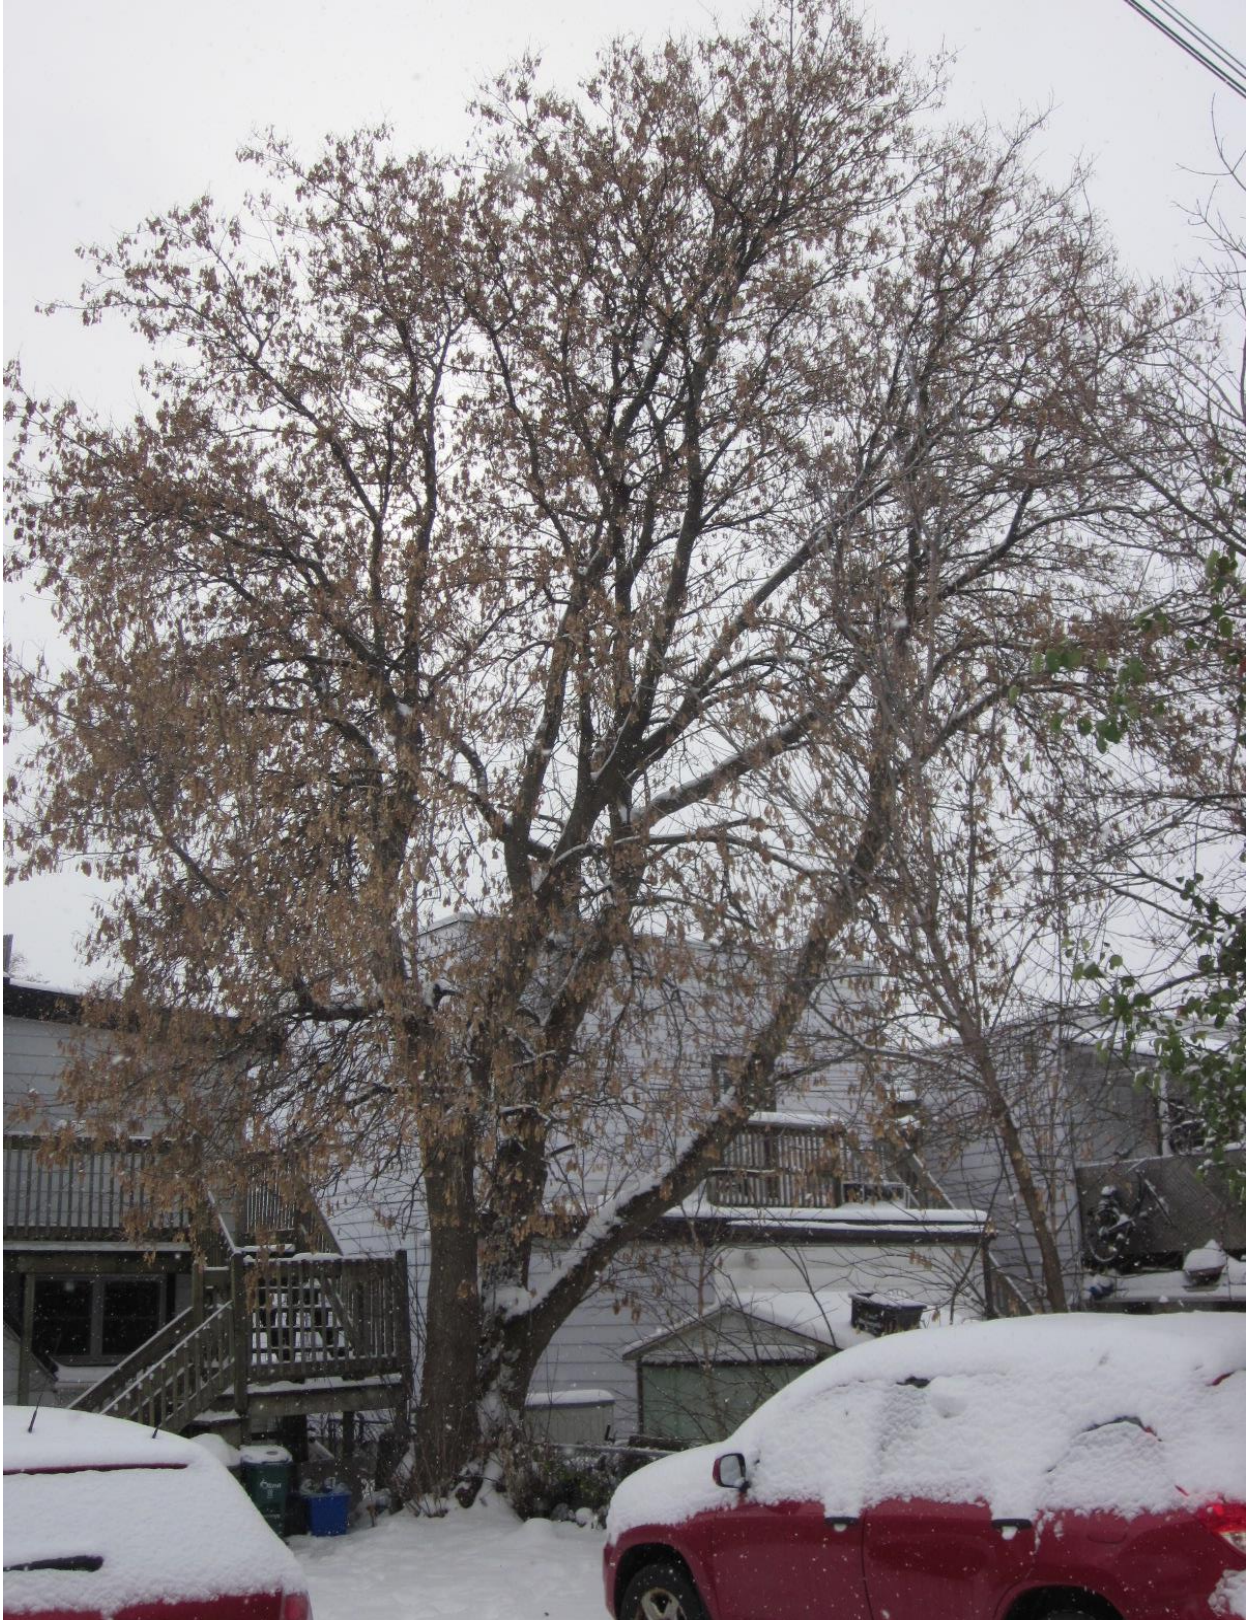
Picture 4. Manitoba maple #6 – on private (subject) property (taken November 2019)

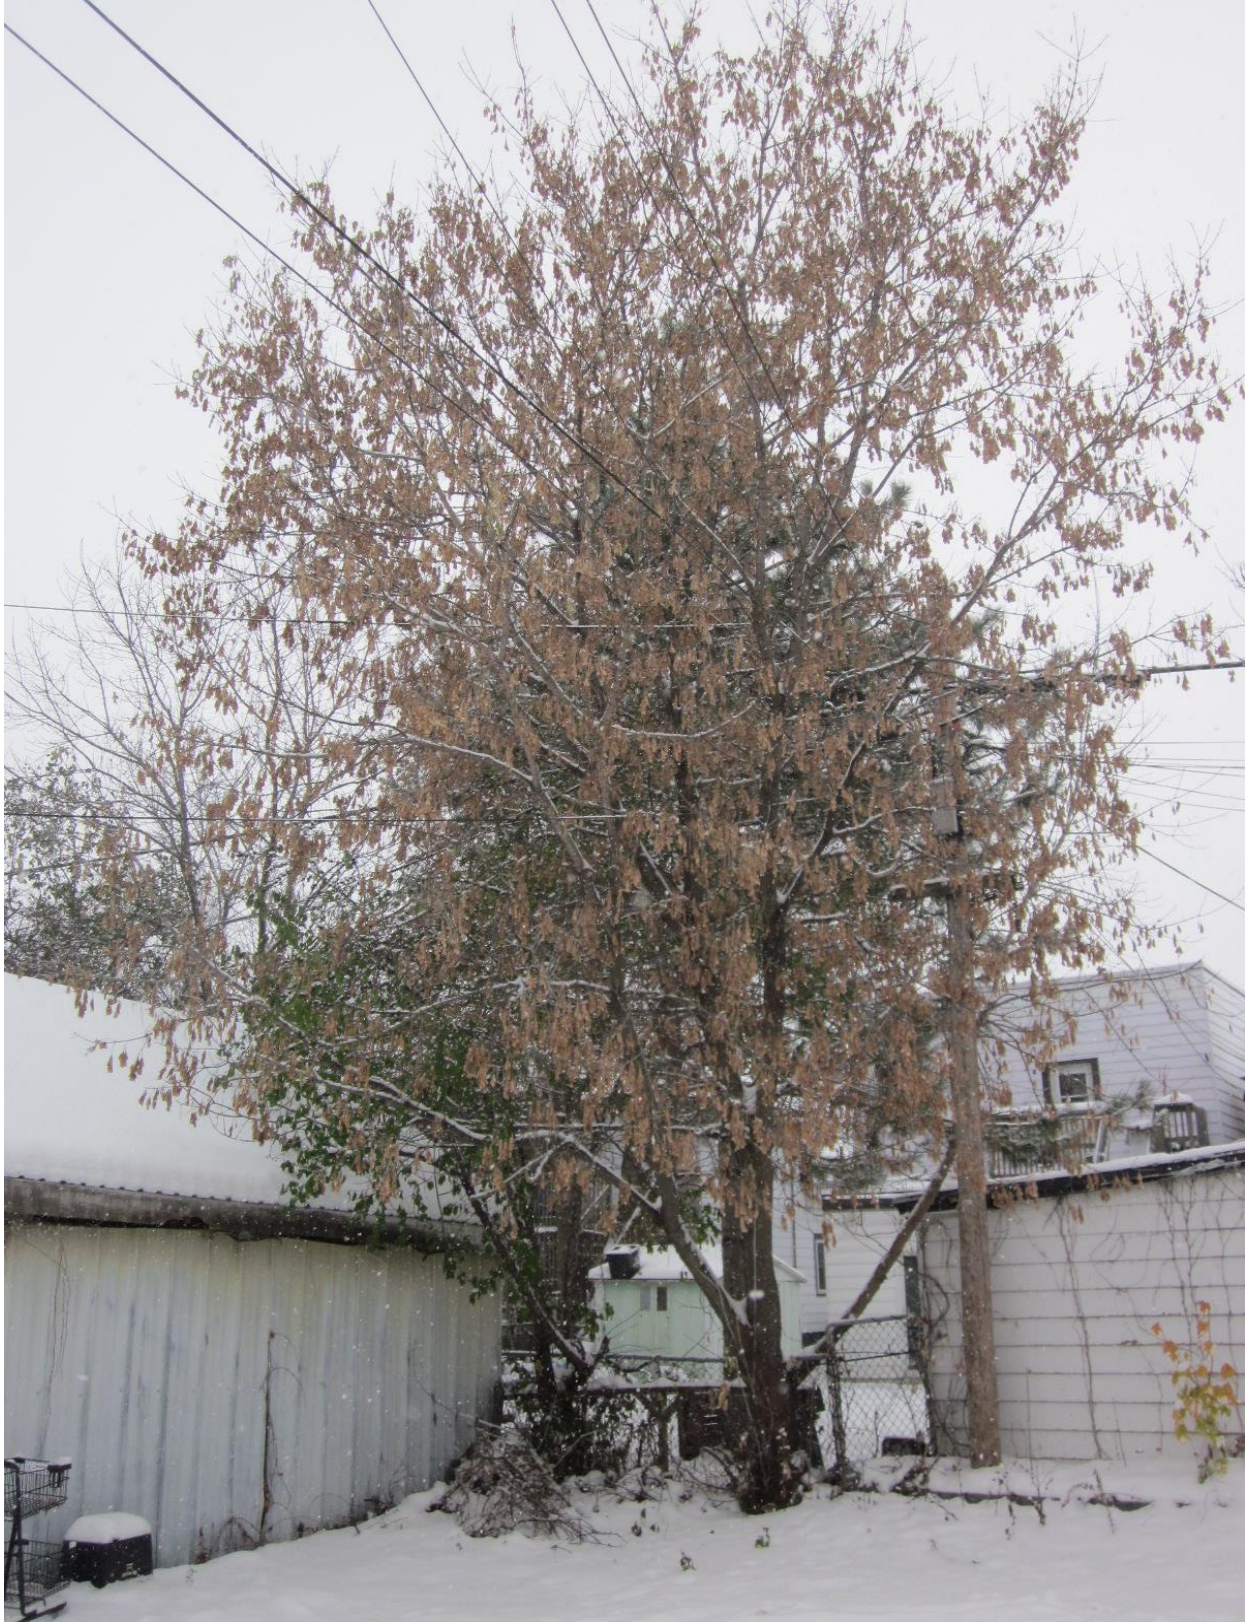
Picture 5. Manitoba maple #8 on private (subject) property (taken November 2019)

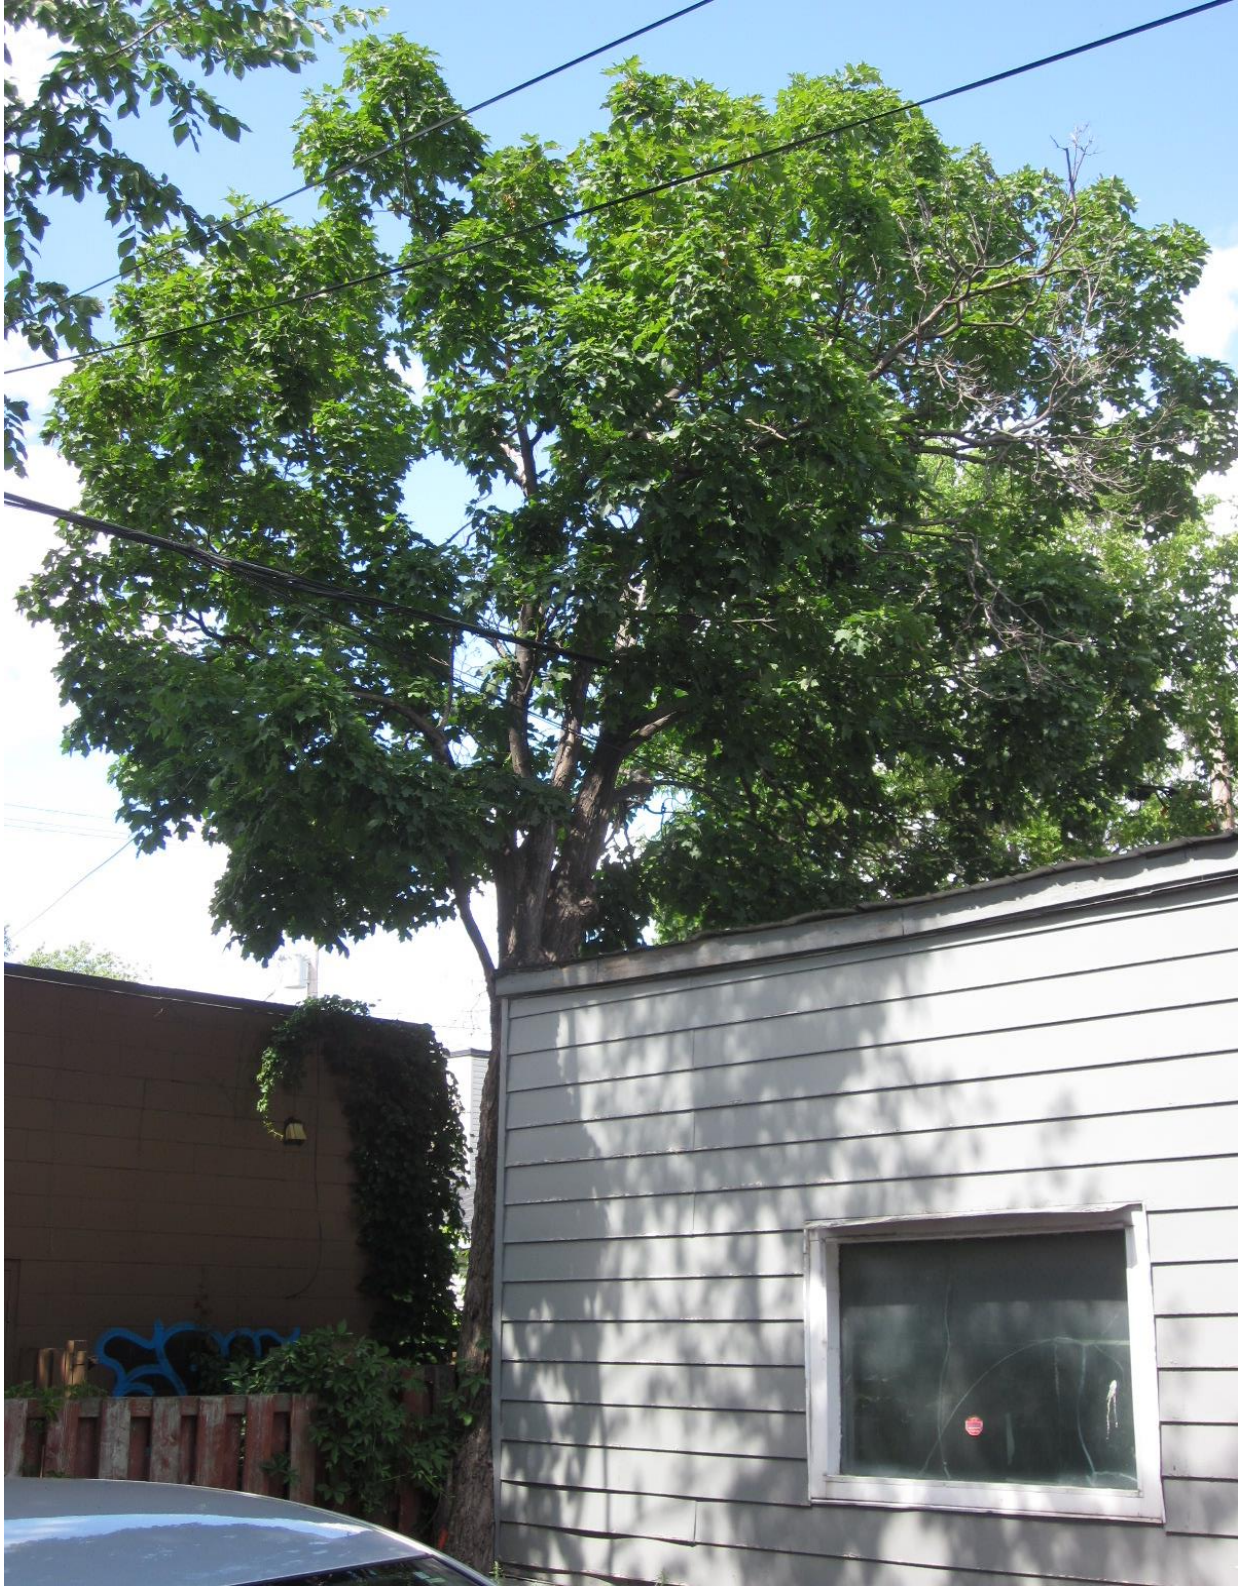
Picture 6. Tree #9 – shared sugar maple (taken July 2020)
