# SUPPLEMENTARY TREE CONSERVATION REPORT

**1050&1060 Bank Street**

**Supplemental Report to Tree Conservation  
Report submitted as Partial Requirements  
for a Site Plan Control Application**

**Date:** November 20, 2020

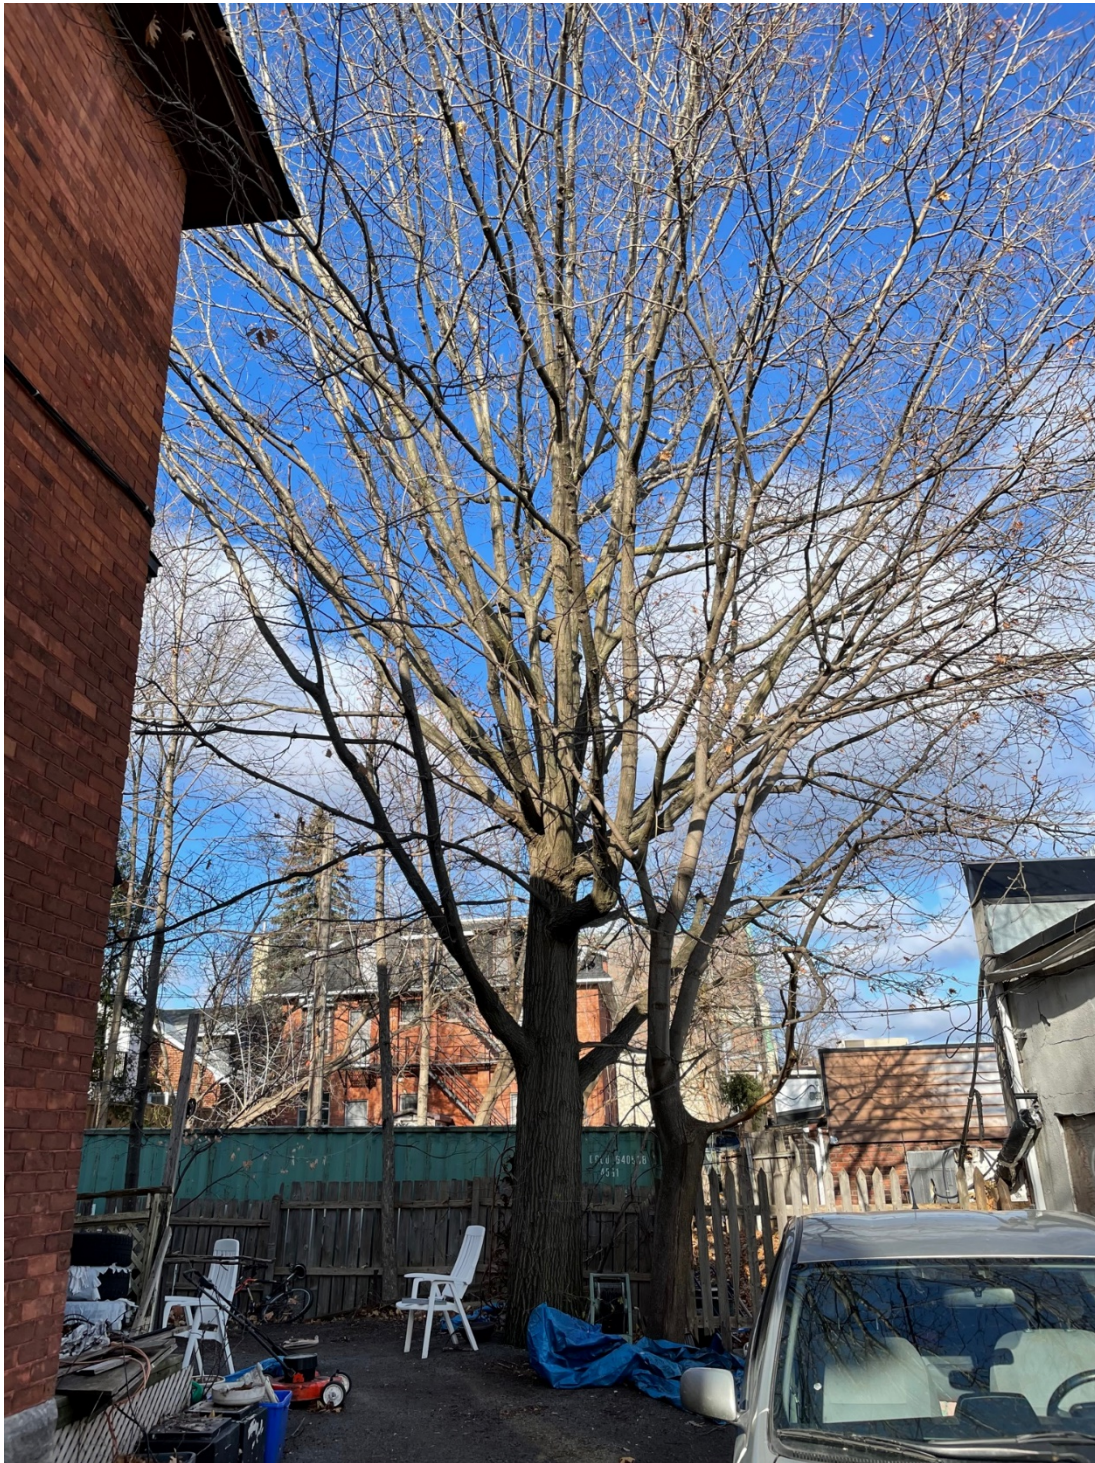
The red oak lies entirely on the 9-11 Euclid property; however, the roots most likely extend onto the adjacent city lane. The tree is currently in good health and has a diameter of 65 cm. The surrounding rooting area is made of hard surface asphalt. The trunk of the tree has outgrown its space and is currently being girdled by the asphalt at the base (see photo). This restriction in growth should be addressed to prevent further girdling of the trunk and roots that could lead to tree decline in the near future.

Figure 1: Photo of tree taken from the Euclid side

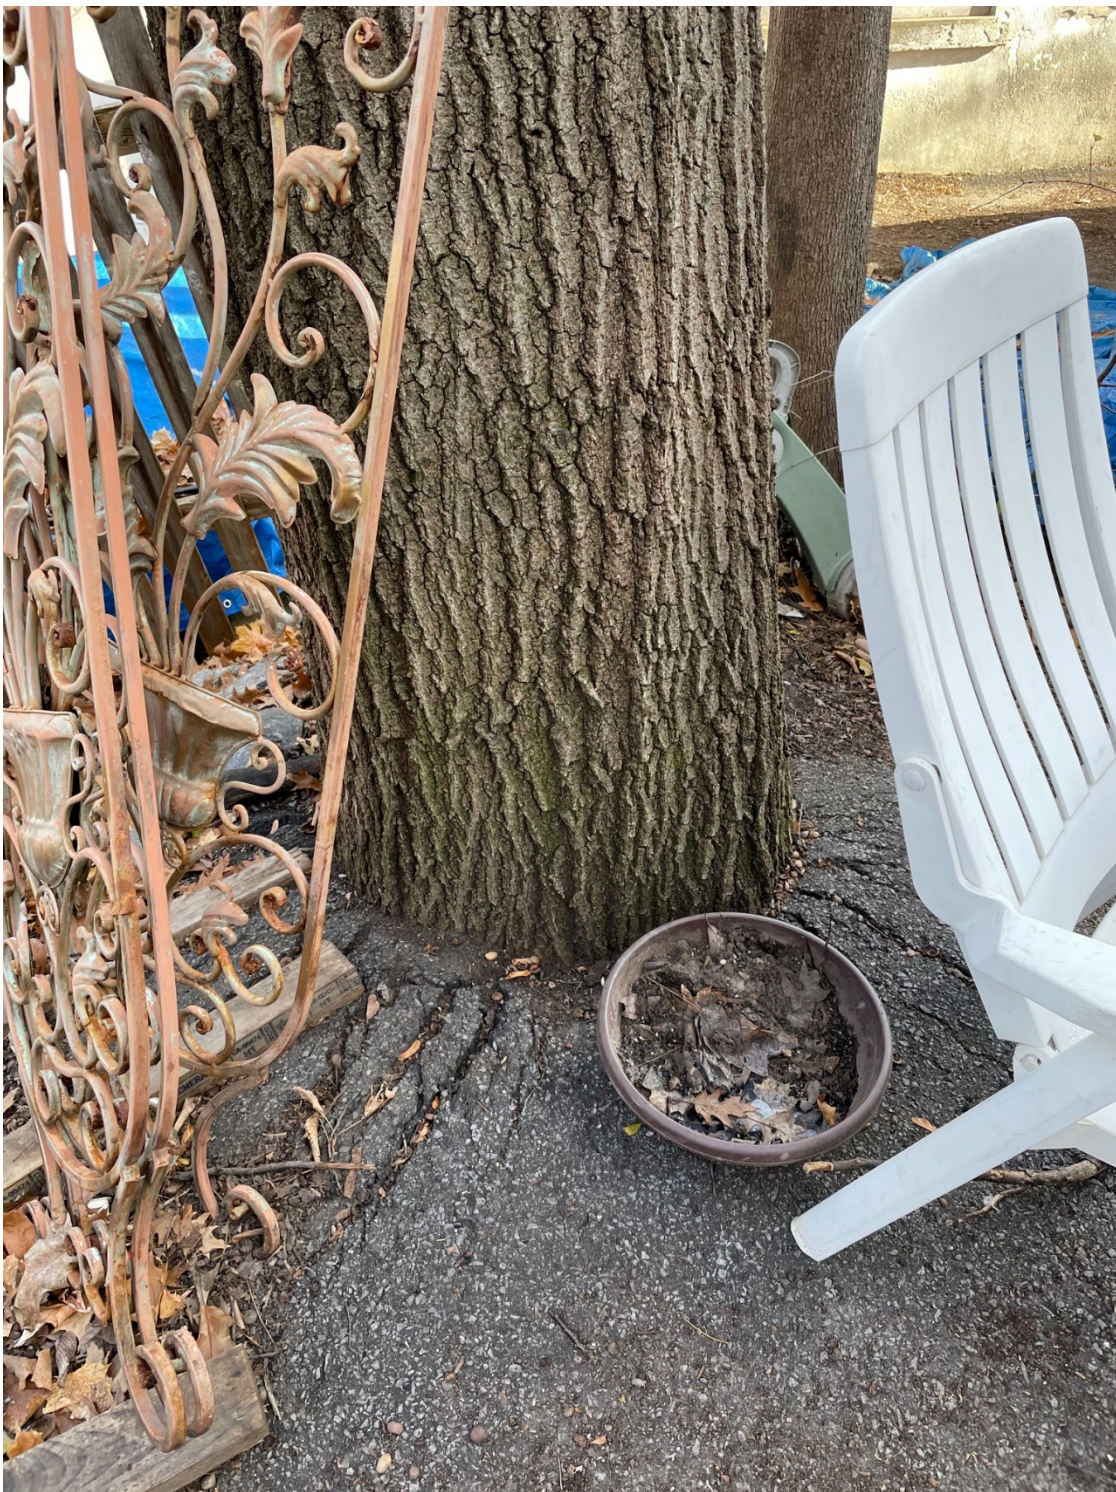
Figure 2: Photo showing how the asphalt is girdling the base of the tree

- 1) Removing the asphalt by peeling it off with as little disruption to the roots as possible
- 2) Replacing the current soil within the tree roots with a structural soil as recommended in the Tree Conservation Report prepared by James B Lennox & Associates. Hydrovacing may not be required if the soil can be replaced manually. If a very low pressure is not used, hydrovacing can

damage the roots by stripping off the bark. Furthermore, it can be costly. If the work can be completed manually, this would be the preferred method to maximize tree protection.

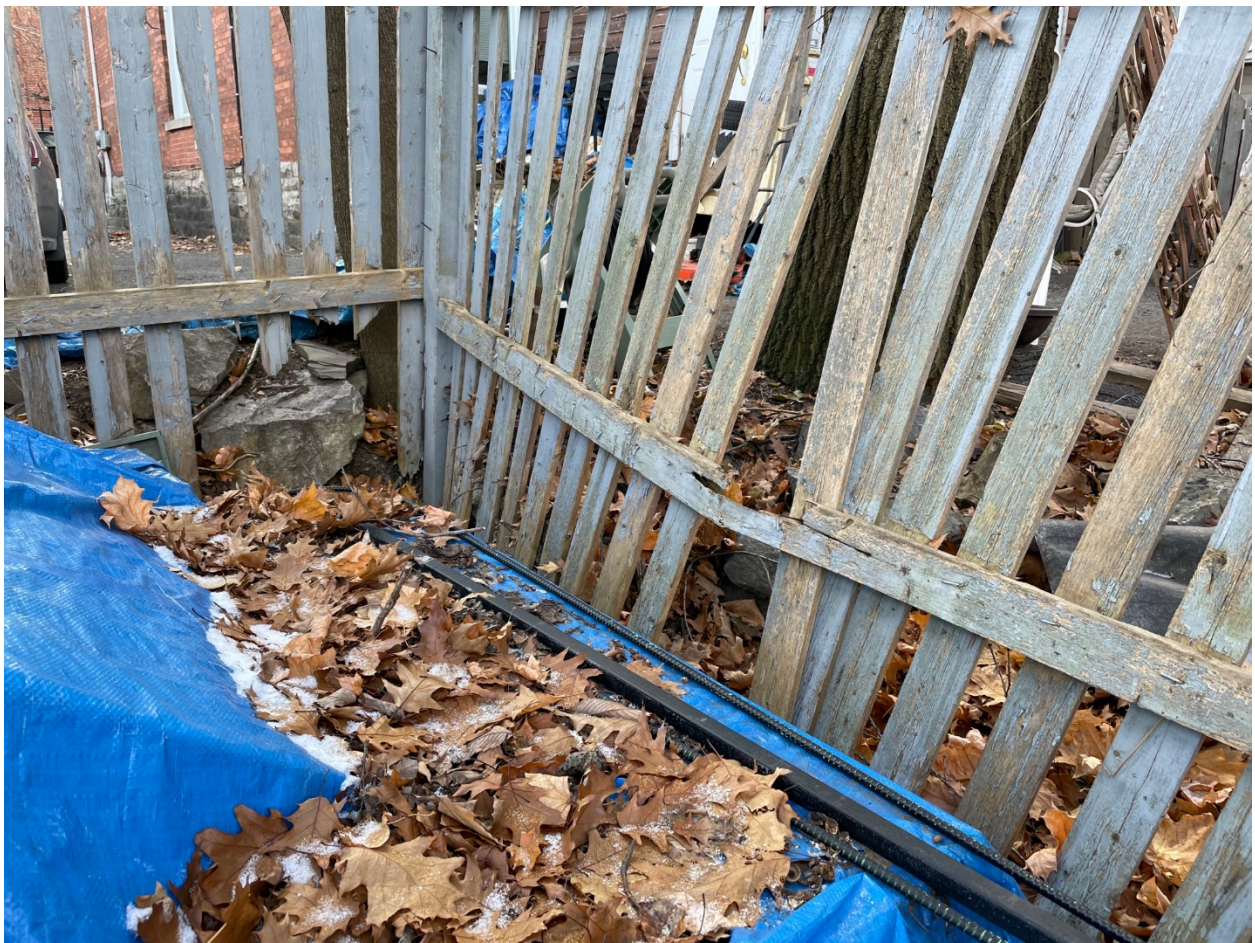
Right beside the tree to the northeast side, there is a sharp drop of approximately 80 cm in elevation and the retaining wall is made up of large rocks. Due to this significant elevation change, it is unlikely that there are roots growing under asphalt in the lower portion of the city lane. It is most likely that those roots that lie under the asphalt on the city lane are entirely in the upper portion that is at the same grade as the tree. Based on this assumption, the estimated rooting area has been drawn on the Tree Conservation Report map. The majority of the roots most likely exist on the property at 9-11 Euclid.

Figure 3: Photo taken from the Bank side demonstrating the 80 cm grade change right beside the tree

- 3) The remaining lane will be graded to match the existing grade. Care should be taken when removing the rocks not to damage any of the roots that may be growing underneath.
