16 October 2019 Project No. 19131354

PHASE ONE ESA UPDATE, BLOCK 232, 1055 CEDAR CREEK DRIVE OTTAWA, ONTARIO

Golder Associates Ltd. (Golder) was retained by DCR/Phoenix Group of Companies (Phoenix) to complete a Phase One Environmental Site Assessment (ESA) Update for Block 232, 1055 Cedar Creek Dive in Ottawa, Ontario (the "Site"). Golder previously completed a Phase One ESA for the larger subdivision development property in 2013 "Phase I ESA – 4800 Bank Street, Remer Lands, Ottawa, Ontario, 13-1121-0083 (1011)" prepared by Golder for Leitrim South Holdings Inc. in November 2013 ("2013 Phase I ESA"). The purpose of this Phase One ESA Update is to provide an update on the 2013 Phase I ESA in relation to the Site and outline any changes to the findings from the 2013 Phase One ESA.

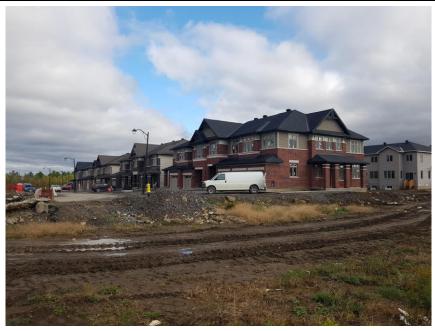
Photo 1 – Photo from the Site looking north towards residential development

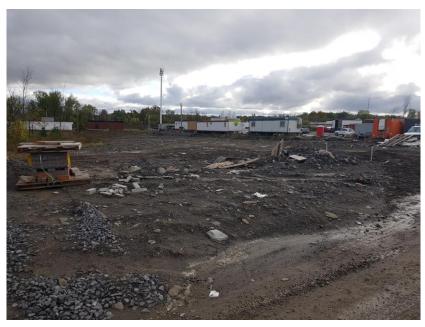
Photo 2 – Construction Staging east of the Site, east of Cedar Creek Drive

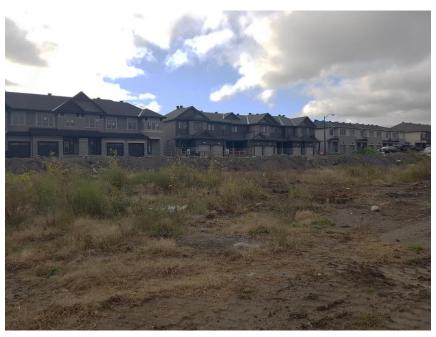
Photo 3 – Photo from the Site looking south towards residential development

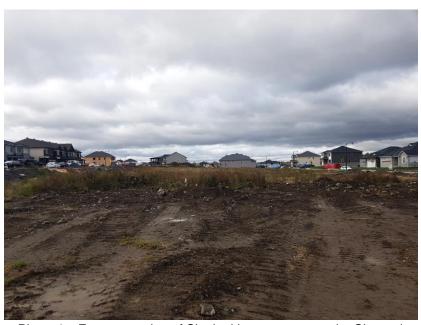
Photo 4 – Eastern portion of Site looking west across the Site and to residential development west of the Site

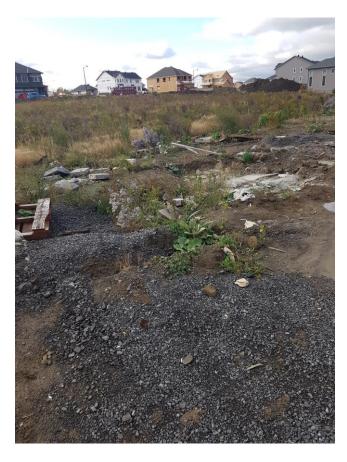
Topic	Observations	Comment / Source
Sanitary/Process Wastewater Receptor	Not applicable	No building
Sanitary Sewer Connection	Not applicable – sanitary sewer is stubbed 1 metre into the property line	No building
Septic Systems	None observed	Site observations
Storm Water Flow	Infiltration into surface soil or runoff to catch basins along Salamander Way to the north	Site observations
Storm Sewer Connection	Not applicable – Storm sewer is stubbed 1 metre into the property line	No building
Ground Cover (i.e. grass, gravel, soil, or pavement, etc.)	Eastern portion of the Site was bare topsoil, western portion of the Site was vegetated	Site observations
Current or Former Railway Lines or Spurs	None observed	Site observations and aerial photographs
Presence of Stained Soil, Vegetation, or Pavement	None observed	Site observations
Presence of Stressed Vegetation	None observed	Site observations
Presence of Fill and/or Debris Materials	Some construction related debris and gravel observed on Site.	Site observations

Photo 5 - Construction debris located on Site
