URBAN FORESTRY & FOREST MANAGEMENT CONSULTING

June 30, 2021

RE: TREE CONSERVATION REPORT FOR 180 KANATA AVENUE, OTTAWA

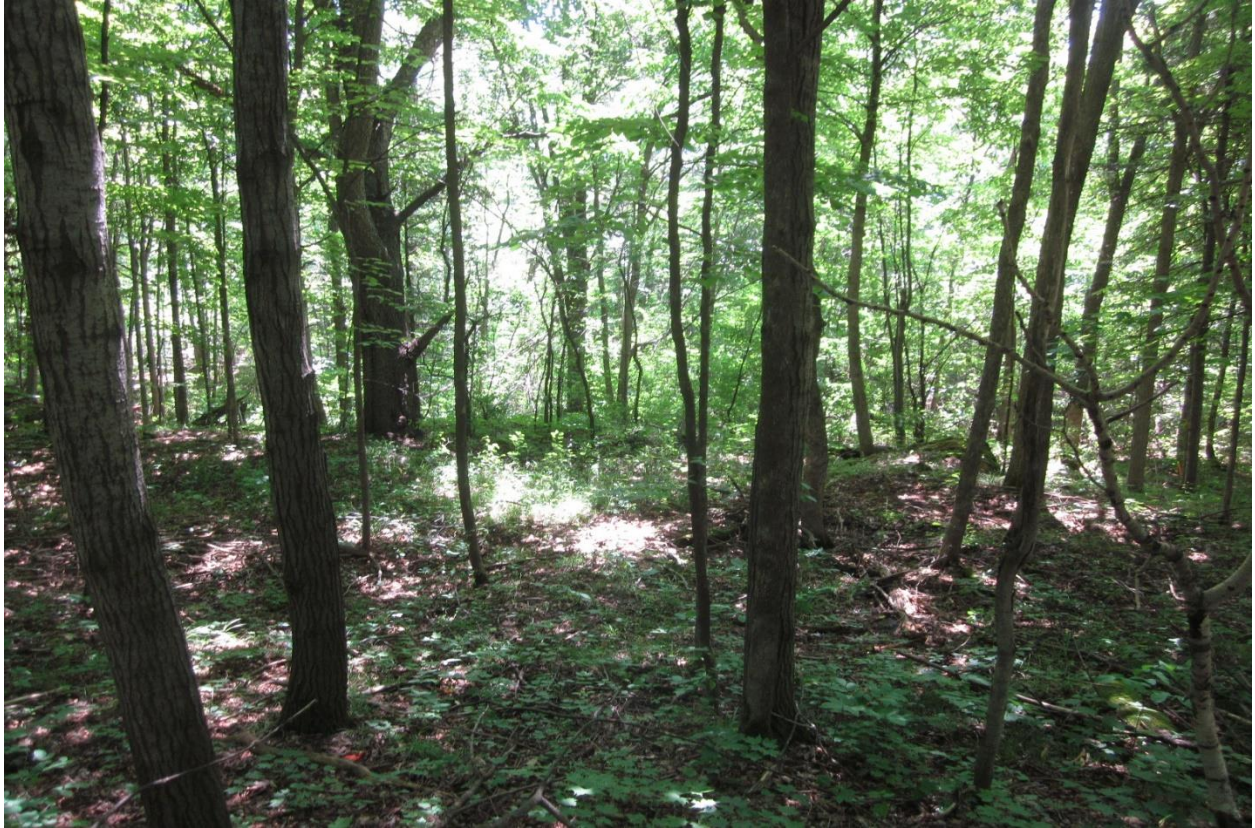
Picture 1. Typical over- and understory conditions at 180 Kanata Avenue property (looking southeastward)

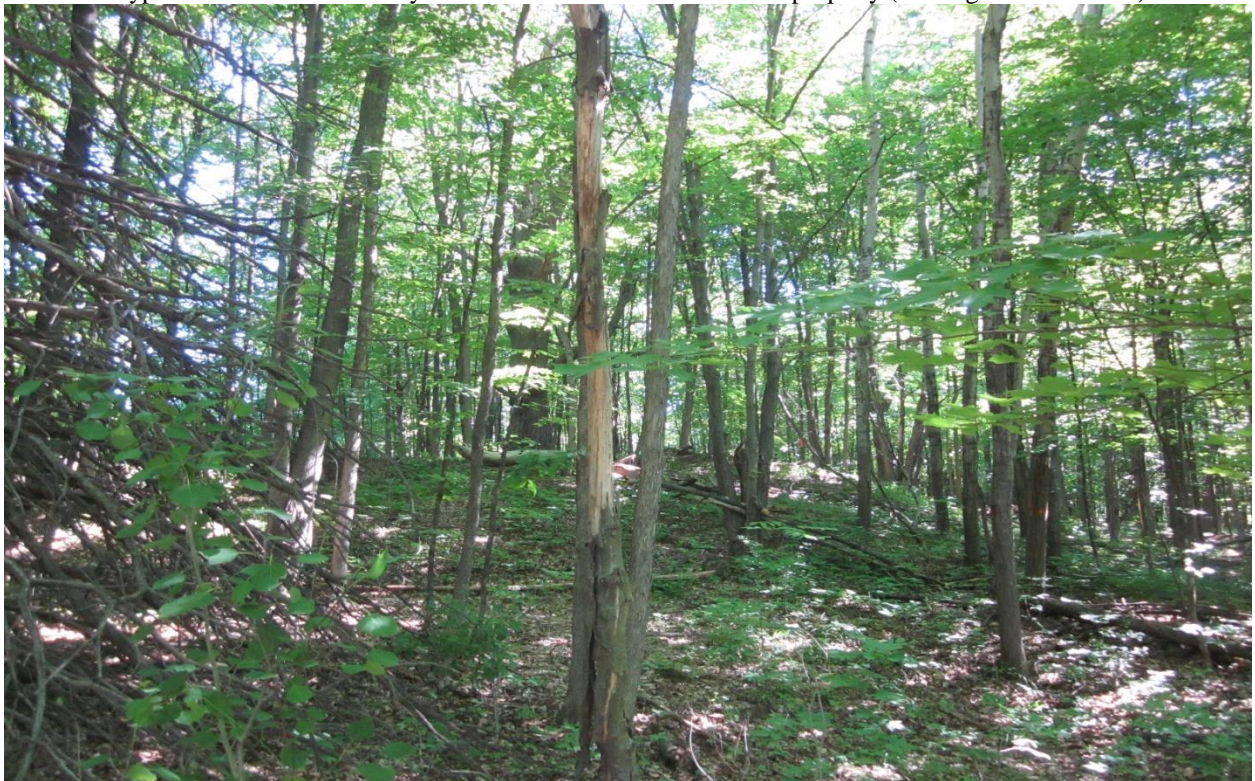
Picture 2. Typical over- and understory conditions at 180 Kanata Avenue property (looking northeastward)

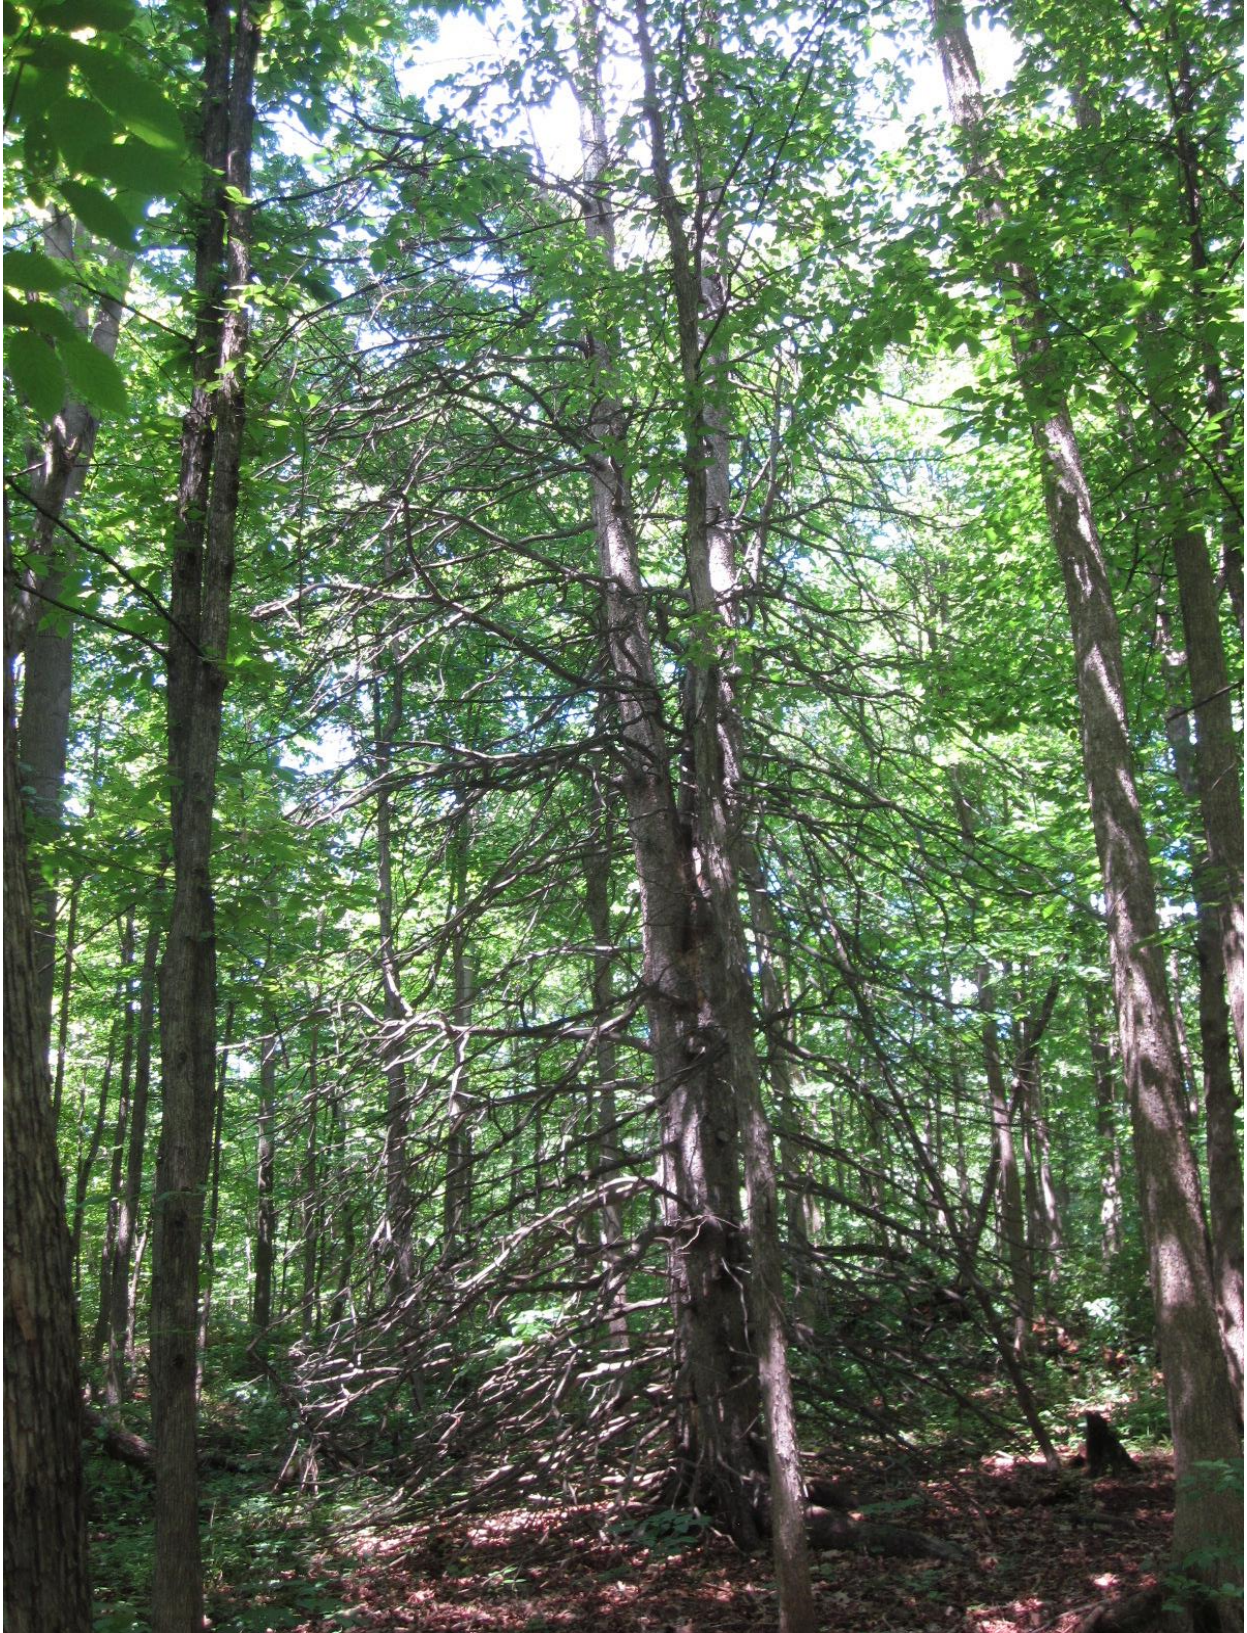
Their diminished presence is one negative consequence to a lack of forest disturbance. White pine seeds require exposed mineral soil for germination, cedars need openings in the canopy for sufficient sunlight and soil moisture (through interception of precipitation) and white spruce seeds will have trouble penetrating the thick litter layer beneath a deciduous stand. Consequently, although trees of seed bearing age are present, no regeneration of the three coniferous species was found in the understory.

Picture 3. Recently dead veteran white spruce at 180 Kanata Avenue property

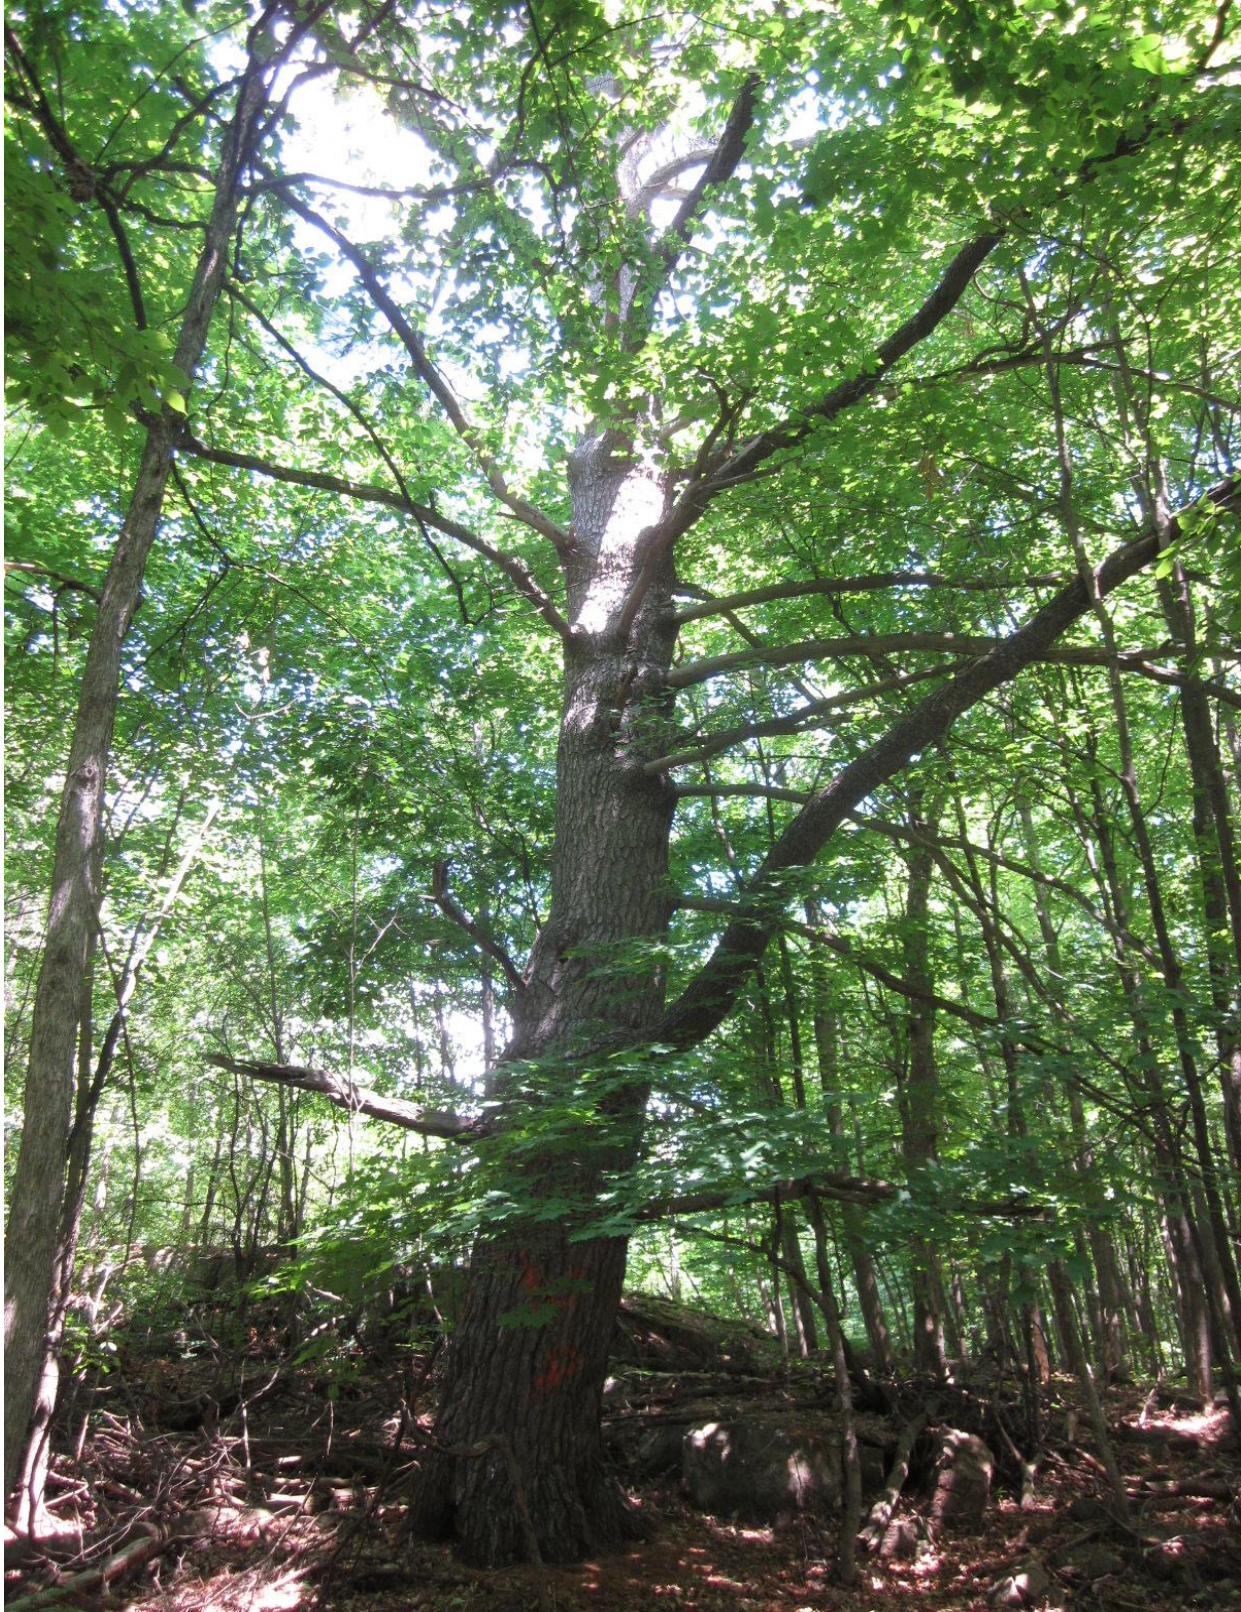
Picture 4. Living veteran white pine tree at 180 Kanata Avenue property (notice canopy opening beneath living crown of pine)

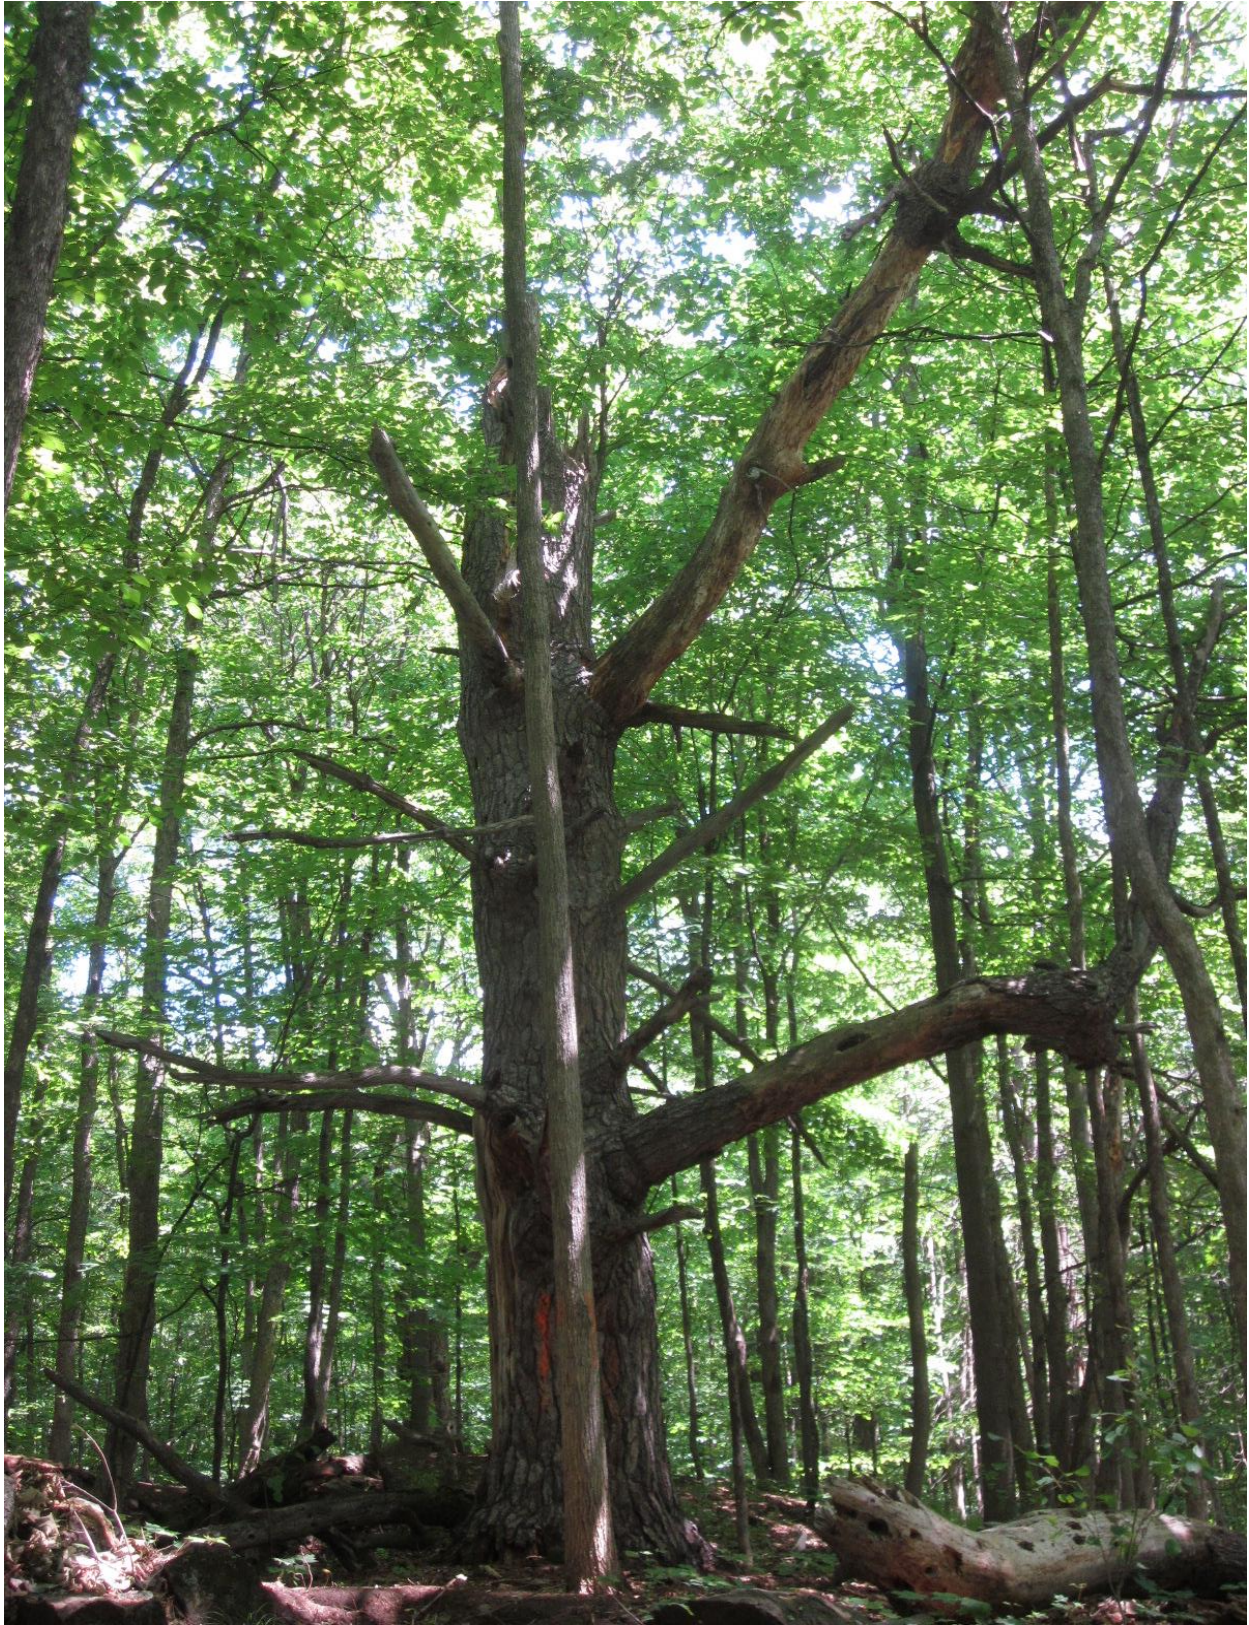
Picture 5. Standing dead veteran white pine tree at 180 Kanata Avenue property (notice closed canopy above broken stem)

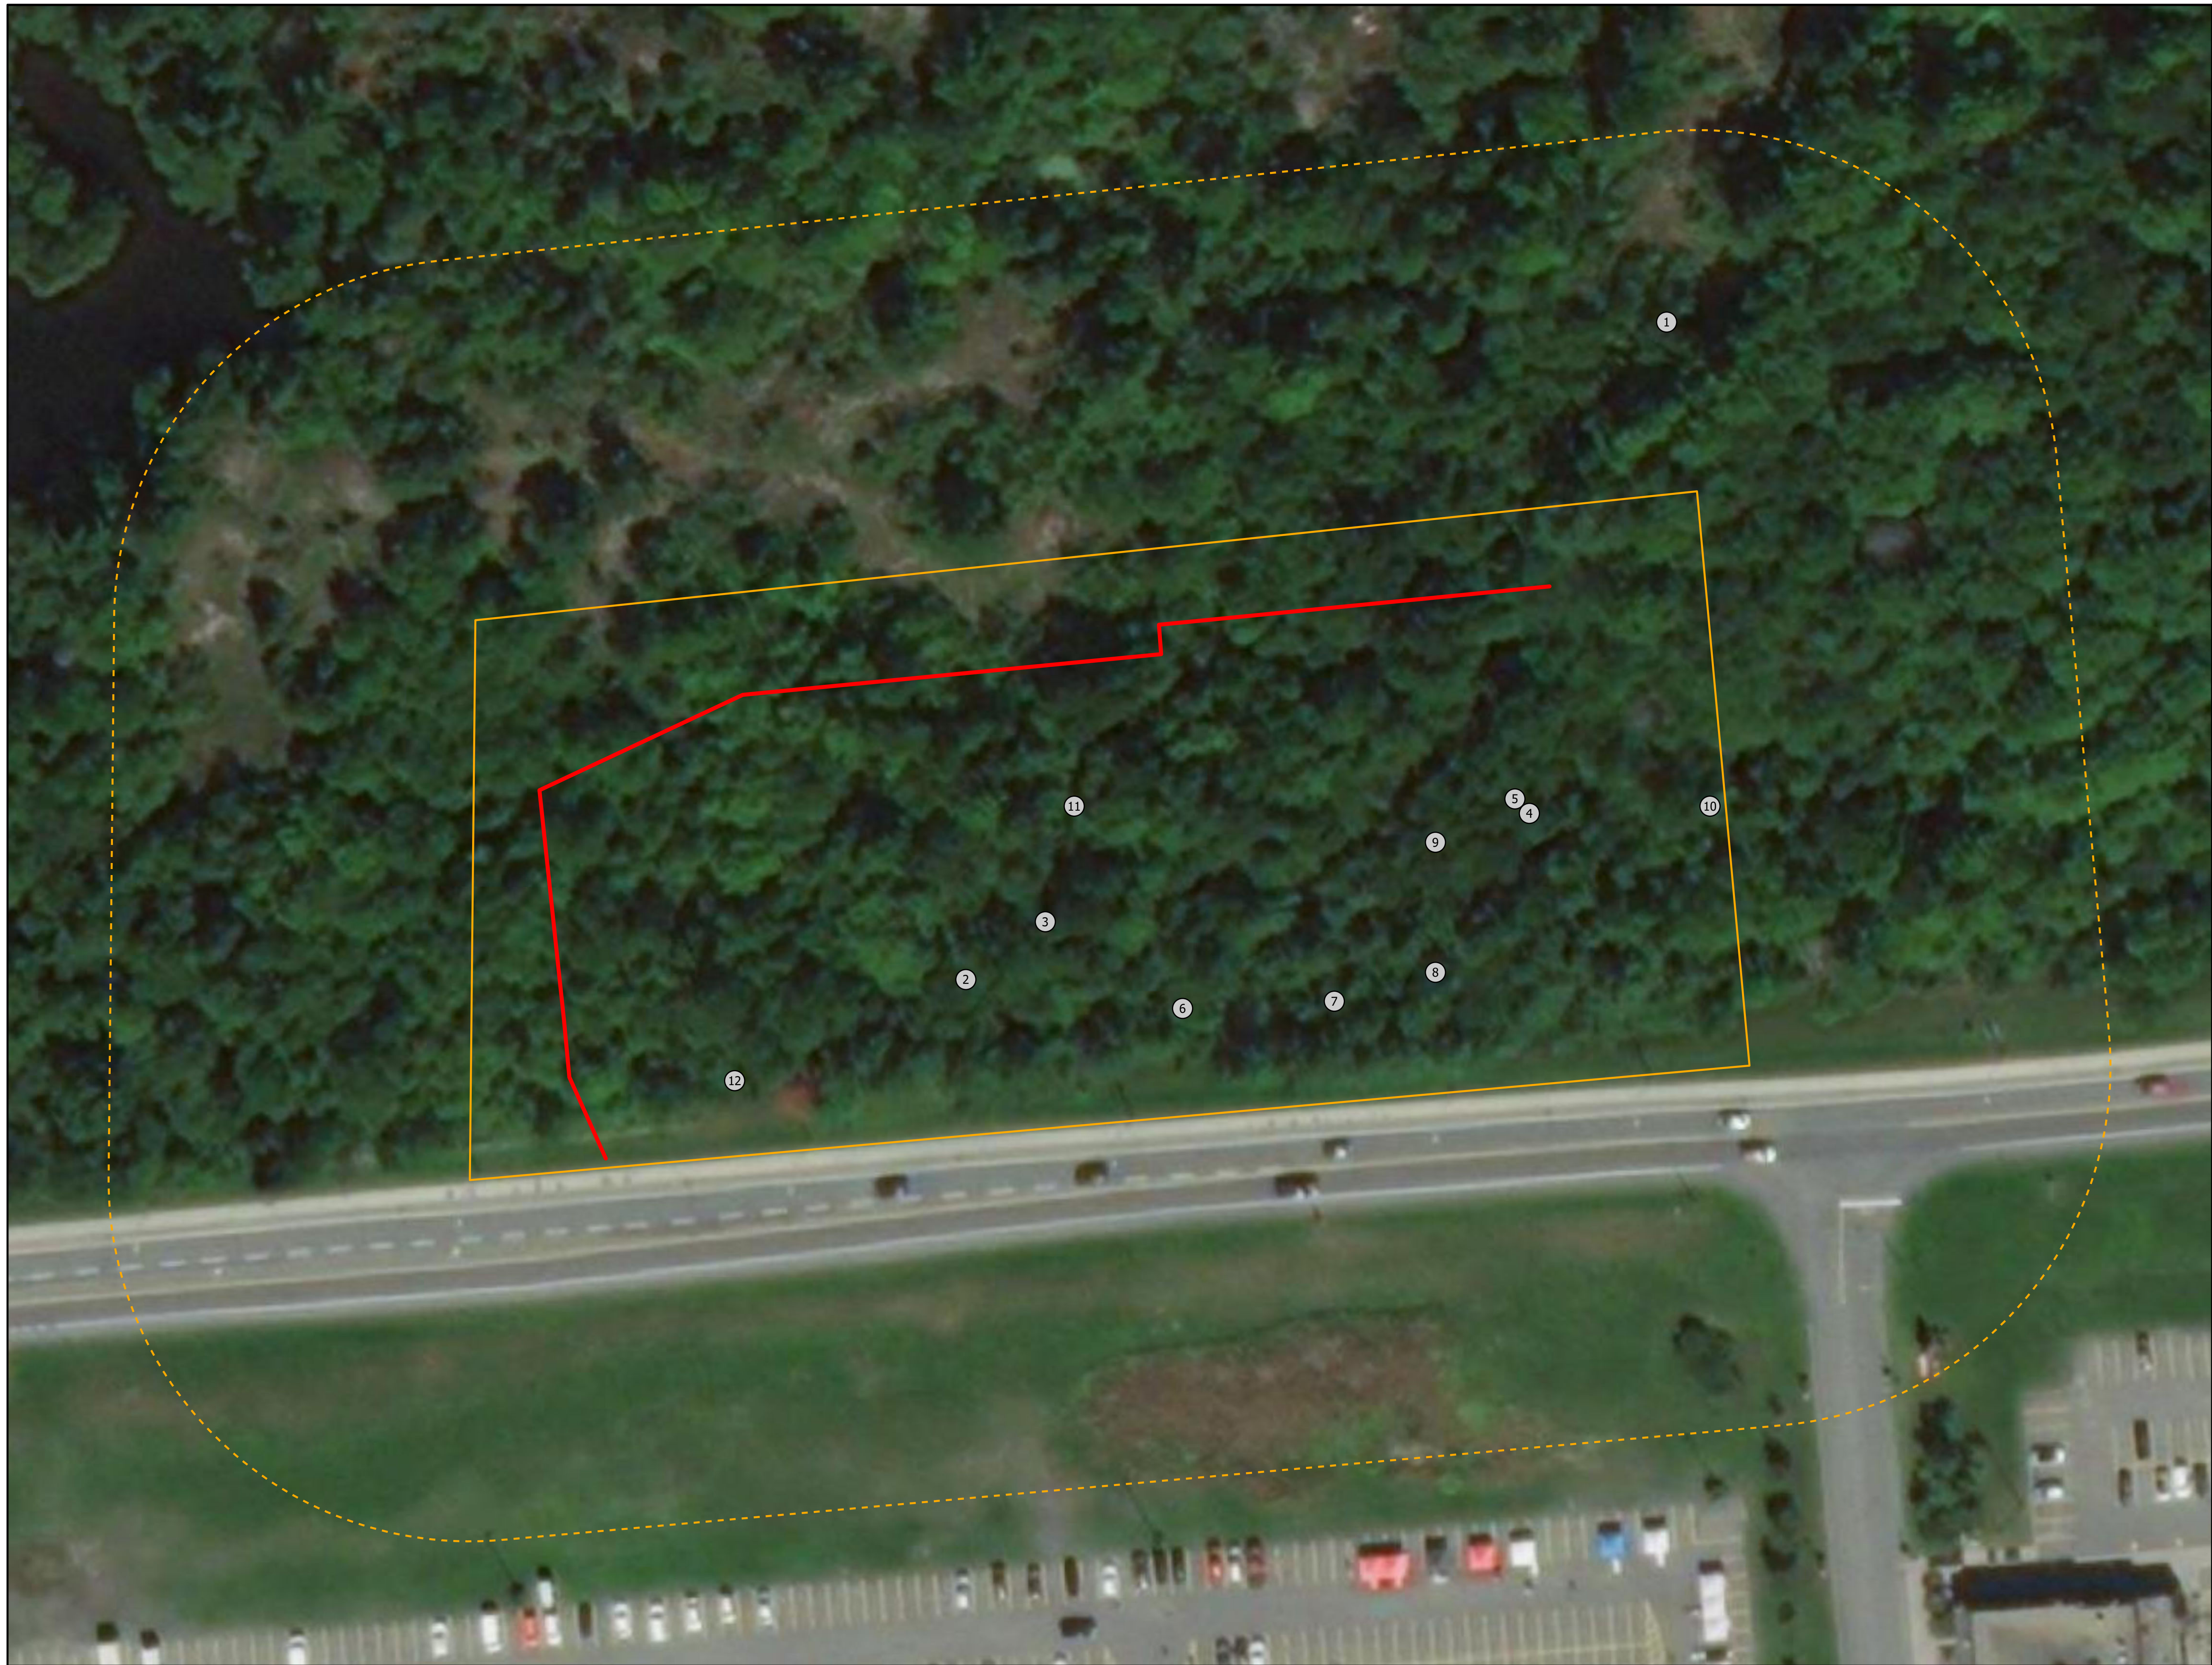
Locations of Butternut

A total of twelve butternuts (*Juglans cinerea*) were found on or within 50m of the subject property. This tree species is listed as endangered under the Province of Ontario's Endangered Species Act (2007) and so is protected from harm. Through the completion of a butternut health assessment all twelve trees were determined to be Category 1 (*i.e.* non-retainable). This assessment was sent to the Ontario Ministry of Environment, Conservation and Parks in June 2021.
