## TREE CONSERVATION REPORT

*18 Louisa Street, Ottawa, Ontario*

May 26, 2021

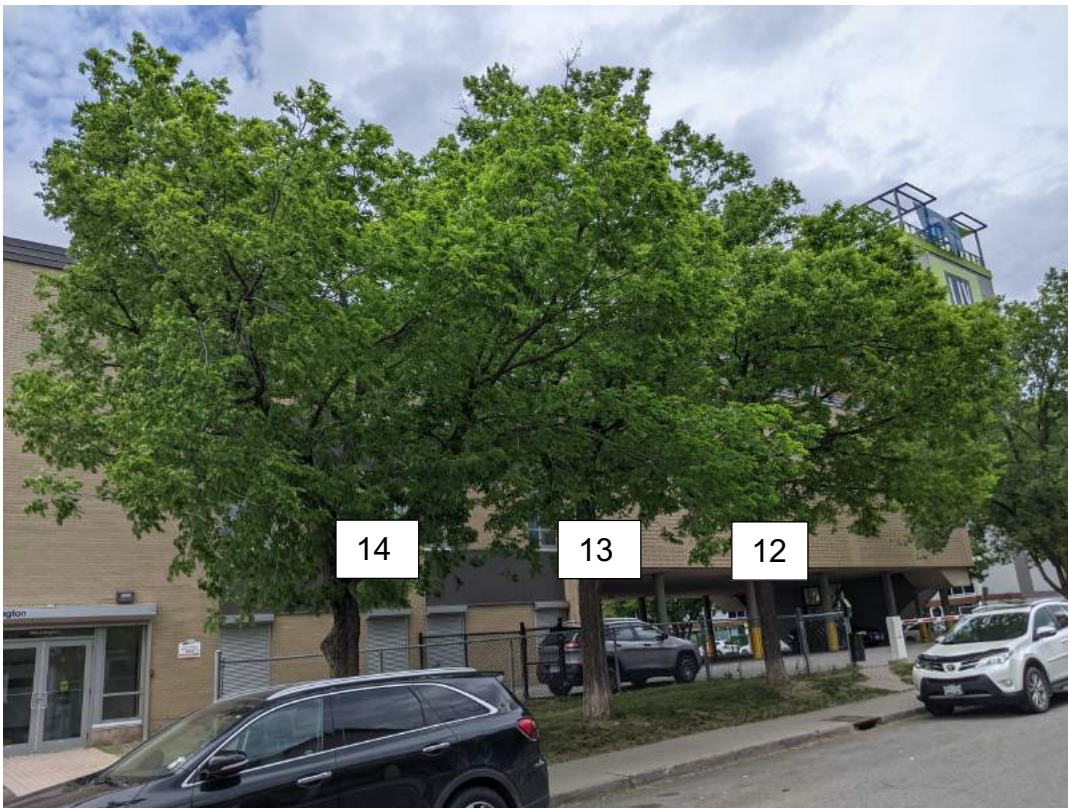
Trees #12, 13, 14 will not be impacted by the proposed development. These are Ash trees and do not appear to have received inoculation against Emerald Ash Borer. As the initial inventory was conducted in the winter, overall canopy condition was impossible to determine. However, as Figure 1 shows, all the Ash trees appear to be in overall good condition as of May 26th, 2021. The roots on all three trees are slightly girdled, but canopies appear to be full and lush.

*Figure 1 Picture of Ash trees on May 26, 2021.*

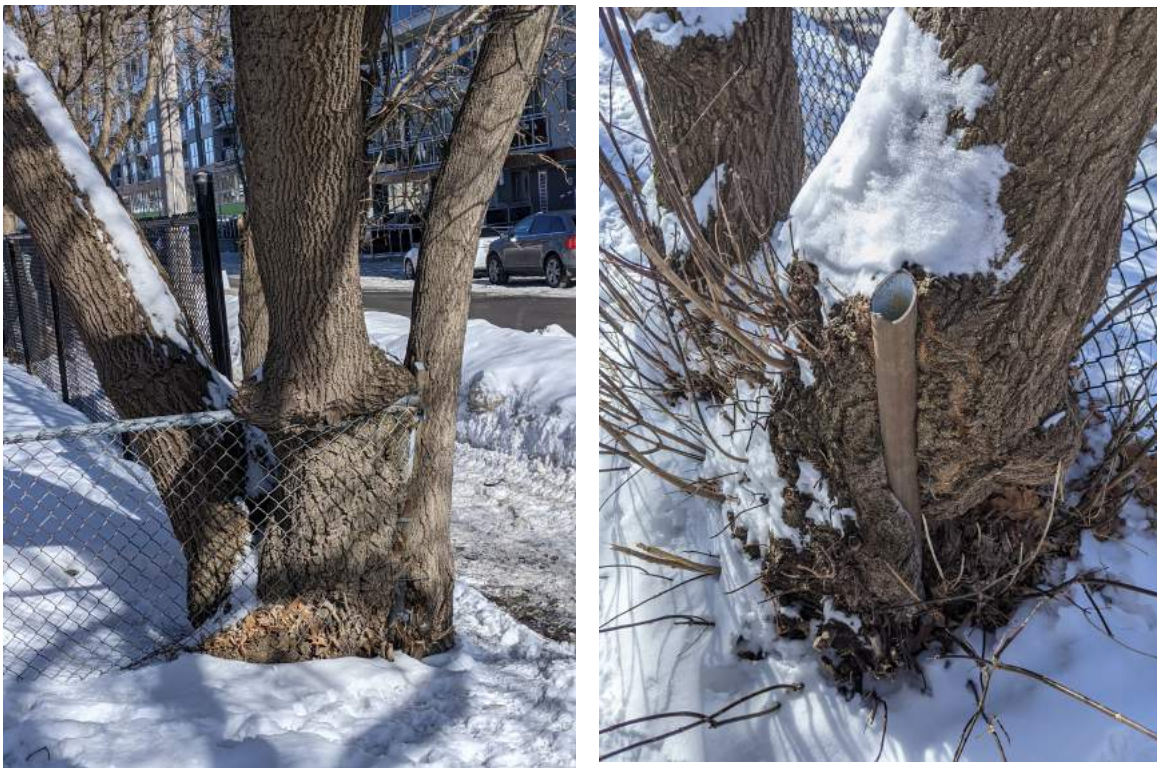
Trees # 1-11 are in direct conflict with the proposed development. According to the proposed site plan, the parking garage extends to the property line on all sides. Therefore, all trees are scheduled to be removed. The majority of these trees were in fair to poor condition, as shown in Figure 2 below.

*Figure 2 Manitoba Maple grown into chain link fence, Manitoba Maple absorbed steel pole in trunk.*

All removals to be done and will require a permit, in accordance with the City of Ottawa tree bylaw 2020-340 and this Tree Conservation Report.

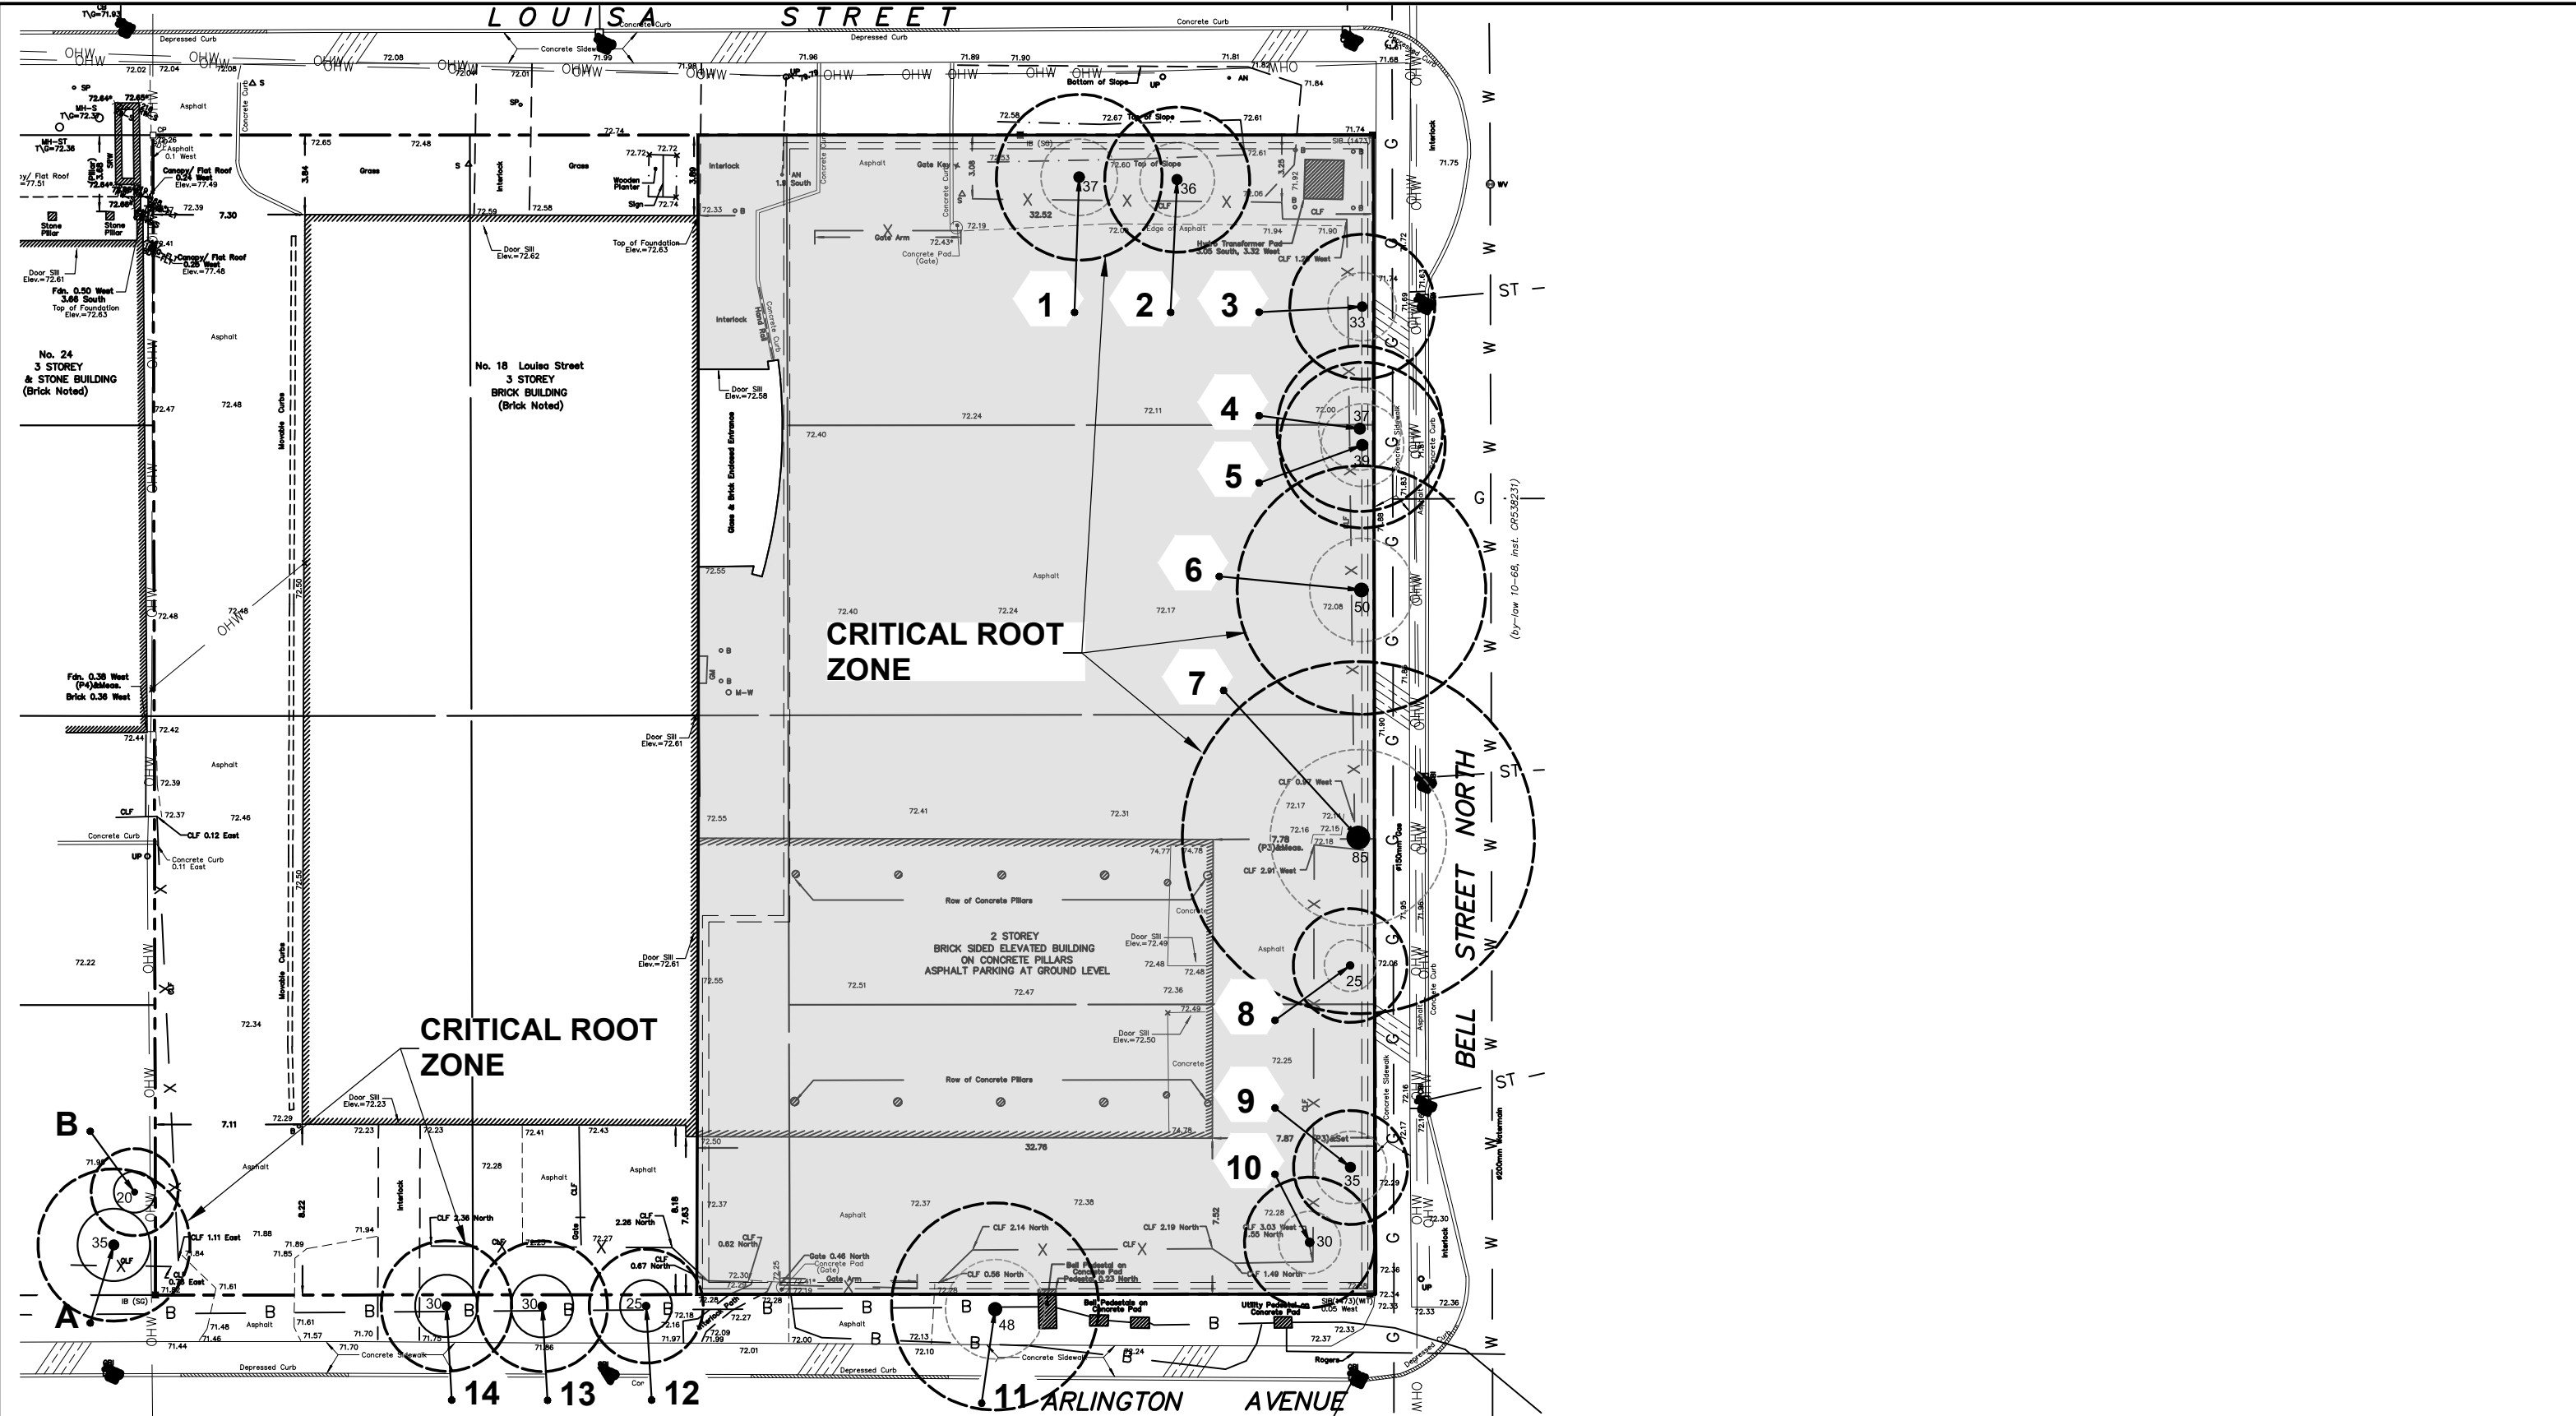
| | | 18 LOUISA STREET | | MAP # 1 - CURRENT VEGETATION | |

| PLANT ID # | SIZE DBH* / ht. (m) | Private (P), City (C), Adjacent (A) | BOTANICAL NAME | COMMON NAME | DISTINCTIVE TREE** | CONDITION | ACTION | COMMENTS |
|---|---|---|---|---|---|---|---|---|
| 1 | 0.37 | C | <i>Fraxinus ssp</i> | Ash ssp. | ✓ | Good | REMOVE | Minor decay and suckering occuring at base of trunk. |
| 2 | 0.36 | C | <i>Fraxinus ssp</i> | Ash ssp. | ✓ | Fair | REMOVE | Minor decay and suckering occuring at base of trunk. Significant deadwood in upper canopy. |
| 3 | 0.33 | C | <i>Acer negundo</i> | Manitoba Maple | ✓ | Fair | REMOVE | Suckering occuring at base of trunk. |
| 4 | 0.37 | C | <i>Acer negundo</i> | Manitoba Maple | ✓ | Poor | REMOVE | Suckering occuring at base of trunk. Steel sign pole and chainlink fence ingrown into trunk at base. Significant deadwood in upper canopy. Suboptimal branch structure with 2 codominant stems at 3m. |
| 5 | 0.39 | C | <i>Acer negundo</i> | Manitoba Maple | ✓ | Poor | REMOVE | Suckering occuring at base of trunk. Steel sign pole and chainlink fence ingrown into trunk at base. Significant deadwood in upper canopy. Decay across half of trunk diameter. Existing conflict with overhead power lines. Suboptimal branch structure with 2 codominant stems at 1m. |
| 6 | 0.5 | C | <i>Acer negundo</i> | Manitoba Maple | ✓ | Fair | REMOVE | Suboptimal branch structure with 6 codominant stems at 0.5m. |
| 7 | 0.85 | C | <i>Acer negundo</i> | Manitoba Maple | ✓ | Poor | REMOVE | Suckering occuring at base of trunk. Steel sign pole and chainlink fence ingrown into trunk at base. Existing conflict with overhead power lines. Suboptimal branch structure with 5 codominant stems at 0.5m. |
| 8 | 0.25 | C | <i>Fraxinus ssp</i> | Ash ssp. | | Good | REMOVE | Wounds in branches of upper canopy. |
| 9 | 0.35 | C | <i>Fraxinus ssp</i> | Ash ssp. | ✓ | Good | REMOVE | Wounds in branches of upper canopy. Suboptimal branch structure with 2 codominant stems at 2m. |
| 10 | 4 x 0.3 | C | <i>Fraxinus ssp</i> | Ash ssp. | ✓ | Fair | REMOVE | Chainlink fence ingrown at trunk base. Multistem (4) at base. |
| 11 | 0.48 | C | <i>Fraxinus ssp</i> | Ash ssp. | ✓ | Fair | REMOVE | Large wounds in one of codominant stems. Suboptimal branch structure with 2 codominant stems at 2m. |
| 12 | 0.25 | C | <i>Fraxinus ssp</i> | Ash ssp. | | Good | REMAIN | Suboptimal branch structure with 2 codominant stems at 2m. |
| 13 | 0.3 | C | <i>Fraxinus ssp</i> | Ash ssp. | ✓ | Good | REMAIN | Minor wounds due to pruning. Slightly unbalanced crown. |
| 14 | 0.3 | C | <i>Fraxinus ssp</i> | Ash ssp. | ✓ | Good | REMAIN | Unbalanced crown towards sidewalk wide due to heavy pruning. |
| A | 0.35 | A | <i>Fraxinus ssp</i> | Ash ssp. | ✓ | Fair | REMAIN | Suckering occuring at base. Potential conflict with overhead power lines. Unbalanced crown towards sidewalk side due to heavy pruning. |
| B | 0.2 | A | <i>Acer negundo</i> | Manitoba Maple | | Fair | REMAIN | Existing conflict with chainlink fence and pole. Potential conflict with overhead wires in <5 years. Otherwise good form with strong leader. |
