URBAN FORESTRY & FOREST MANAGEMENT CONSULTING

November 12, 2021

RE: TREE CONSERVATION REPORT FOR 2 ROBINSON AVENUE, OTTAWA

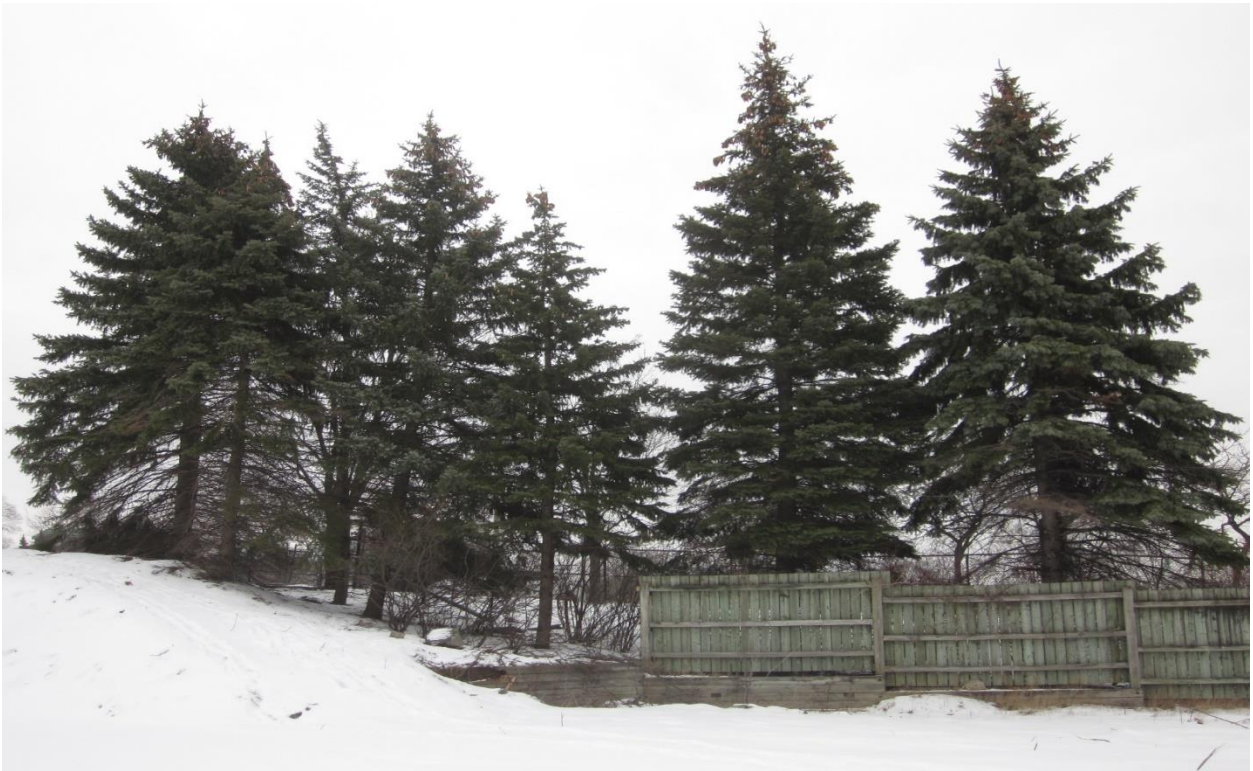
Picture 5. Planted grouping of Colorado spruce at 2 Robinson Avenue

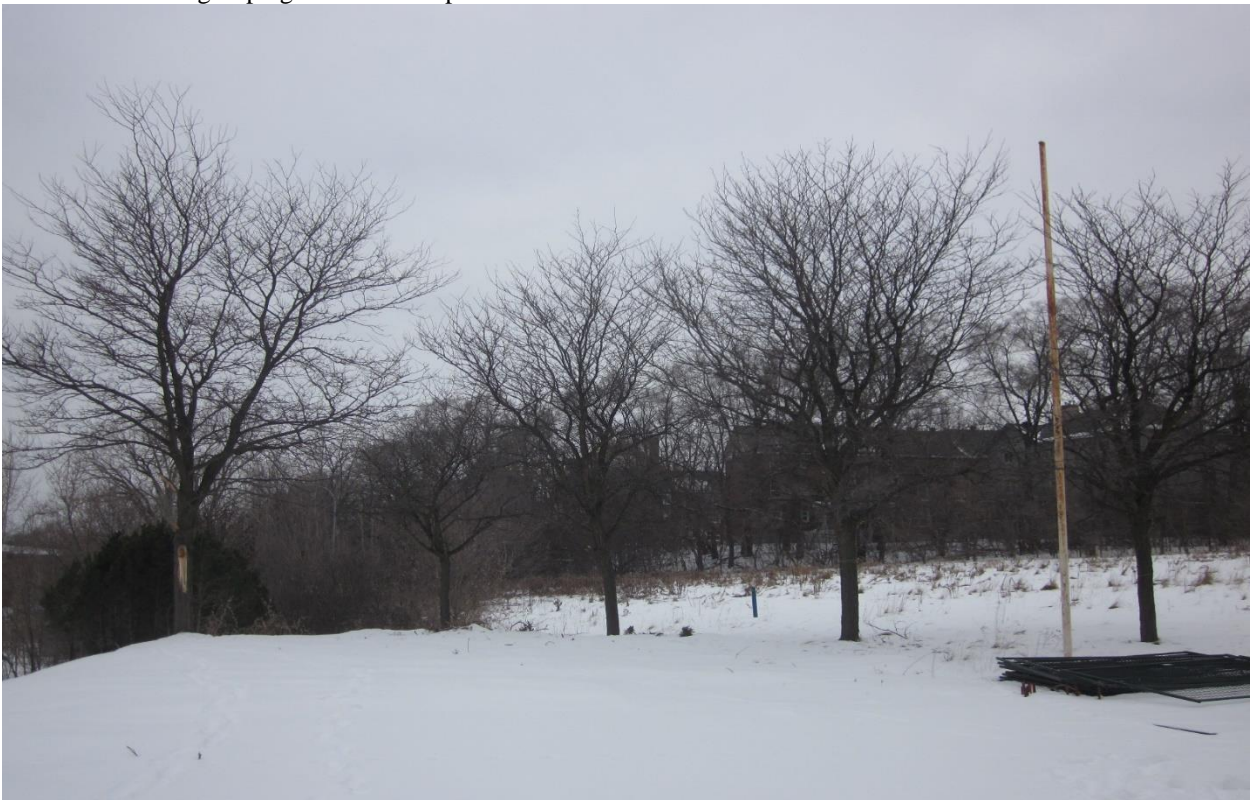
Picture 6. Line of planted honey-locust at 2 Robinson Avenue
