1161 OLD MONTREAL ROAD  
ORLEANS, ONTARIO

ARCH CORPORATION LTC (ORLEANS) (21024)

TREE CONSERVATION REPORT  
FOR SITE PLAN APPROVAL

PREPARED BY: RON KOUDYS LANDSCAPE  
ARCHITECTS INC

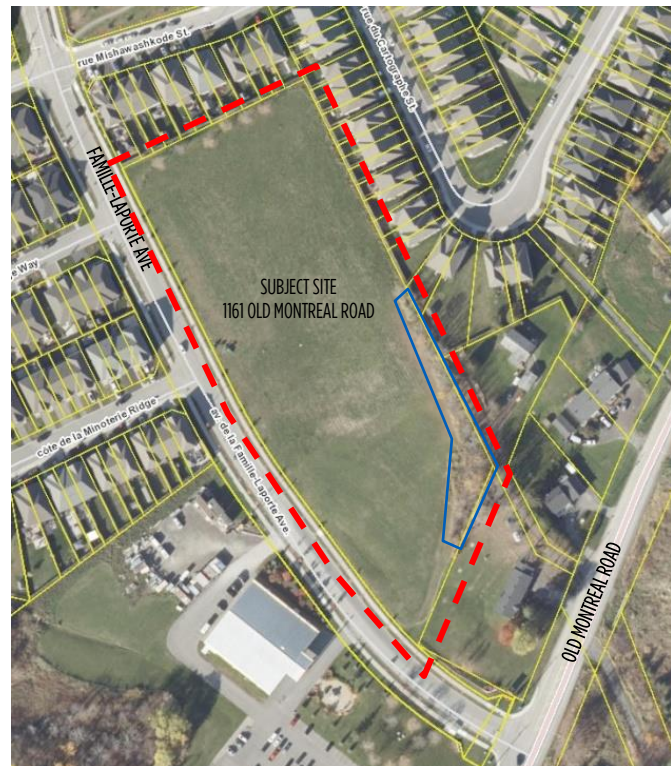
Figure 1 - Image capture from GeoOttawa with 2019 aerial  
 Red dashed line - limit of tree inventory  
 Blue line - dense group of trees
