STAGE II CULTURAL HERITAGE IMPACT STATEMENT & CONSERVATION PLAN

145 Loretta Avenue & 951 Gladstone Avenue, Ottawa,
Ontario

PREPARED BY: COMMONWEALTH HISTORIC RESOURCE MANAGEMENT

Revision V5 January 2022

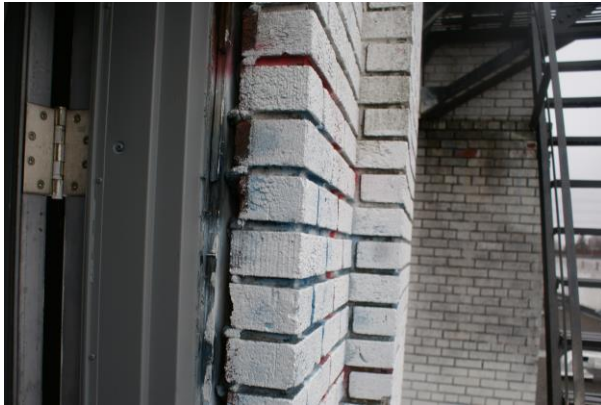
The bricks are a pressed brick with ground shale as the primary raw material, common for the period as clay deposits were being exhausted. The bricks are wire cut and have a textured surface that is painted. The removal of the paint from the interstices in the brick surfaces will be difficult if not impossible as the oil-based paint is well adhered to the surfaces. The brickwork is generally in good condition with localized spalled bricks. The brickwork in the areas that were inspected appeared to be well adhered to the terra-cotta backup walls when sounded with a hammer.

The original pointing mortar mix would appear to be a 1-part Portland, 3 parts sand with an admixture of lime to improve workability and adhesion to the masonry units. The Portland cement mortar mix was in common use when the building was completed in 1924 and is noted in manufacturers specifications for brickwork and terra-cotta tile. The joint profile is a recessed joint with a depth equal to the distance between bricks. The original mortar included a black pigment which has faded over the years where exposed. The pointing is in good condition, except for localized areas.

Figure 32: View of the exterior brickwork from a second-floor fire escape. Note the highly textured brick surfaces and recessed joint profile. Source: Commonwealth 2020.

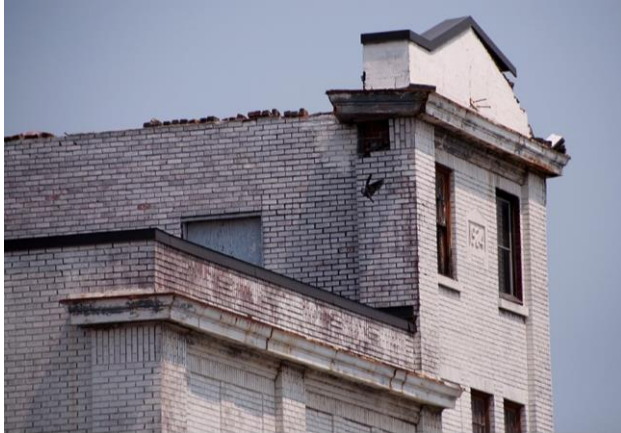
The gabled brick and metal parapets are in poor condition (figure 32) and will require restoration and for whole sections the details will have to be refabricated based on the historic photographs.

Figure 33: The gabled brick and metal parapets will be re-instated to their original form and design. The height of the parapet can be determined from period photos. The original colour of the brick is evident in areas where the paint has worn off.

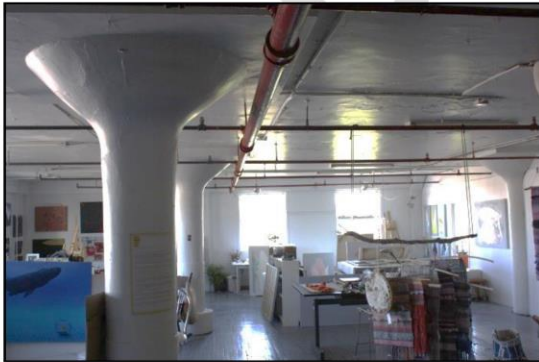
The interior concrete columns and floor slabs appear to be in good condition in general. An area of spalled concrete on the underside of the 3rd floor was observed. Loose concrete has been removed and the corroded rebar is visible. Although this is not an immediate structural concern, it does create a weak point in the floor slab. The deterioration does not appear active and was likely caused by water leakage or elevated moisture levels from previous building operations.

Photo 2: Typical columns inside the building [JCAL 2018].

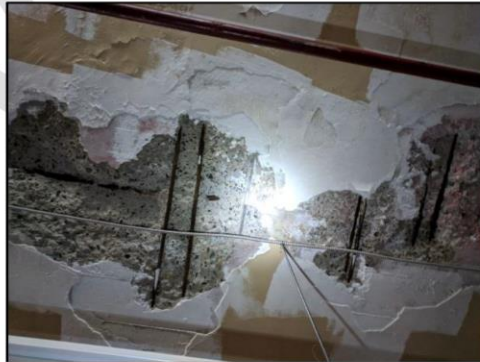
Photo 3: Corroding rebars have caused the concrete to spall on the underside of the third floor. [JCAL]

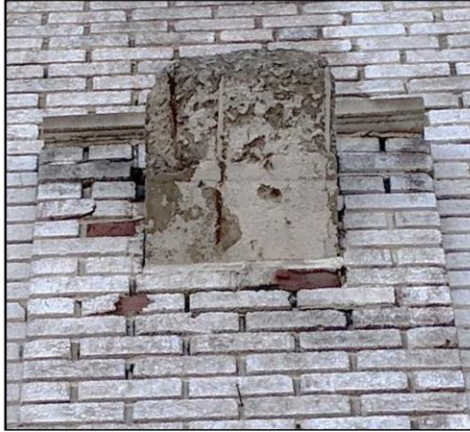
The exterior brick veneer in general is in good condition but does have localized areas of eroded mortar joints and face spalled bricks. These conditions were typically observed below window sills and other areas of high exposure to water, such as on the pilasters on the west and east elevations. Specifically on the west elevation, the bricks adjacent to the concrete corbels are in poor condition. The concrete corbels have minor vertical and horizontal cracks and typically have exposed rebar. Similarly, on the east elevation localized areas of masonry deterioration was observed.

Photo 4: Typical corbel on the west elevation. Concrete and bricks are deteriorating [JCAL 2018].

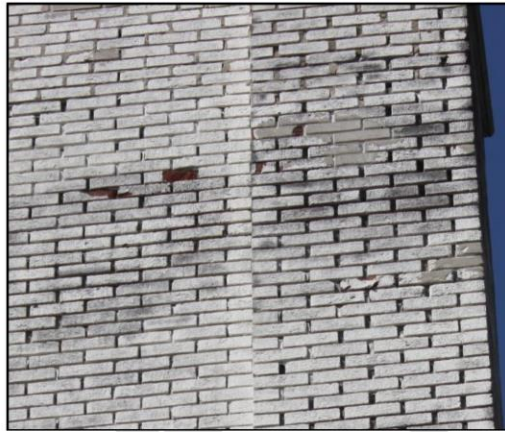
Photo 5: Typical localized area of eroded joints and face spalled bricks [JCAL 2018].

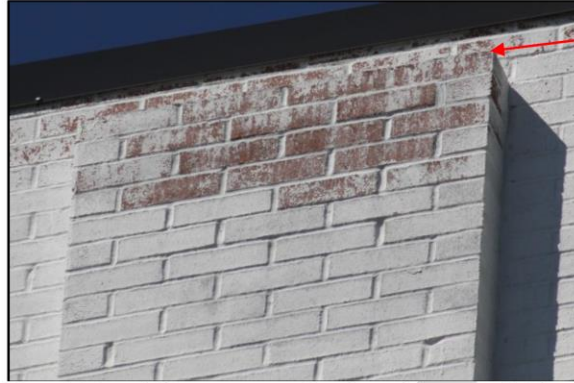
Photo 9: Top of pilaster, on east elevation, with no cap flashing [JCAL 2018].
