LAURIER & SWEETLAND

SEWER CCTV INSPECTION REPORT

108465SA1

October 13, 2021

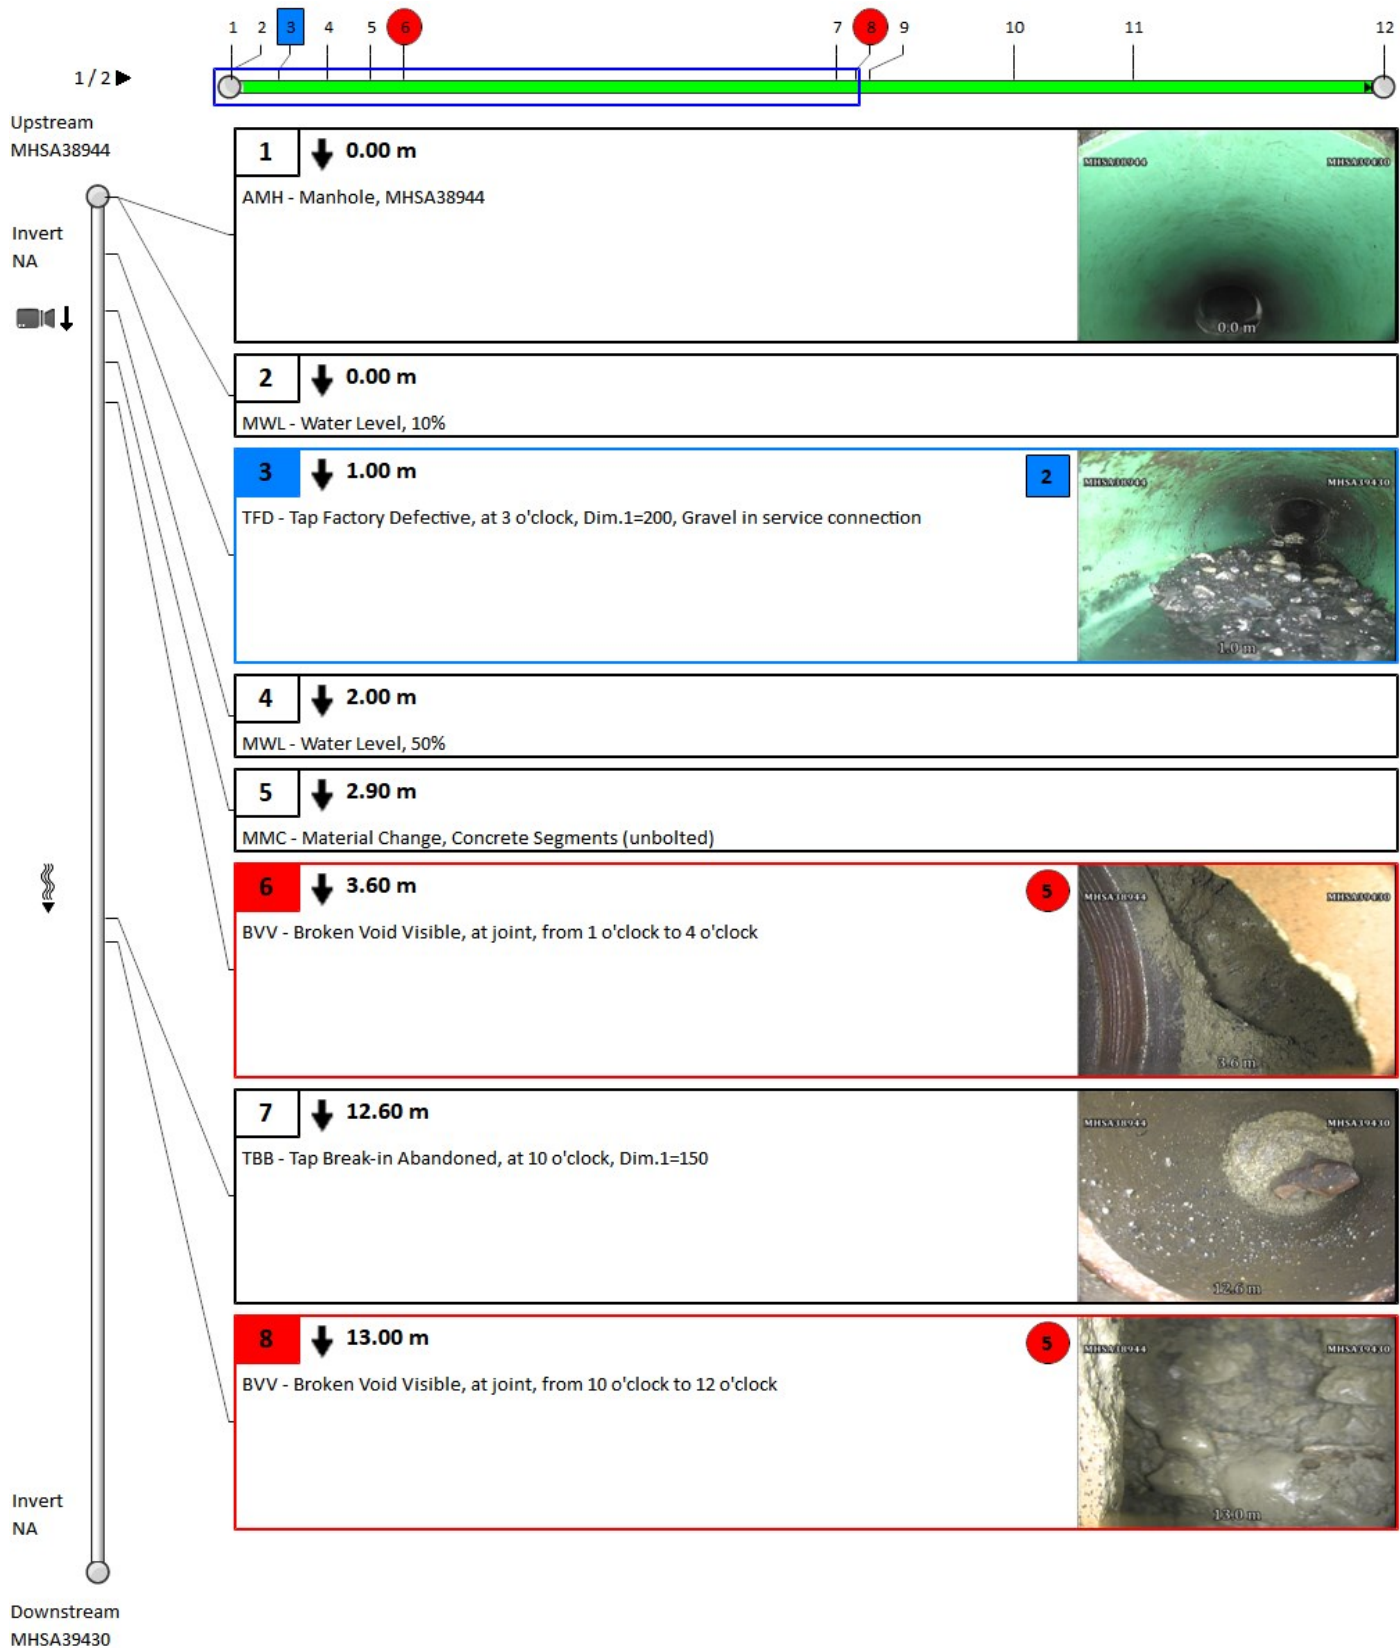
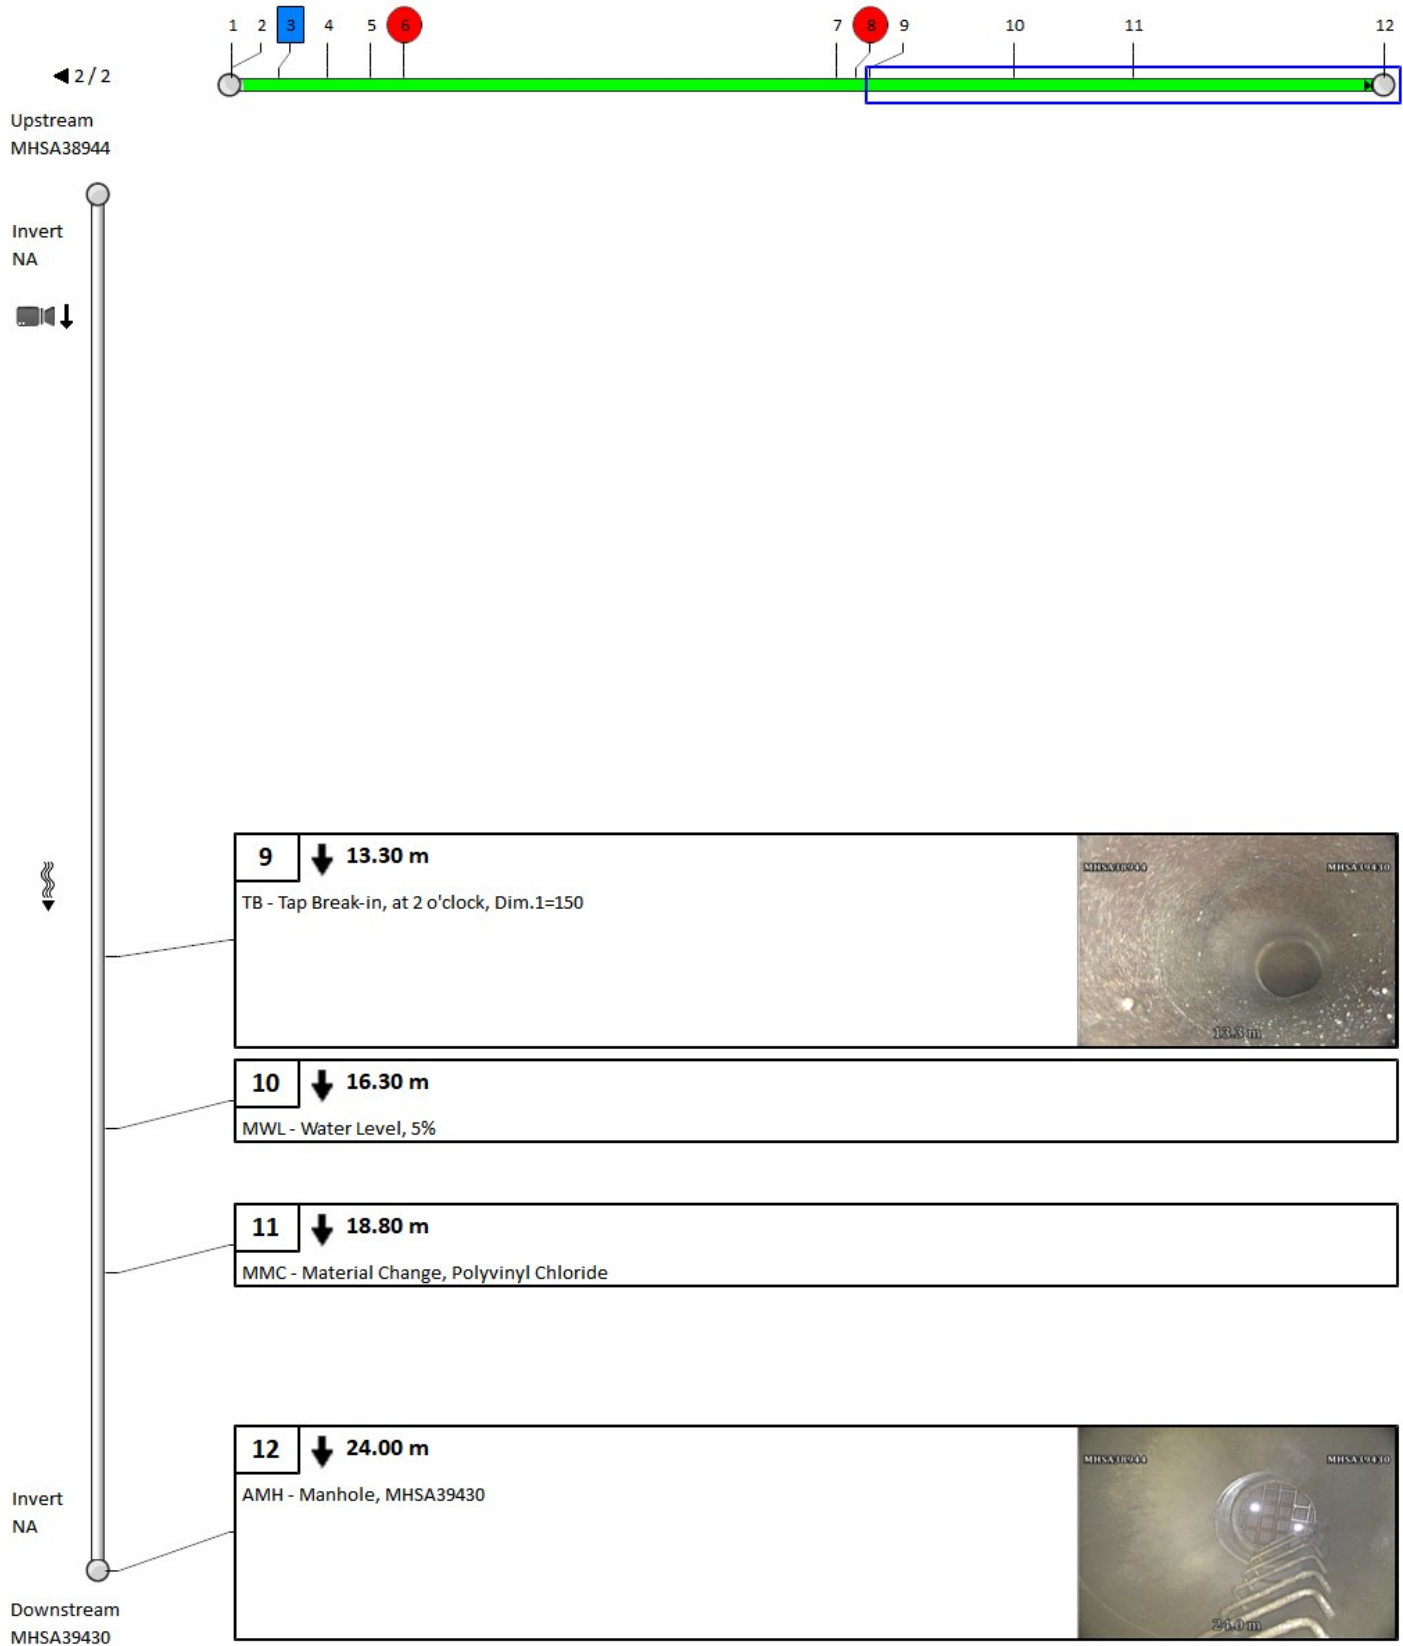
Pipe:	MHSA38944 MHSA39430	Direction of inspection:	MHSA38944 --> MHSA39430
Direction of flow:	MHSA38944 --> MHSA39430	Direction:	Direction of flow

Peak:	5	Peak:	2	Peak:	5
Quick rating:	5200	Quick rating:	2100	Quick rating:	5221
Score:	10	Score:	2	Score:	12
Index:	5	Index:	2	Index:	4

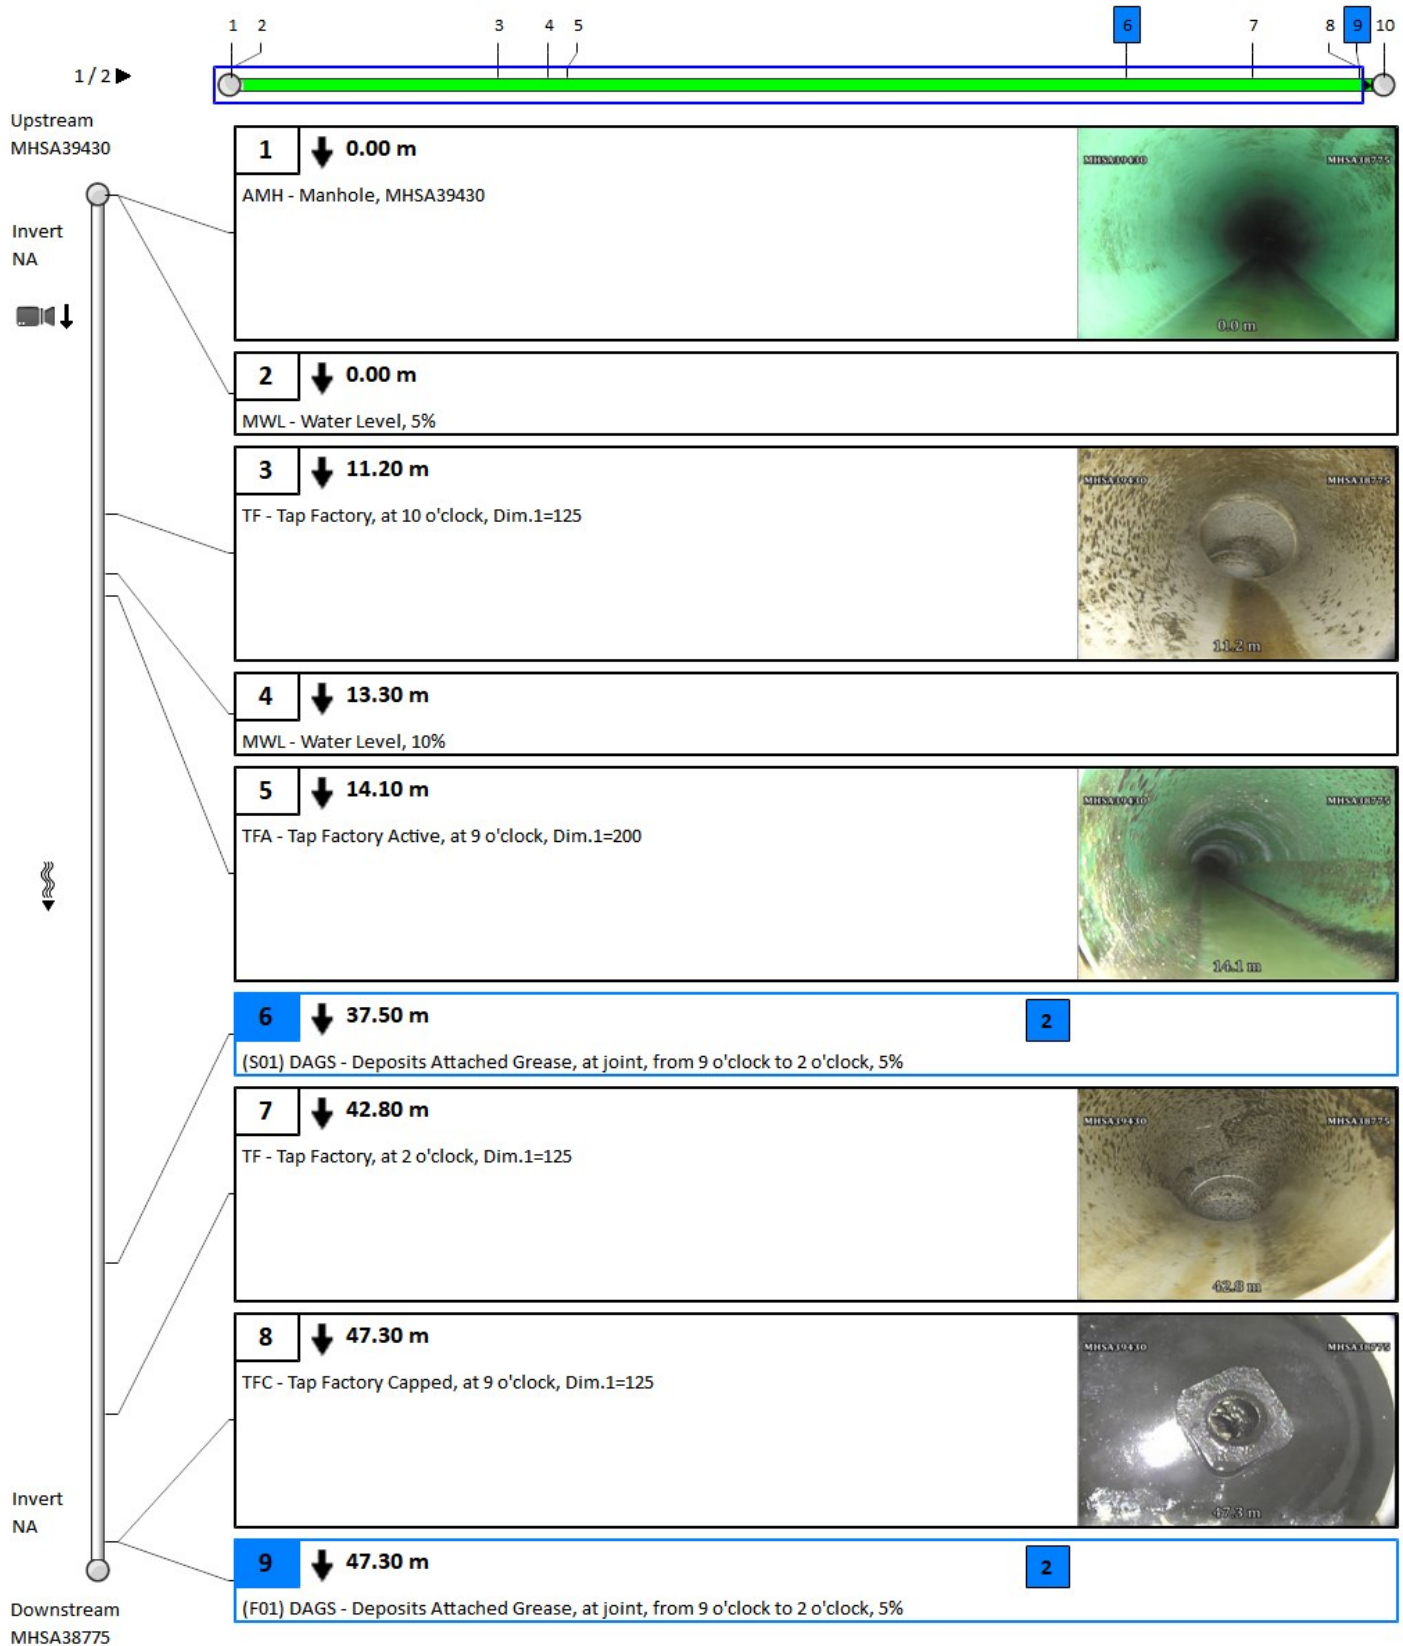
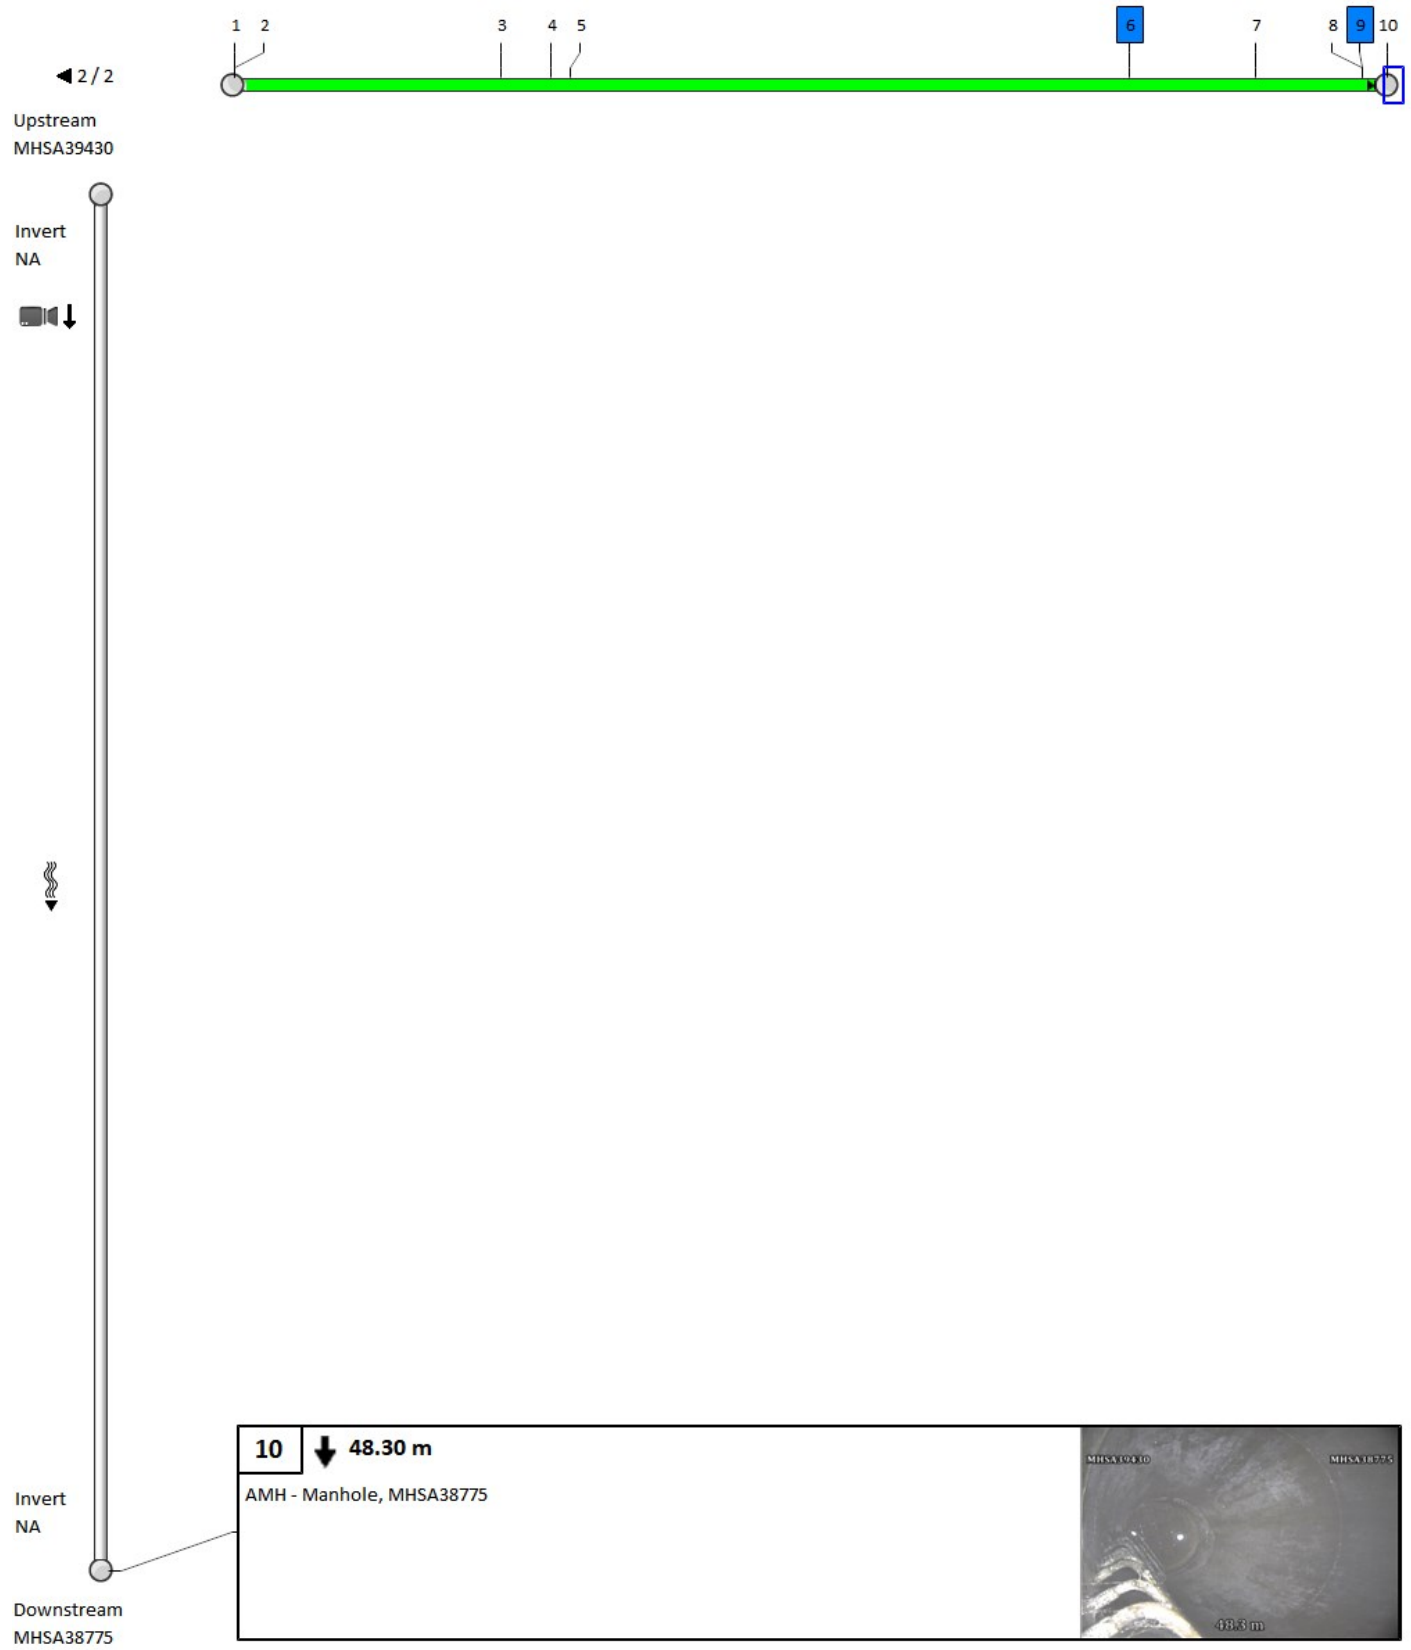
Pipe: MHSA39430 MHSA38775	Direction of inspection: MHSA39430 --> MHSA38775
Direction of flow: MHSA39430 --> MHSA38775	Direction: Direction of flow

Peak: 0	Peak: 2	Peak: 2
Quick rating: 0000	Quick rating: 2600	Quick rating: 2600
Score: 0	Score: 12	Score: 12
Index: 0	Index: 2	Index: 2
