URBAN FORESTRY & FOREST MANAGEMENT CONSULTING

March 29, 2022

RE: TREE CONSERVATION REPORT FOR 2 ROBINSON AVENUE, OTTAWA

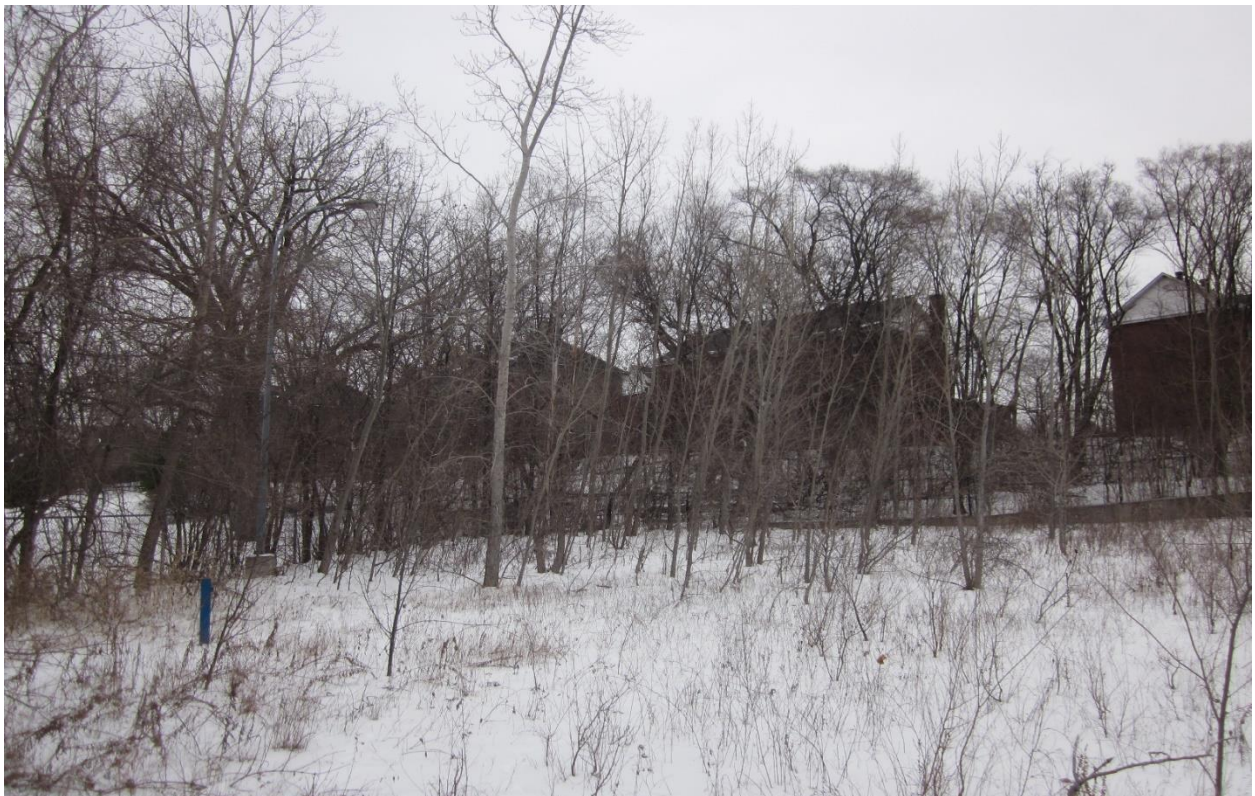
Picture 2. Poplars resulting from root sprouts at 2 Robinson Avenue

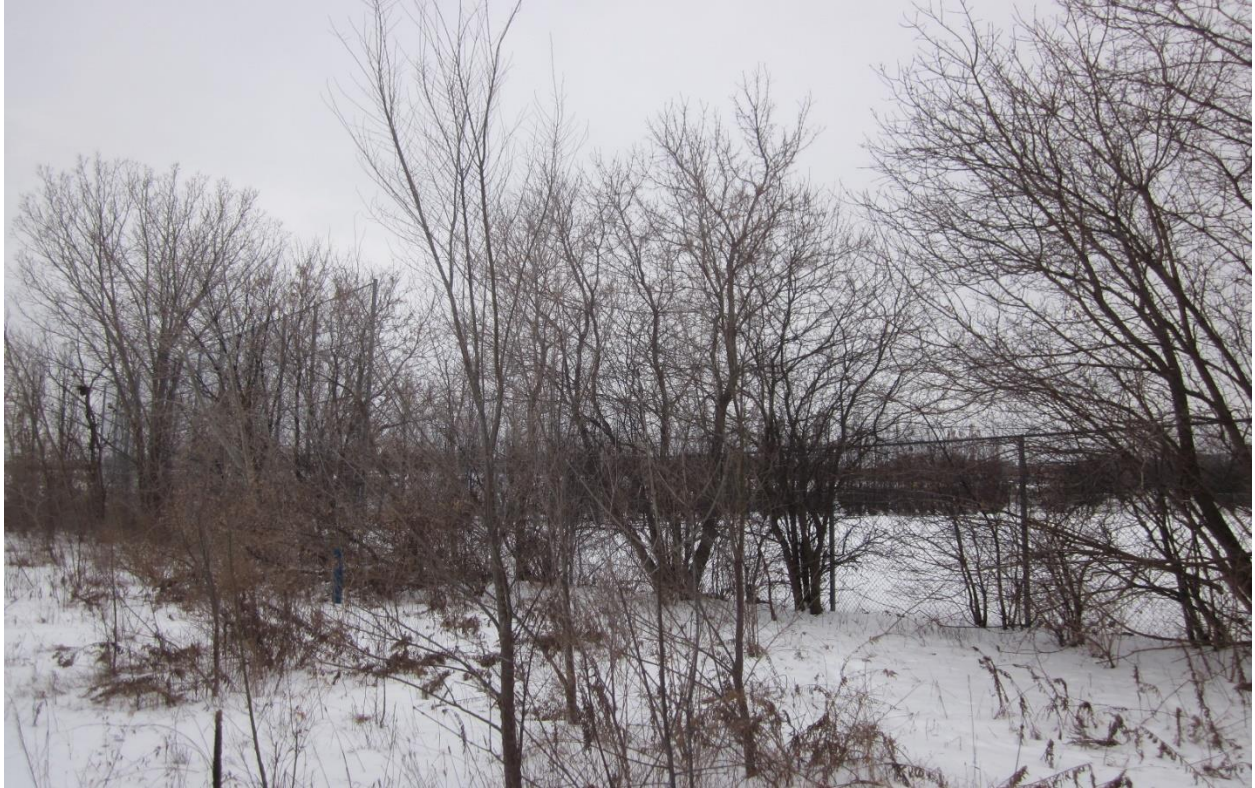
Picture 3. Seeded Siberian elms and Manitoba maples at 2 Robinson Avenue

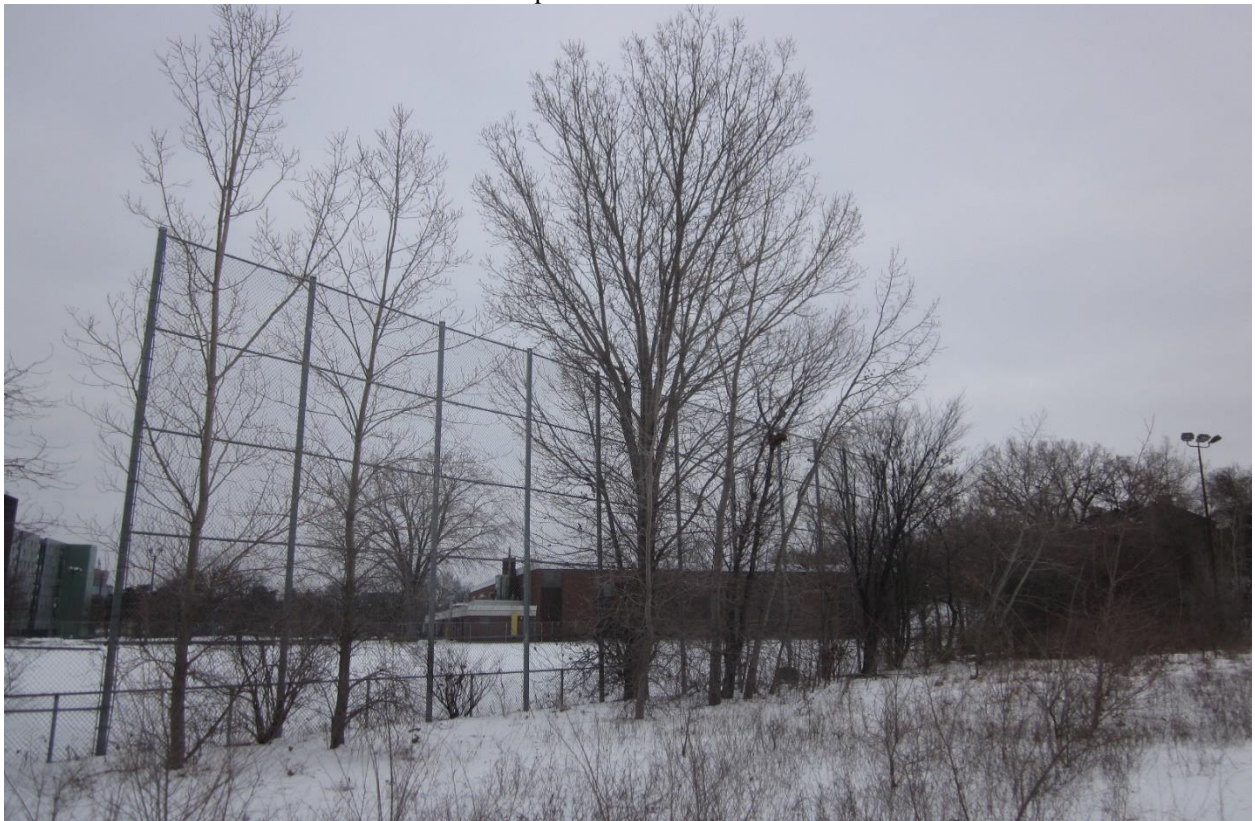
Picture 4. Poplars along western property line of 2 Robinson Avenue

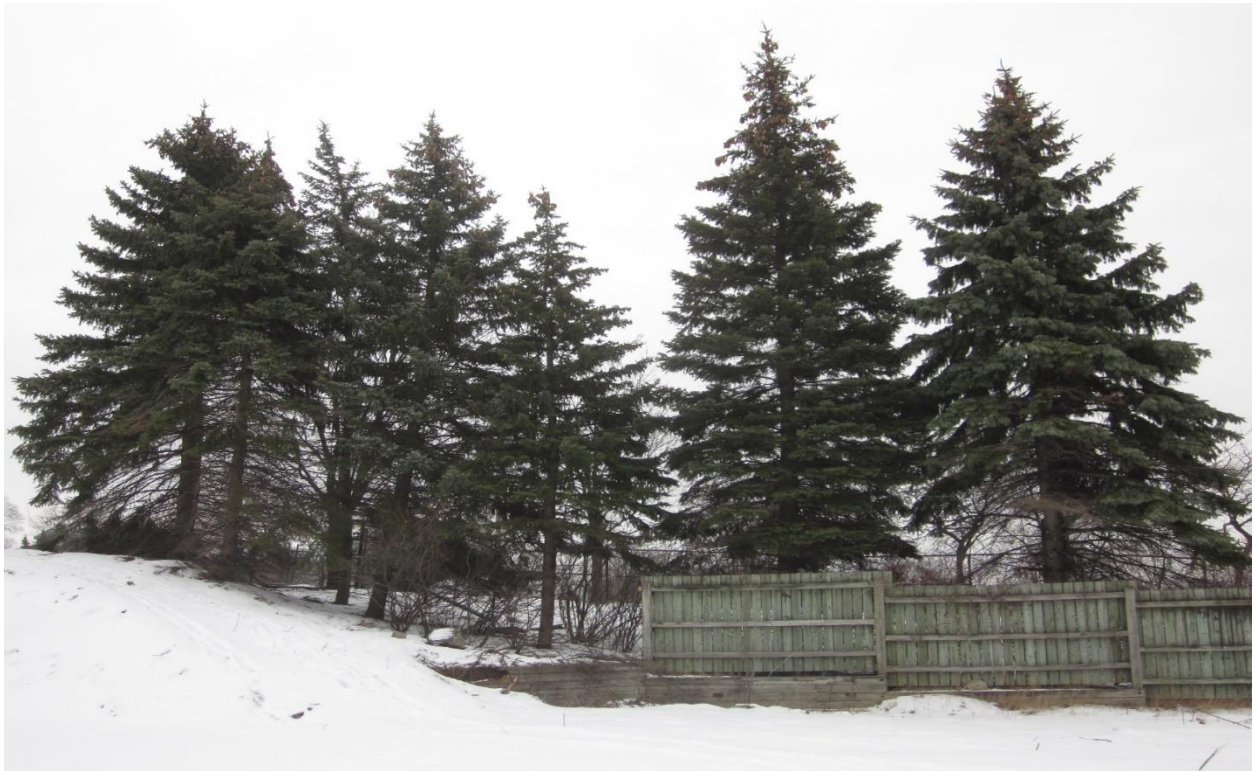
Picture 5. Planted grouping of Colorado spruce at 2 Robinson Avenue

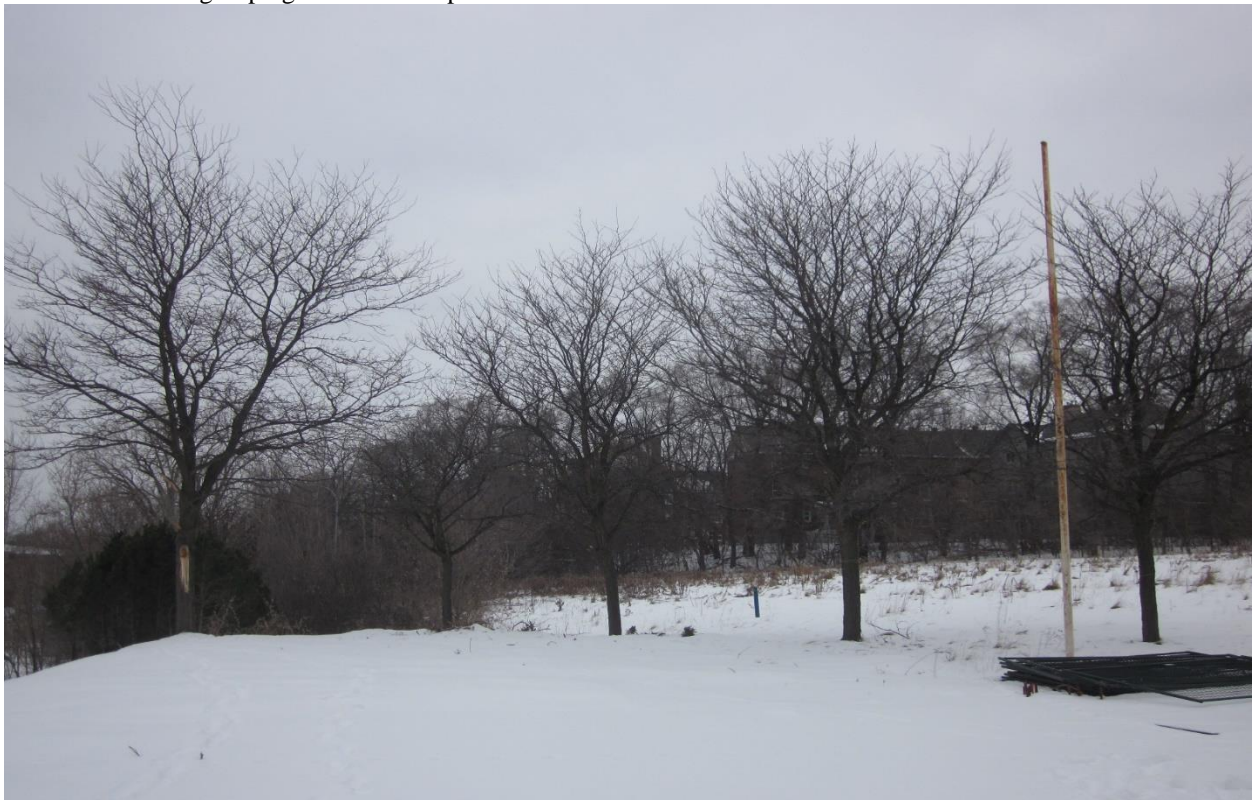
Picture 6. Line of planted honey-locust at 2 Robinson Avenue

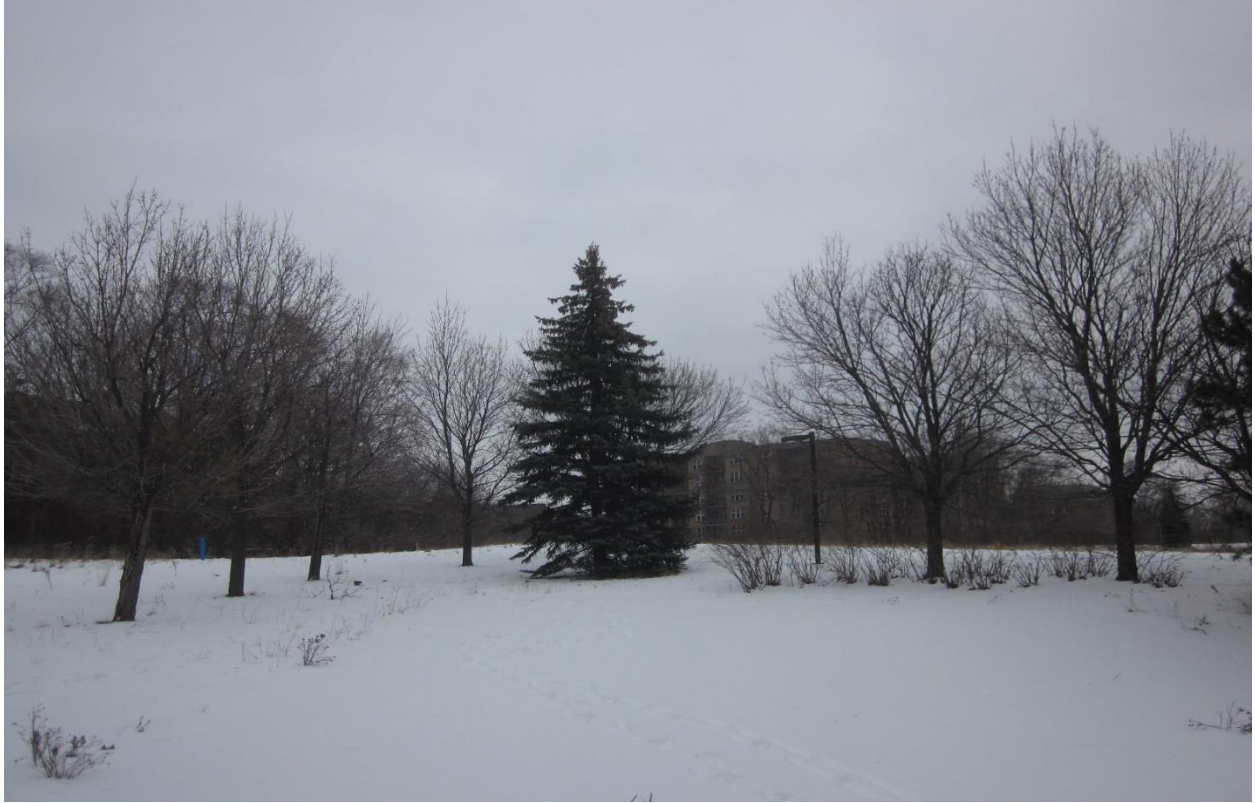
Picture 7. Line of planted Colorado spruce (centre) and Norway maples at 2 Robinson Avenue

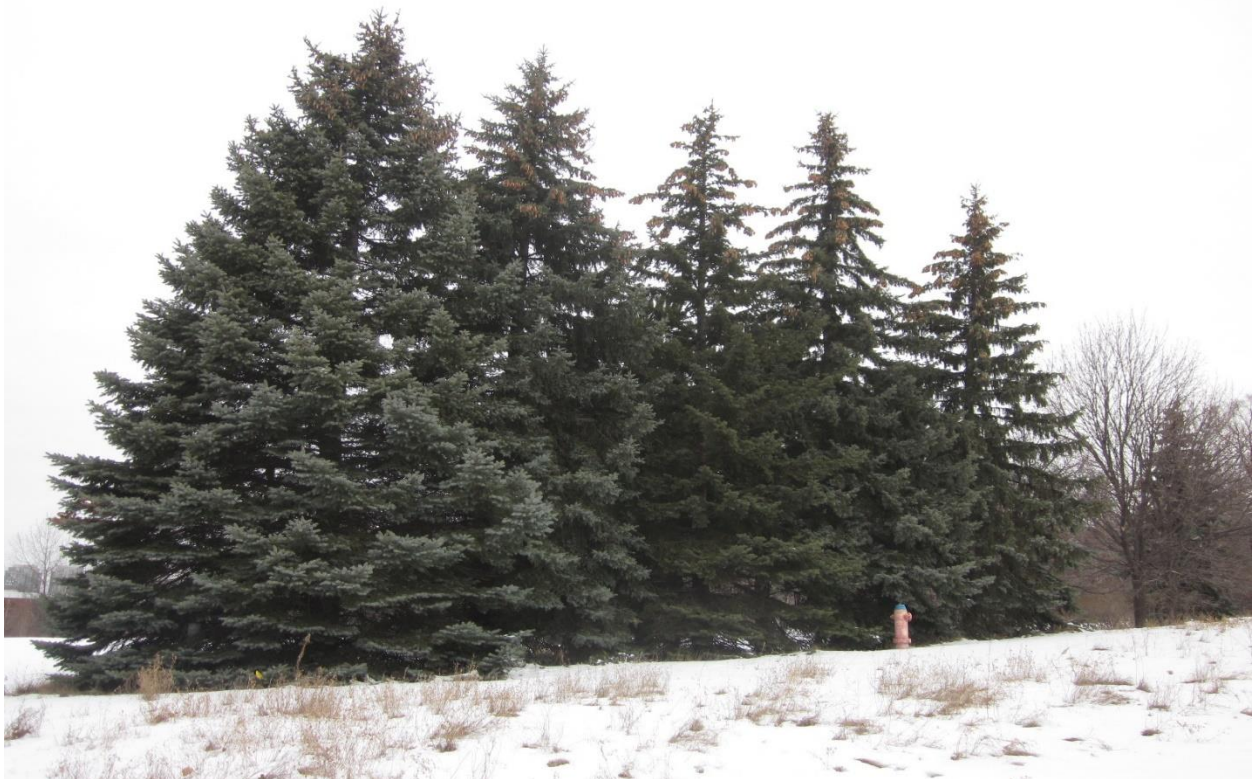
Picture 8. Planted grouping of Colorado spruce at 2 Robinson Avenue
