**Project:**  
**70 RICHMOND ROAD DEVELOPMENT**

**Drawing:**  
**TREE INFORMATION REPORT**

Scale: 1:150	Date: 2021 08 10
Design By: JM	Drawn By: HP/PG
Project Number: 2067-01	Sheet Number: TIR 01

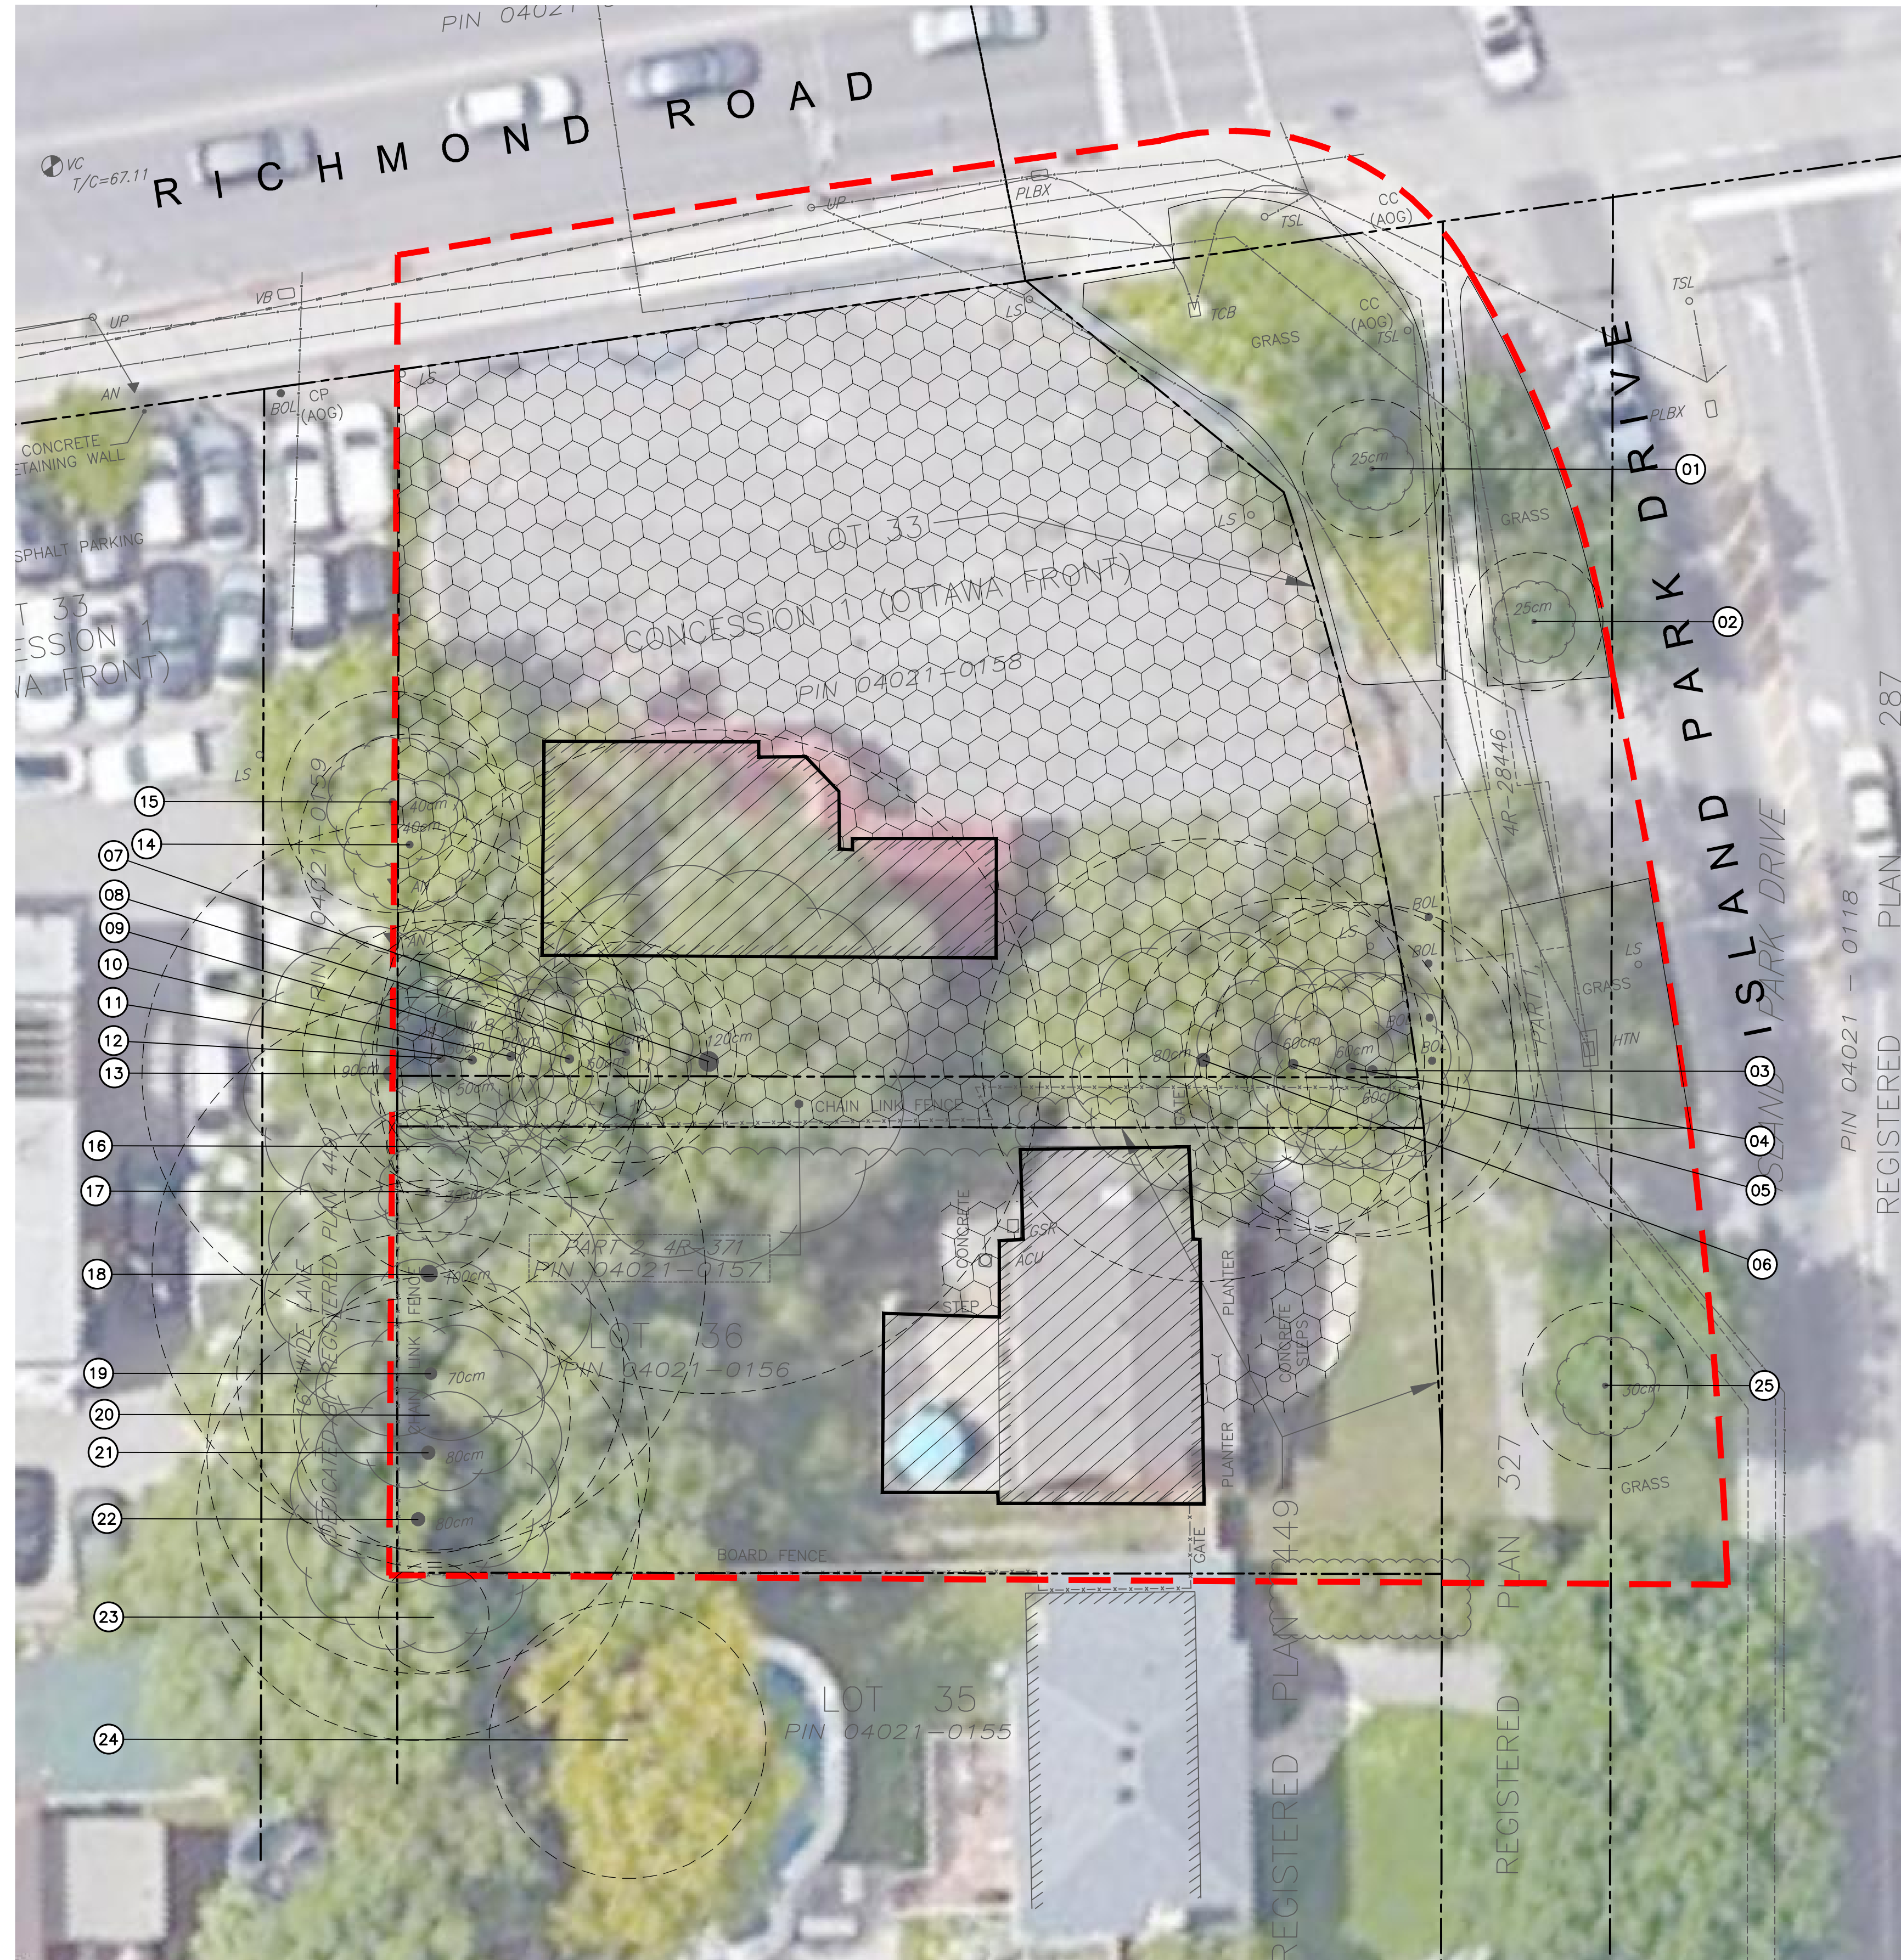
- GENERALLY, THE TREES ON THE PROPERTY ARE IN MODERATE TO POOR CONDITION WITH NEARLY ALL SPECIES BEING INVASIVE.
  - 25 TREES WERE INVENTORIED WITHIN OR IN PROXIMITY TO THE PROJECT.

- 18 TREES ARE WITHIN THE PROJECT PROPERTY LIMITS, 2 TREES ARE SHARED WITH THE CITY, 2 TREES ARE ON AN ADJACENT PROPERTY AND 3 TREES ARE IN THE ISLAND PARK DRIVE RIGHT-OF-WAY.

- THE TWO TREES IN THE ISLAND PARK DRIVE RIGHT-OF-WAY WILL BE SIGNIFICANTLY IMPACTED WITH CONSTRUCTION UP TO THE PROPERTY LIMIT.
  - THE TREES ARE OF MODERATE SIZE WITH SOME POSITIVE IMPACTS TO THE USERS ALONG ISLAND PARK DRIVE.

- BOTH TREES HAVE MINOR AFFLICTIONS THAT WILL PRESENT AS MORE SERIOUS STRUCTURAL PROBLEMS AS THE TREES CONTINUE TO MATURE.

Tree #	Botanical Name	Common Name	DBH (cm)	Ownership	Condition	High Quality Tree	Rare Tree	Comments	Arborist Recommendation	Removal Reason
1	Ulmus americana 'cultivar'	Elm cultivar	25	NCC	Good	No	No	Symmetrical canopy, Poor branch angle, Single stem, Co-dominant leaders: 2 at ~2m above grade, Large scar on upper limb, Absent central leader, Significant split of main trunk	Remain	
2	Ulmus americana 'cultivar'	Elm cultivar	25	NCC	Good	No	No	Asymmetrical canopy, Die-back <5% at canopy, Single stem	Remain	
3	Ulmus pumila	Siberian Elm	60	Private	Moderate	No	No	Symmetrical canopy, Die-back ~15%, Poor branch angle, Single stem, Co-dominant leaders: 3 at ~2m above grade, Bark rot at limbs	Remove	Construction conflict
4	Ulmus pumila	Siberian Elm	60	Private	Moderate	No	No	Asymmetrical canopy, Die-back ~10%, Single stem, Bark rot at limbs	Remove	Construction conflict
5	Ulmus pumila	Siberian Elm	60	Private	Moderate	No	No	Asymmetrical canopy, Die-back ~10%, Single stem, Bark rot at limbs	Remove	Construction conflict

6	Ulmus pumila	Siberian Elm	80	Private	Moderate	No	No	Asymmetrical canopy, Die-back ~20%, Poor branch angle, Single stem, Co-dominant leaders: 2 at ~4m above grade, Heart rot at trunk, girdled around adjacent tree	Remove	Construction conflict
7	Ulmus pumila	Siberian Elm	120	Private	Moderate	No	No	Asymmetrical canopy, Die-back ~10% at canopy, Multi stem: 2, Bark rot at limbs, girdled around adjacent tree, girdled around adjacent tree	Remove	Construction conflict
8	Ulmus pumila	Siberian Elm	40	Private	Poor	No	No	Asymmetrical canopy, Die-back ~40% at canopy, Broken limbs, Single stem, Co-dominant leaders: 2 at ~4m above grade, Bark rot at limbs	Remove	Construction conflict
9	Ulmus pumila	Siberian Elm	50	Private	Moderate	No	No	Asymmetrical canopy, Die-back ~10%, Broken limbs, Single stem, Co-dominant leaders: 2 at ~6m above grade, Bark rot at limbs	Remove	Construction conflict
10	Ulmus Americana & Acer Saccharum	American Elm & Sugar Maple	50	Private	Moderate	No	No	Asymmetrical canopy, Die-back ~5-10%, Poor branch angle, Single stem, Bark rot at trunk & limbs, Maple has large scar at trunk flare	Remove	Construction conflict

11	Ulmus pumila	Siberian Elm	50	Private	Moderate	No	No	Asymmetrical canopy, Die-back ~20%, single stem, Bark rot at limbs	Remove	Construction conflict
12	Ulmus pumila	Siberian Elm	50	Private	Poor	No	No	Asymmetrical canopy, Die-back ~30% at canopy, Poor branch angle, Single stem, Co-dominant leaders: 2 at ~4m above grade, Bark rot at trunk & limbs, Hazard tree	Remove	Construction conflict
13	Ulmus pumila	Siberian Elm	90	City/Private	Poor	No	No	Asymmetrical canopy, Die-back ~20% at canopy, Single stem, Heart rot at trunk, Bark rot at limbs, Leaning, Hazard tree, Cavity & rot at trunk flare	Remove	Construction conflict
14	Ulmus pumila	Siberian Elm	40	Private	Moderate	No	No	Asymmetrical canopy, Die-back ~30%, Single stem, Bark rot at limbs	Remove	Construction conflict
15	Acer negundo	Manitoba Maple	40	City/Private	Moderate	No	No	Asymmetrical canopy, Broken limbs, Single stem, Co-dominant leaders: 2 at ~2m above grade, Leaning	Remove	Construction conflict

16	Acer platanoides	Norway Maple	15	Private	Moderate	No	No	Asymmetrical canopy, Die back ~20% @ canopy, Poor branch angle, Single stem	Remove	Construction conflict
17	Ulmus pumila	Siberian Elm	30	Private	Poor	No	No	Symmetrical canopy, Die back ~50% @ canopy, Broken limbs, Pruned limbs @ OH Utilities, Single stem, Leaning	Remove	Construction conflict
18	Ulmus pumila	Siberian Elm	100	Private	Moderate	No	No	Asymmetrical canopy, Die back ~15% @ canopy, Broken limbs, Pruned limbs @ OH Utilities, Single stem, Co-dominant leaders: 2 @ ~2m above grade, Bark rot @ trunk	Remove	Construction conflict
19	Ulmus pumila	Siberian Elm	70	Private	Moderate	No	No	Asymmetrical canopy, Broken limbs, Pruned limbs @ OH Utilities, Single stem	Remove	Construction conflict
20	Ulmus pumila	Siberian Elm	50	Private	Moderate	No	No	Asymmetrical canopy, Pruned limbs @ OH Utilities, Single stem, Leaning	Remove	Construction conflict

21	Ulmus pumila	Siberian Elm	80	Private	Moderate	No	No	Asymmetrical canopy, Pruned limbs @ OH Utilities, Single stem, Leaning, Dead leader	Remove	Construction conflict
22	Ulmus pumila	Siberian Elm	80	Private	Poor	No	No	Asymmetrical canopy, Broken limbs, Pruned limbs @ OH Utilities, Poor branch angle, Single stem, Bark rot @ cavities, Leaning	Remove	Construction conflict
23	Aesculus hippocastanum	Horse Chestnut	~20	Private	Good	No	No	Asymmetrical canopy, Single stem. Access to private property not available - approximate caliper only	Remain	
24	Gleditsia triacanthos	Honey Locust	~50	Private	Good	No	No	Symmetrical canopy, Die back ~15% @ canopy, Single stem. Access to private property not available - approximate caliper only	Remain	
25	Ulmus pumila	Siberian Elm	30	NCC	Good	No	No	Symmetrical canopy, Die back ~5% @ branches, Single stem, Bark rot @ crotches	Remain
