March 19, 2020

RE: TREE CONSERVATION REPORT FOR 1330 CARLING AVENUE, OTTAWA

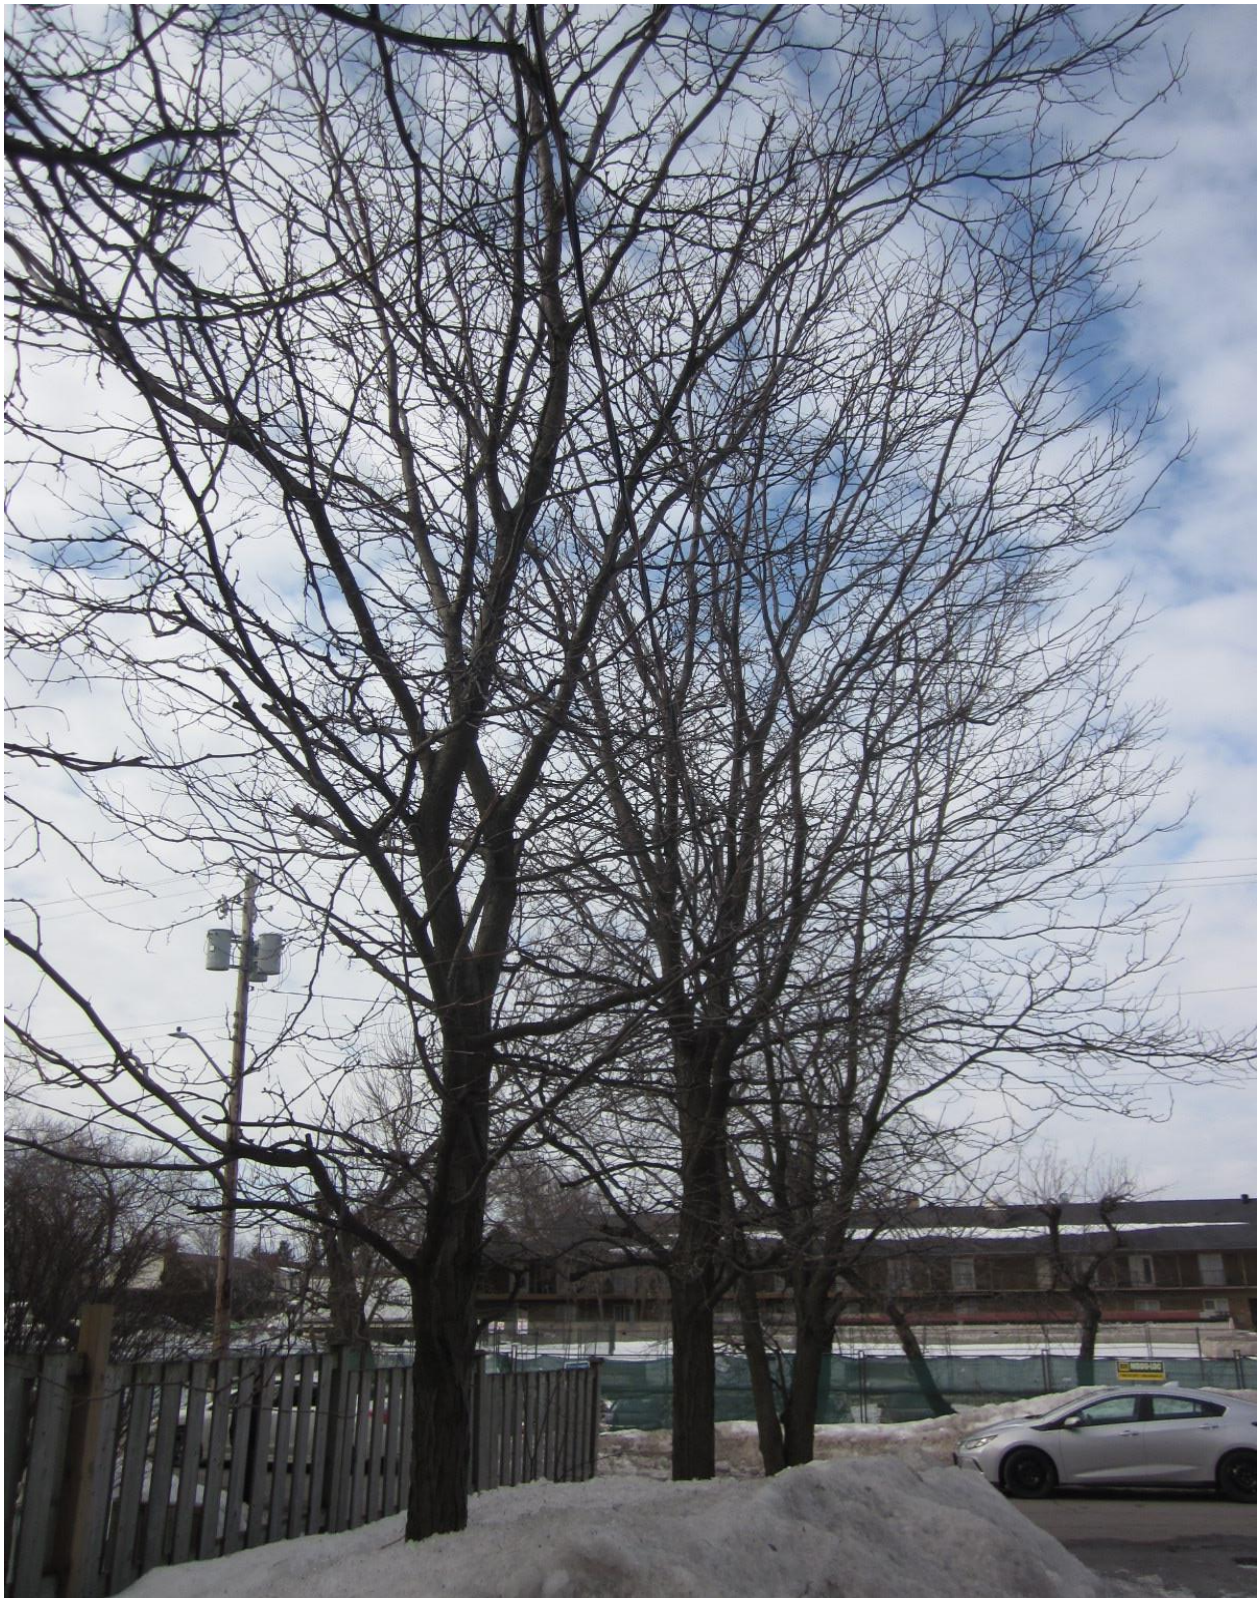
Tree No.	Tree species	Condition (VP→E)	DBH ¹ (cm)	Owner -ship	Age class, tree condition notes & preservation status (to be removed or preserved and protected)
1	Honey-locust (<i>Gleditsia triacanthos</i>)	Fair	24 & 20	City	Mature; double stemmed at 0.7m from grade; lower branch loss/damage from passing trucks; root collar obscured by piled snow; restricted rooting area; to be removed

2	Honey-locust	Good	30	Private	Mature; upright growth form due to proximity of building; root collar obscured by snow; restricted rooting area; to be removed
3	Honey-locust	Good	25	Private	Mature; upright growth form; root collar obscured by snow; restricted rooting area; to be removed
4	Honey-locust	Good	26	Private	Mature; upright growth form; central stem with competing lateral at 1.7m on south side; co-dominant leaders; good root collar; restricted rooting area; to be removed
5	Honey-locust	Good	23	Private	Mature; upright growth form; co-dominant leaders at 4m - Nectria dieback (<i>Nectria cinnabarina</i>) present at union; fair root collar – one embedded binding root; very restricted rooting area; to be removed
6	Honey-locust	Good	22	Private	Mature; strongly upright growth form; central stem with competing lateral at 2m – strong union; good root collar; very restricted rooting area; to be removed

Picture 1. Trees #1, 2 and 3 (background to foreground) located at 1330 Carling Avenue, Ottawa

All of the trees on the subject property are proposed for removal either due to conflicts with the extent of excavation required for the underground parking structure, in the case of trees #1 through 8, or due to their present poor condition - in the case of trees #9, 10 and 11. Permission for the removal of tree #11 should be sought first from the adjacent land owner.

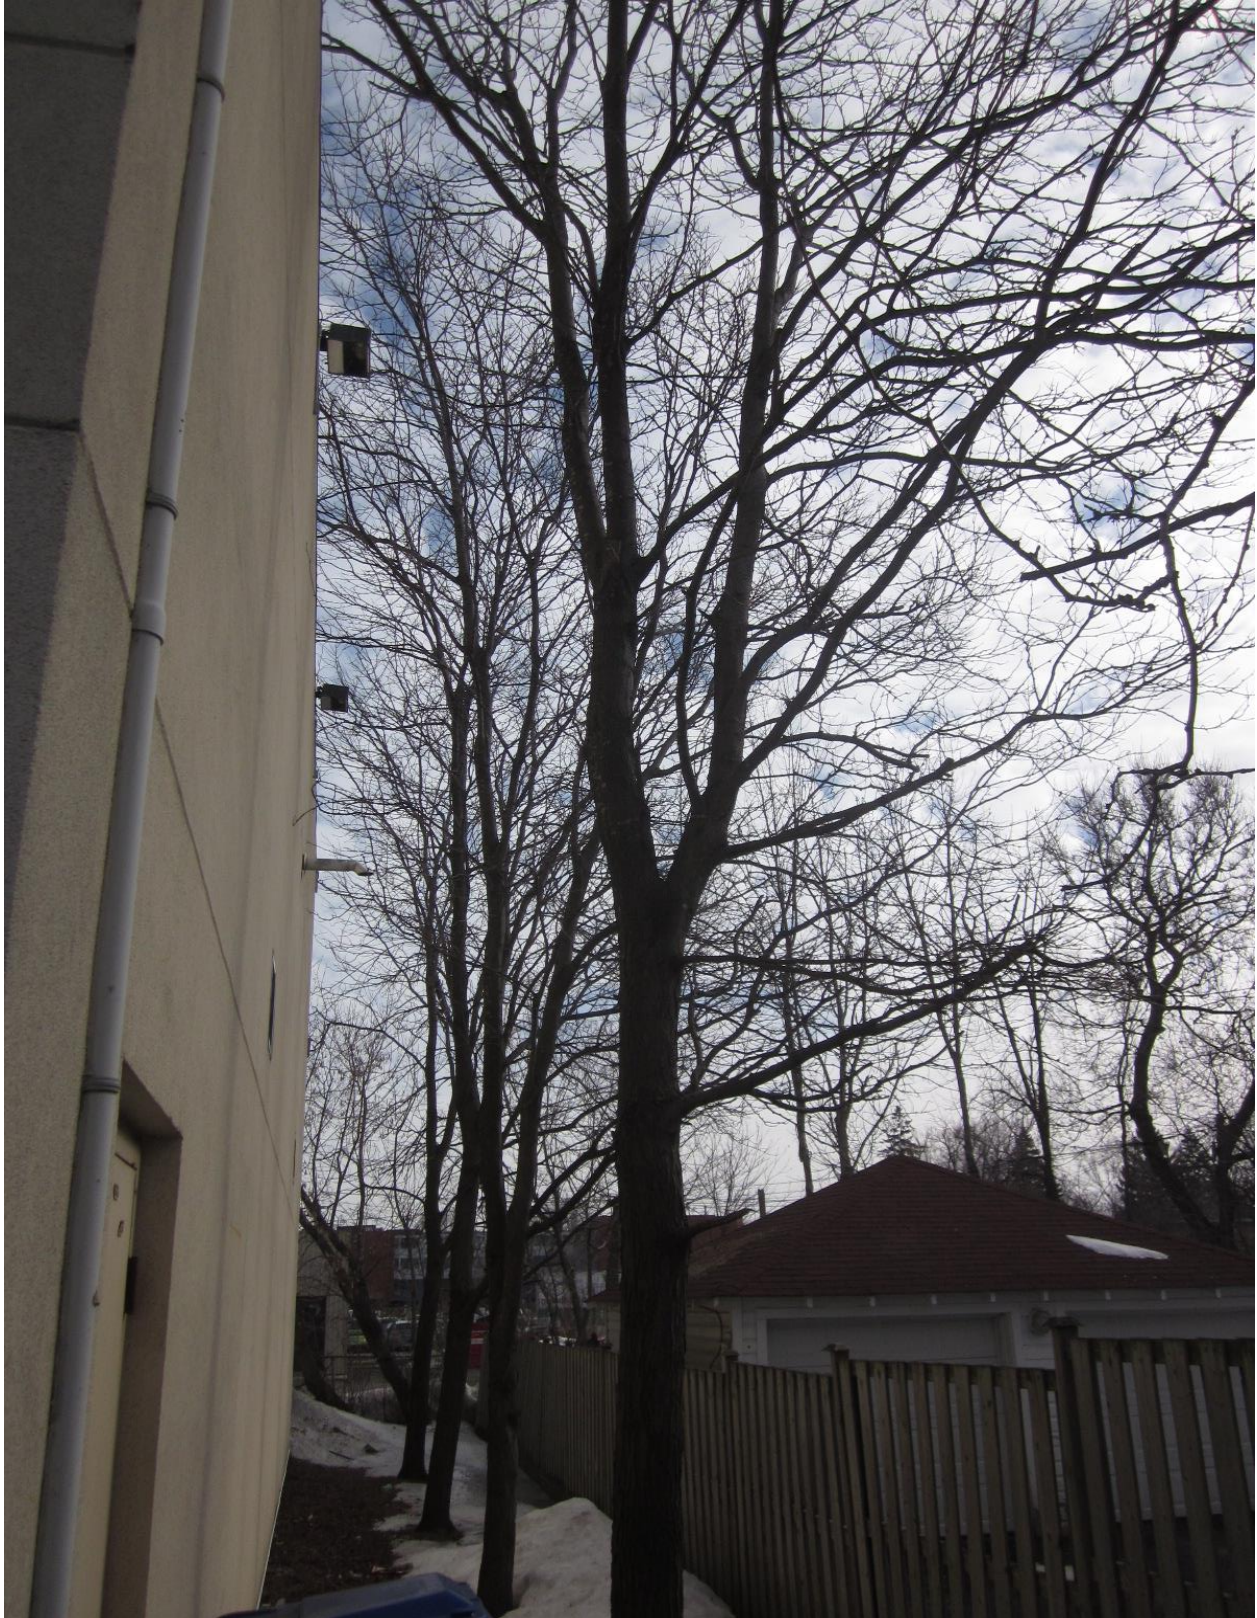
7	Honey-locust	Good	26	Private	Mature; strongly upright growth form; central stem with competing leaders at 4m; good root collar; to be removed
8	Honey-locust	Good	25	Private	Mature; upright growth form; central stem with competing lateral on east side at 3m and competing leaders at 4.5m; crown asymmetrical towards southeast; to be removed
9	Manitoba maple (<i>Acer negundo</i>)	Poor	26	Shared	Mature; heavily divergent form towards north; located on outside of chain-link fence; naturalized species; to be removed
10	Manitoba maple	Poor	23	Shared	Mature; heavily divergent form towards north; located on inside of chain-link fence; to be removed
11	Ash (<i>Fraxinus</i> spp.)	Dead	+/-25	Neighbour	Dead due to emerald ash borer (<i>Agrilus planipennis</i>); native species; Recommended for removal

Picture 2. Locust trees #5, 6, 7 and 8 (and maples #9 and 10 in background) located at 1330 Carling Avenue, Ottawa
