July 29, 2022

**RE: TREE PROTECTION AND PRESERVATION REPORT FOR CITY MAPLE AT 1364-1370
STITTSVILLE MAIN STREET**

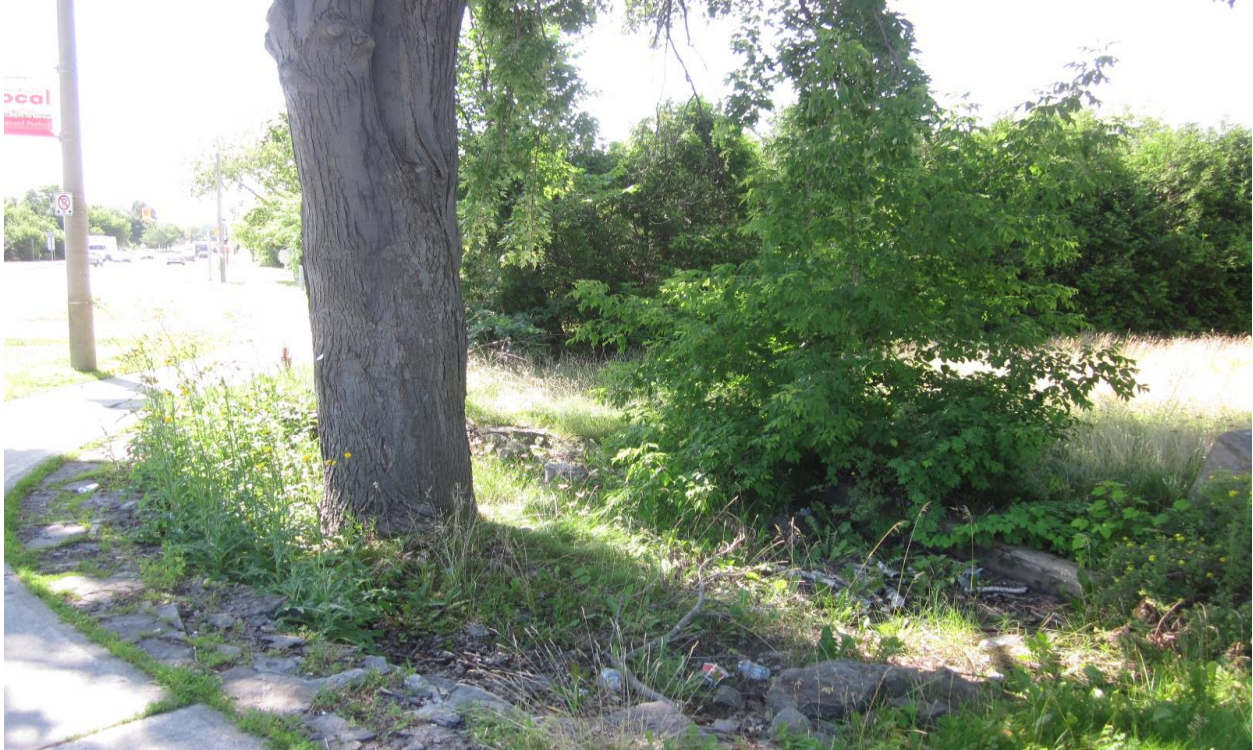
- 3) Rooting is restricted to the northeast by a concrete sidewalk less than 2m away. It is partially restricted to the northwest by the aforementioned compacted stone driveway and is completely unrestricted in all other directions (see Pictures 1 and 2 on page 4).

Picture 1. Looking southward - lower bole and existing growing environment of mature red maple located within City of Ottawa ROW adjacent to 1364-1370 Stittsville Main Street (proposed building will be located to the right)

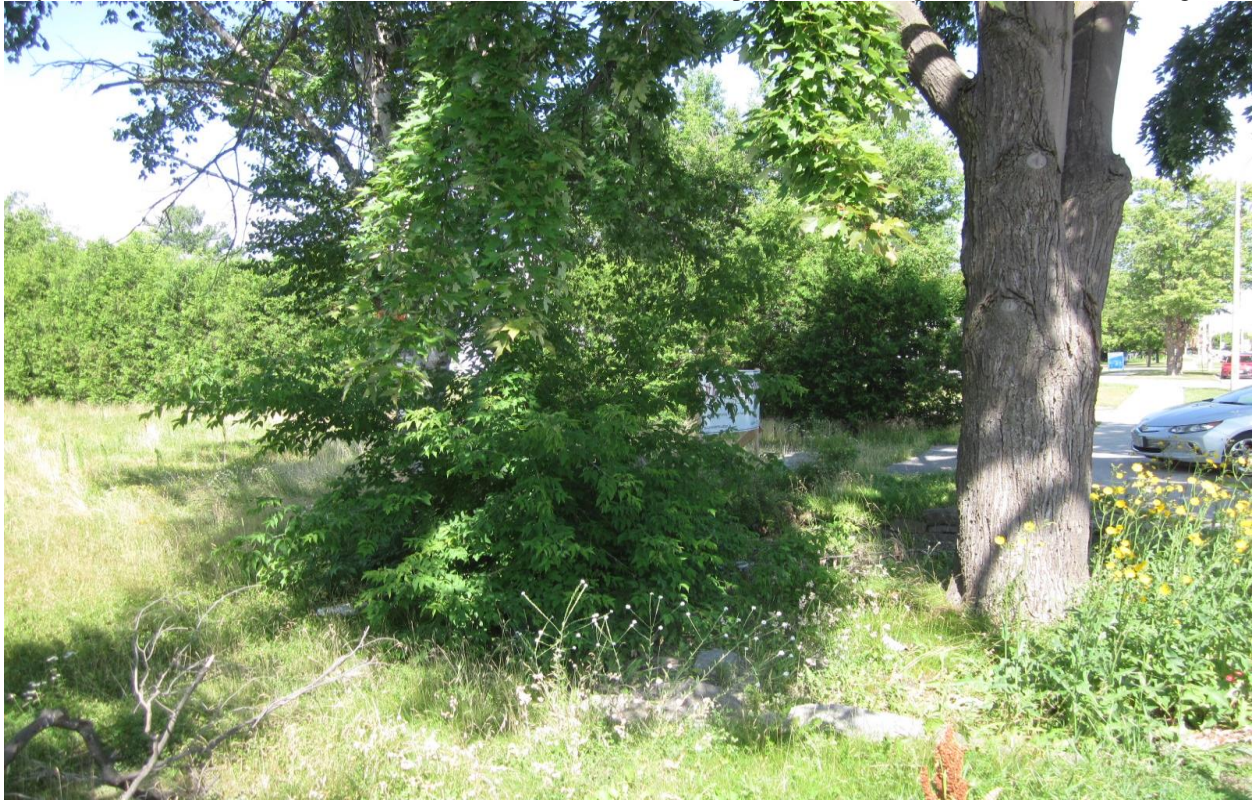
Picture 2. Looking towards northwest - lower bole and existing growing environment of mature red maple located within City of Ottawa ROW adjacent to 1364-1370 Stittsville Main Street (proposed building will be located to the left of tree)

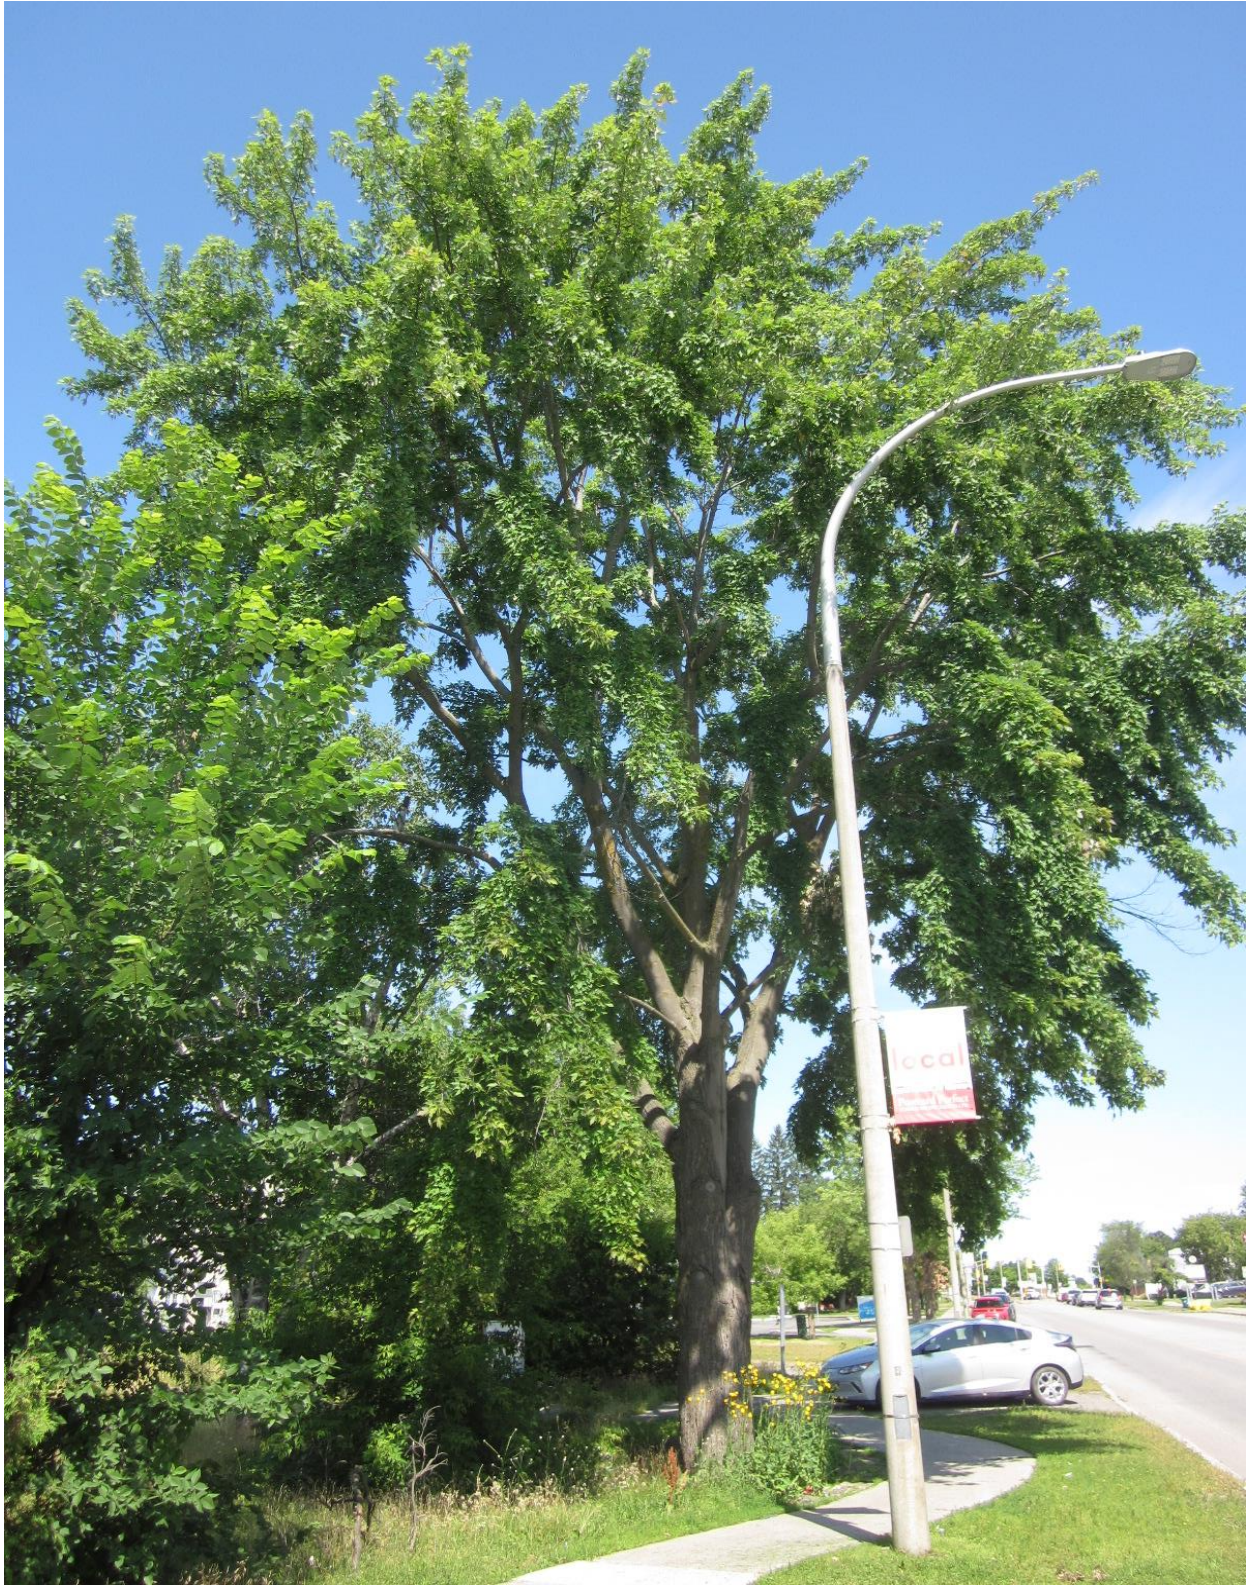
- 4) Root flares at the tree's root collar are not visible indicating the grade was likely raised around the tree in the past.
- 5) The tree's crown is comprised of a central stem with competing and suppressed laterals arising at 3.5m from grade. The crown is broad with a moderately good density of foliage. At the time of inspection the crown showed less than ten percent dieback.

Picture 3. Crown and existing growing environment of mature red maple located within City of Ottawa ROW adjacent to 1364-1370 Stittsville Main Street (all pictures taken July 2022).

Over the next several years the maple should be monitored and any dieback or dead branches be pruned from the crown.
