McINTOSH PERRY

COMBINED LATERAL SEWER CCTV INSPECTION

**637 CUMMINGS AVENUE
OTTAWA, ONTARIO**

Tuesday, May 17, 2022

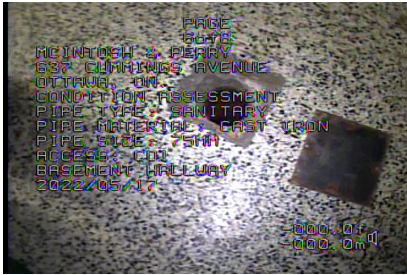
0.0 m

Figure#1: Start of inspection at access point HALLWAY FLOOR CO

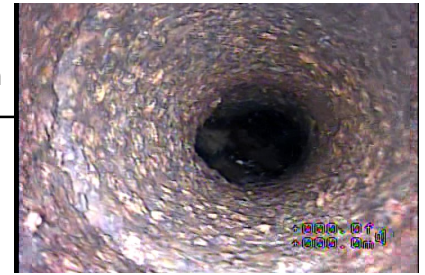
0.0 m

Figure#2: A view to the line deviation downwards at 0.0 meters. Notice the rough surface in the pipe wall.

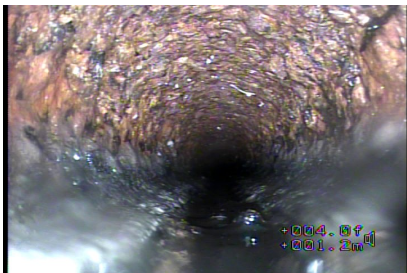
0.6 m

Figure#3: A view to the 0% water level, grease and surface wear large due to corrosion at 1.2 meters.

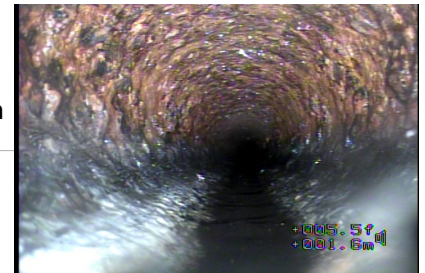
1.6 m

Figure#4: A view to the Surface Wear Large due to corrosion and grease at 1.6 meters from the top of the floor CO.

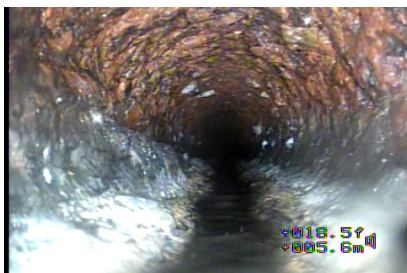
5.6 m

Figure#5: A view to the Roughness in the pipe walls and grease at 5.6 meters from the top of HALLWAY FLOOR CO.

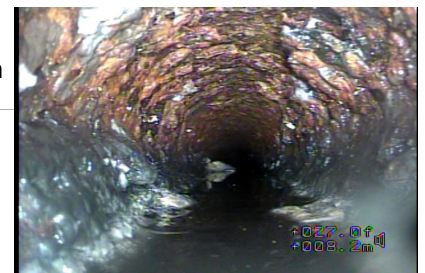
8.2 m

Figure#6: A view to the Pipe wall falling apart due to surface wear large at 8.2 meters from the top of the floor CO.

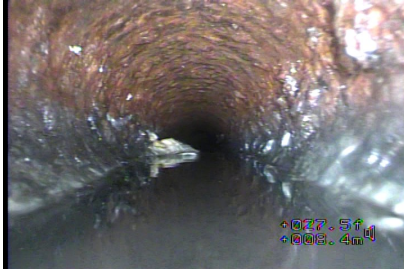
Figure#7: A view to the 10% water level and debris ragging at 8.4 meters from the top of HALLWAY FLOOR CO.

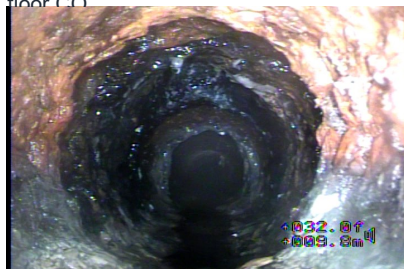
Figure#9: A view to the diameter change to 150mm and 12 o'clock connection at 9.8 meters from the top of floor CO.

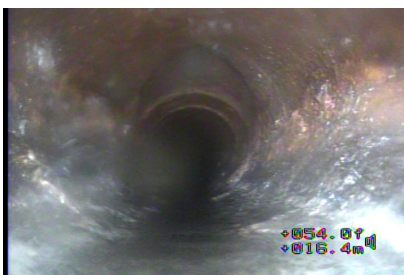
Figure#11: A view to the 150mm 12 o'clock connection at 16.4 meters from the top HALLWAY FLOOR CO.

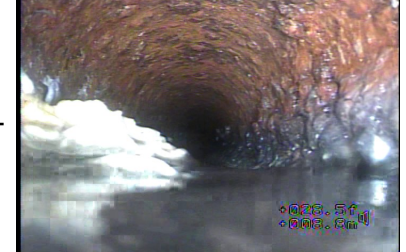
Figure#8: A view to the 10 % Debris ragging at 9.8 meters from the top of HALLWAY FLOOR CO.

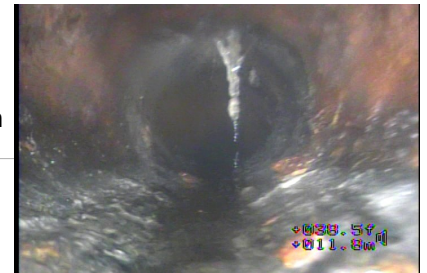
Figure#10: A view to the 50mm 12 o'clock connection at 11.8 meters from the top HALLWAY FLOOR CO.

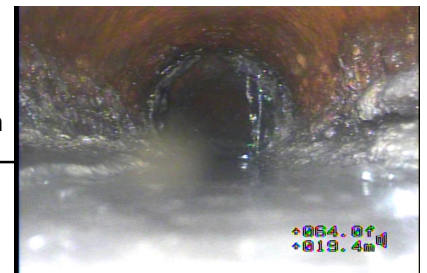
Figure#12: A view to the 100mm 12 o'clock connection at 19.4 meters from the top HALLWAY FLOOR CO.

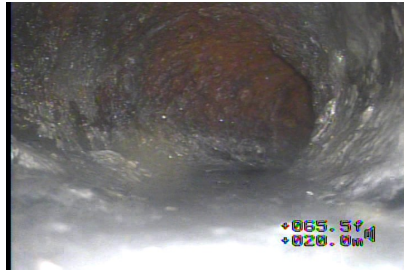
20.0 m

Figure#13: A view to the right line deviation at 20.0 meters from the top of HALLWAY FLOOR CO.

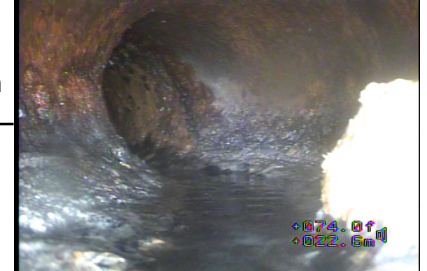
22.6 m

Figure#14: A view to the left line deviation at 22.6 meters from the top of HALLWAY FLOOR CO.

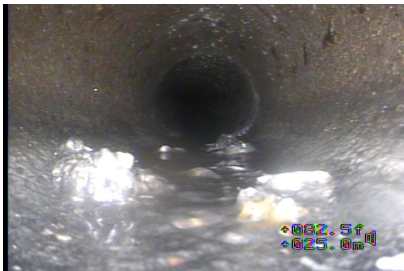
25.0 m

Figure#15: A view to the 150mm 12 o'clock connection at 25.0 meters from the top of HALLWAY FLOOR CO.

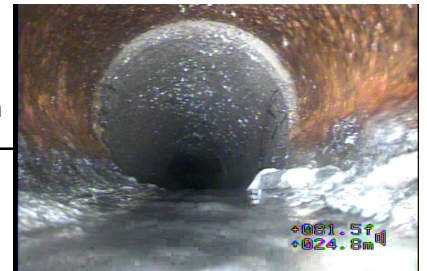
24.8 m

Figure#16: A view to the material change to Asbestos cement at 24.8 meters from the top of HALLWAY

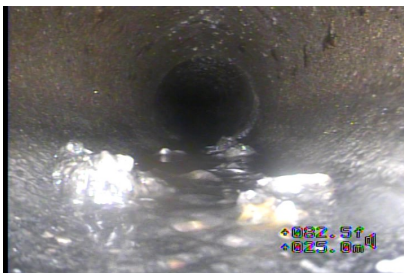
25.0 m

Figure#17: A view to the 10 % Debris ragging and sediment at 25.0 meters from the top of HALLWAY FLOOR CO.

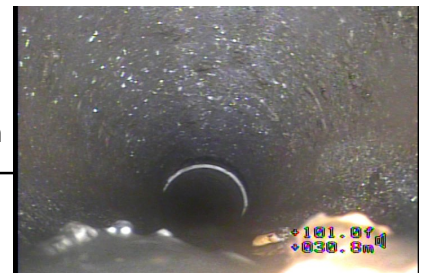
30.0 m

Figure#18: A view to the line deviation downwards at 30.0 meters from the top of HALLWAY FLOOR CO. Angular

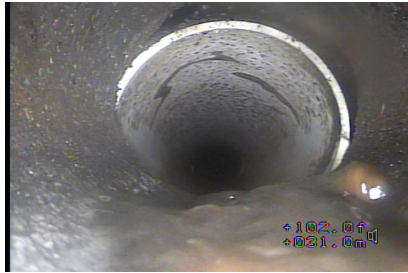
Figure#19: A view to the joint displaced large (angular offset) at 31.0 meters from the top of HALLWAY FLOOR CO.
